# The 26 December (Boxing Day) 1997 sector collapse and debris avalanche at Soufriere Hills Volcano, Montserrat

**Abstract:** The southern sector of Soufriere Hills Volcano failed on 26 December 1997 (Boxing Day), after a year of disturbance culminating in a devastating eruptive episode. Sector collapse produced a c.  $50 \times 10^6 \text{ m}^3$  volcanic debris avalanche, and depressurized the interior of the lava dome, which exploded to generate a violent pyroclastic density current. The south-directed growth of a lava lobe and build-up of lava-block talus, since early November 1997, brought the hydrothermally weakened sector to a condition of marginal stability. Limit-equilibrium stability analyses and finite-difference stress-deformation analyses, constrained by geomechanical testing of edifice and debris avalanche materials, suggest that the sector collapse was triggered by a pulse of co-seismic exogenous lava shear-lobe emplacement. Slip-surface localization was influenced by strain-weakening.

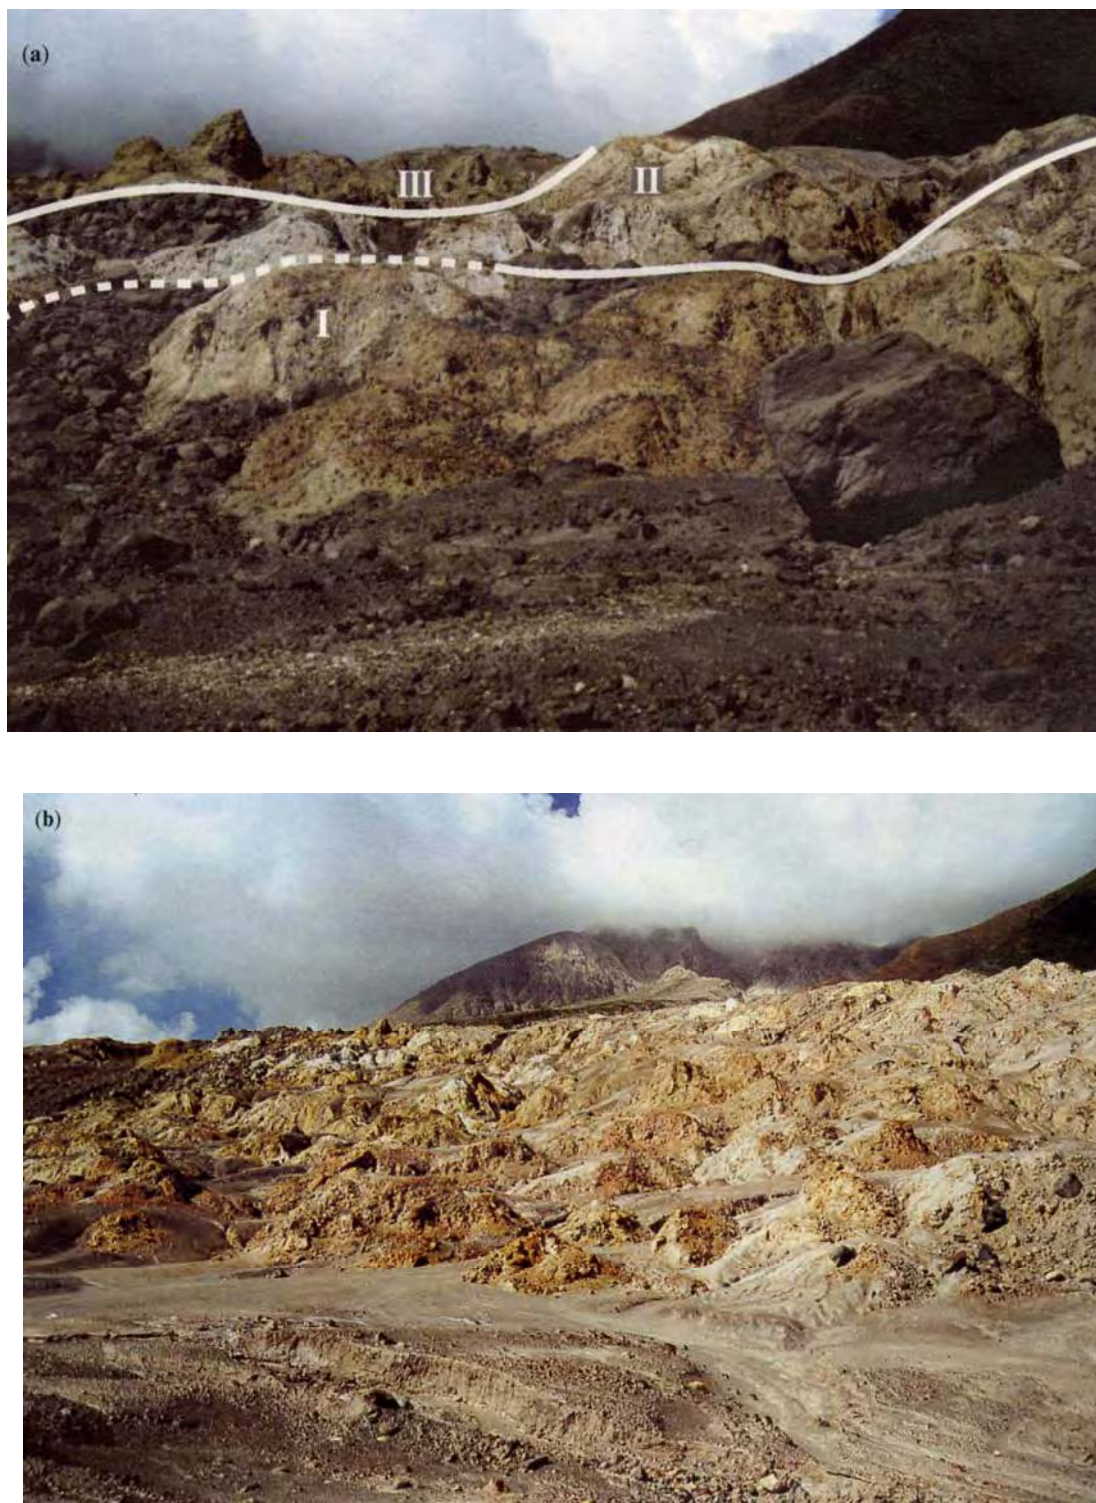
Fig. 21. Debris avalanche morphology and structure in distal region, (a) Stair-stopped sets of the main coloured unit/subunit lithologies, shown by roman numerals, with frontal ridges I 5-20 m high. March 1999. Surface is hummocky with 3-10 m relief (photo J.C.K.). (b) Distal hummock field in avalanche deposit in March 1999, showing multicoloured lithologies (cf. Fig. 4). Relief 2-5 m (photo J.C.K.). (c) Soufriere Subunit hummock on 8 March 1999, buried by flat-surfaced, coarse Boxing Day pyroclastic density current deposits containing reworked avalanche clasts. Relief 3-4 m. Top surface is covered by fine pyroclastic density current deposits. Near sample location 8-1 (Fig. 23) (photo A.B.B.). (d) Multicoloured hummocky terrain displaying megablock facies (Fumarolic Unit), partly buried by flat-surfaced, olive-grey, pyroclastic density current deposit sequence (foreground). Post-depositional erosion channel on right. 8 March 1999 (photo B.V.)

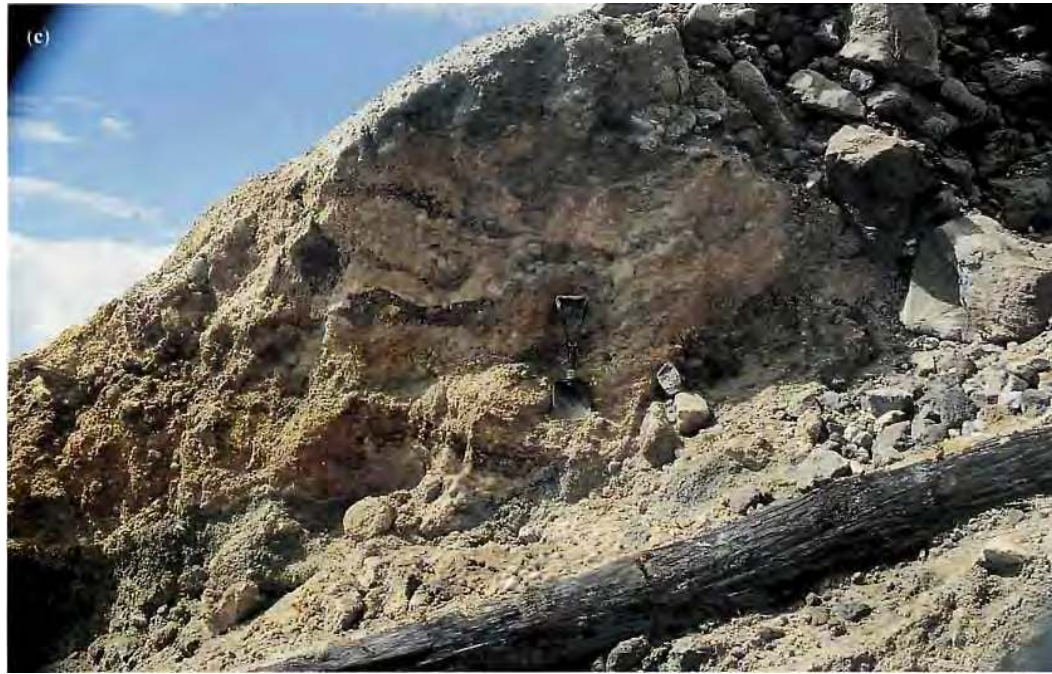
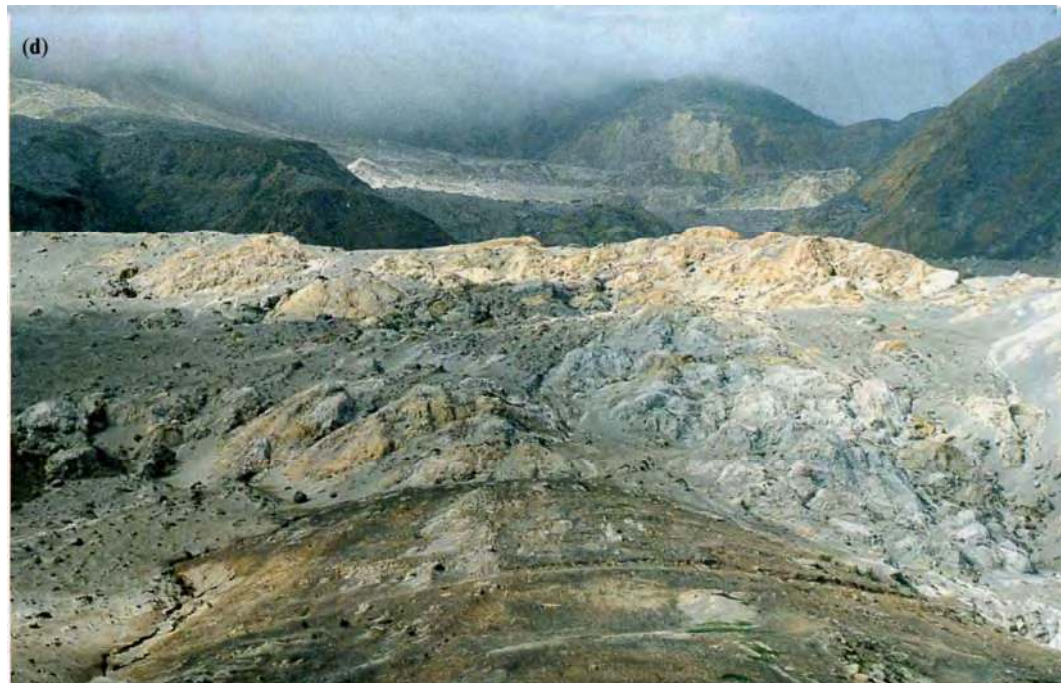
**Fig. 22.** Overflow areas, medial region, (a) Sweeping view to south of White River valley from above upper bend at Fergus Mountain, June 1998. Avalanche ramped over west bank, toward Morris', and formed levee-like deposit over inside bend of east bank. Hummocky distal deposit at upper left shows frontal avalanche lobes. Valley centre filled by coarse pyroclastic density current deposits, and post-Boxing Day block-and-ash flow and lahar deposits. Pyroclastic density current deposits include arcuate deposit inside bend at lower left, and table-shaped overflow pyroclastic deposit in left-centre (photo J.C.K.). (b) Overflow areas viewed toward west in June 1998, showing complex pile-up of avalanche debris against and over the west channel bank (photo J.C.K.). Avalanche deposits on Fergus Mountain flank at lower right (for detailed view, see Fig. 20c). (c) Detail at east edge of Fergus Mountain overflow, January 1998 (photo B.V.). View to west. Sheared Soufriere Subunit pyroclastic sequence on left, talus unit on right. Near sample location 15-2 (Fig. 23). (d) View of Morris' overbank deposit, 8 July 1998, showing prominent hummocky flow front 20-40 m high (photo MVO). Ground surface in front of avalanche was scoured by the subsequent pyroclastic density current (grey deposits) and was veneered by a tar-like coating. A second flow front in the avalanche deposit is in sunlight a few hundred metres behind first flow front.

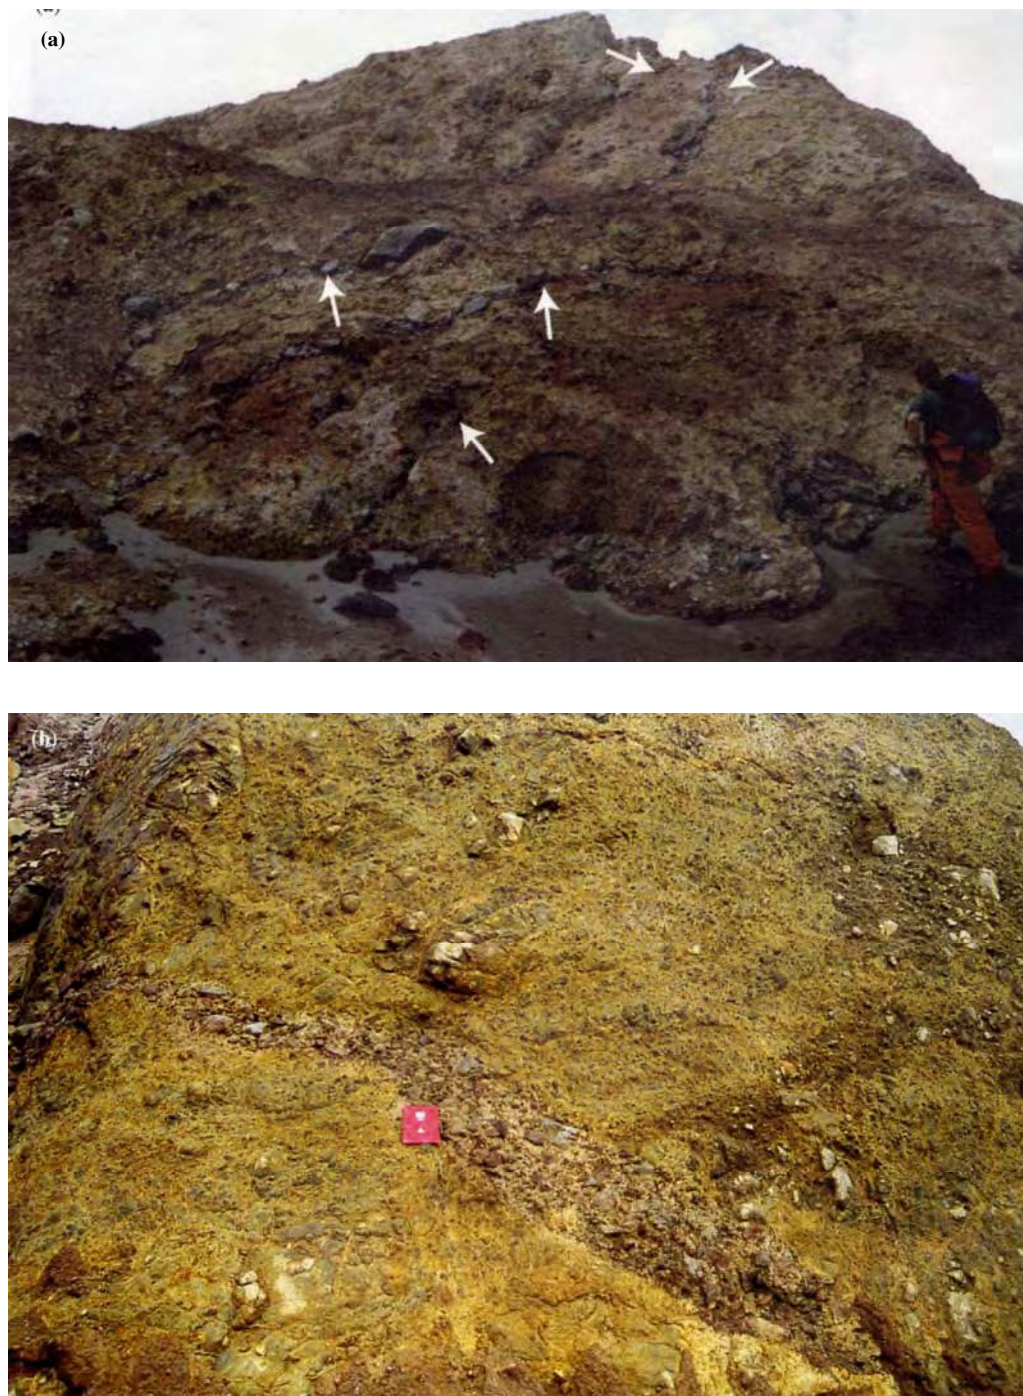
**Fig. 24.** Deformation structures in avalanche deposit (photos J.C.K.). (a) Dome lava clasts intruded as elastic dykes (arrows) into massive Soufriere Subunit materials in the Morris' overflow deposit, upper lobe, in June 1998. (b) Clastic dykes of dome lava clasts intruded into Chartreuse Subunit materials, probable toeva block, east side of proximal region of avalanche deposit in June 1998. Lava clasts were probably derived from November 1997 block-and-ash flow deposits forming the valley surface material before the sector collapse. (c) Shearing of soft avalanche blocks into elongate slivers that enclose more rigid blocks. Distal region in June 1998. (d) Flattened, sheared block texture in avalanche deposit in distal region in March 1999. Shearing prominent near basal part of 20 m flow front. Chartreuse Subunit overlain in sharp contact by Soufriere Subunit, with dome lava Talus Unit on top.

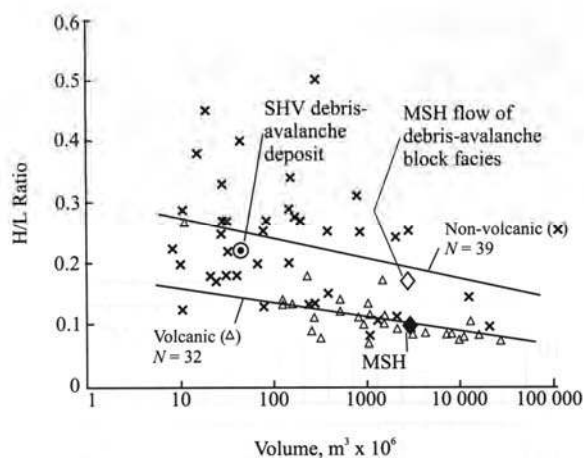
**Fig. 25.** Ratio of vertical fall height ( $H$ ) to horizontal runout distance ( $L$ ) versus volume for volcanic (triangles) and non-volcanic (crosses) debris avalanches, with regression lines after Voight *et al.* (1985). Boxing Day avalanche (SHV) compared with Mount St Helens (MSH) avalanche I (block facies, open diamond), and entire avalanche (black diamond), based on Glicken (1986, 1998).

avalanche 1 (avalanche megablock facies) was characterized by  $H/L = 0.17$ , and the full Mount St Helens avalanche had  $H/L = 0.09$  (Sousa & Voight 1995).  $H/L$  ratios have been observed to be volume-dependent (Fig. 25), with the observed  $H/L$  ratios ranging from 0.09 to 0.18 (average 0.13) for Quaternary volcanic debris avalanches between 0.1 and 1  $\text{km}^3$  in volume, and from 0.04 to 0.13 (average 0.09) for avalanches  $>1 \text{ km}^3$  (Voight *et al.* 1985; Siebert 1996). Thus, from this simple measure, the Boxing Day debris avalanche had low mobility compared to those reported for large volcanic debris avalanches elsewhere (Fig. 25). This result is consistent with the relatively small volume of this deposit in comparison to, say, the Mount Si Helens debris avalanche, and the tortuosity of the channel. Numerical modelling of the emplacement dynamics is considered below.

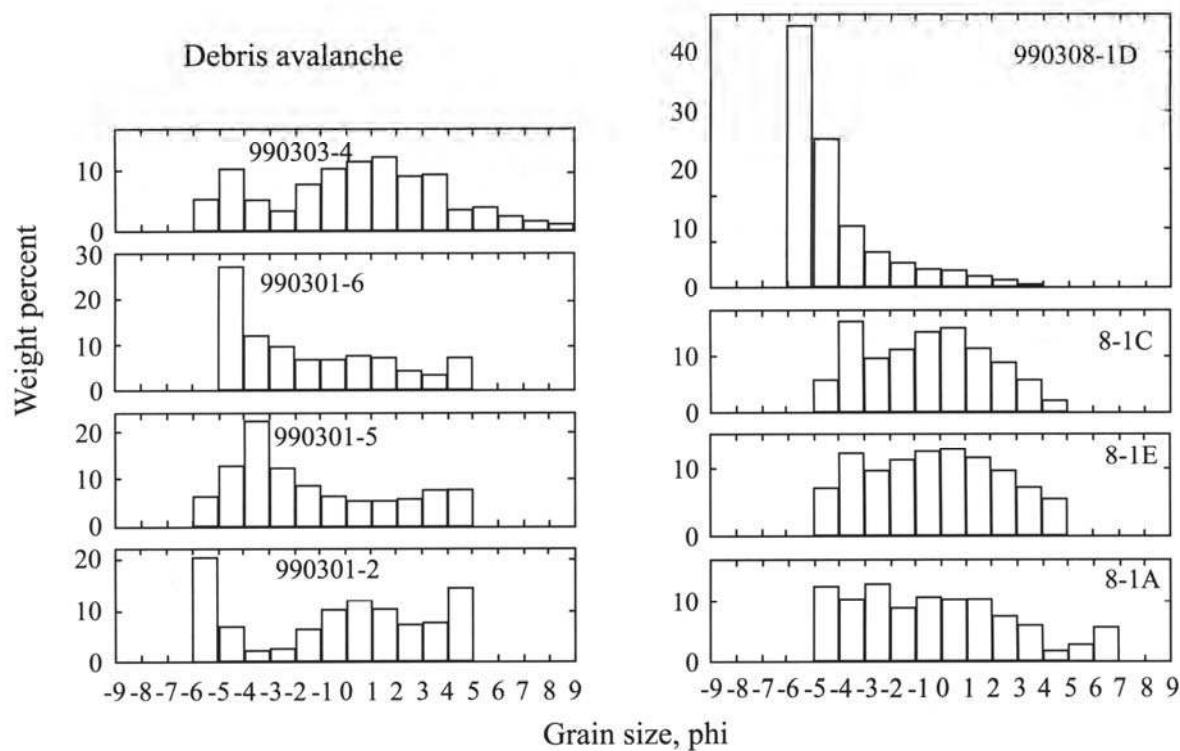
Fig. 27. Typical grain-size histograms of debris avalanche. Sample locations shown in Figure 23.

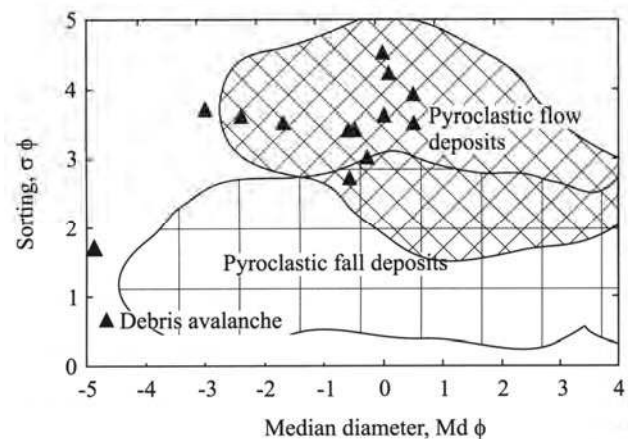
Fig. 28. Sorting and median diameter (Intnan coefficients) for the debris avalanche deposits. Cross-hatched field shows pyroclastic flow deposits after Walker (1971).

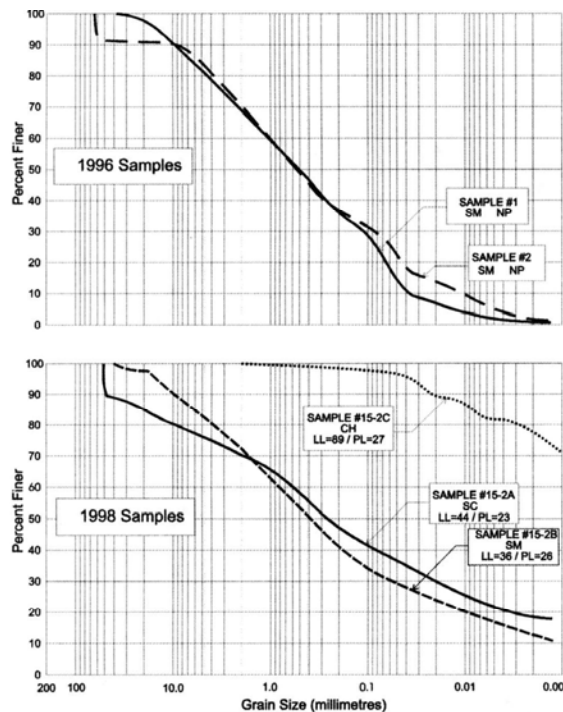
Fig. 30. Size-distribution curves for edifice (1996) and avalanche debris (1998) samples subjected to geotechnical testing.

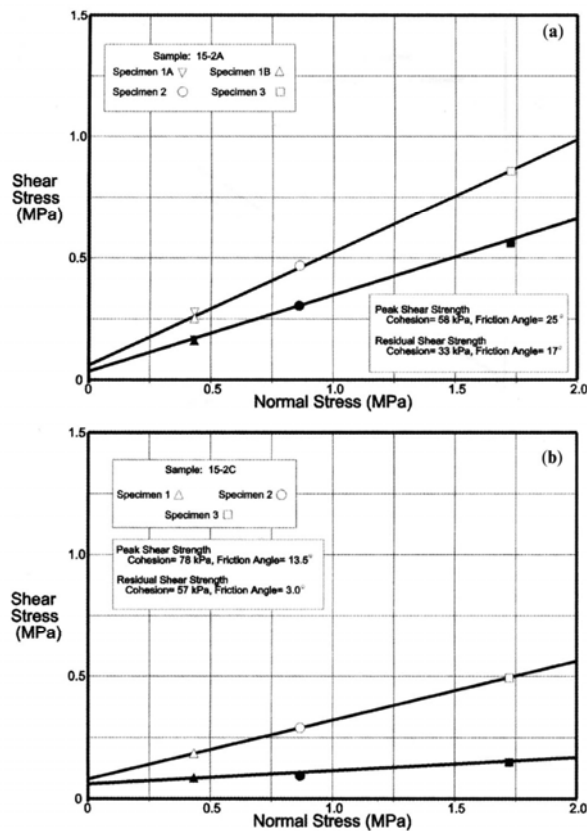
**Fig. 32.** Shear strength versus effective normal stress for Soufriere facies debris avalanche materials subjected to direct-shear tests, (a) Remoulded sample 15-2A, clayey sand with gravel, (b) Block sample 15-2C, highly plastic inorganic clay. Open symbols show peak shear strength; filled symbols show residual shear strength.

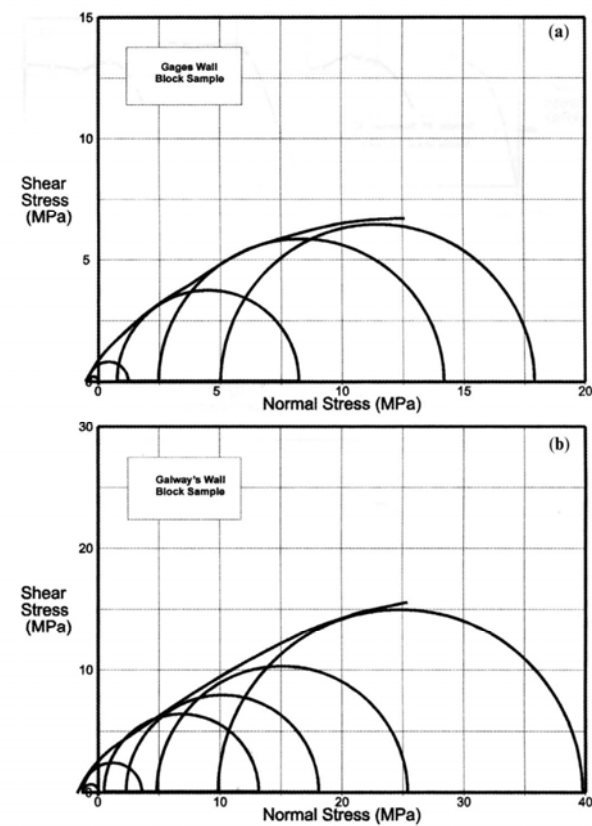
**Fig. 33.** Shear stress versus effective normal stress for intact samples of edifice materials subjected to triaxial and indirect-tension tests. Data plotted as Mohr circles, with curved envelope according to Hoek-Brown criterion, (a) Gages Wall tuff, altered, (b) Galway's Wall tuff

In general, the experimental Mohr-circle data indicated curved strength envelopes as a function of confining pressure. For Galway's Wall tuff, with dry bulk density of  $1980\text{kgm}^{-3}$  and tensile strength of 1.21 MPa, results are shown in Figure 33. The data gave good agreement with the Hoek & Brown (1980) failure criterion that predicts a parabolic envelope for brittle rocks subjected to compressive stress conditions, and approximates classic Griffiths theory in the region of tensile effective normal stresses.

The weathered Gages Wall tuff was less dense and weaker, with dry bulk density of  $1840\text{kgm}^{-3}$  and tensile strength of 0.41 MPa. Coulomb parameters for moderate compressive confining pressures were, approximately, cohesion = 1.7 MPa, friction angle =  $32^\circ$ , although, as noted, the envelope was non-linear (Fig. 33). Corresponding data for fresh dome lava collected in the southwest moat inside English's Crater, and mildly altered lava from prehistoric dome-derived breccia exposed in Galway's Wall, were obtained. Approximate Coulomb friction angles are  $5^\circ$  and  $44^\circ$ , respectively.

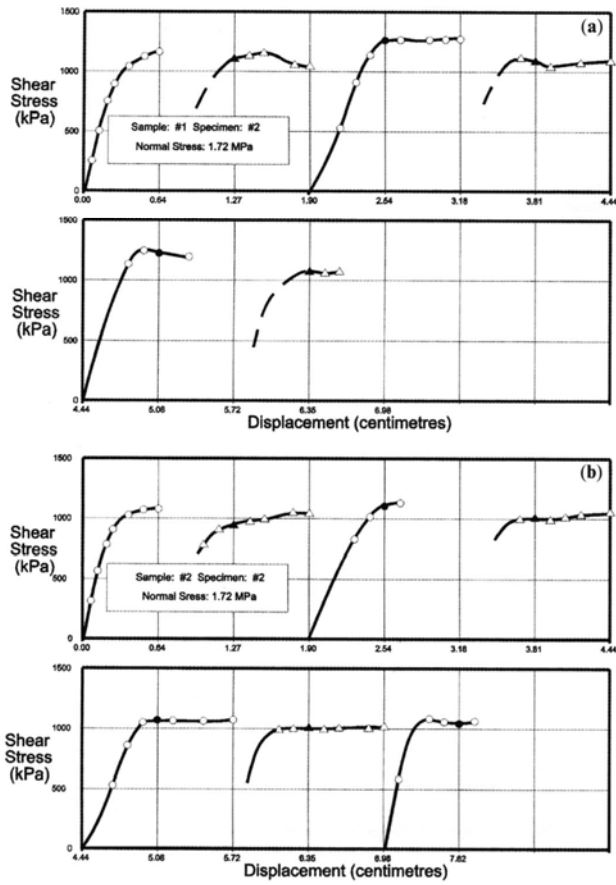
Fig. 34. Shear stress versus displacement for reversal direct-shear tests on disaggregated edifice tufts. Note small strength loss with displacement. (a) Sample 1: Gages Wall tuff, altered, (b) Sample 2: Galway's Wall tuff.

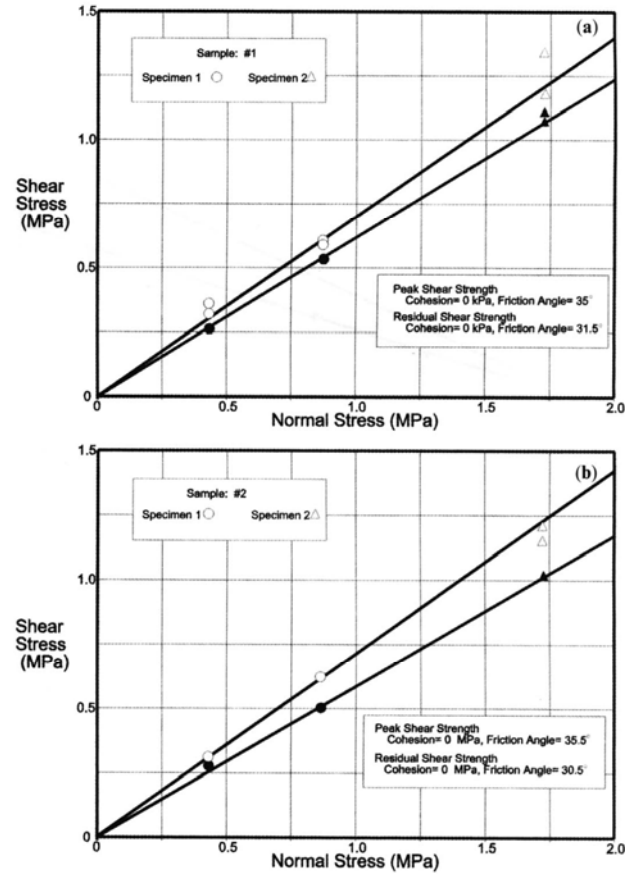
Fig. 33. Shear strength versus effective normal stress for edifice materials subjected to direct-shear tests, (a) Sample 1: Gages Wall tuff, altered, (b) Sample 2: Galway's Wall tuff. Open symbols show peak shear strength; filled symbols show residual shear strength.

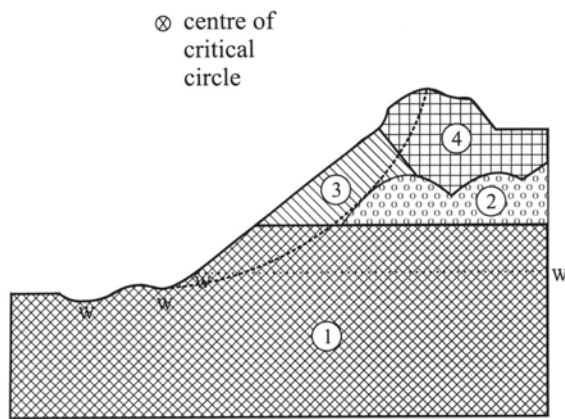
**Fig. 36.** North-south cross-section for Boxing Day collapse, showing materials and slip plane boundaries assumed in limit-equilibrium stability analyses. Material properties are given in Table 1. The water table, indicated by the dotted line at 'w' joins the ground surface at the toe of the slope.

Table 1 lists material properties assumed, specific unit weights, and strength properties given by cohesions and effective-stress friction angles, varied selectively according to material type. The distributions of materials, and piezometric surface assumed, are shown in Fig. 36. A centre of rotation and radius was specified to represent the actual Boxing Day failure surface (assuming it to be circular), as inferred from construction of cross-sections (Fig. 12). The slip surface was assumed to be constrained by the south edge of the partly eroded Galway's Wall (Figs 36 and 9b).

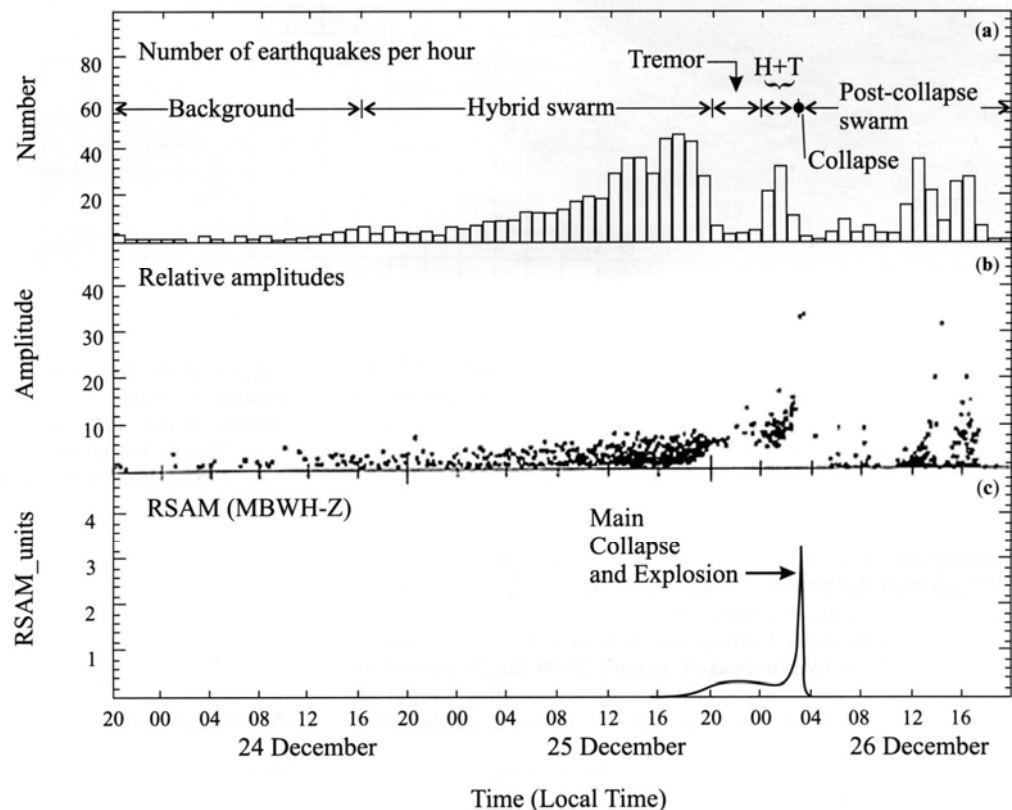
**Fig. 37.** Seismic data for 24-26 December 1997, for MBWH (Windy Hill, vertical component) seismic station (Fig. 2). (a) Number of earthquakes per hour. (b) Amplitudes of hybrid earthquakes as a measure of relative energy in units of  $\text{ms}^{-1}$ . (c) Real-time seismic amplitude measurements (RSAM), in arbitrary.

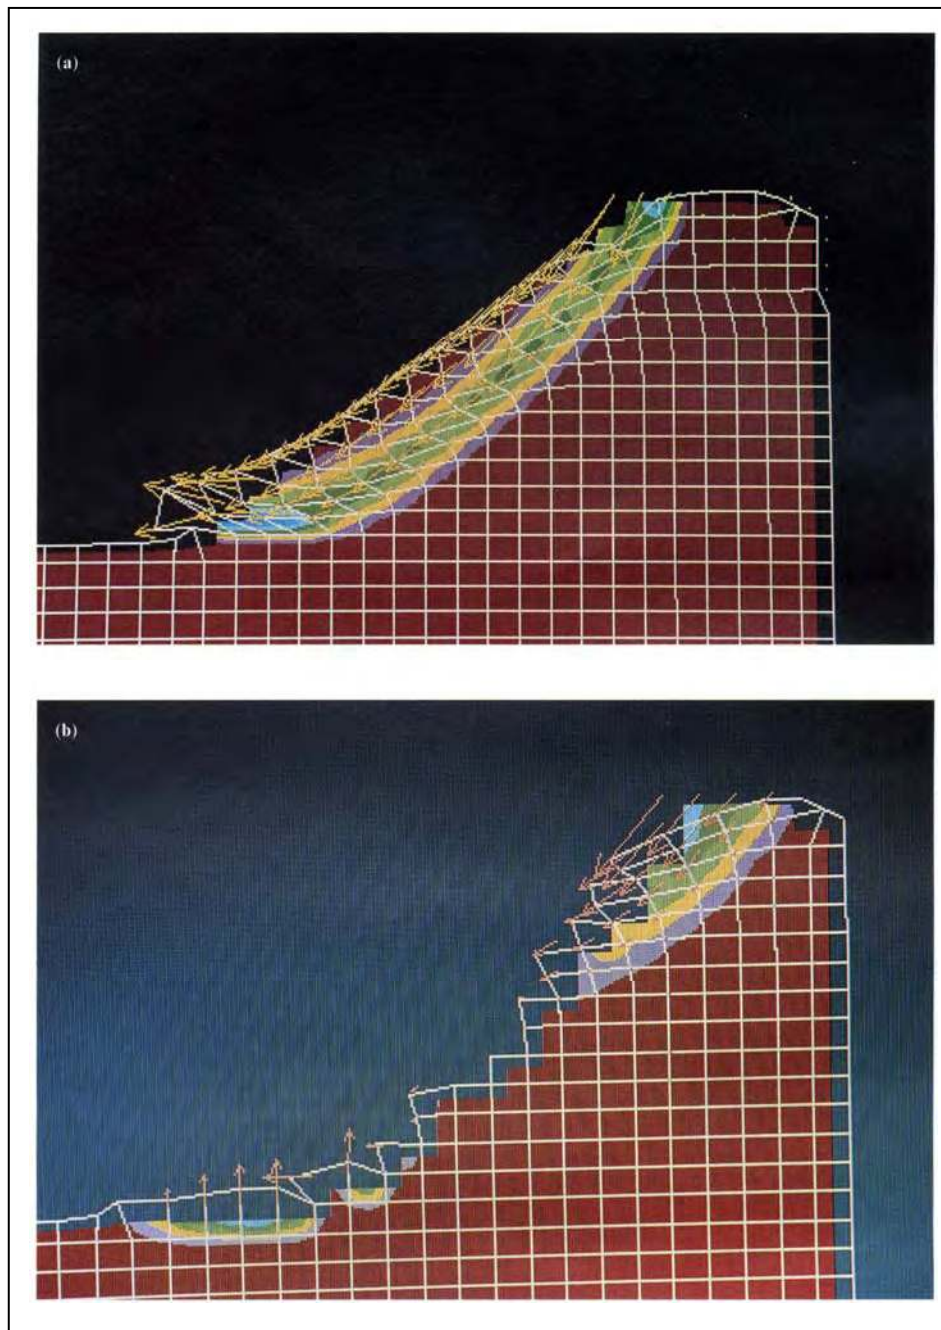
**Fig. 40.** (a) As Figure 39, with material in outer slope strain-weakened to:  $c' = 20\text{kPa}$ ,  $\phi' = 30^\circ$  in zone 1 (talus and rockfall debris); and  $c' = 20\text{kPa}$ ,  $\phi' = 20^\circ$  in zone 3 (soufriere material). Lava-lobe emplacement still continues as in figure 39 (note grid distortion at upper right), but gravity-driven movements on outer slope dominate the grid distortion, shear strain-rate and velocity vector field. Grid distortion scale 24x, max. vector  $5.0\text{ ms}^{-1}$ . (b) Gravity collapse of the outer part of the slope results in an oversteepened and decompressed face of fresh lava, which begins to collapse (grid distortion scale 1.1 x). Generation of the decompression-induced explosions is beyond the scope of the model.
