The Distal Triceps Tendon Footprint and a Biomechanical Analysis of 3 Repair Techniques

Peter C. Yeh, Kelly T. Stephens, Olga Solovyova, Elifho Obopilwe, Lawson R. Smart, Augustus D. Mazzocca and Paul M. Sethi

Am J Sports Med 2010 38: 1025 originally published online March 3, 2010

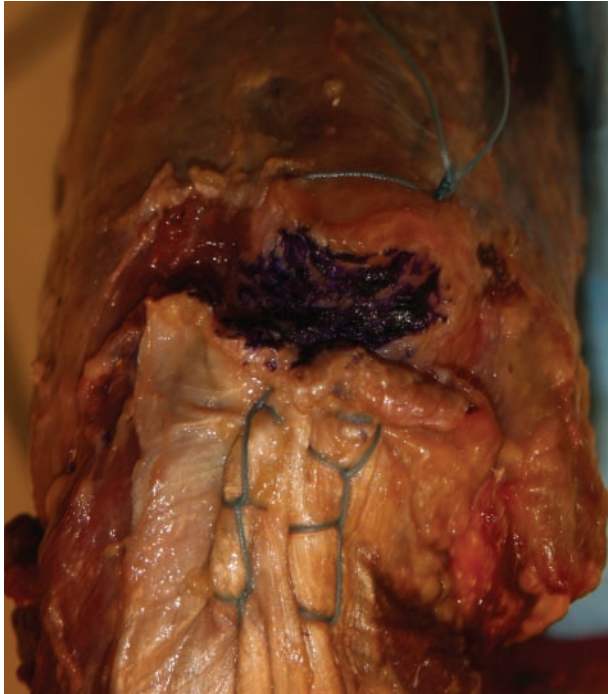
Figure 1. The transosseous cruciate repair. The suture ends on the ulna are tied down over a bone bridge with the purple markers indicating the triceps footprint that is still exposed (pre-cyclic loaded). At least 8 to 10 mm of the footprint is still exposed distally. Reflection of the tendon also yields the uncovered footprint proximally.

Florida) is first passed through the end of the ruptured tendon. Four passes of the whipstitch are made on each side of the tendon with the same suture. Two crossing transosseous drill holes are made on the olecranon parallel to the joint surface. These crossing drill holes were made by best approximating the center of the footprint and ensuring that the holes were made 11.75 mm distal to the tip of the olecranon (to avoid joint penetration). Each strand of the suture is passed into each drill hole from proximal to distal and tied (with 5 alternating half-hitch knots) to each other over the bone bridge (Figure 1).

Qualitative assessment of the 3 repairs revealed 3 distinct patterns of footprint coverage. The transosseous cruciate repair yielded point fixation on the olecranon, with at least 8 to 10 mm of footprint length exposed proximally and distally. This translates to the repair covering an average of 146 mm² (31%) of the footprint (Figure 1). The suture anchor repair yielded a repair that had both proximal

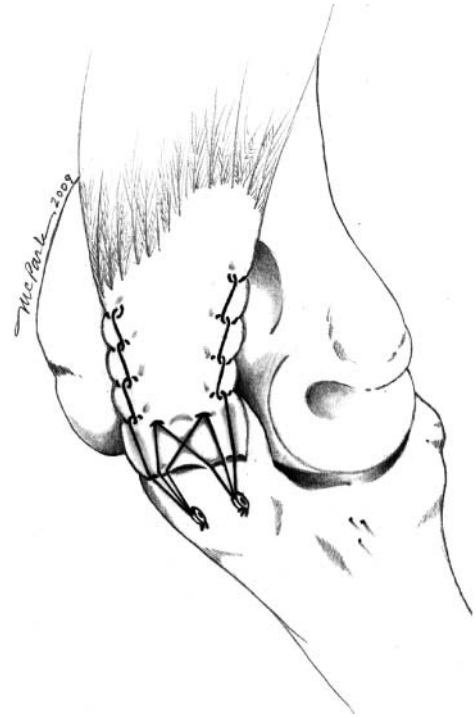
Figure 3. Triceps tendon repair using an anatomic repair technique. Reproduced with permission Maxwell C. Park, MD.

tendon to its desired position on the footprint), the anchor is advanced with a mallet into the pilot hole until flush. To avoid differences, 1 surgeon (P.M.S.) was used to gauge tension. The sutures can then be cut flush. The remaining sutures are threaded into the eyelet of a second PushLock anchor and this is driven into the other pilot hole with the suture ends cut flush (Figures 3 and 4).

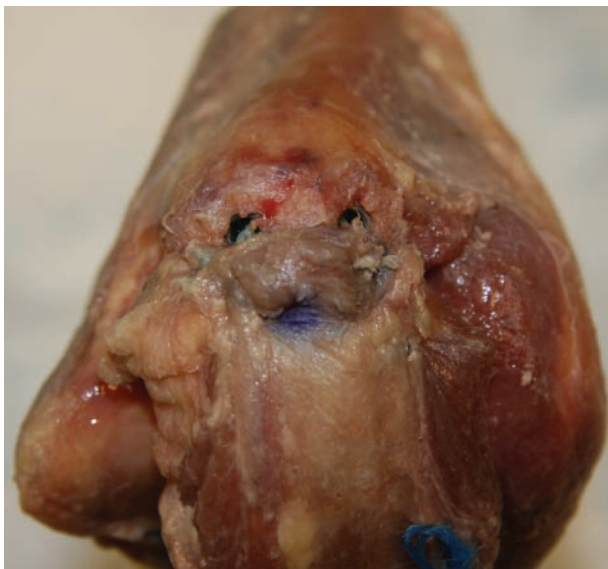
Figure 2. The suture anchor repair. A smaller region of footprint (6-8 mm) is exposed.

Two metal 4.5-mm suture anchors (Arthrex) are placed in the middle of the footprint, with use of the dead man's angle, aimed away from the joint. A #2 nonabsorbable FiberWire suture is passed in a Krackow-type whipstitch fashion. Four passes of the whipstitch are made on each side of the tendon with the same suture. Each strand from the whipstitch is tied down to each suture anchor with 5 alternating half-hitch knots each (Figure 2).

and distal footprint exposed, but to a lesser degree than the transosseous cruciate repair, with 6 to 8 mm total left on both sides combined; thus an average of 226 mm² (48%) of the footprint was covered (Figure 2). The anatomic repair restored all but the native proximal insertion with 1 to 2 mm exposed proximally and no footprint exposure distally, thus covering 400 mm² (86%) of the footprint (Figure 7).
