NASA Technical Memorandum 82732

Effects of Artificially Produced Defects on Film Thickness Distribution in Sliding EHD Point Contacts

Prepared for the
Joint Lubrication Conference
cosponsored by the American Society of Lubrication Engineers
and the American Society of Mechanical Engineers
New Orleans, Louisiana, October 5-7, 1981

**EFFECTS OF ARTIFICIALLY PRODUCED DEFECTS ON
FILM THICKNESS DISTRIBUTION IN
SLIDING EHD POINT CONTACTS**

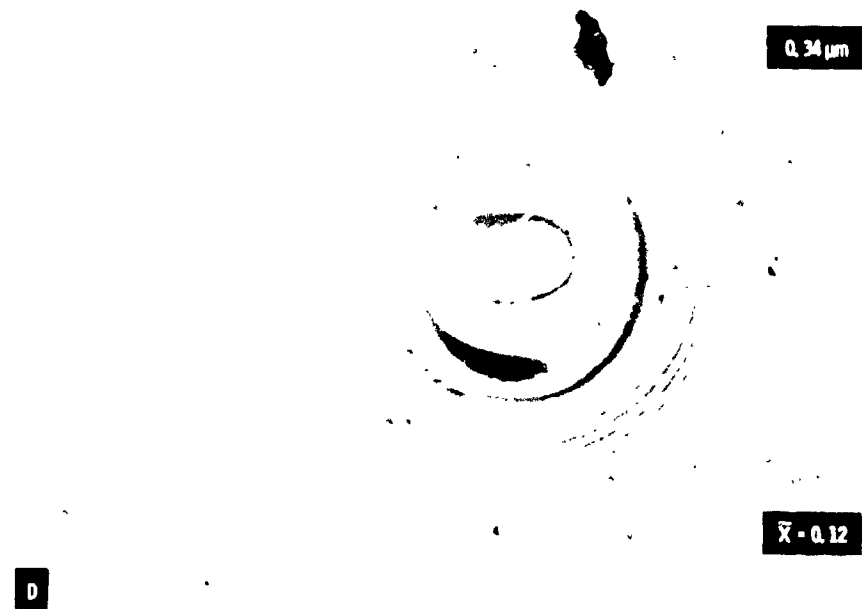
Figure 6. - Concluded.

Figure 6. - Medium dent progressively positioned closer to inlet and in contact. Disk velocity - 0.12 m/s,
 $P_{max} = 1.13 \times 10^9 \text{ /m}^2$, $T = 24.4^\circ \text{ C}$.

In Figs. 5 and 6(a) to (d) a dent with a $\Delta = 3.8$ and $C = 0.42$ is shown. In Fig. 6(a) the position of the dent does not influence the central film thickness which, in this case, is $0.26 \mu\text{m}$. The general trends shown in Fig. 6 are the same as those shown in Fig. 4. An even larger dent is shown in Figs. 7 and 8(a) to (g) for which $\Delta = 6.7$ and $C = 0.53$. Note that the film thickness variations again occur within a band which is approximately equal to the width of the dent. From Fig. 8(g) it is noted that, once the dent is within the contact, the film thickness variations are more localized in the vicinity of the dent and that complete film recovery again occurs upstream of the dent. In Fig. 9, a cross-sectional plot of the dent corresponding to its position in Fig. 8(g) is shown to indicate the micro-EHD effects caused by the built-up edge on the right-hand side of the dent (see Fig. 7). A stylus trace of the dent is also shown in Fig. 9. The position of this trace is such that its horizontal line corresponds to the smooth-surface central film thickness of $0.26 \mu\text{m}$. As with previous finding [5], it is noted that the stylus trace of the "undeformed" dent predicts contact between the surfaces while the trace

The effects of X , the position parameter, on the film thickness distribution is shown in Fig. 10 where the data given in Figs. 6 and 8 are shown in a more compact form. In this figure $H = h/h_0$ where h is the film thickness downstream of the dent and h_0 is the central film thickness based on smooth surfaces. Since the film thickness is only known at discrete values of X , the lines connecting the data points do not represent actual film thickness distribution but only general trends. Although not shown in Fig. 10, the data given in Fig. 4 follow the same pattern.

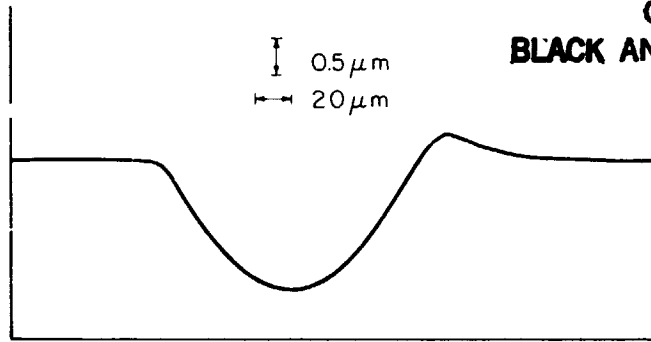
Figure 7. - Stylus trace of large dent, $\Delta = 6.7$, $C = 0.53$.

Even though the three dents discussed above have different geometries, some general trends can be observed. The dents shown in Figs. 3 and 7 have values of Δ which are approximately the same while the values of C are quite different. Figure 4 shows that the maximum percentage change in the central film thickness, from its smooth surface value, varies from -37 to 44 percent while from Fig. 8, this change is from -38 to 46 percent. Thus, it is noted that, for approximately the same Δ , approximately the same percentage changes in film thickness are observed. For the dent shown in Fig. 5, the value of Δ is much smaller than the Δ values of the dents shown in Figs. 3 and 7. From Fig. 6, the maximum percentage change in film thickness from the smooth-surface value varies from -27 to 54 percent. These findings suggest that Δ is a useful parameter for predicting the changes in the central film thickness, from its smooth-surface value, caused by dents.

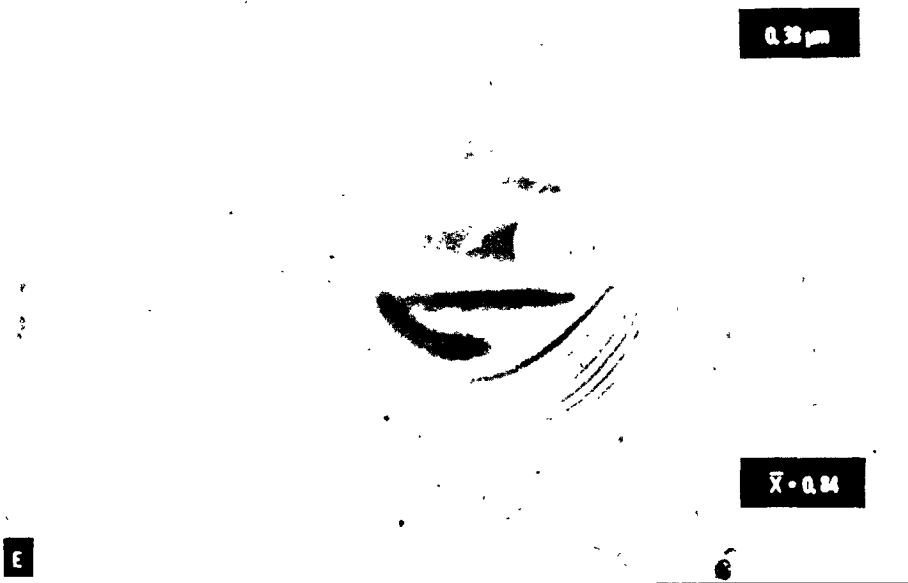
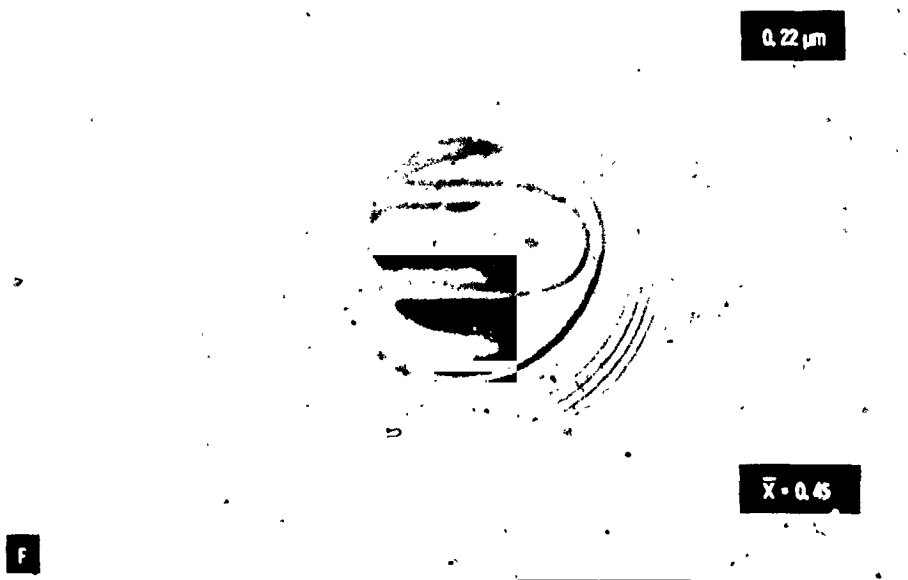
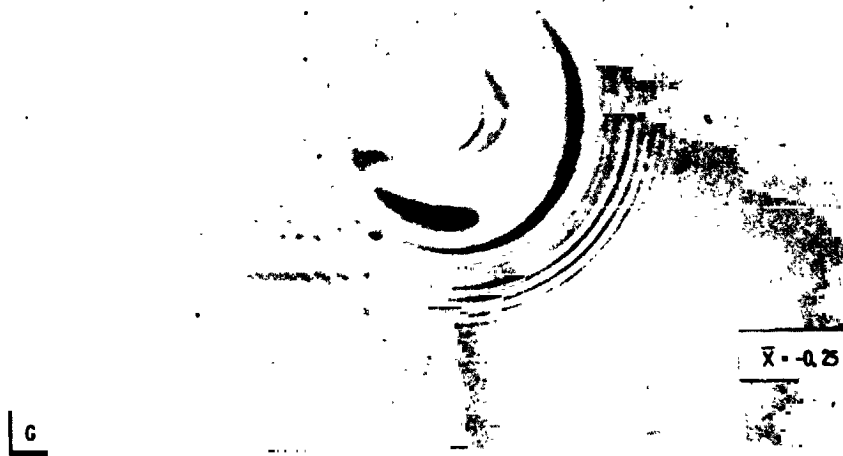
Figure 8. - Concluded.

Figure 8. - Large dent progressively positioned closer to inlet and in contact. Disk velocity - 0.12 m/s ,
 $P_{\text{max}} = 1.13 \times 10^9 \text{ N/m}^2$, $T = 24.4^\circ \text{C}$.

from Fig. 8(g) shows the existence of a film and considerable deformations in the vicinity of the built-up edge. In addition, note that, with this larger dent, the downstream film thickness is approximately equal to or below the smooth-surface value once the dent enters the contact.

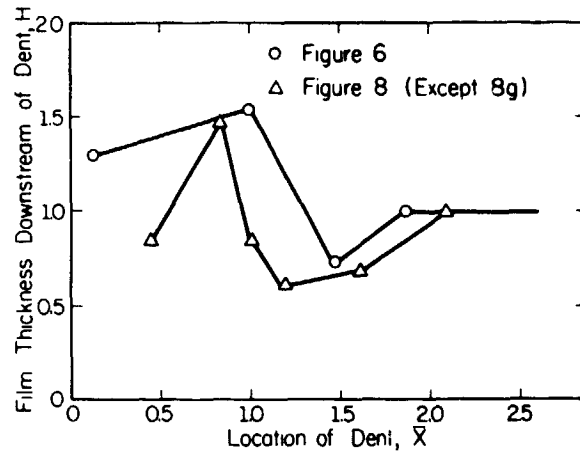
Figure 10. - Film thickness variations for dents shown in figures 6 and 8.

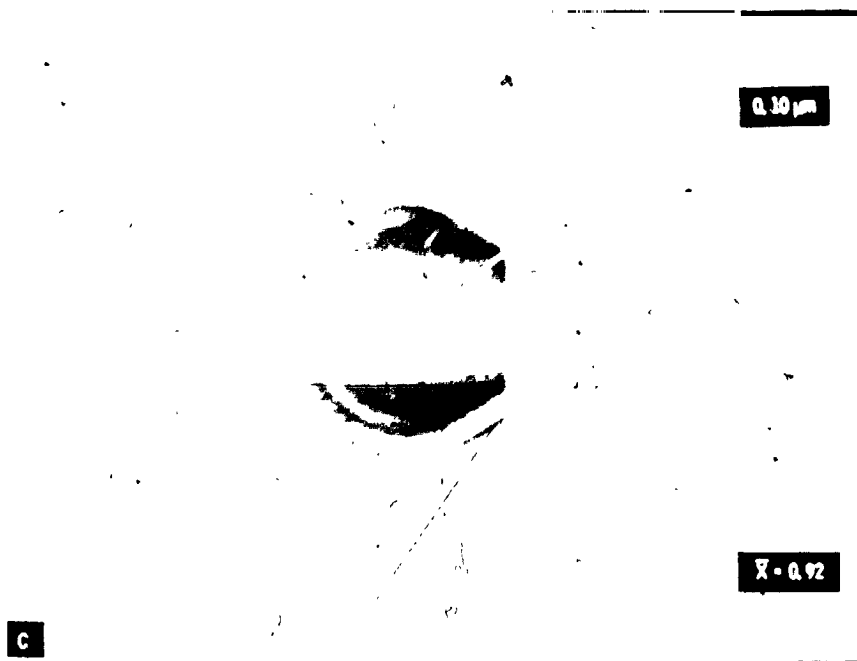
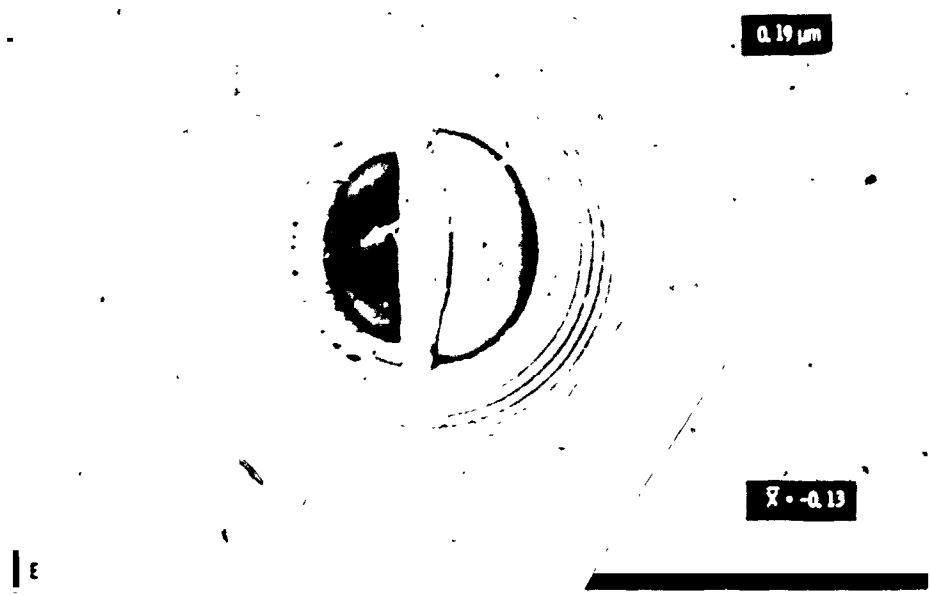
Figure 14. - Concluded.

Figure 14. - Groove progressively positioned closer to inlet and in contact. Disk velocity = 0.12 m/s , $P_{\text{max}} = 1.1 \times 10^6 \text{ N/m}^2$, $T = 24.4^\circ \text{C}$.

A deeper groove is shown in Figs. 13 and 14(a) to (e). For this groove, $\Delta = 3.4$ and $C = 0.08$. Again, the central film thickness is not affected when the groove is located far enough from the inlet as shown in Fig. 14(a). In Figs. 14(b) and (c) a film reduction is seen when the groove is in the inlet region while a partial film recovery downstream of the groove (to its left) takes place as the groove enters the contact as shown in Figs. 14(d) and (e). Note that unlike the previous groove, this recovery is less than the smooth-surface value. As before, upstream of the groove, a full film recovery takes place. Since continuity of flow has to exist, some fluid has to be "drained" along the groove in order to obtain the change in film thickness between the upstream and downstream sections of the groove as shown in Fig. 14(e). Similar effects have been found with a moving deep groove and a stationary disk as indicated by Fig. 22 of [4]. Figure 14(e) also shows considerable micro-EHD effects caused by a built-up edge in this area (see Fig. 13). In Fig. 15 a partial cross-sectional plot of the film thickness at the edges of the groove is shown to indicate the large deformations caused by this micro-EHD action. In this figure the horizontal line of the stylus trace is positioned at the smooth-surface central film thickness as done previously with the dent. Again, note that the stylus trace of the "undeformed" groove predicts contact between the surfaces while the measured profile shows the existence of a film.
