**The effects of microstructural features on the performance gap in corrosion resistance between bulk and HVOF sprayed Inconel 625**

**N. Ahmed, M.S. Bakare, D.G. McCartney, K.T. Voisey\*.**

Mechanics, Materials and Structures Research Division,

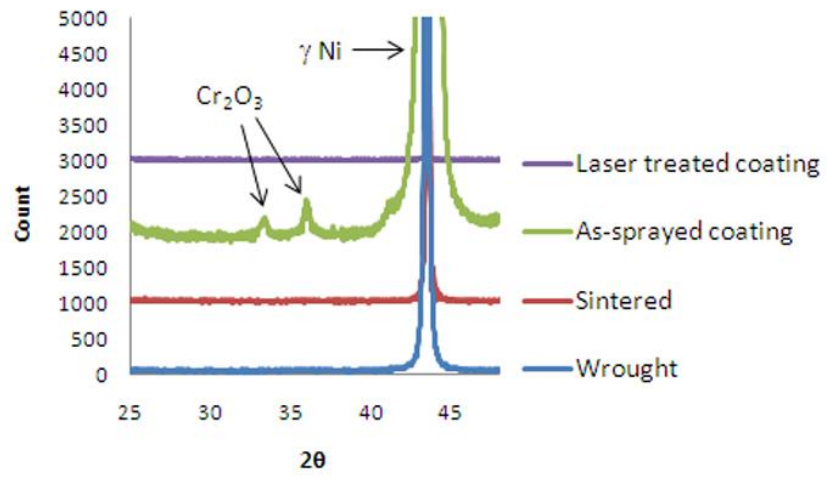
The XRD pattern obtained from the wrought sheet is shown in Figure 2 and the peaks can be indexed as a face centred cubic structure, this is  $\gamma$ -Ni as expected for a Ni-based alloy. The peaks are seen to be of small angular width and no other phases could be detected in the XRD pattern.

Figure 2: XRD patterns of the different forms of Inconel 625 used: wrought, sintered, as-sprayed HVOF coating, laser treated HVOF coating after surface grinding to remove accumulated oxides.

As well as the distinctive lamellar structure the coating showed other microstructural features typical of thermal sprayed coatings, namely pores and oxides. The presence of oxides in the thermally sprayed coatings was verified by XRD (Figure 2). The HVOF coatings contained peaks of  $\text{Cr}_2\text{O}_3$ , not observed in the wrought case. The strong peak at  $\sim 44^\circ$  resulting from the  $\gamma$  Ni face centre cubic matrix was broader in the coating compared with the wrought material. This is due to a combination of fine grain size and/or microstrain within the material [14].

The XRD pattern of the laser melted coating (after the top surface had been removed by grinding) is shown in Figure 2. No oxide peaks are evident, confirming that the oxide present in the as-sprayed coating was removed.

The average porosity of the sintered samples was 12% and 6% for isothermal sintering at 1310°C and 1325°C respectively. No oxide peaks were detected in the XRD spectra of the sintered samples (Figure 2). The etched SEM micrograph shown in Figure 7 shows that the marked segregation present in the as-sprayed coating and the laser treated material (Figure 3, Figure 5 Figure 6) is absent from the sintered samples. It is also clear that the pores had a near-spherical morphology with diameters ~15-30 µm. Oxide peaks were not seen in the XRD spectra of the sintered material (Figure 2).

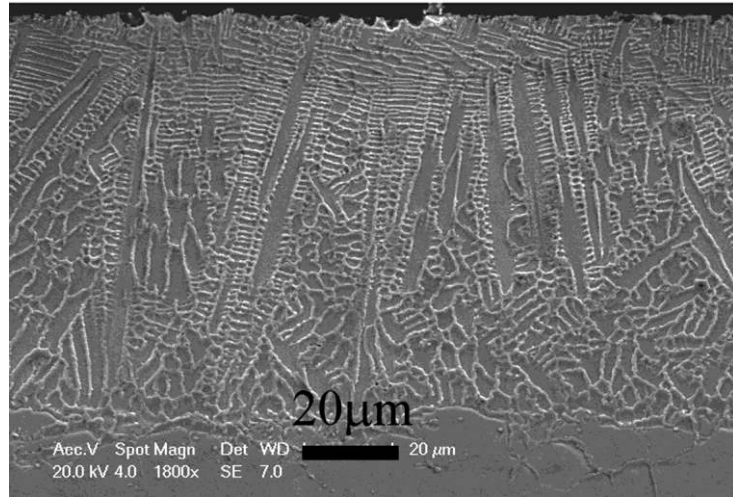
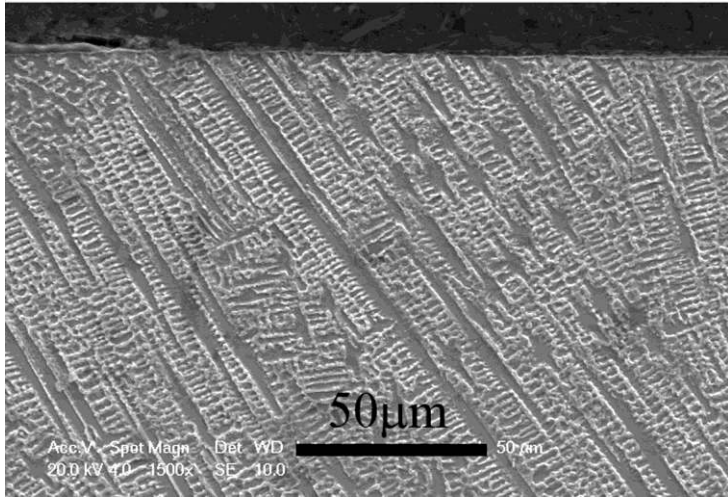
Laser melting of wrought material resulted in the rapidly solidified microstructure featuring aligned dendrites, as shown in Figure 3. The micrographs were obtained from a section taken parallel to the beam traverse direction. Evidently the dendrites have solidified with the  $\langle 100 \rangle$  growth direction tilted towards the moving heat source which is a typical solidification pattern for laser surface melting and welding [12, 13]. The measured secondary dendrite arm spacings (SDAS) are included in Table iii and indicate that, as expected, SDAS decreases with increasing traverse speed i.e. with increasing cooling rate.

Figure 3: SEM secondary electron micrographs showing the rapidly solidified microstructure of laser melted wrought Inconel 625, arrows indicate the beam traverse direction (a) 500 mm min<sup>-1</sup> (b) 2000 mm min<sup>-1</sup>.

The similarity in behaviour of wrought and laser treated wrought samples (Figure 8a) reveals that the presence of a rapidly solidified microstructure does not have any significant effect on electrochemical behaviour. Therefore it can also be stated that the observed microsegregation (Figure 3Figure 6) resulting from rapid solidification has no significant effect on electrochemical behaviour.

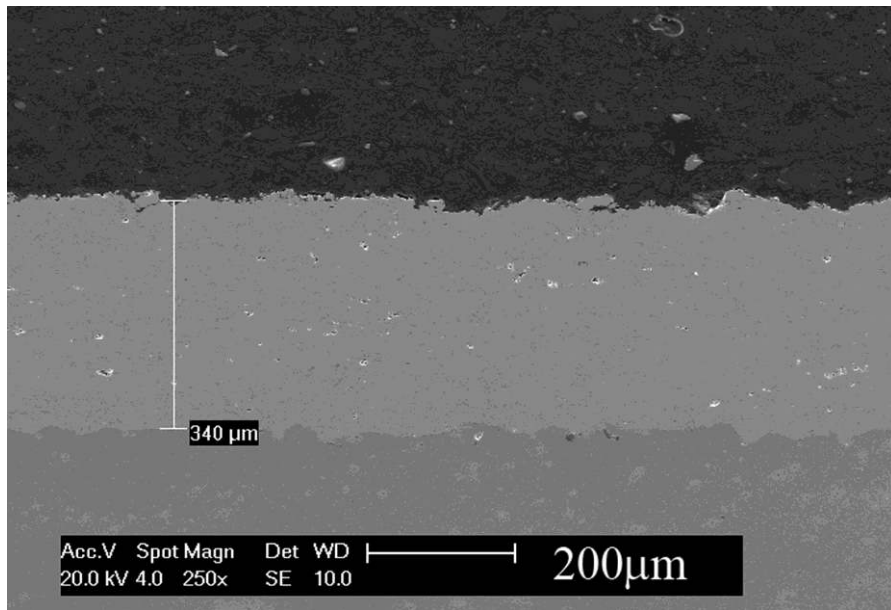
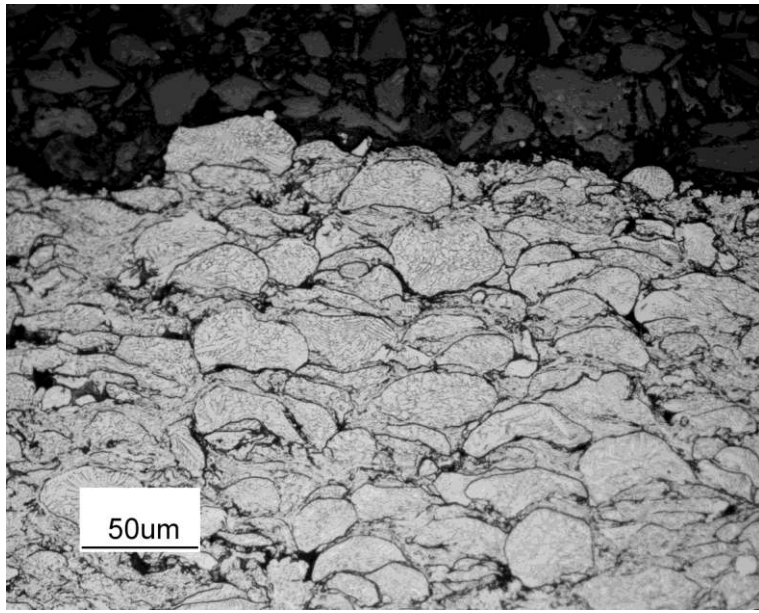
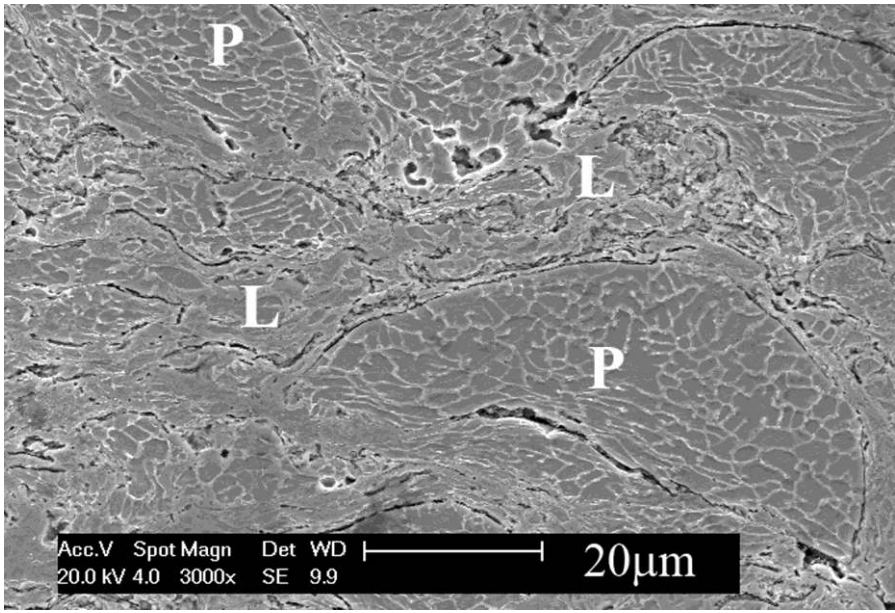
The as-sprayed coating was  $\sim 350 \mu\text{m}$  thick (Figure 4a). The coating had a characteristic thermally sprayed microstructure, resulting from the successive deposition of individual powder particles (Figure 4b). Figure 4 c shows a dendritic microstructure in the deformed particles, this was a retained microstructure from the gas atomised feedstock powder. Figure 4 c also shows that the coating is seen to comprise of deformed, near-spherical particles (P) as well as lamellar splat-like features (L). These arise from the impact and solidification of partially and fully melted powder particles respectively. The microstructure observed is characteristic of coatings produced by this type of liquid fuel gun as discussed elsewhere [3].

Figure 4: HVOF thermally sprayed Inconel 625 coating (a) SEM secondary electron micrograph showing full coating thickness (b) optical micrograph showing the individual splats from which the coating is formed (c) SEM secondary electron micrograph showing the retained dendritic structure in deformed particles (P) as well as lamellar splat-like features (L).

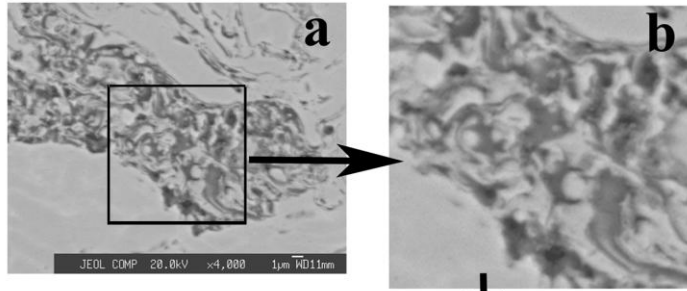
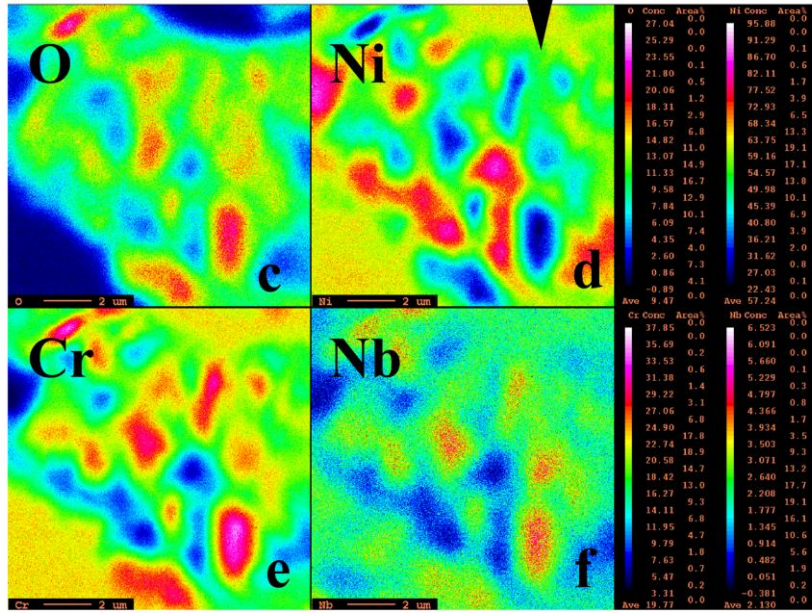
Figure 5 a & b are secondary electron SEM images indicating the oxide rich area of the coating which was examined with EPMA. Figure 5(c) – (f) show elemental concentration maps of this region for the elements O, Ni, Cr and Nb respectively. In the top right and bottom left corners of this region are areas which correspond to unmelted particles. The central region results from resolidification of molten material and is seen to have a non-uniform structure and composition with high levels of oxygen indicating oxide formation. The concentration maps reveal a clear association of high Cr and O concentrations which confirm the location of the  $\text{Cr}_2\text{O}_3$  phase in this interparticle and/or intersplat region. There is also clear evidence for significant Cr and Nb depletion in the metallic regions in this area.

Figure 5: Oxide rich region in as-sprayed coating and EPMA maps for various elements for the same area.

Examination of samples after potentiodynamic testing (Figure 9) clearly show that corrosion is preferentially occurring in the regions between adjacent splats. These regions have a complex heterogeneous microstructure (Figure 5) including a mixture of nonmelted and resolidified material, oxidised regions and porosity. Laser surface melting eliminates all of these features. The extent of the role of porosity has already been identified. The relative effects of the mixture of nonmelted and resolidified material and oxidised regions on the corrosion performance gap now need to be examined.

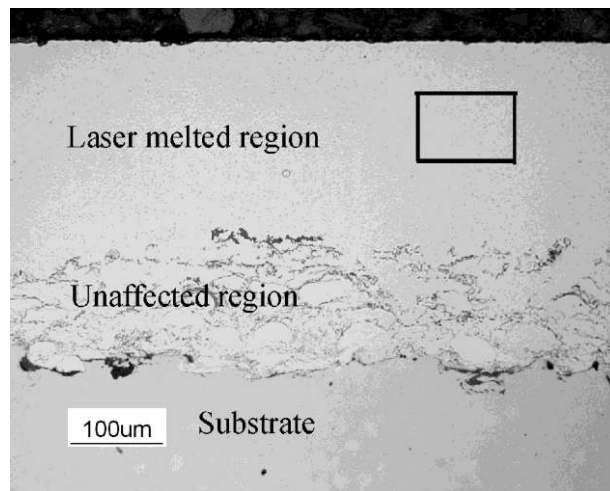
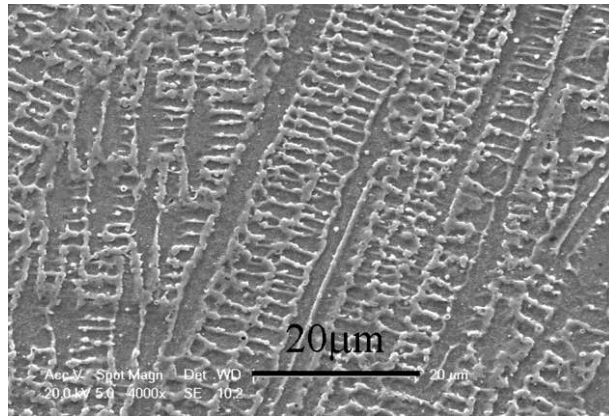
Laser surface melting of HVOF coatings resulted in a structure which was free from the pores and oxides found in the as-sprayed condition (Figure 6). The low magnification optical micrograph in Figure 6a shows that the coating was melted to a depth of approximately  $200\mu\text{m}$  and that melting was confined to the coating, avoiding any coating/substrate mixing. Porosity was eliminated on resolidification and any pre-existing oxides floated and accumulated at the top surface. This top surface, and hence the accumulated oxide, was removed by grinding before corrosion testing. Rapid solidification following laser surface melting produced the dendritic structure as shown in Figure 6b, this is identical to that previously seen in the laser melted wrought material (Figure 3). EDX revealed that bright interdendritic areas were enriched in Nb and Mo, while Cr content remained almost uniform

Figure 6: Microstructure of coating after laser surface melting with a scan speed of 1000 mm min<sup>-1</sup>. (a) optical micrograph, (b) secondary electron SEM image of the area indicated.

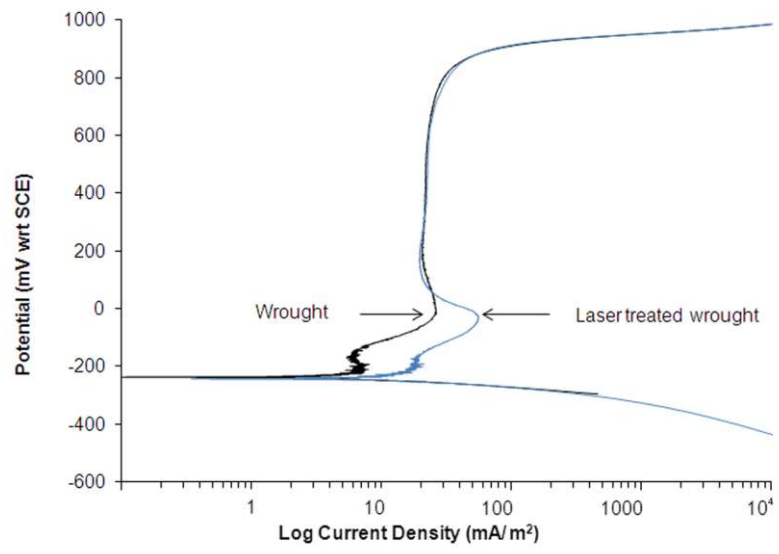
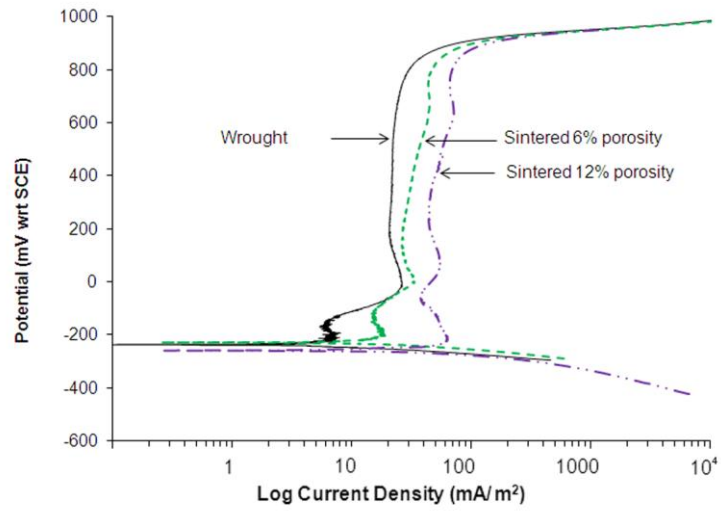
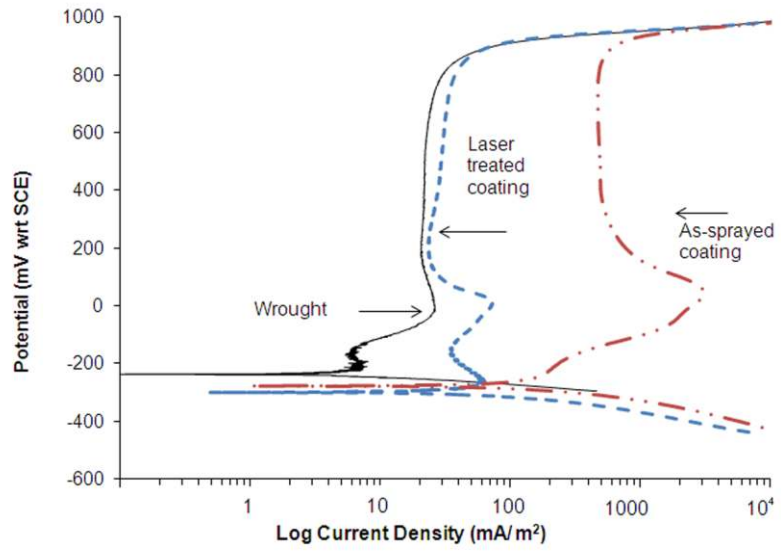
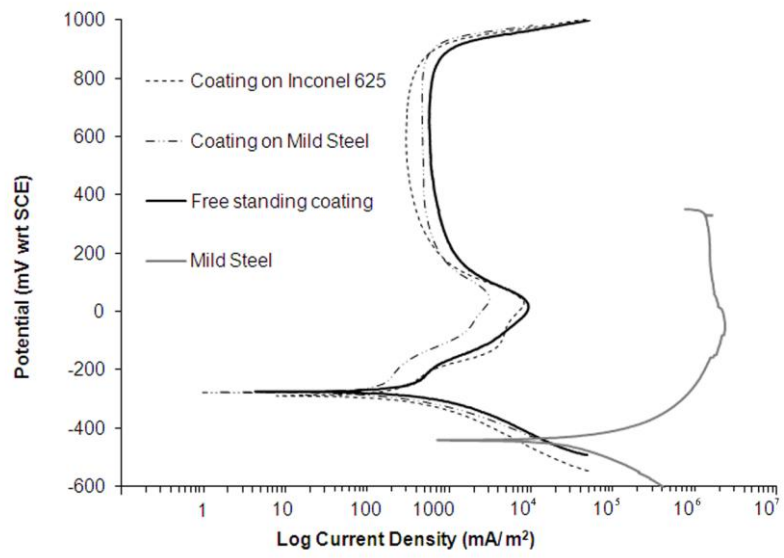
Figure 8 shows potentiodynamic scans in 0.5M H<sub>2</sub>SO<sub>4</sub> for the various forms of Inconel 625. Passive current density values,  $I_p$ , are listed in Table iii the current densities correspond to a potential of 450 mV SCE, within the passive region. **This potential was chosen as it was well within the passive range for all samples considered here.**

In Figure 8a the corrosion behaviour of wrought and laser melted wrought material, **with a traverse speed of 1000 mm min<sup>-1</sup>**, are seen to be almost identical with only a small difference in behaviour just above  $E_{corr}$ . The average passive current density measured for the wrought material was  $22 \pm 9 \text{ mA m}^{-2}$ . This therefore indicates that the fine scale dendritic structure with associated microsegregation had a negligible influence on corrosion behaviour. Figure 8b compares the wrought material with that of sintered samples with different degrees of porosity. The porosity did not affect the  $E_{corr}$  value but is seen to increase  $I_p$ ; increased

porosity caused a greater increase in  $I_p$ . In Figure 8c the behaviour of wrought material, as-sprayed HVOF coating and laser melted coating are compared. The laser melted coating results are from a sample melted using a traverse speed of  $1000 \text{ mm min}^{-1}$ . The as-sprayed HVOF coating had a lower  $E_{\text{corr}}$  valued and a significantly larger  $I_p$ ; about 40 times that of the wrought material. This is similar to previously measured differences in  $\text{H}_2\text{SO}_4$  [3]. Finally, in Figure 8d the behaviour of as-sprayed coatings on mild steel and Inconel 625 and a de-bonded coating are compared. All previous coating results relate to deposits on mild steel and the aim of this set of results was to identify any contribution of the substrate to the polarisation results. The differences in behaviour are small and within the experimental scatter observed for a batch of as-sprayed coatings. Therefore, it can be concluded that there is not a significant contribution from a mild steel substrate. For comparison, the polarisation curve for mild steel in the same solution is also displayed.

Figure 8: Potentiodynamic scans (a) wrought and laser melted wrought material, (1000 mm min<sup>-1</sup> traverse speed); (b) sintered samples with different levels of porosity; (c) wrought, as-sprayed HVOF coating and laser melted HVOF coating (1000 mm min<sup>-1</sup> traverse speed); (d) HVOF coated Inconel 625, HVOF coated mild steel, free standing HVOF coating and uncoated mild steel.

The potentiodynamic results shown in Figure 8c confirm the performance gap between bulk Inconel 625 and the HVOF Inconel 625 coating. It can also be seen that laser surface melting of the sprayed coating largely eliminates the performance gap. However, laser melting of the coating, followed by resolidification, simultaneously changes several aspects of the microstructure: porosity is eliminated on resolidification; oxides float and accumulate on the top surface and are thereby removed from the material; the resolidified material gains a

It has already been established that there are no effects due to interconnected porosity in the coatings considered in this work. However, non-interconnected porosity is clearly present in the coatings and may affect their corrosion behaviour via crevice corrosion. The potentiodynamic scans presented in Figure 8b show that the passive current density decreases as the level of porosity decreases. This indicates that at least part of the improvement in corrosion behaviour observed after laser surface melting of coatings is due to elimination of porosity. It is suggested that the presence of porosity increases the passive current density due to crevice corrosion occurring in the pores. Elimination of the porosity eliminates this mechanism of corrosion, hence improving corrosion resistance.

accumulate at the top surface when the coating is melted by the laser. This top, oxide rich, layer is ground away before potentiodynamic testing. The material tested is oxide free but will be uniformly slightly Cr depleted. Figure 8c shows that laser surface melting of coatings largely, but not completely, eliminates the performance gap. The passive current density seen for laser treated coatings is still higher than that of the wrought material. The laser treated coating has a rapidly solidified microstructure and, as explained above, will be slightly depleted in Cr. The presence of a rapidly solidified microstructure has already been shown to have no significant effect on the observed potentiodynamic results. The minor Cr depletion is therefore attributed to be the cause of the higher passive current density of laser treated coatings compared to the wrought material.

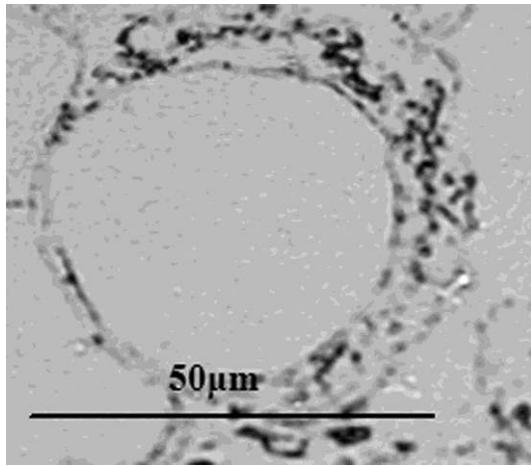
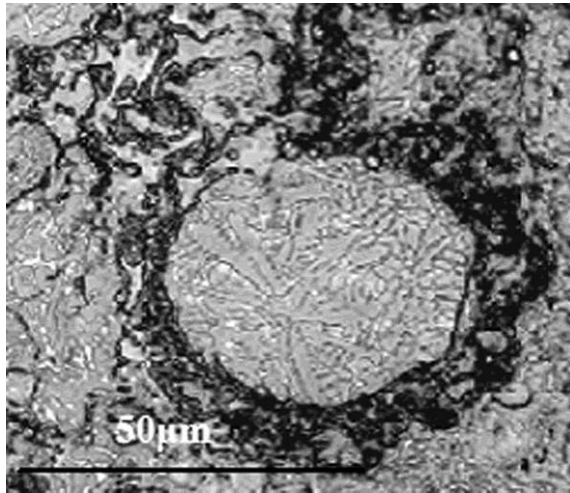
Figure 9 presents as-sprayed coatings after polarisation to  $10^4$  and  $10^5 \text{ mA m}^{-2}$  respectively. In each micrograph the central, circular feature is an unmelted powder particle within the coating. It was observed that the particle boundary regions started to corrode preferentially (Figure 9a). When current density values were increased, these areas became more heavily corroded and corrosion of the internal structure of the splats occurred (Figure 9b).

Figure 9: As-sprayed HVOF coatings after polarisation; (a) to  $10^4 \text{ mA m}^{-2}$ , (b) to  $10^5 \text{ mA m}^{-2}$ .
