The January 2014 Flashflood in the Ambato River (Catamarca, Argentina)- A Case Study of Megaboulders Fluvial Transport

Megaboulders mantle the steep channels of mountainous rivers, and moderate incision rates by increasing channel roughness. Direct measurement of the transport of boulders in natural rivers is difficult, therefore there are few field studies on the subject. The transportation of megaboulders downslope in catastrophic floods in urban environments-releases a destructive power. This study analyses the Ambato river flood that occurred in Argentina in January 2014 with an assumed recurrence interval of 1:100 years. The flood was caused by concentrated rainfall in the upper basin, at an elevation of 4000 m.

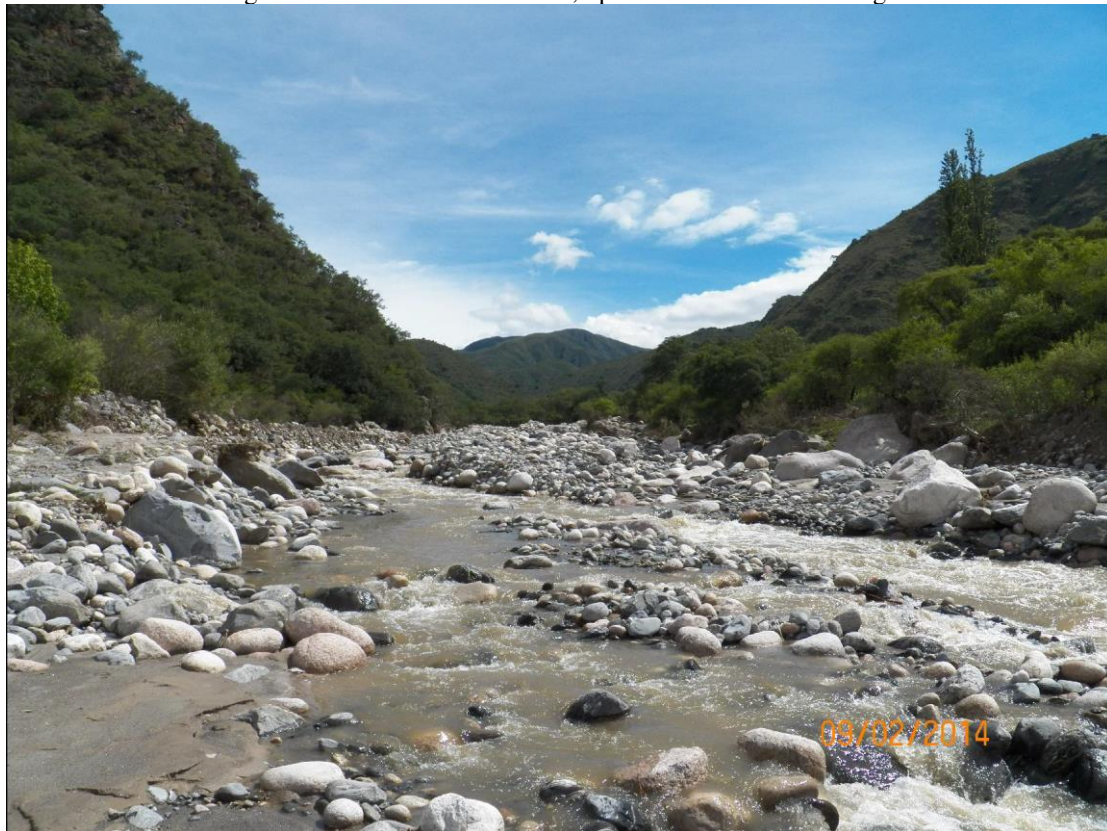
Fig. 2 The Ambato river channel, upstream of El Rodeo village

Two rivers drain into the El Rodeo valley in wide alluvial fans. The main channel is the Ambato river, originating in the mountains at an altitude of about 4500 m with a drainage basin area of 140 sq km. The channel runs from the divide to the village area, its average slope, based on the 3200m difference from the 4500m divide to the 1300m altitude of El Rodeo, is 0.08 or 8%, for the total channel length of 40 km (Fig. 2).

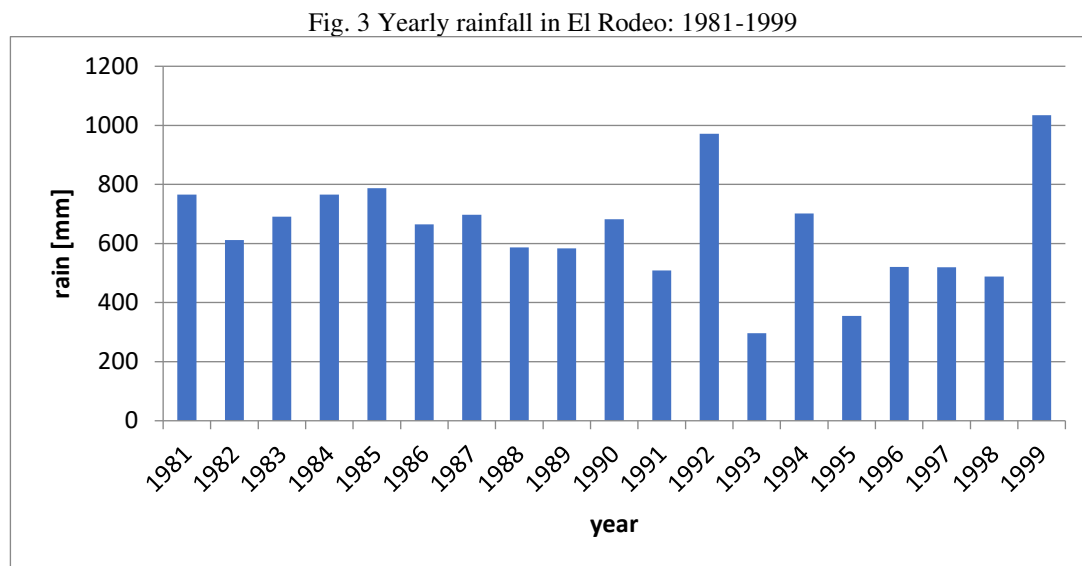
Rainfall data are sporadic and available for the capital's airport and several village stations. In the village of El Rodeo, daily rainfall data were collected from 1981 to 1999 (Fig. 3). 1999 was the rainiest year with a total of 1,034 mm.

There is no hydrological record and daily rain measurements are only available from the last 20 years, therefore an accurate recurrence interval for the flood (Fig. 3) cannot be defined. One estimate, based on hydrological models, gave an order of 400 to 600 years. Assuming a peak discharge of 450 m³/sec, the recurrence interval is 1:200 years. Another estimate based on satellite images during past floods, showing flooded areas, gave the 2014 flood a recurrence interval of 75 to 100 years (Eremchuk, 2015) (Fig. 12). A preliminary estimation based on flood marks upstream of the camping site gives a recurrence interval of 100 years (SEGEMAR, 2014).

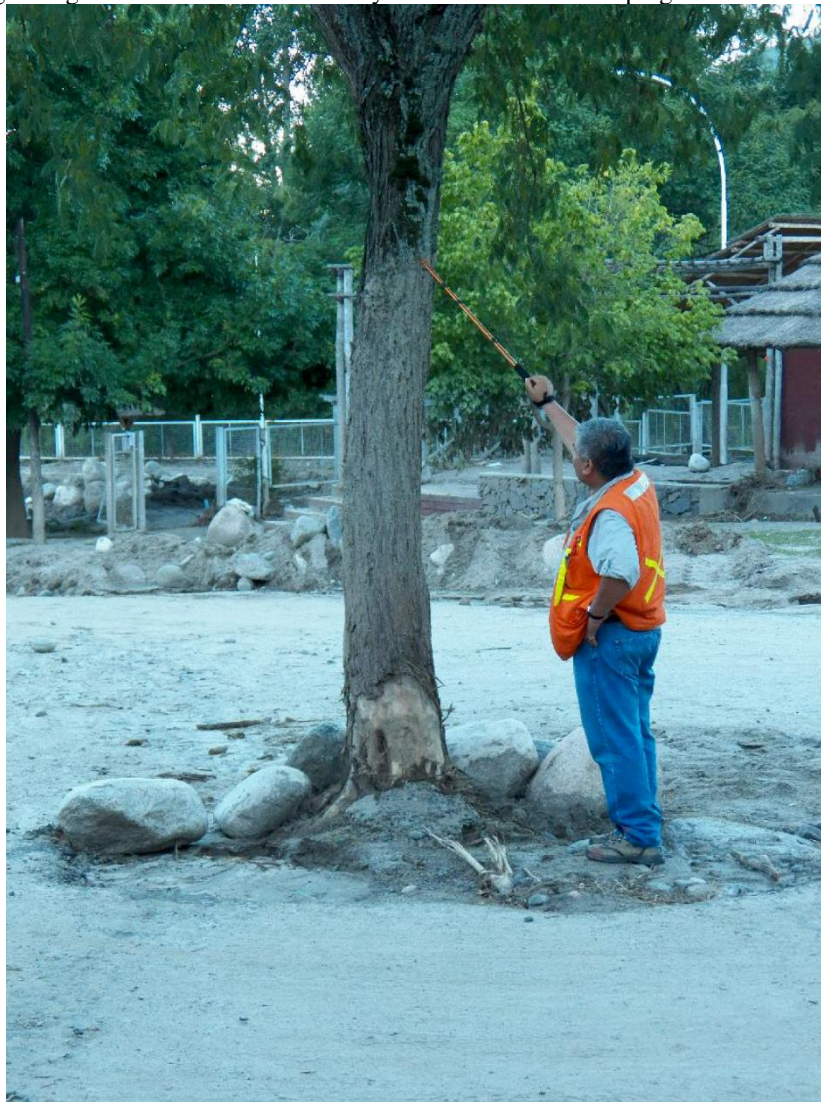
Fig. 4 High flood-marks of the January 2014 flood in the camping area of El Rodeo.

The total water flow discharge was ~ 4 MCM with a peak of 400 m³/sec to 600 m³/sec based on floodmarks and application of the Manning equation at several transversal channel cross-section surveys

(Fig. 4). The flow decreased to tens of cubic meters and several cubic meters after twelve hours according to witnesses.

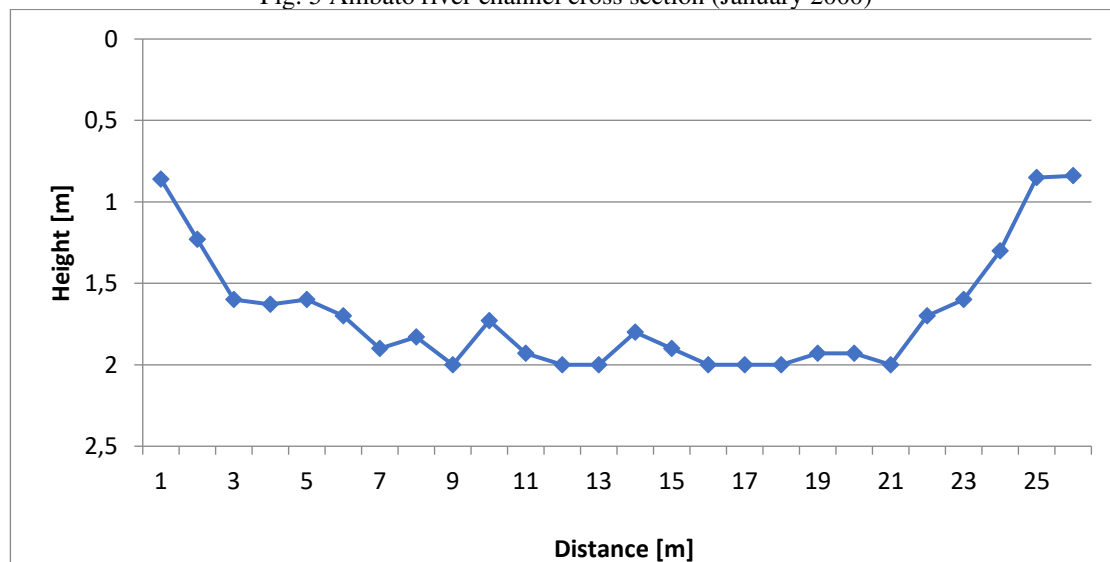
Fig. 5 Ambato river channel cross section (January 2000)

A previous major flood affected the village in 1999, and a detailed channel survey was conducted by the authors in 2000. The estimated maximum discharge was 60 m³/sec based on floodmarks. Several cross sections were performed. No major damage was reported in 1999 but the authorities decided to remove boulders and increase the depth of the active channel (Fig. 5).

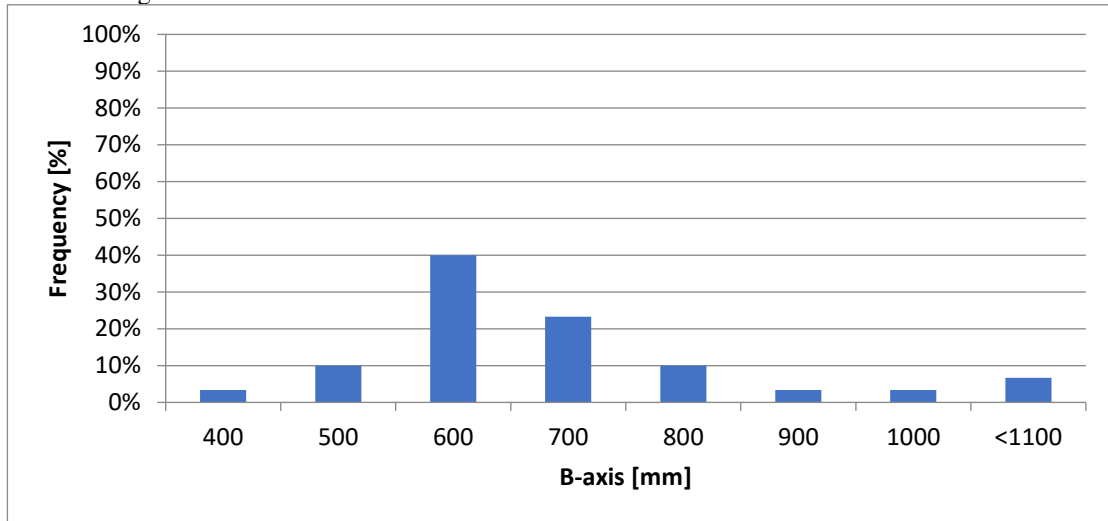
Fig. 6 Size distribution of coarse material and boulders in the Ambato river channel

A detailed survey of the megaboulders was conducted during fieldwork in September 2016. Megaboulders with a median diameter- b axis- of 1000 mm were deposited in the Ambato channel, before the junction of the three main streams draining the village (Fig. 6). Further down, the average slope decreases from 4% to 2% and no megaboulders have been found. These values are consistent with findings from other mountainous rivers (Baker and Costa, 1987; Inbar, 2000). It is assumed that during peak flow the water energy surface slope was above 0.04 thereby increasing stream power values.

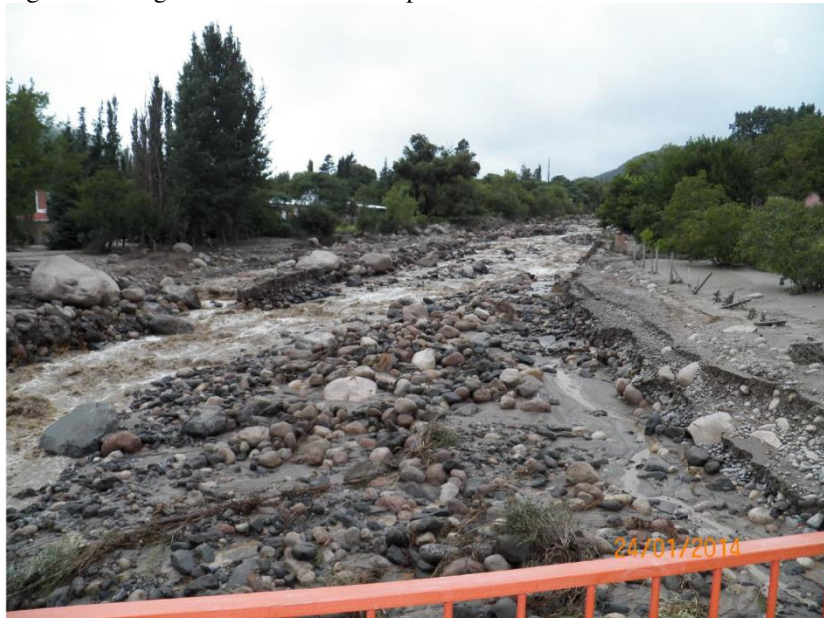
Fig. 7 Coarse gravels and boulders deposited in a bar structure after the flood.

The validity of any general relationship between the transport rate to unit stream power is contingent upon the availability of an adequate amount of detritus in the channel, as found in the early field work done by the authors, forming a supply of material that is released during the flood. The bedload actually transported during the high flow is rather well represented by the bed material measured after the flood (Fig. 7).

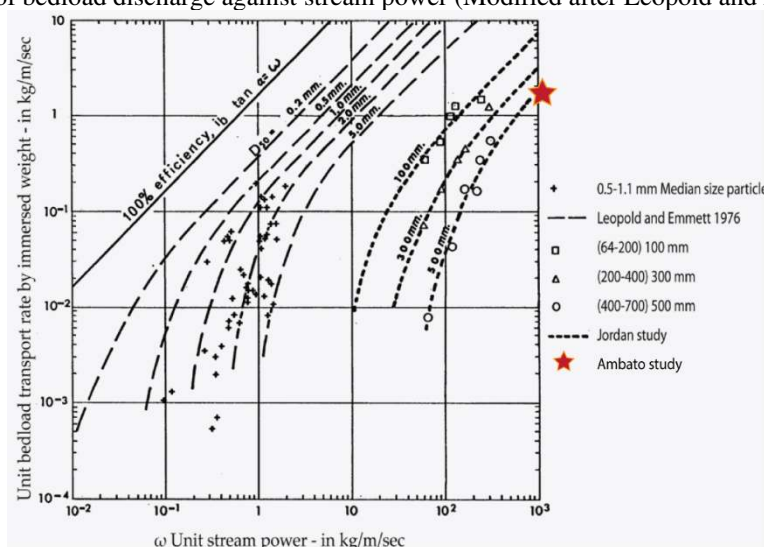
Fig. 8 Empirical equation of bedload discharge against stream power (Modified after Leopold and Emmett, 1976, Inbar, 2005)

The relation of stream power to bedload transport has been investigated in a few field studies. The movement of coarse material correlates with power expenditure of the flowing water as suggested by Bagnold. The dependent variable is the bedload transport rate, i_b , in kilograms per meter of channel width per second. The independent variable is stream power per unit width of channel, ω , in kilograms per meter of width per second. Regarding megaboulder transport, the equation indicates the order of magnitude of the bedload transported (Dunne and Leopold, 1978)

We applied the empirical theory for boulder mobility, developed for the Jordan river in Israel (Inbar and Schick, 1979). The obtained stream power value for a stream discharge of 400 m³/sec was 333 kg/m/sec. The empirical value shown in figure 8 gives a sediment discharge for the dominant debris size of ~ 3 kg/m/sec. For a total flood width of 60m and a period of 5 hours, the total boulder discharge is 33,000 tons or about 3,000 to 4,000 boulders. The results of a field survey of the fresh sediment deposited in the channel were similar to those obtained by the empirical equation (Fig. 8).

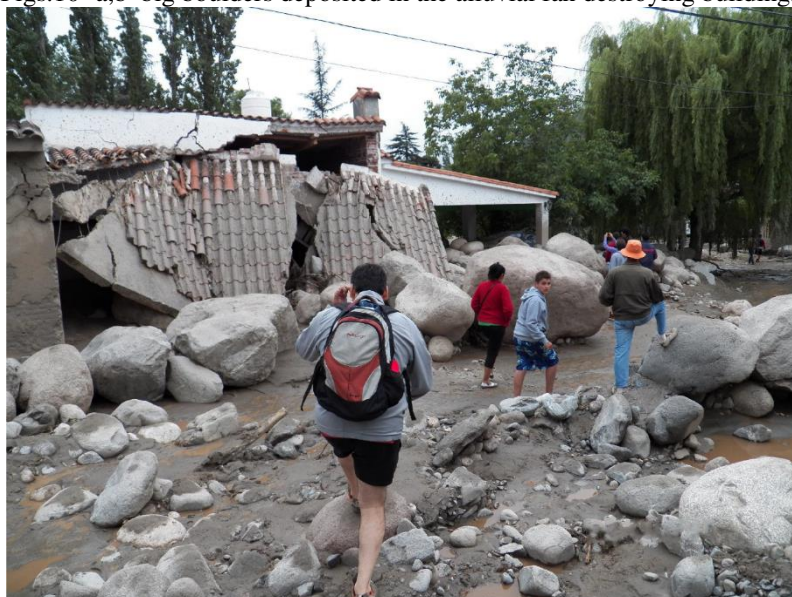
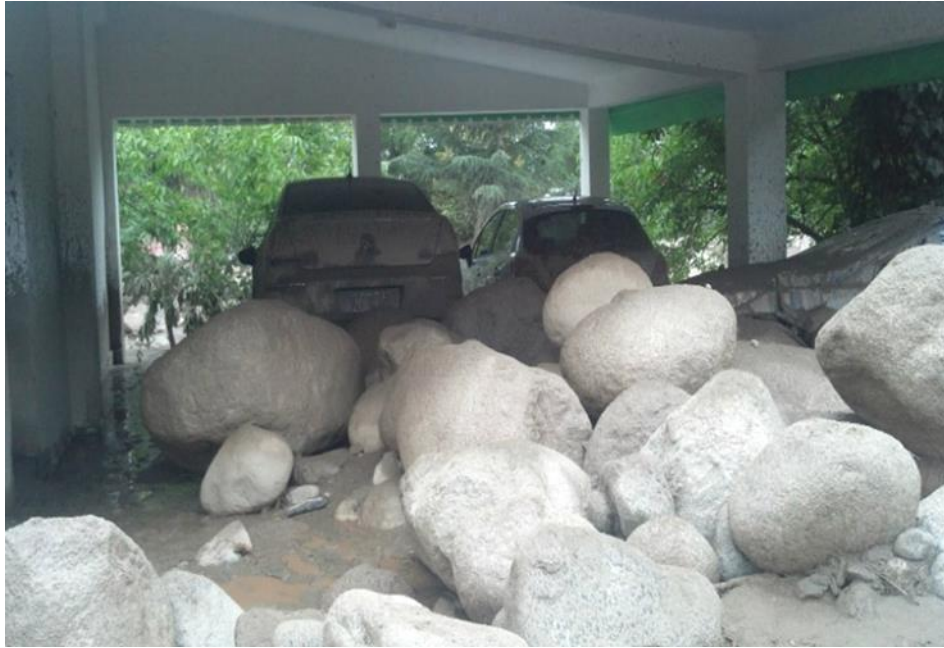
Figs.10- a,b big boulders deposited in the alluvial fan destroying buildings.

Data from field measurements of the movement of boulders above 500 mm- b axis- agree with calculated values from the bedload transport rate/unit stream power ratio established by the empirical equation for particles 0.5- 2 mm and were also valid for boulder size bedload movement (Bagnold, 1986; Inbar, 2000) (Fig. 10).

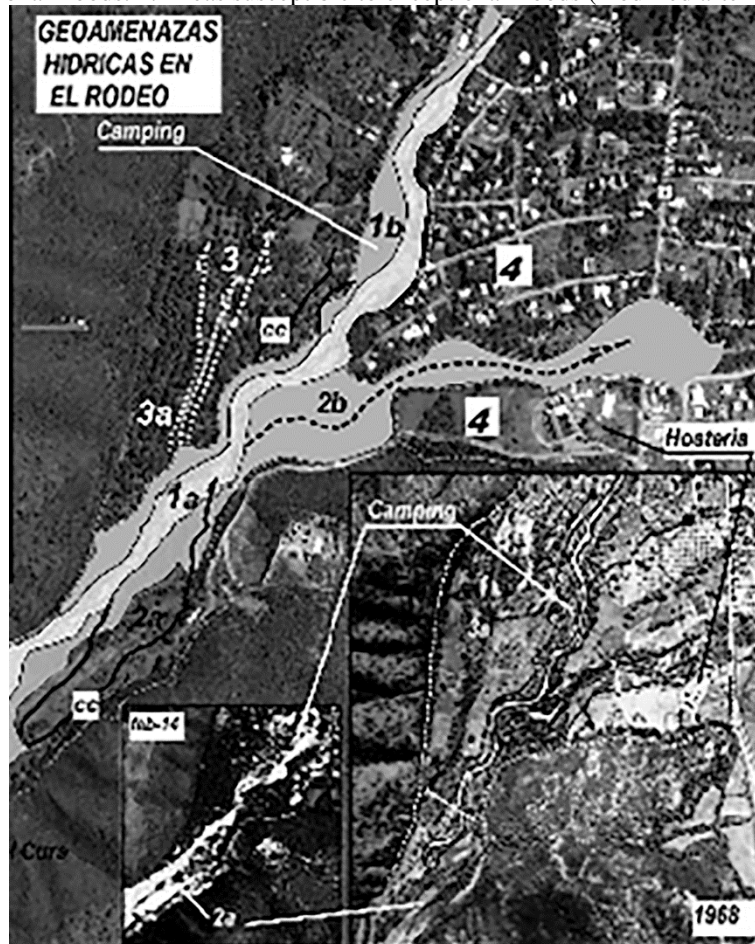
Fig. 12 frequently flooded areas in the river floodplain. 1. Frequently flooded areas. 2. Areas flooded by 1:50 year floods. 3. Areas susceptible to occasional floods. 4. Areas susceptible to exceptional floods (modified after Eremchuk, 2015).

The key morphological effects of a flood on the fluvial system depend on: (1) the local physiographic conditions, and (2) the size of the particles transported. The main areas affected by the flood were the flood plain adjacent to the river and several paleo-channels flowing into the village (Eremchuk, 2014) (Fig. 12).

Transversal cross-sections were made in the field studies (Bravo, 2014). The active channel is about 20 m wide and at the annual flood ~ 1-1.5 m deep. The active floodplain is about 10 m wide on each river bank comprised of coarse sediment. The upper part is a river terrace covered by fine shallow sediments and wild vegetation or planted trees. The extreme catastrophic flood covered the upper terrace as well as the dry channels incised into them.

The village is built on an alluvial cone with a typical braided system for channels, some of them were not active (defined as paleo-channels), and were reactivated by the flood. No major incision was observed and most erosion features were on the banks and floodplains.

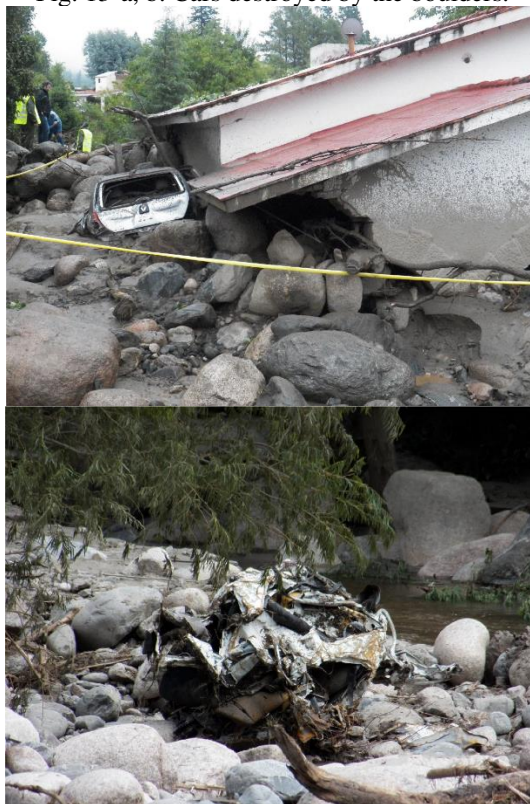
Fig. 13-a, b. Cars destroyed by the boulders.

One bridge, several houses and vehicles were totally destroyed (Figs. 13a-13b). The main road and a number of other village roads were severely affected. The total cost of the damage was estimated as one to two million dollars. Most of the properties were not insured and no clear estimate of the direct damage of the flood has been made. The summer tourist season was badly affected (El Esquiú).

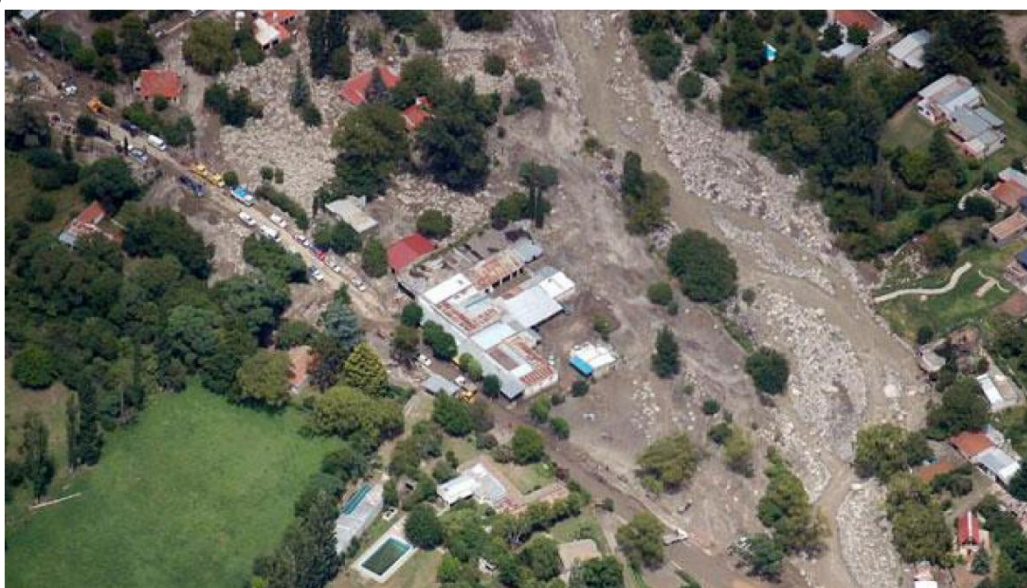
Fig. 14. Aerial view of the alluvial fan showing built areas in the floodplain damaged by the flood (El Esquiu newspaper, 25 January 2014)

The geomorphological signature of natural hazards in general, and flood events in particular are important to analyze. By examining the factors involved prediction of future floods may be possible, as may decisions regarding land use and infrastructure planning. The alluvial plain must be considered as an integral part of river dynamics (Fig. 14).
