The role of stacking faults for the formation of shunts during potential-induced degradation of crystalline Si solar cells

Volker Naumann^{*1}, Dominik Lausch¹, Andreas Graff², Martina Werner¹, Sina Swatek¹, Jan Bauer³, Angelika Hähnel³, Otwin Breitenstein³, Stephan Großer¹, Jörg Bagdahn¹, and Christian Hagendorf¹

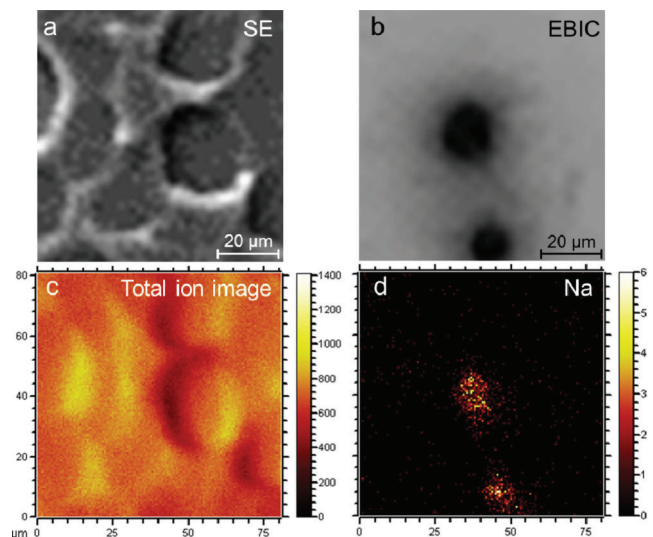
Figure 2 Small-section view ($80 \times 80 \mu\text{m}^2$) of a monocrystalline cell imaged by SEM (a, b). The ToF-SIMS images (c, d) have been integrated over a depth of 0.05 to $\sim 1 \mu\text{m}$ below the SiN_x/Si interface after removal of the SiN_x layer. (a) Surface topography (SE image) in correlation to the total ion mapping (c). The corresponding EBIC view (b) shows dark spots at exactly the same two positions where Na is measured within the uppermost $\sim 1 \mu\text{m}$ of Si substrate (d).

For the purpose of an elaborate ToF-SIMS experiment, first the SiN_x layer of a monocrystalline cell with PID-shunts was removed by O_2^+ ion etching on an area of $700 \times 700 \mu\text{m}^2$ until the Si substrate was eroded to a depth of $\sim 0.05 \mu\text{m}$. In the following, a ToF-SIMS depth profile with increased sensitivity for Na was found inside the Si in PID-shunt regions, i.e. at the stacking faults. Figure 2 shows details of secondary-electron (SE) (a) and EBIC (b) images acquired at 30 kV. The corresponding ToF-SIMS ion images (Fig. 2c and d) are integrated over a depth profile between $0.05 \mu\text{m}$ and $\sim 1 \mu\text{m}$ below the SiN_x/Si interface. The ToF-SIMS total ion image (Fig. 2c) proves congruence with the SEM/EBIC images.

A thorough estimation based on this ToF-SIMS depth profile measurement yields a number of $\sim 10^8$ Na-atoms per stacking fault up to the depth of $\sim 1 \mu\text{m}$. Projected on the stacking fault plane this corresponds to a density of $\sim 10^{15}$ Na-atoms per cm^2 . This number is in the same order of magnitude as the area density of Si atoms within a $\{111\}$ plane. Thus, roughly a monolayer of Na can be assumed to lay in the stacking faults analyzed in Fig. 2.
