# The Zagreb (Croatia) M5.5 Earthquake on 22 March 2020

**Abstract:** On 22 March 2020, Zagreb was struck by an M5.5 earthquake that had been expected for more than 100 years and revealed all the failures in the construction of residential buildings in the Croatian capital, especially those built in the first half of the 20th century. Because of that, extensive seismological, geological, geodetic and structural engineering surveys were conducted immediately after the main shock. This study provides descriptions of damage, specifying the building performances and their correlation with the local soil characteristics, i.e., seismic motion amplification. Co-seismic vertical ground displacement was estimated, and the most affected area is identified according to Sentinel-1 interferometric wide-swath data. Finally, preliminary 3D structural modeling of the earthquake sequence was performed, and two major faults were modeled using inverse distance weight (IDW) interpolation of the grouped hypocenters. The first-order assessment of seismic amplification (due to site conditions) in the Zagreb area for the M5.5 earthquake shows that ground motions of approximately 0.16–0.19 g were amplifie

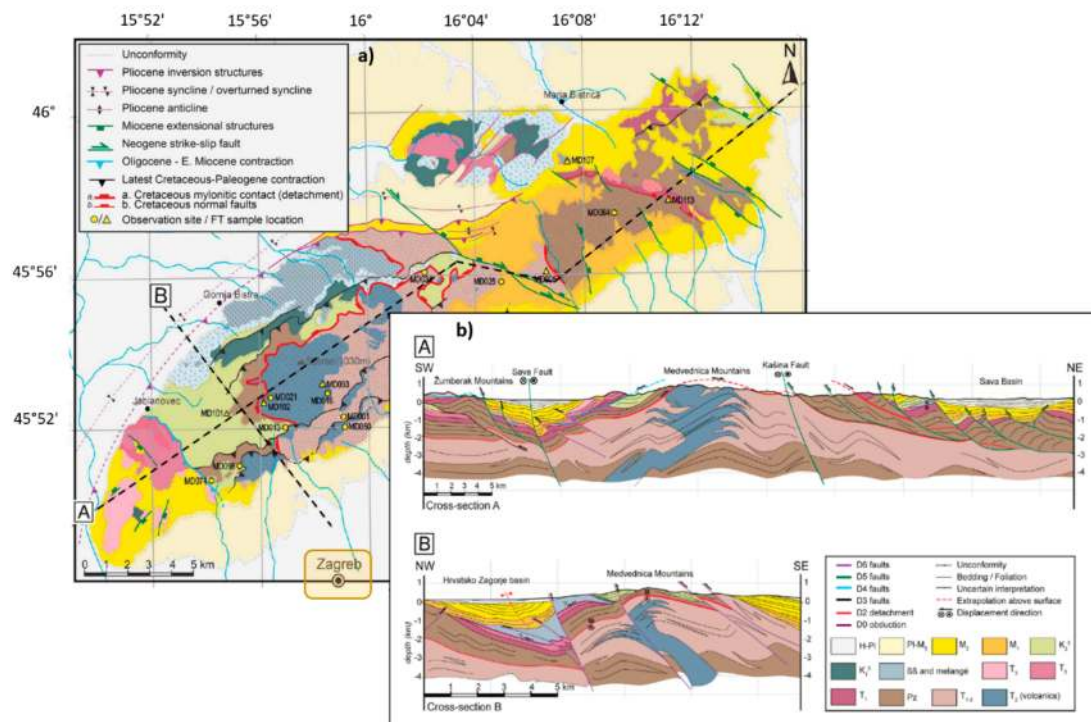
**Figure 1.** (a) Geological map of the Medvednica Mountains. The map shows the location of the cross-sections A and B; (b) Cross-sections across the Medvednica Mountains: (A) longitudinal (SW–NE) and (B) transversal (NW–SE) (after [11]).

The Medvednica Mountains are composed of a Paleozoic to Mesozoic metamorphic core overlain by non-metamorphic Mesozoic and Cenozoic rocks ([13–15]; Figure 1a). All units are truncated by normal and reverse faults and are surrounded by the Miocene–Quaternary deposits of the Pannonian Basin.

Using the previously described methodology, a primary fault plane was modeled (Fault 1) based on the dataset containing 45 hypocenters, including most of the highest magnitude events in the Zagreb 2020 earthquake sequence. The fault is characterized by an orientation similar to the southeast-dipping instrumentally calculated fault-plane solutions of the main shock and the strongest aftershock (Figure 4). The rupture along Fault 1 propagated towards the northwest, apparently along a deep-rooted southeast-dipping thrust fault (125/31, dip direction/dip angle). The thrust fault can be projected to the surface where it virtually appears in the central part of the Hrvatsko Zagorje basin (Figures 1b and 13).

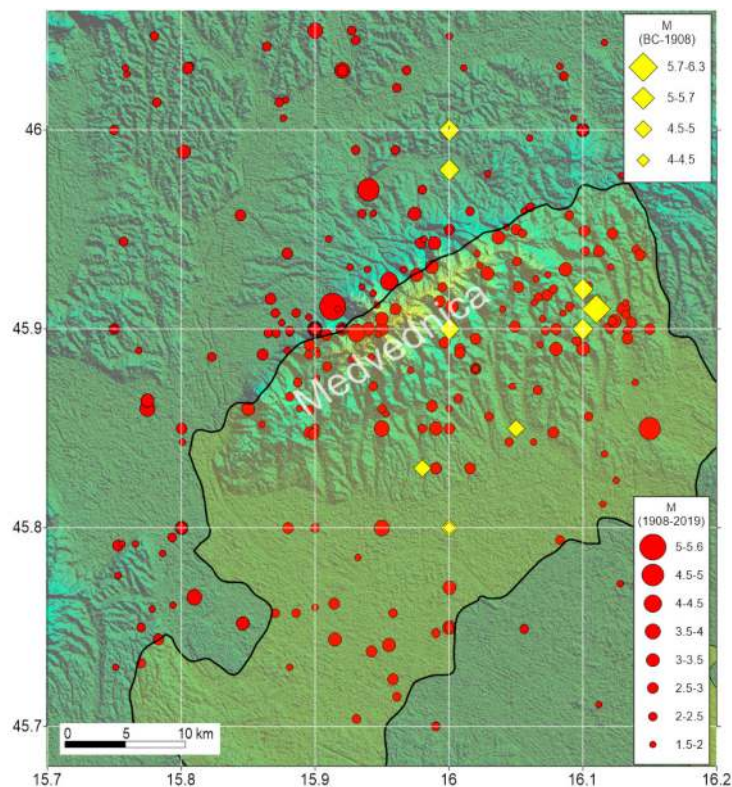
Figure 2 displays the locations of the epicenters of all earthquakes that have occurred in the wider Zagreb area (BC to 2019).

**Figure 2.** Spatial distribution of earthquakes with locations in the wider Zagreb area from BC to 2019 (according to the updated version of the Croatian Earthquake Catalogue, first described in [18]). The urbanized Zagreb city area is displayed with yellow shadowing.

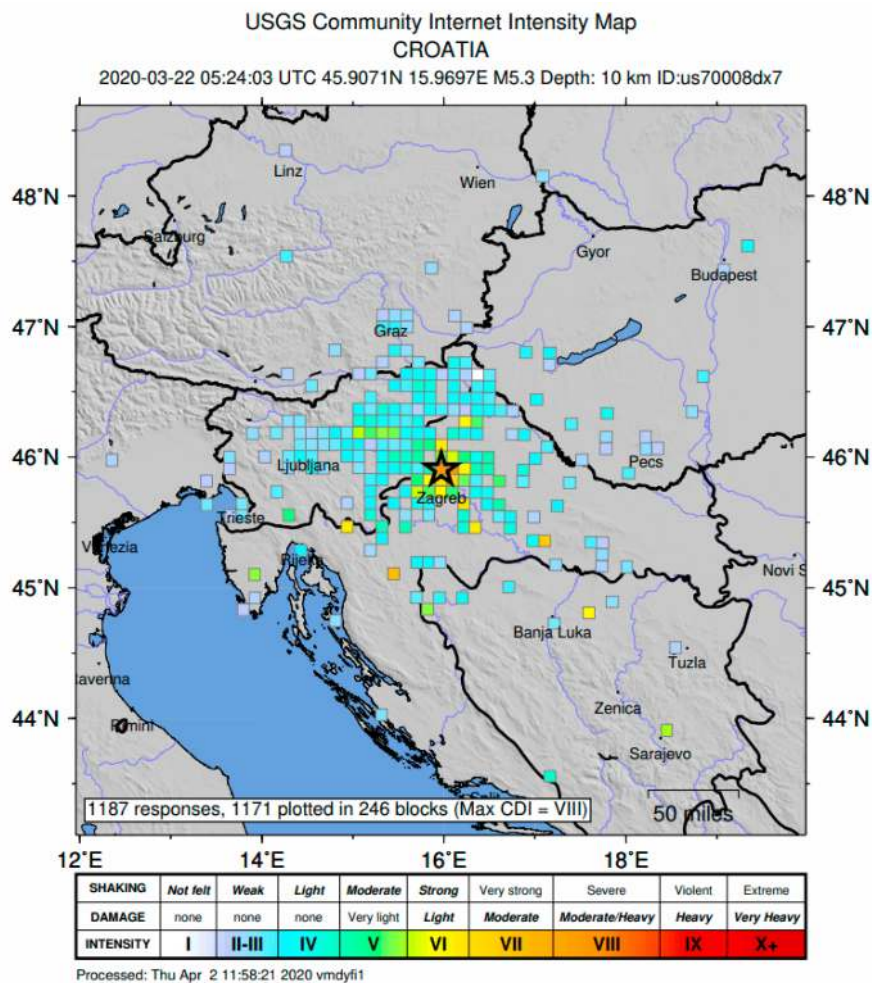
Figure 3. Intensity map according to data collected by USGS [19].

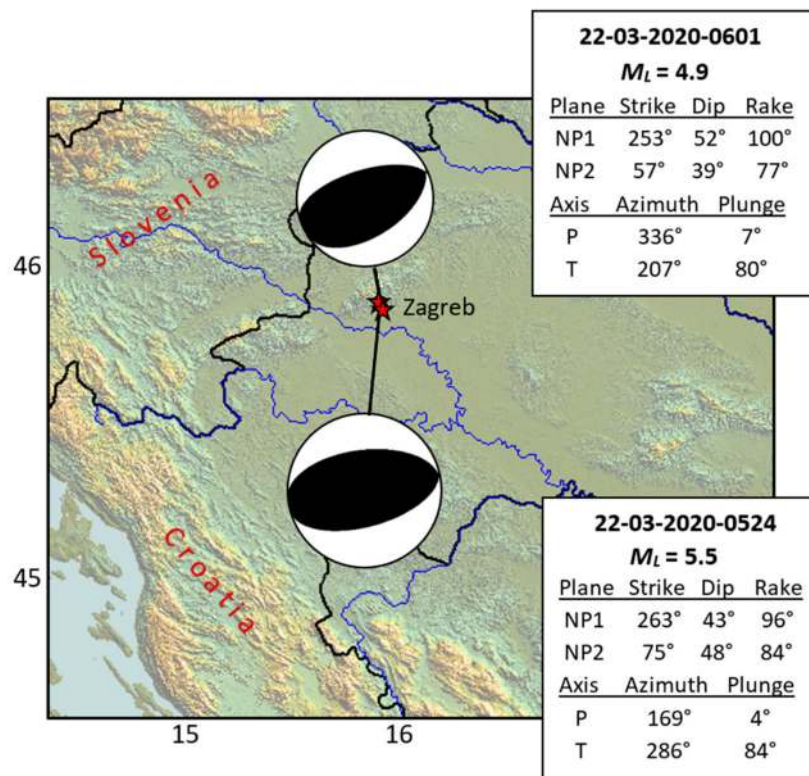
The fault-plane solution of the main shock indicates that the earthquake occurred on a reverse fault whose fault plane dips at an angle of  $43^\circ$  to the south-southeast or at an angle of  $48^\circ$  to the north-northwest. The axis of maximum tectonic pressure (P) was horizontal and in the SSE-NNW direction, while the axis of maximum tension (T) was almost vertical. The calculated fault mechanisms will be described in greater detail in Section 4.5 and linked to the geological features of the study area.

**Figure 4.** Fault-plane solutions of 22 March 2020 earthquakes at 05:24 UTC and 06:01 UTC. The focal sphere is shown in stereographic projection.

Based on the analysis of data recorded in Croatia and around the world (waveform data taken from the USGS National Earthquake Information Center [20]), the focal mechanisms of the main earthquake and the strongest aftershock were calculated (Figure 4).

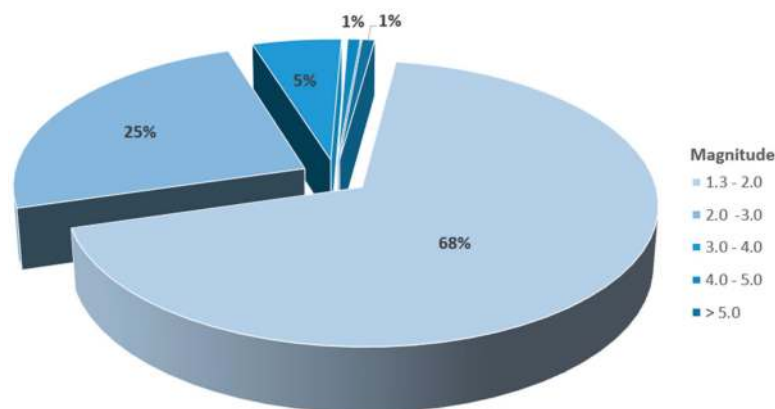
**Figure 5.** Percentage of earthquakes of each magnitude interval that occurred in the epicentral area of the Zagreb earthquake in the period from 22 March to 1 April 2020.

Since no one knows how much accumulated energy is released through a main earthquake, the aftershock activity is normal and not uncommon. Figure 5 presents the number of earthquakes of a certain magnitude (greater than 1.3) that occurred after the main earthquake of 22 March 2020 at 05:24 UTC.

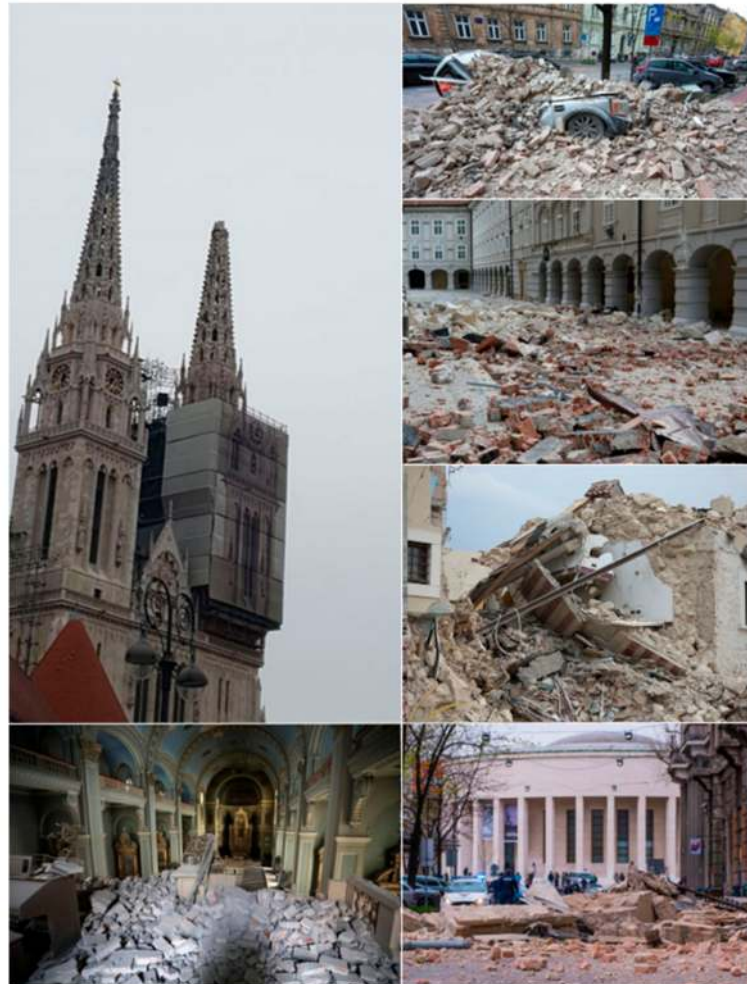
The earthquake hit the city center hardest, and the initial information indicated that the damage was great. Much damage to the cultural and historical architectural heritage of the city of Zagreb was reported, with severe damage to the south tower of Zagreb Cathedral. About 16,555 residential, public and monumental buildings were damaged (Figure 6) as declared by [21,22].

**Figure 6.** Photos of damage in Zagreb caused by the 22 March 2020 earthquake.

Figure 6 illustrates that in the old city center, three- to five-story masonry buildings, constructed from the time period of the Austro-Hungarian monarchy to 1920, sustained very heavy damage or were destroyed due to the M5.5 Zagreb earthquake on 22 March 2020. There were 26,197 damaged buildings in total (approximately 1900 uninhabitable), among which 9642 were family houses (as declared by [21,22]). As stated in the Disaster Risk Assessment for the Republic of Croatia [24], before 1920, masonry buildings used wooden slab construction, while reinforced concrete (RC) slabs were introduced in the period from 1920 to 1945. Before 1945, buildings possessed only initial earthquake resistance, and earthquake load was not considered in design (up to 5% of relevant peak ground acceleration-PGA was considered in design due to wind load). In compliance with Earthquake Hazard Map of Republic of Croatia [25], the relevant PGA based on 10% exceedance in 50 years, i.e., a return period of 475 years in the Zagreb area goes up to 0.28 g. The consideration of earthquake action in the design of buildings dates from 1946; however, the designs provided inadequate solutions. From 1945 to 1964, earthquake load was considered in the design of buildings by using simplified methodologies (the horizontal force at the top of the building); however, only up to 10% of the relevant PGA was considered in design. In 1964, as a result of the M6.9 Skopje (North Macedonia) earthquake in 1963, the Ordinance on Temporary Technical Regulations for Construction in Seismic Areas (Federal Republic of Yugoslavia (FRY) Official Journal, [26]) was issued. The ordinance required the construction of vertical or horizontal confining elements in masonry buildings, but it provided low earthquake resistance in general. In 1981, it was replaced by the Ordinance on Technical Standards for the Construction of High-Rise Buildings in Seismic Areas (FRY Official Journal, [27]), which provided moderate resistance. Between the years 1964 and 1998, 30–50% of the relevant PGA was considered in the building earthquake resistance design, and 70–100% was considered between 1998 and 2013. The aforementioned regulations were completely replaced by the contemporary standard EN 1998-1 [28] in 2013, which ensured high earthquake resistance (i.e., the earthquake load considered equals 100% of the relevant PGA).

On the basis of the observed building damage, a subsequent retrofitting of the most sensitive and dangerous buildings (e.g., city center URM family houses, URM city center residential three- to five-story buildings and cultural heritage buildings) to reduce their vulnerability in compliance with the EN 1998-3 [31] provisions is required, particularly when an earthquake with M6.5 (MMI 8–9) is likely to occur (e.g., once every 475 years, [32]). Considering the structural weaknesses of the damaged buildings, especially those in pre-1964 structures, attention should be given to local and global strengthening and stiffening and unnecessary mass removal. In general, based on recommendations from [30], pre-1964 URM buildings can be retrofitted by, e.g., spraying concrete on the walls from inside to protect the outward appearance. However, heritage buildings require special attention due to their cultural significance and heritage conservancy requirements. An additional way to improve the performance of URM family houses is to insert confining elements into their structural wall intersections. The costs of building repair, estimated to be 6 billion US dollars, should also cover building performance improvement, at least for the most sensitive and dangerous buildings. Considering the case of the recent and nearby M6.4 Durres, Albania, 26 November 2019 earthquake [33] as an example, buildings with moderate and high levels of earthquake-resistant design experienced negligible to slight and moderate damage to RC components (DG 1 and 2). However, they also experienced substantial to heavy damage, including very heavy damage and destruction of URM components (DG 3, 4 and 5). The damage resulting from the Durres, Albania, earthquake could be easily related to laboratory experiments, as described in [34,35]. If such an event affects Zagreb, it could have high social and economic consequences (human casualties, i.e., deaths and injuries, and financial costs) due to buildings collapsing or becoming mostly unserviceable.

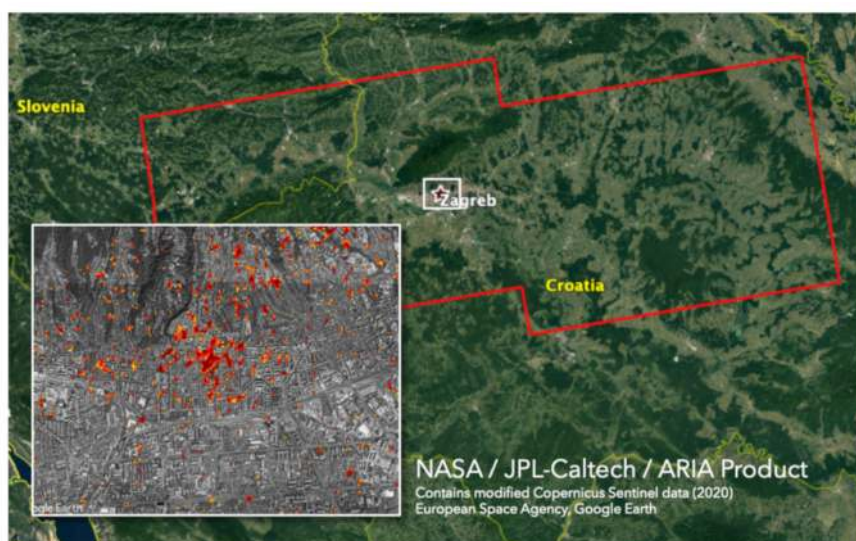
The extent of the damage is also visible on the damage proxy map (DPM) (Figure 7), which was created by the Advanced Rapid Imaging and Analysis (ARIA) team at NASA's Jet Propulsion Laboratory and the California Institute of Technology, both in Pasadena, California. The map depicts areas that were likely damaged. The map was derived from synthetic aperture radar (SAR) images from the Copernicus Sentinel-1 satellites, operated by the European Space Agency (ESA). The team compared a post-event image acquired on 23 March 2020 with pre-event images taken since January 2020. The image covers an area of 166 by 56 km (103 by 35 miles), shown by the large red polygon. Each pixel measures approximately 30 m across. The color variations from yellow to red indicate increasingly significant surface changes. Preliminary validation was performed by using photographs from various sources, including news media. This damage proxy map should be used as a guide to identify damaged areas. The full map is available online at [23].

**Figure 7.** Damage proxy map created by the Advanced Rapid Imaging and Analysis (ARIA) team at NASA's Jet Propulsion Laboratory (JPL) and the California Institute of Technology. This map contains modified Copernicus Sentinel data, processed by the ESA and analyzed by the NASA JPL/Caltech ARIA team. This task was carried out at the JPL, funded by NASA. [23].

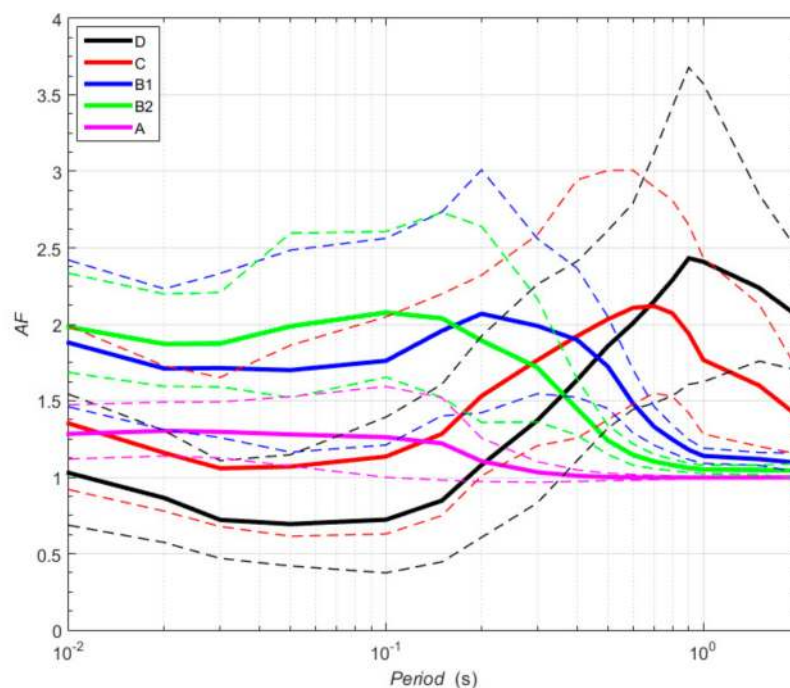
the well-known properties of random vibration theory (RVT) and seismological source theory [52],  $PGA_{ROCK}$  values for the M5.5 Zagreb earthquake were estimated (from the Fourier amplitude spectrum (FAS)). The input motion in the RVT-based method is typically defined by Brune's [53] omega-squared point-source stochastic model. The stress drop was set to the prescribed constant value of 100 bar (e.g., see [54]), the focal depth was taken as  $h = 10$  km, the average value of crustal shear wave velocity was equal to 3.5 km/s and the density was 2800 kg/m<sup>3</sup>. Frequency-dependent attenuation, the  $Q(f)$  value, was adopted from [55] as  $Q_c(f) = 78f_c^{0.69}$ , and the near-site attenuation parameter  $\kappa_0 = 0.028$  s was adopted from [56]. We chose to select locations near epicentral area and set the epicentral distance to vary from 1 to 5 km. The corresponding target values of  $PGA_{ROCK}$  were calculated in the range of 0.159–0.185 g. Based on these results, we estimated the median site amplification factor ( $\pm 1$  standard deviation) using the Stanko et al. [48] model for  $V_{S30}$  categories defined by Eurocode 8 (Figure 9). Standard deviation of median site amplification describes site response variability as the effect of variations in ground motions and local site parameters. For site class B, we used two bins, 360–600 m/s (B1) and 600–800 m/s (B2), consistent with the findings of [57]. As underlined in [58], profiles with relatively shallow surface layers underlain by hard bedrock surfaces may have high impedance contrasts leading to strong resonance effects, which is the case for the Zagreb Podsljeme zone. The dominant period/frequency of the ground motion and the natural period/frequency of the soil are especially critical for possible resonance effects during earthquakes, which can result in heavy destruction. Therefore, knowing the building resonance frequency is important for structural stability during earthquakes and for limiting the extent of resonance damage. If the period of ground motion matches the natural resonance of a building, it undergoes the largest oscillations possible and suffers the greatest damage [30]. In general, the Zagreb residential area in terms of  $V_{S30}$  categories is in categories B1 (Podsljeme) and C (city center and Novi Zagreb), which show site amplifications most prominent between 0.1–0.5 s (2–10 Hz) and 0.4–0.9 s (1.1–2.5 Hz). Compared to the period–building relationship of  $T = 0.016H$  presented in [59], these periods correspond to family houses and 3- to 4-story (B1) and 4- to 15-story buildings (C1).

**Figure 9.** Median site amplification factors [41] for  $V_{S30}$  site classes based on Eurocode 8 with ( $\pm 1$  standard deviation (dashed lines) for the  $PGA_{ROCK}$  in the range of 0.159–0.185 g.

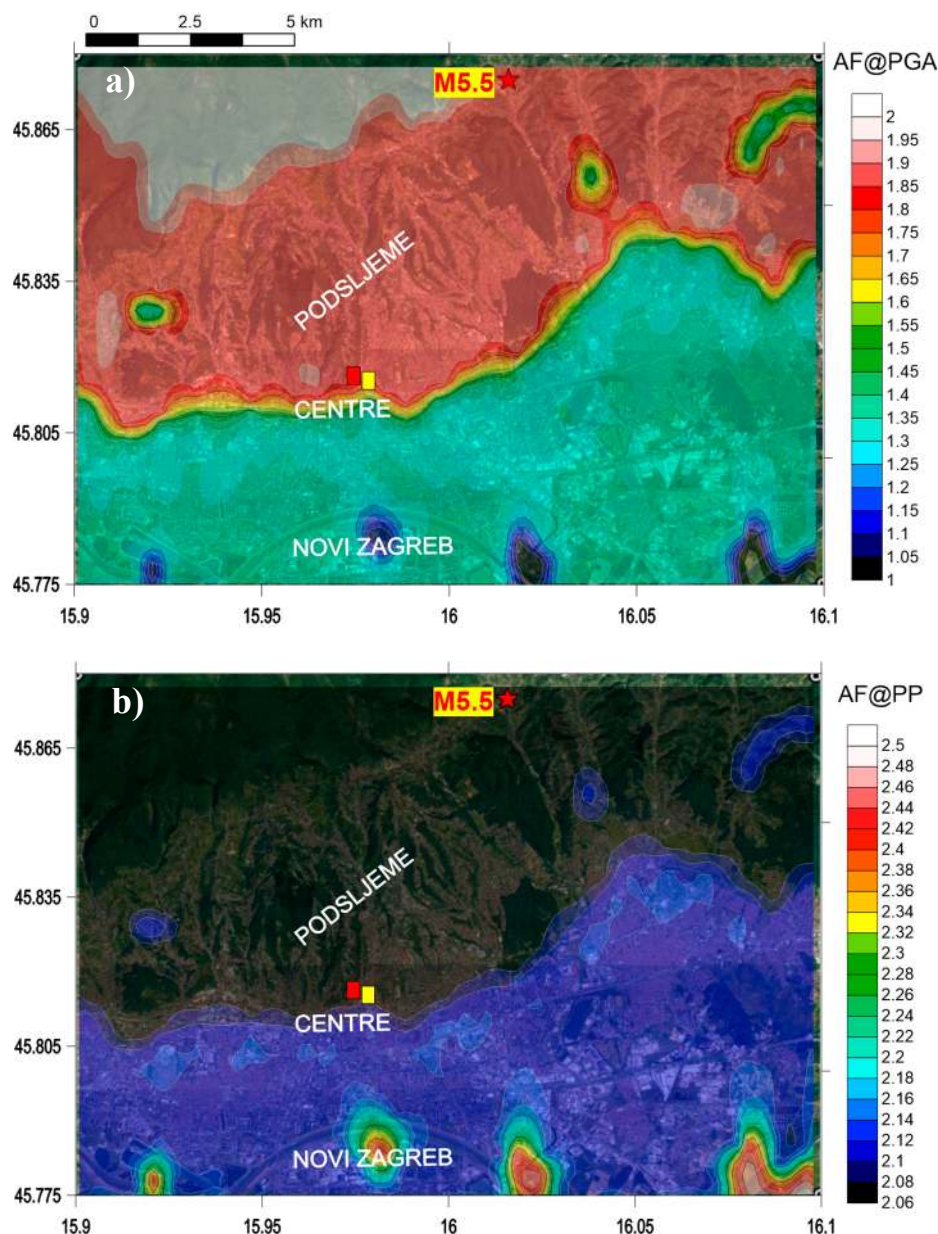
Figure 10 shows two site amplification maps for the PGA at the surface (AF@PGA) and for the predominant amplification peak period (AF@PP) for estimated  $PGA_{ROCK}$ . The amplification factor at the surface (AF@PGA) of the input M5.5 event seismic motion (approximately estimated between 0.16–0.19 g) tends to be 1.6–1.8 in the Podsljeme zone, approximately 1.4–1.6 in the city center and approximately 1.3 in the alluvial Sava zone (Novi Zagreb) due to the nonlinear effects of strong shaking [42]. At the resonant period (AF@PP), the observed amplification factor varies from 2.1 in the Podsljeme zone to 2.2 in city center and 2.4 in the Sava alluvial zone. Observed amplifications probably can also be correlated with ground motion polarization and directionality at sites with pronounced topography [60].

The first-order assessment of seismic amplification (due to site conditions) in the Zagreb area for the M5.5 earthquake shows that ground motions of approximately 0.16–0.19 g were amplified at least twice (if the standard deviation is taken into account, they can be amplified by a factor of 3.0 at some locations) in the Podsljeme and city center zones where the greatest extent of the damage is reported. Damage is most prominent in older buildings built before 1964, while newer buildings that were built using Eurocode 8 sustained very little or no damage, particularly in the Novi Zagreb area where the amplification factor at the resonant period is up to 2.4 (with standard deviation, it can be up to 3.6). Severe damage to the south tower of the Zagreb Cathedral (yellow square) could likely be the result of old construction and resonance effects; for category C, AF@PP = 2.2 at the period of 0.8–0.9 s (1.1–1.25 Hz), which corresponds closely to the Cathedral period of 0.71–0.92 s (1.08–1.4 Hz) [61]. Similar results are observed for the Croatian Parliament (also an old building that suffered considerable damage), where the soil category is B1 with estimated AF@PP = 2.08 at a period 0.31 s (3.16 Hz).

**Figure 10.** (a) Site amplification map for the  $PGA$  at surface ( $AF@PGA$ ) and (b) the predominant amplification peak period ( $AF@PP$ ) for estimated  $PGA_{ROCK}$ .

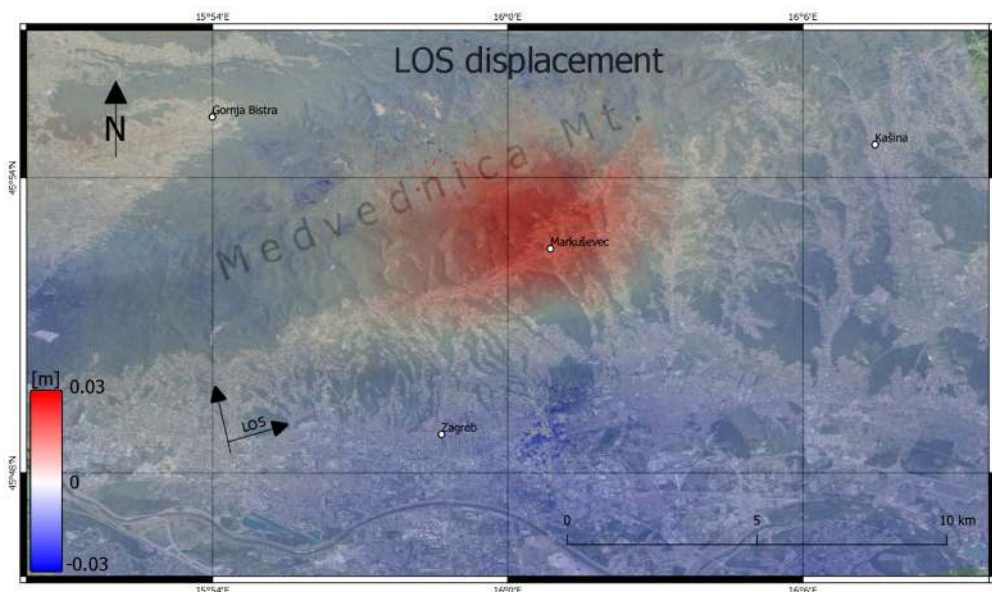
**Figure 11.** Unwrapped interferogram map indicating co-seismic line-of-sight (LOS) deformation of the 22 March 2020 earthquake.

The observed co-seismic deformation implies an approximately 3 cm uplift of the epicentral area that covers approximately 20 km<sup>2</sup>.

Two Sentinel-1A IW SLC images were processed to derive the co-seismic surface deformation at the Medvednica Mountains (Table 1). Space-borne SAR data are available on the Sentinel data hub [67]. The co-seismic displacement was investigated using differential interferometric synthetic aperture radar (DInSAR) technique [68]. The estimation of earthquake strength was based on the determination of the differential phase angle between two SAR images taken from almost the same satellite position at different times. The differential interferogram was filtered by relevant coherence ( $>0.2$ ). Interferogram coherence values were moderate on average (0.46), although the affected area is covered with thick vegetation. Time series processing and post-earthquake analysis using radar interferometry were performed with the open-source Sentinel Application Platform (SNAP). Deformation was referenced with the line-of-sight (LOS) direction from radar. The LOS data were acquired by merging different swath phases and then unwrapped using SNAPHU (Statistical-Cost Network-Flow Algorithm for Phase Unwrapping). The results of co-seismic deformation were geocoded to a WGS84 geographic coordinate system (Figure 11). Figure 11 shows an unwrapped interferogram from which it is possible to identify the most affected area.

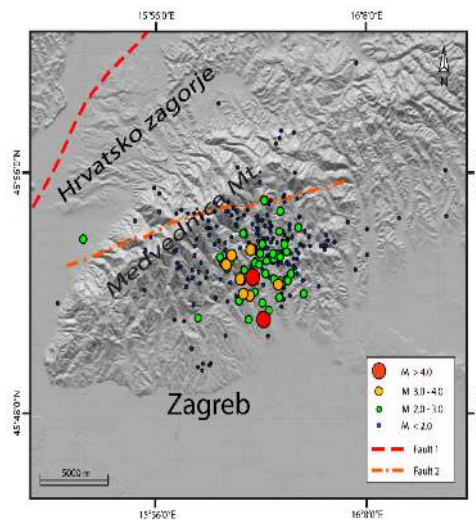
A set of 257 measurements was analyzed both spatially and temporally and processed for import into geological 3D modeling software. To achieve better visual insight, the hypocenters were scaled based on magnitude values ( $M_L$ ) into four intervals: <2.0, 2.0–3.0, 3.0–4.0 and >4.0 (Figure 12).

**Figure 12.** Spatial distribution of earthquake epicenter locations in the period from 22 March to 1 April 2020 (the Zagreb 2020 earthquake sequence). Fault lines are simple projections of the two modeled fault plains from the deep subsurface of the Medvednica Mountains to the surface (see Supplement 1 and Figure 13).

A system of south-dipping longitudinal reverse faults has been mapped on the surface along the Medvednica Mountains [15] and interpreted in one of the latest tectonic models as the youngest (Pliocene to Quaternary) system of reverse faults ([11]; Figure 1) that are probably still active [7]. The reverse slip of the primary ruptured fault (Fault 1) of the Zagreb 2020 earthquake sequence (Figure 13; Supplement 1) generally corresponds to the frontal reverse fault striking along the northern foothills of the mountain (Figure 1b). However, the interpreted steep frontal reverse fault does not match the modeled gently inclined primary fault that is here interpreted as a thrust fault (Figure 13). Thus, a fault that could accommodate such a movement is probably a southeast-dipping thrust fault that completely dissects the basement of the central part of the Medvednica Mountains. This master thrust could represent a basal detachment (décollement) of the system of steeper reverse faults striking along the Medvednica Mountains. It could be steeper in the frontal part and thus could match the North Medvednica reverse fault, or it could be buried below the Neogene Hrvatsko Zagorje basin (Figure 1b; Figures 12 and 13).

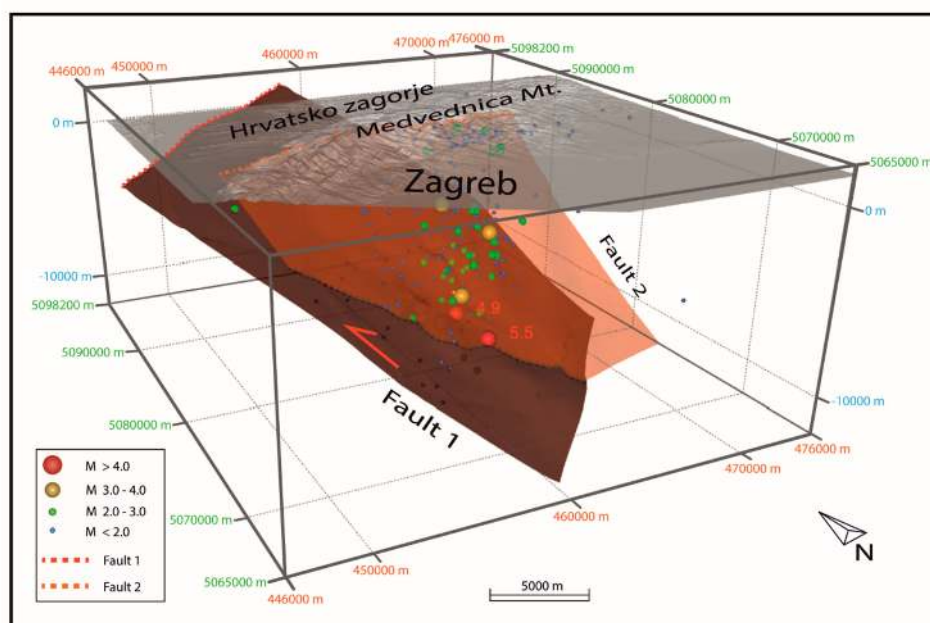
**Figure 13.** Preliminary structural 3D model of the Zagreb 2020 earthquake sequence. Coordinates are shown in HTRS96/TM coordinate system, and the elevation is in meters (no vertical exaggeration). Fault 1 is interpreted as a primary thrust fault, and Fault 2 is interpreted as a secondary (reverse?) fault.

Based on the selected datasets, two major faults were modeled using inverse distance weight (IDW) interpolation of the preselected datasets (hypocenters). The faults represent the preliminary structural model of the Zagreb 2020 earthquake sequence (Figure 13).

In addition to Fault 1, a generally south-dipping fault (166/57) of unknown character (Fault 2) was modeled based on a dataset with 77 hypocenters situated above the main shock. Fault 2 includes most of the moderate magnitude events of the earthquake sequence.
