**THERMAL BARRIER COATING LIFE PREDICTION
MODEL DEVELOPMENT
SECOND ANNUAL REPORT**

Written by J.T. DeMasi
Approved by Dr. K.D. Sheffler

UNITED TECHNOLOGIES CORPORATION
Pratt & Whitney Group
Engineering Division

14. SPONSORING AGENCY CODE	
15. SUPPLEMENTARY NOTES Project Manager: Dr. Robert A. Miller NASA Lewis Research Center, Cleveland, Ohio					
16. ABSTRACT The objective of this program is to establish a methodology to predict thermal barrier coating life in an environment simulative of that experienced by gas turbine airfoils. Critical experiments were conducted to determine important failure modes of the thermal barrier coating. Analytical studies coupled with appropriate physical and mechanical property determinations were employed to derive a life prediction model relative to the predominant failure mode(s). A review of experimental and flight service components as well as laboratory post evaluations indicates that the predominant mode of TBC failure involves thermo-mechanical spallation of the ceramic coating layer. This ceramic spallation involves the formation of a dominant crack in the ceramic coating parallel to and closely adjacent to the topologically complex metal

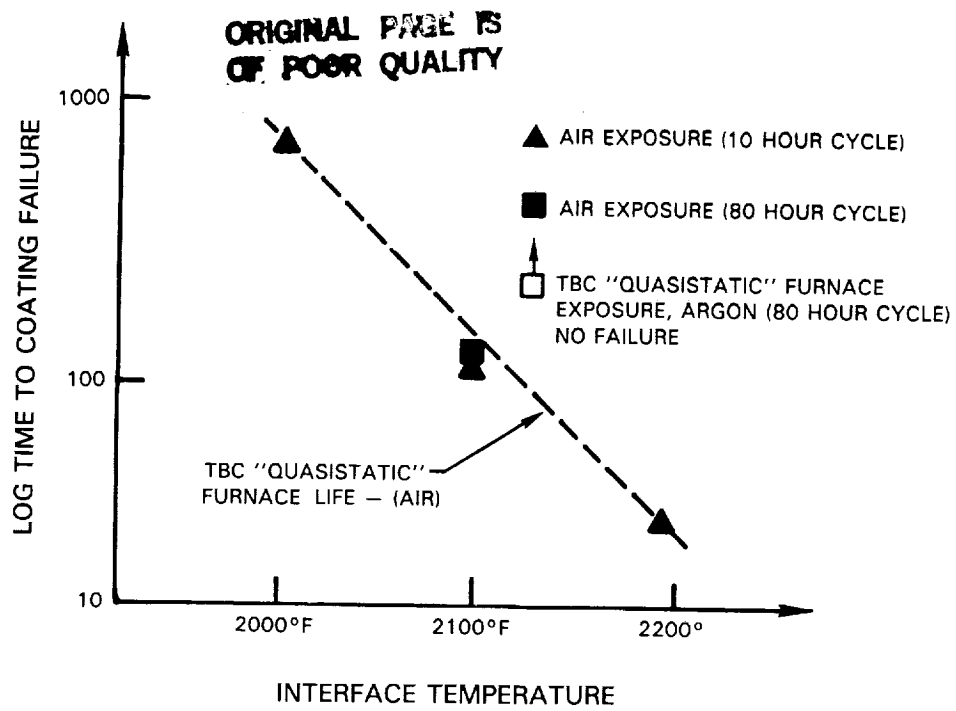
Figure 6 Test Data Showing Thermal Exposure Atmosphere Effects on Coating Durability

Review of the failure time data in Table VII clearly shows the influence of temperature, exposure environment and cycle frequency on ceramic spallation life. The results show that thermal exposure in Argon does not cause coating failure for an extended period of time compared to air exposure. For furnace exposure conducted in air, frequent thermal cycling appears to slightly decrease the total exposure time to failure, as shown by comparison of 2100°F air tests with 10 hour and 80 hour inspection intervals. Thermal barrier coating life was shown to be more dramatically dependent on "cyclic content" by previous work conducted by Miller, (Ref. 37) and McDonald and Henricks (Ref. 19).

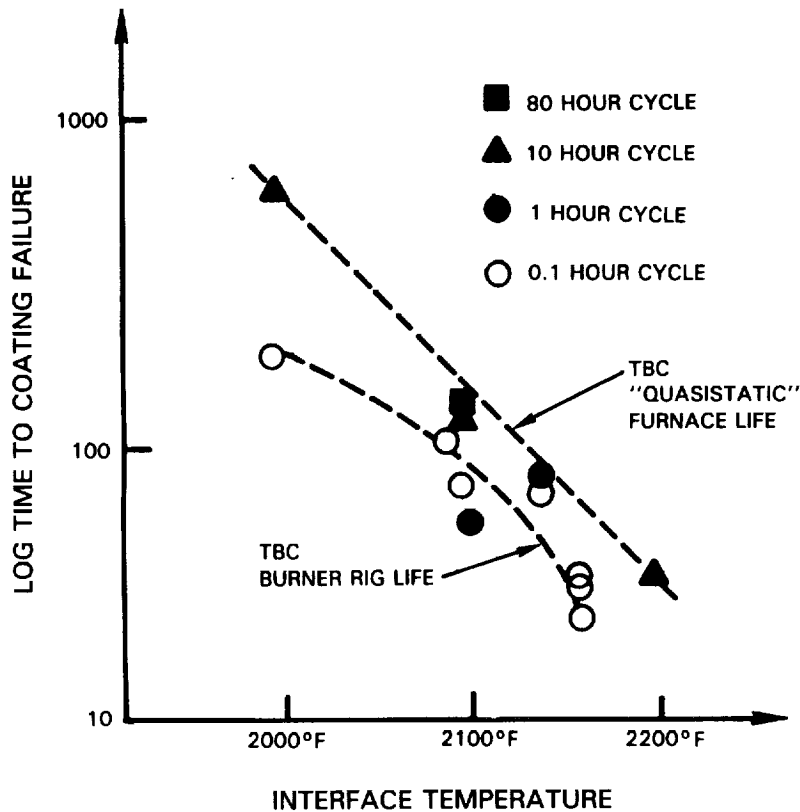
Figure 22 Test Data Showing Coating Life Dependent on Temperature, "Cyclic Content"
