Technical Report CHL-98-22  
July 1998

# Three-Dimensional Breakwater Stability Tests at Vale de Cavaleiros, Cape Verde

by Ernest R. Smith, Jeffrey A. Melby

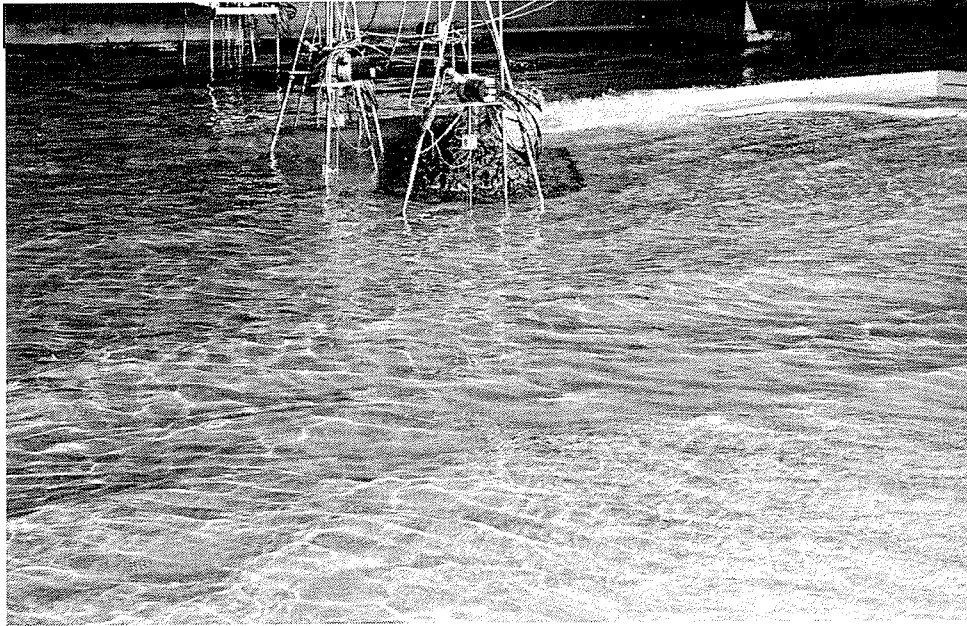
Figure 5. Three-dimensional stability model

Experiments were conducted in a 29.3-m-long, 29.6-m-wide, 1.5-m-deep wave basin. The model was constructed and molded of concrete to represent approximately 825 m of shoreline encompassing the harbor and breakwater location. Contours were molded to -20 m CD, and a 1V on 5H transition slope was molded from the -20-m contour to the model floor elevation of -21.3 m CD. Wave absorber was placed around the perimeter of the basin to minimize the effects of reflection. A photograph of the model is shown in Figure 5.

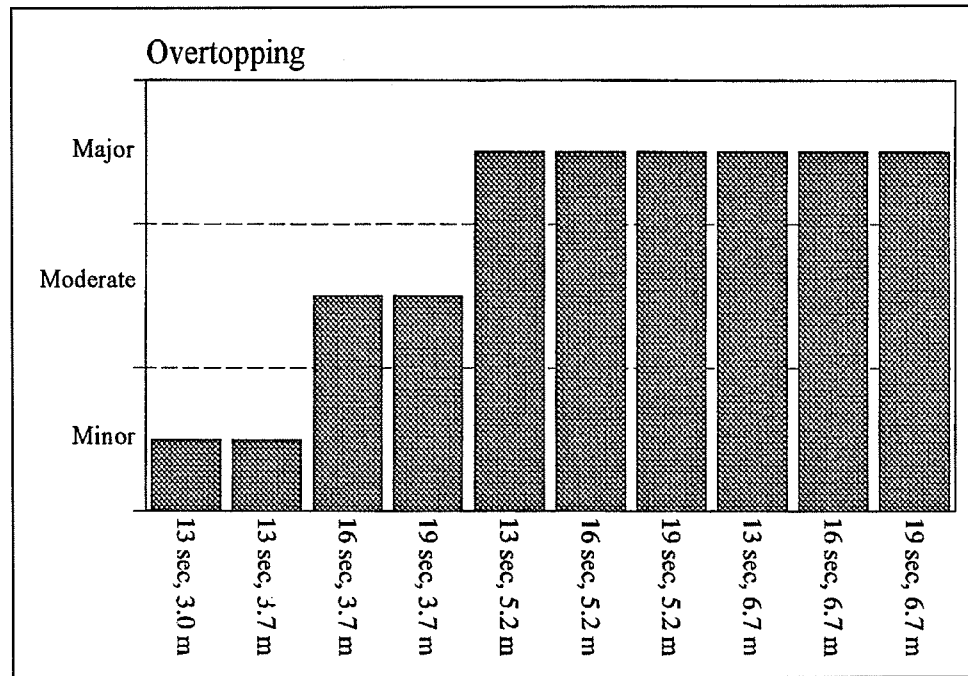
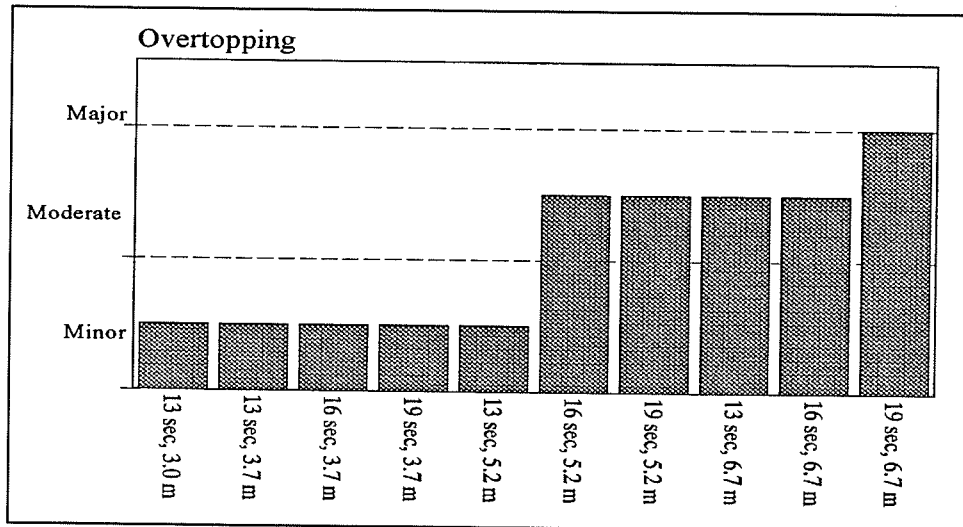
Overtopping was classified as minor, moderate, or major. Minor overtopping was defined for the present study as occasional or no overtopping. Moderate overtopping was defined as regular overtopping with occasional green water. Conditions that produced frequent overtopping and green water were classified as major.

The classification of overtopping (minor, moderate, or major) is plotted versus wave condition in Figures 17 through 19. The wave conditions in the figures are labeled from left to right by the sequence in which they were generated during the experiment, i.e., 13-sec, 3.0-m waves were generated first and 19-sec, 6.7-m waves were generated last. Figure 17 shows the amount of overtopping that occurred at the trunk for all plans. Major overtopping occurred at the trunk for 16-sec, 6.7-m waves, but was minor or moderate for all other conditions. Figures 18 and 19 show overtopping classifications for Plan 1 and Plan 2 series experiments at the head, respectively. The figures illustrate the reduction of overtopping by raising the crest elevation to +8 m CD (Plan 2 series) from +5 m CD (Plan 1 series).

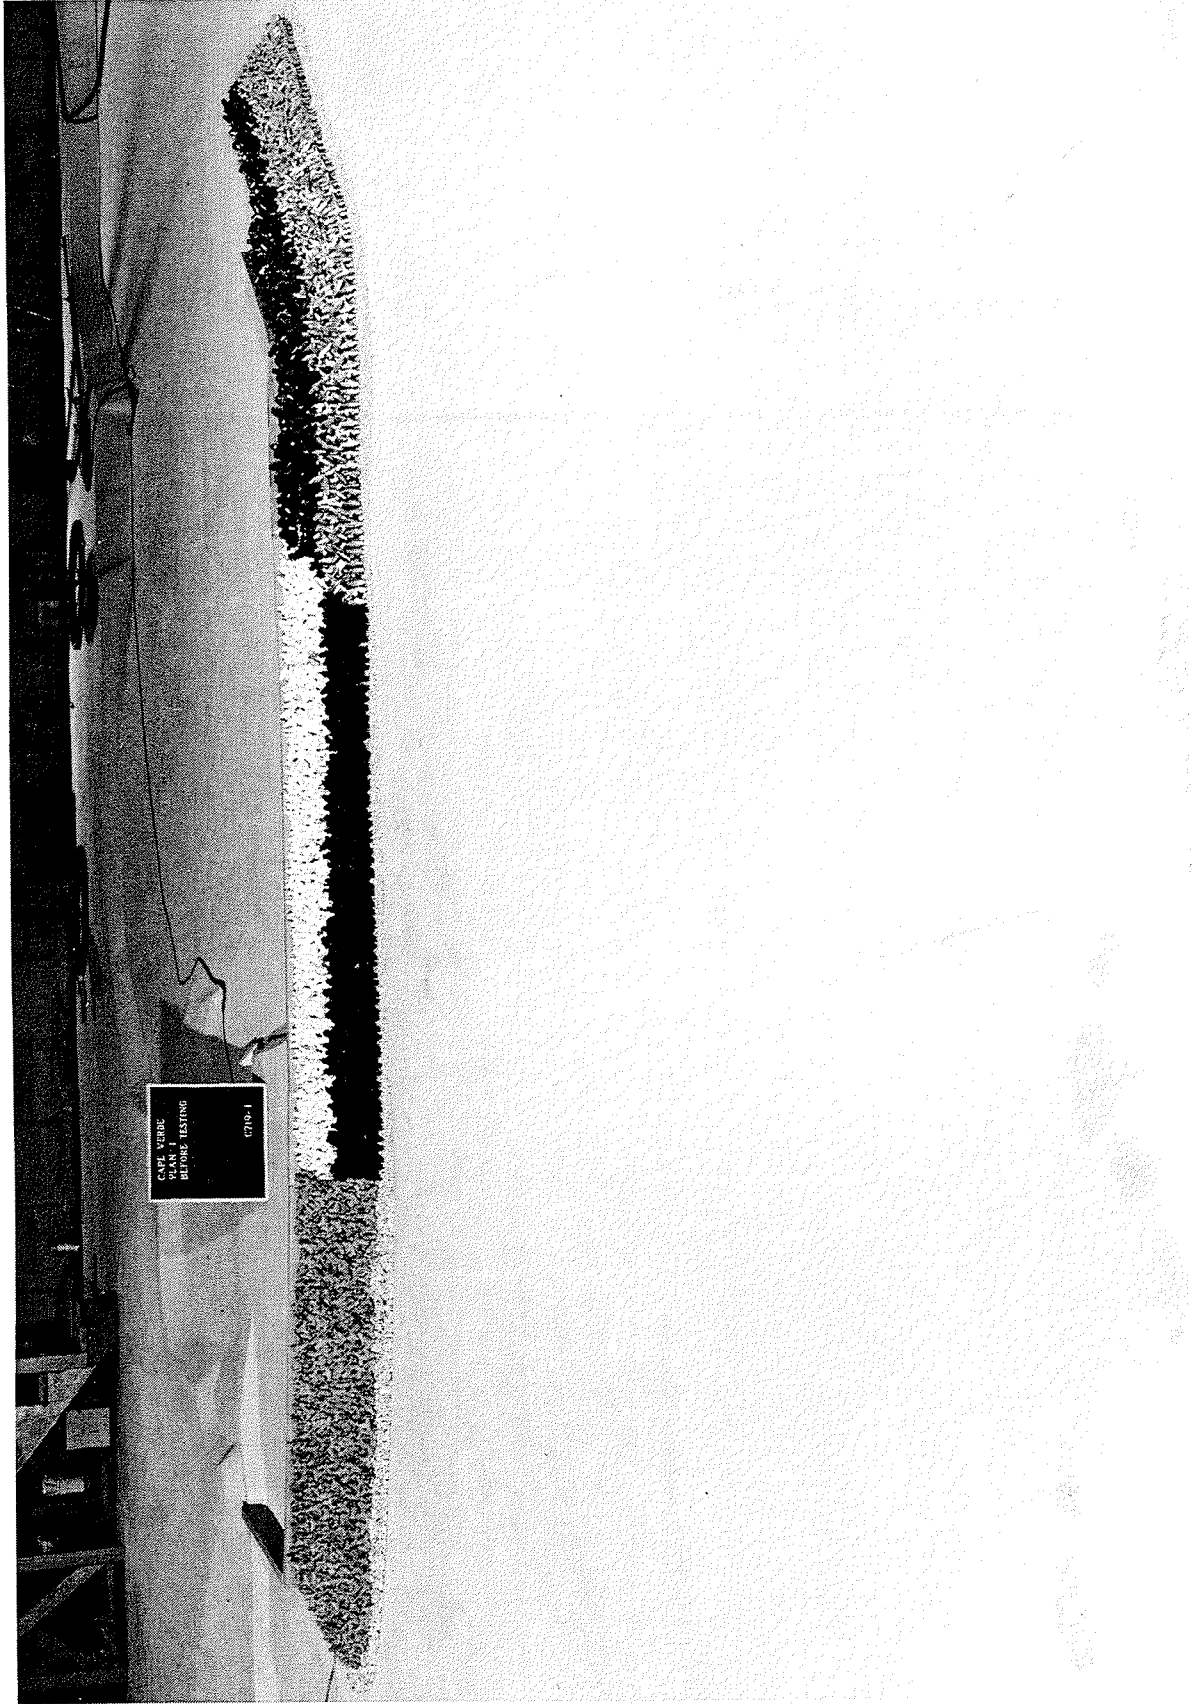
Photo A1. Sea-side view of plan 1 before testing

Plan 1, the initial plan (Figure 10, Photos A1 through A3), consisted of 6.25-tonne tetrapods from the shoreward end of the breakwater to Profile 4; 8-tonne Core-Locs from Profile 4 to a point between Profiles 6 and 7 (a total reach of approximately 92 m); and 11-tonne Core-Locs on the remainder of the seaward trunk, around the head and terminating at the quay wall on the leeward side of the structure. For this plan, packing densities of the 8- and 11-tonne Core-Loc reaches were 0.55 and 0.59, respectively. The crest elevation of the head section was +5 m CD. Plan 1 was subjected to “shakedown” waves (13 sec, 3 m) to settle and nestle the armor units. During the wave series, apron material was displaced between Profiles 4 and 9, and Core-Locs were displaced at the toe near Profile 4 (Photos A4 through A6). The structure was subjected to 3.7-m waves for 13- and 16-sec periods, which caused additional toe unit displacement at Profile 4 and at the elbow near Profile 8.
