**TSUNAMI ON 26 DECEMBER 2004: SPATIAL DISTRIBUTION OF  
TSUNAMI HEIGHT AND THE EXTENT OF INUNDATION  
IN SRI LANKA**

Janaka J. Wijetunge  
Department of Civil Engineering, University of Peradeniya,  
Peradeniya 20400, Sri Lanka  
(e-mail: janaka@fluids.pdn.ac.lk)

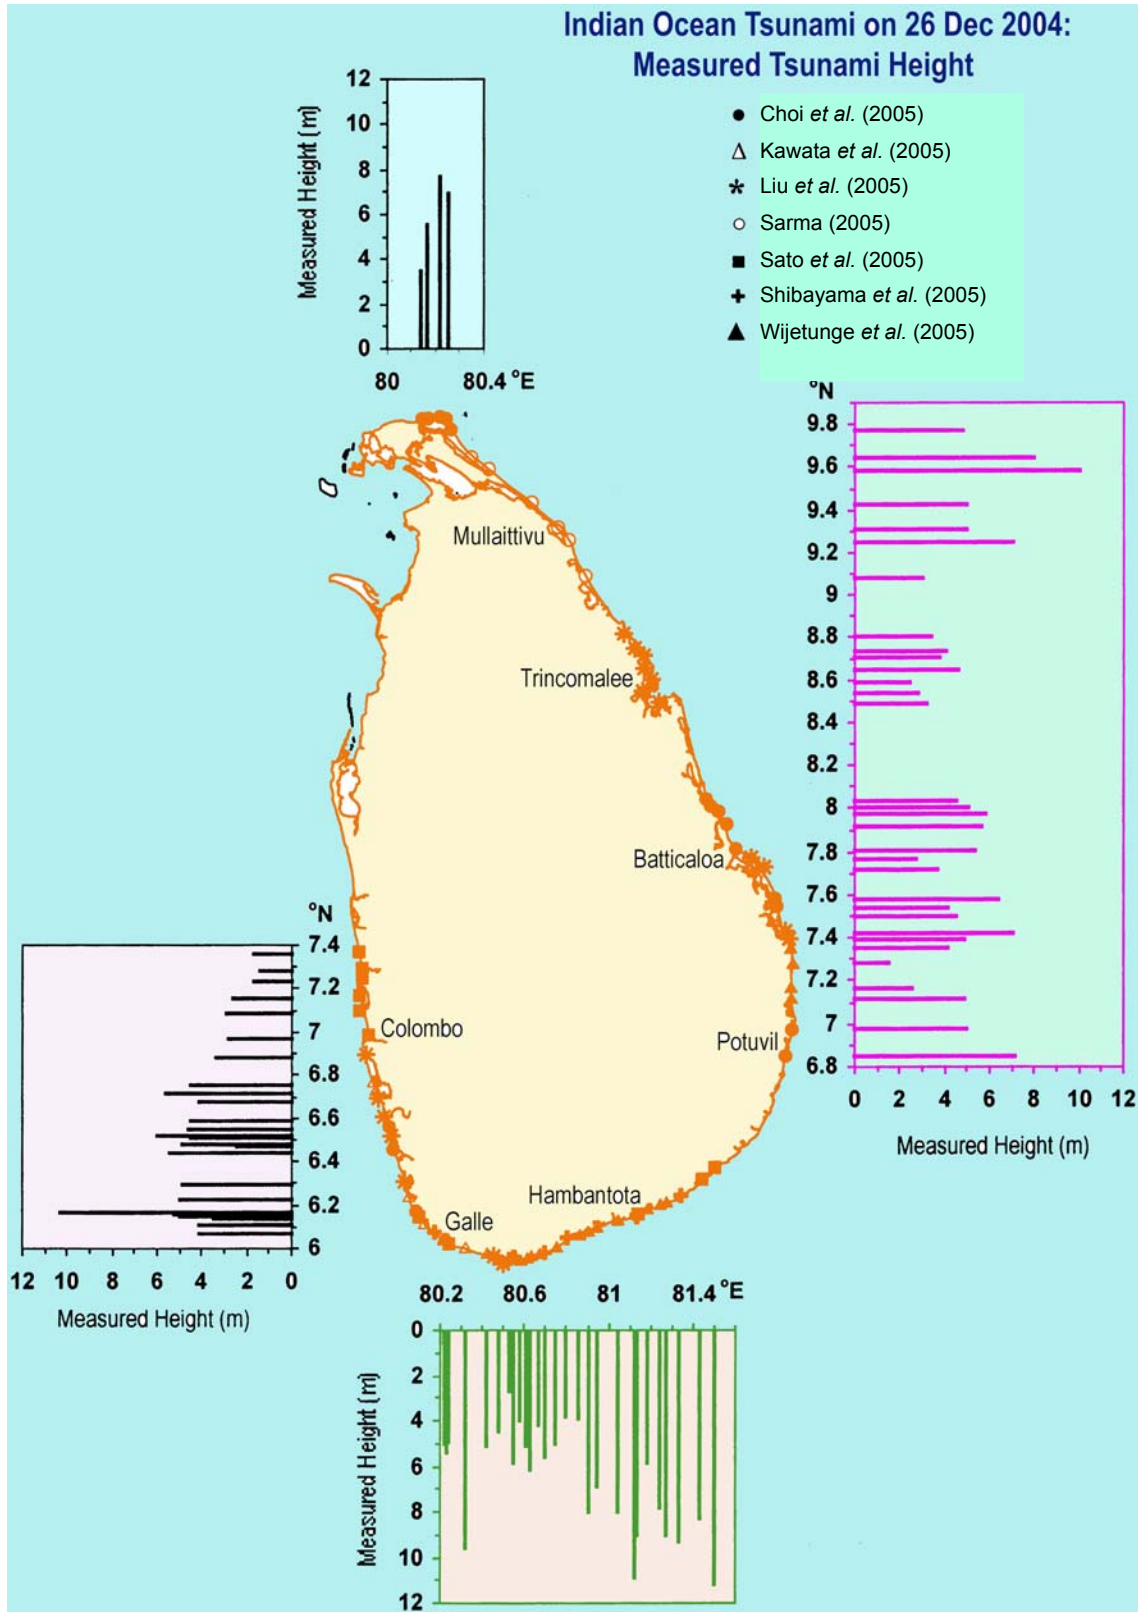
Figure 1. Distribution of tsunami height along the coastline of Sri Lanka.

Fig. 1 also shows that, on the whole, the distribution of the tsunami height along the affected coastline around the country is not uniform. In general, such non-uniform distribution of tsunami height could be attributed to many factors including the travel path of the tsunami waves, the width of the continental shelf, the energy focusing effects, the shape of the coastline and the nearshore bathymetry.

We first consider the distribution of the estimated tsunami heights in the significantly affected parts of the coastline around the country in Fig. 1. The measurements of Choi *et al.* (2005) as well as those of Kawata *et al.* (2005), Liu *et al.* (2005), Sarma (2005), Sato *et al.* (2005), Shibayama *et al.* (2005), and Wijetunge *et al.* (2005) are shown.

The measurements of Choi *et al.* (2005) and Liu *et al.* (2005) suggest maximum tsunami heights of 3 m – 7 m along the east coast from Nilaweli (~8.66°N) through Trincomalee, Mutur, Vakaneri, Batticaloa, Kalmunai and Akkarapattu down to Potuvil, with an increasing trend towards the south.

Meanwhile, on the south coast, there appears to be considerable variation in the tsunami height with values ranging from less than 3 m to as high as over 11 m. Kawata *et al.* (2005) have made tsunami height measurements at five locations at the city of Galle (~80.22°E), and we see in Fig. 1 that the average tsunami height there is about 4.5 m – 5 m.

The measured tsunami heights in the coastal stretch from Galle to Tangalle are about 4 m – 6 m except at two locations; the measurements of Kawata *et al.* (2005) suggest tsunami heights of over 9 m at Koggala Airport (~80.32°E) and those of Shibayama *et al.* (2005) indicate a maximum water level of only 2.7 m at Polhena (~80.52°E). Moreover, the measurements of Shibayama *et al.* (2005), Liu *et al.* (2005) and Sato *et al.* (2005) clearly indicate considerably high tsunami heights of about 9 m – 11 m at Hambantota, Kirinda as well as in Mahaseelawa and Patanangala beach areas of the Yala National Park (coastal stretch from ~81.0°E – 81.5°E).

On the south-west and the west coasts, the measured tsunami heights show a decreasing trend towards the north. The recorded tsunami heights in the Dodanduwa–Beruwala stretch (~6.1°N–6.5°N) is about 4 m – 5 m barring one location at Kahawa (~6.16°N) where the estimated water elevation is over 10 m according to Kawata *et al.* (2005).

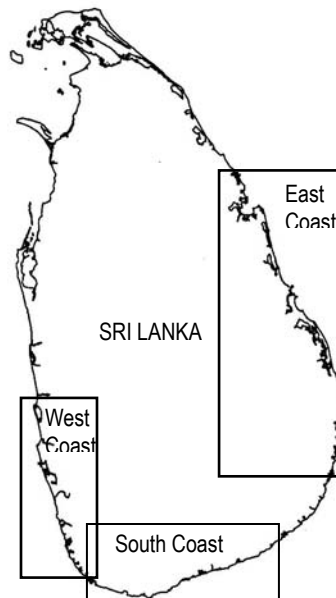
Figure 2. Coastal sectors covered in the inundation survey.

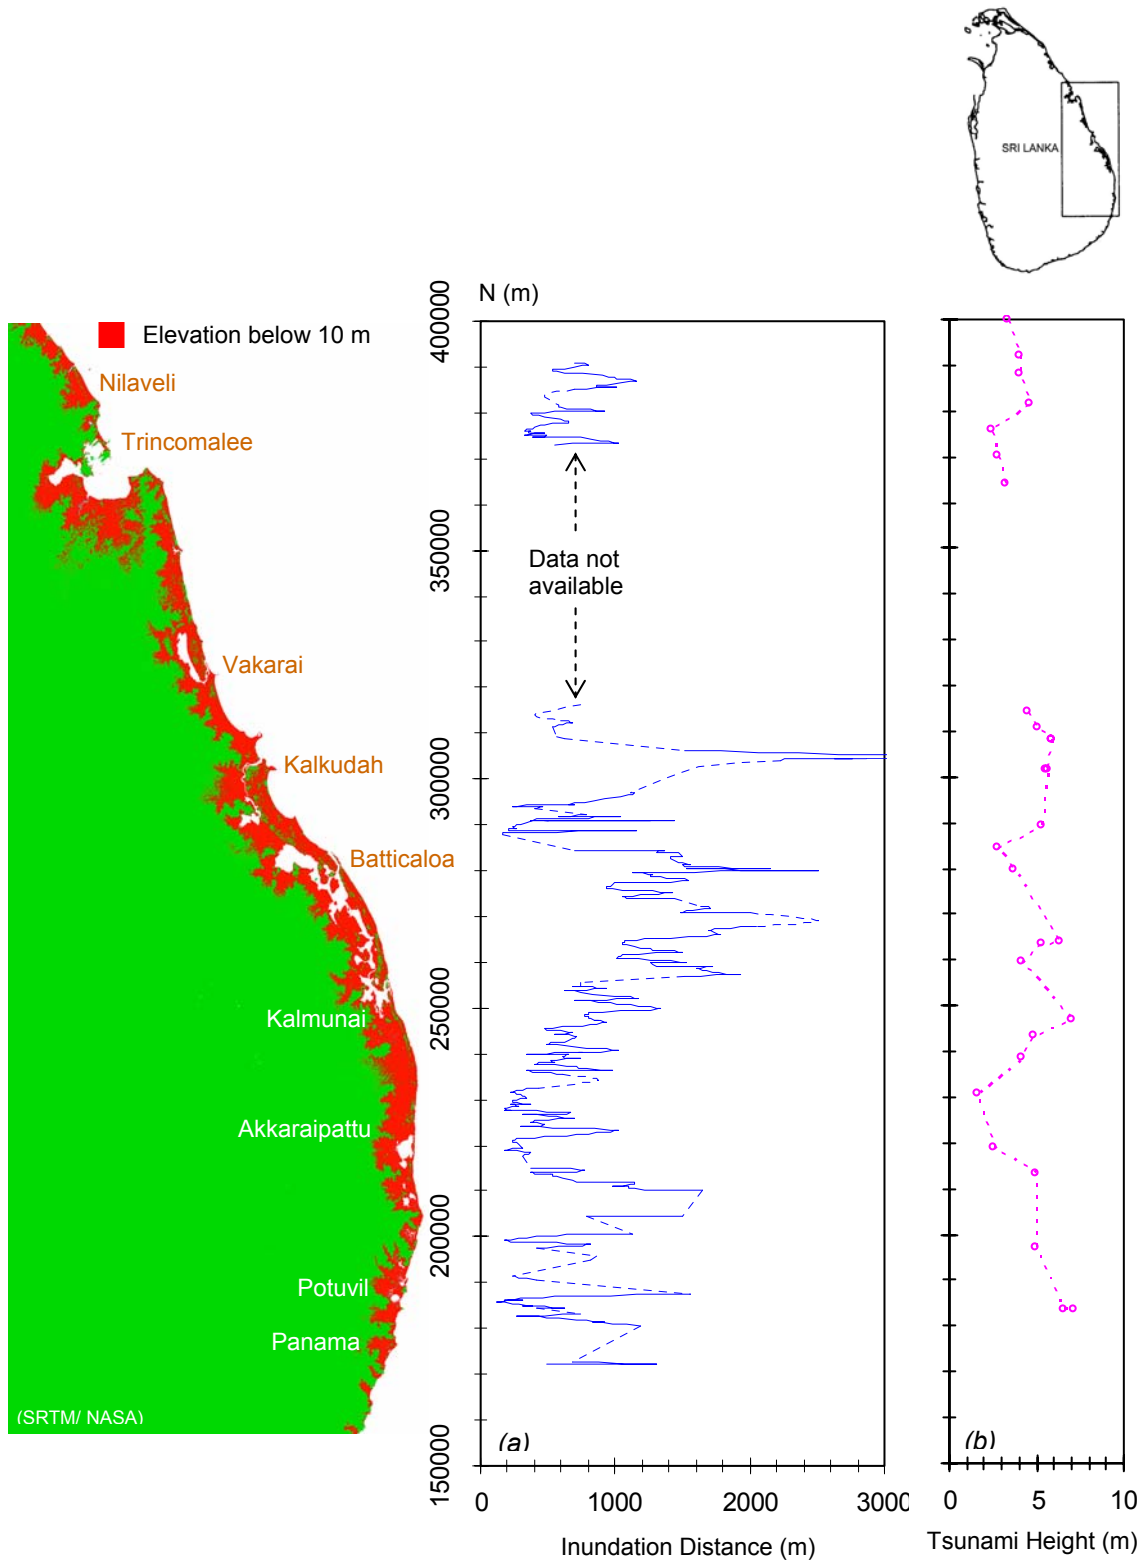
Fig. 3 shows the tsunami inundation distances for the east coast of Sri Lanka together with the estimated tsunami heights for comparison. The two plots give (a) the horizontal inundation distance in metres from the shoreline (taken as 0 m MSL), and (b) the maximum tsunami water level near the shore in metres above the tide level at the time of tsunami attack (already presented in Fig. 1), against the Northing (N) of that part of the coastline. Note that wherever the spacing between two adjacent inundation measurements is more than 1 km, such data points are connected by a broken line.

The map of the east coast of Sri Lanka also shows the coastal areas with elevation below 10 m MSL. The digital elevation data used in this image are those that were acquired by the Shuttle Radar Topography Mission (SRTM) of the United States National Aeronautics and Space Administration (NASA) in February 2000. The SRTM used Synthetic Aperture Radar (SAR)

Figure 3. Spatial distribution of (a) inundation, and (b) tsunami height for the east coast of Sri Lanka.

We see that, on the whole, tsunami inundation had been quite extensive at several locations along the east coast from Nilaveli (~387 kmN) down to Panama (~172 kmN). Such significant inundation peaks, indicating inundation distances of over 2 km, can be seen at Kalkudah (~305 kmN), Batticaloa (~280 kmN), Chuddipalaiyam (~269 kmN) and Kalawanchikudi (~257 kmN). Furthermore, several other locations such as Tirukkovil (~205-210 kmN), Potuvil (~187 kmN) and Panama (~172 kmN) have recorded tsunami penetration distances of 1.5 km – 2 km. In some areas, for instance, around Batticaloa and Kalkudah, the lagoons and other water bodies have certainly helped convey the tsunami surge large distances inland. Moreover, numerous small waterways scattered in the east coast, known as ‘Thona’ (see Fig. 4), have also helped to carry tsunami surge into settlements interior, which would otherwise not have received tsunami flood waves over the land. In contrast, sand dunes just north of Potuvil (see Fig. 5) have protected some localities from severe flooding due to the recent tsunami.

It is also interesting to note that there is comparatively less inundation of about 200 m at Addalachchenai (~230 kmN) where the maximum tsunami height too is only about 1.5 m – 2 m.

On the whole, a comparison of the inundation peaks with elevation below 10 m areas seems to suggest a strong correlation between tsunami inundation and the topography of the land.

It must also be added that the stretch south of Mutur down to around Kokavillu was, unfortunately, not accessible, so inundation and tsunami height data are not available between 320 ~ 360 kmN.

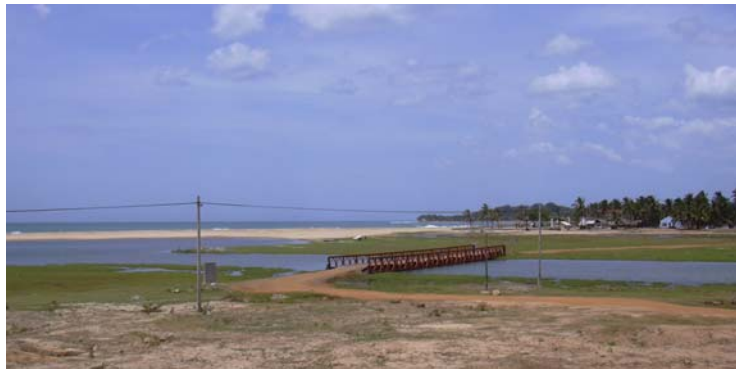
Figure 4. Shore-connected small waterways commonly known as ‘Thona’ in the east coast.

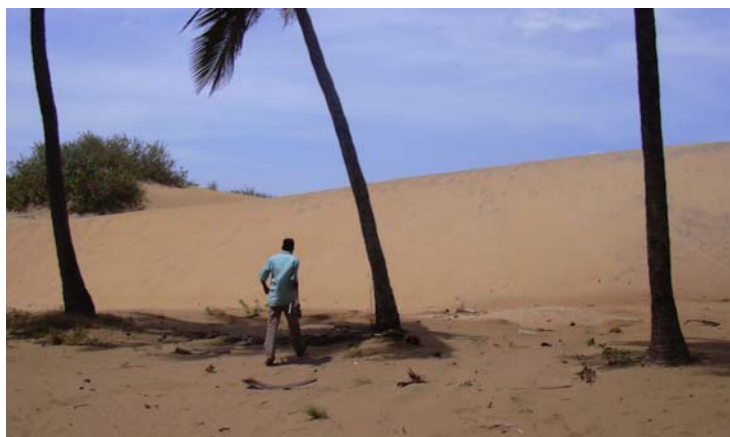
Figure 5. Sand dunes north of Potuvil in the east coast.

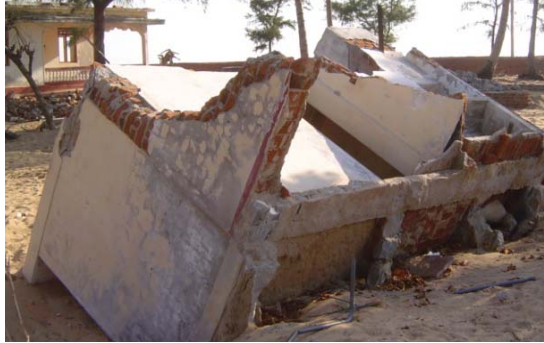
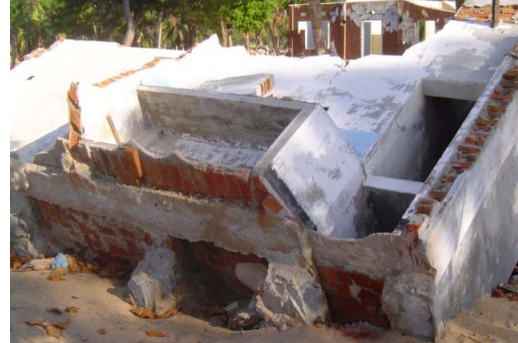
**(a) Overturning**

The field observations of damaged boundary walls, brick-mortar type single-storey housing, and multi-storey reinforced concrete framed structures suggested three different failure modes under tsunami loading, namely, overturning, sliding and scouring, as shown in Fig. 6.

Figure 6. Failure modes of structures under tsunami loading in the east coast of Sri Lanka.

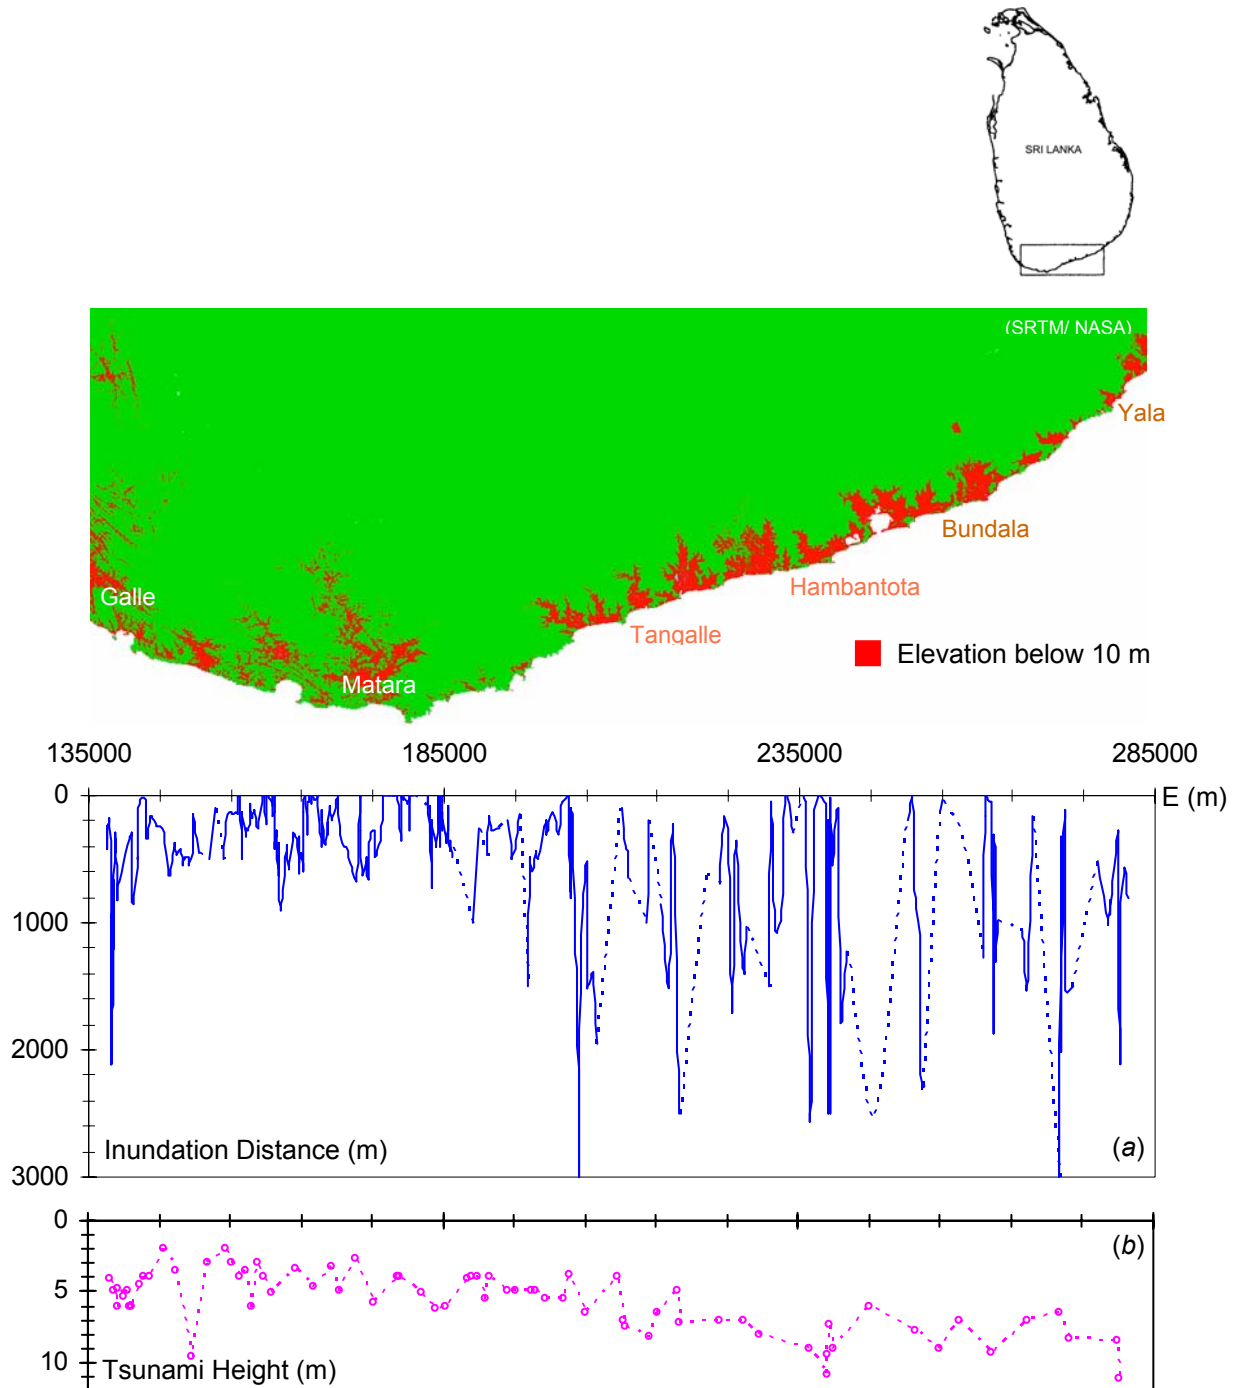
Fig. 7 gives the tsunami inundation distances for the south coast of Sri Lanka from Galle to Yala National Park. The estimated tsunami heights for the south coast are also given in this Figure for comparison.

Figure 7. Spatial distribution of (a) inundation, and (b) tsunami height for the south coast of Sri Lanka.

We see that the deepest tsunami wave penetration in the south coast is at Hambantota, up to three kilometres near the salt-pans, and also near Bundala albeit with the aid of the bay. Significant inundation can also be seen further east of Hambantota, particularly around the smaller lagoons and bays. Hungama-Tangalle beach to the west of Hambantota too has recorded notable inundation, especially where tsunami surge waves had been conveyed inland through water bodies opening to the sea such as lagoons and lakes.

The inundation plot for the south coast shows a stretch of the shoreline without significant tsunami damage between 175 ~ 185 kmE, to the east of Matara. This was not because the tsunami wave heights were low, but because the coastal lands there are at a comparatively higher elevation with steep beach slopes, as observed during the field survey (see Fig. 8) and further confirmed by the topography (elevation above 10 m) map in Fig. 7.

The coastline from Galle to Matara too suffered badly with particularly deep inundation occurring along the coastal belt of Talpe–Koggala–Ahangama (~145 – 150 kmE), besides the tragic loss of life and destruction in the densely populated coastal cities of Galle and Matara.

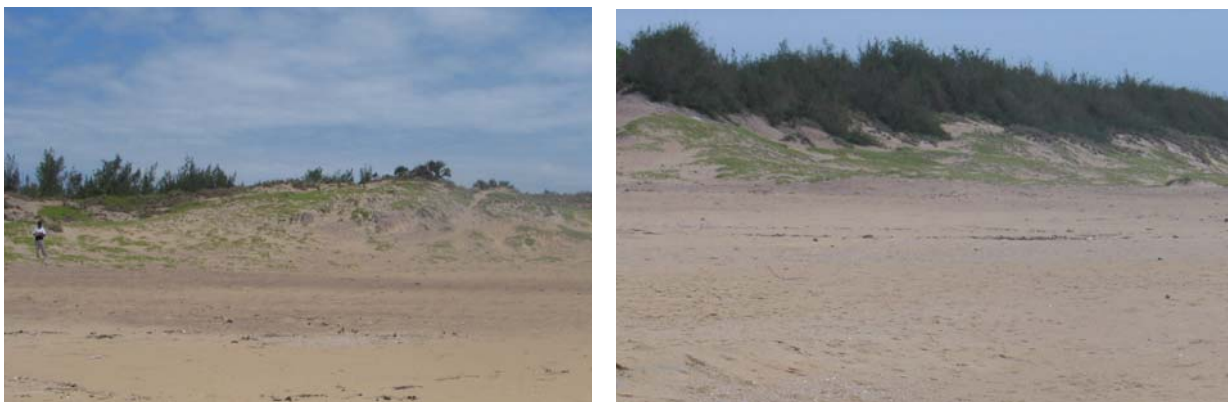
One prominent feature of the coastal belt from Dickwella (195 kmE) to Yala (285 kmE) is the 7 – 10 m high sand dunes with thick cover of overgrowth (see Fig. 9.). The presence of such sand dunes has certainly helped reduce tsunami penetration inland. However, wherever gaps existed in the dune system, or at locations where the dune height was low or had been cut open for various activities, it appears that the tsunami surge had rushed through with enormous power causing considerable destruction. This was most evident where the popular *Yala Beach Resort* once existed; there, a section of the dune just in front of the resort hotel had been cut open to provide the occupants with a good view of the sea!

Figure 9. Sand dunes near Yala on the south-east coast.

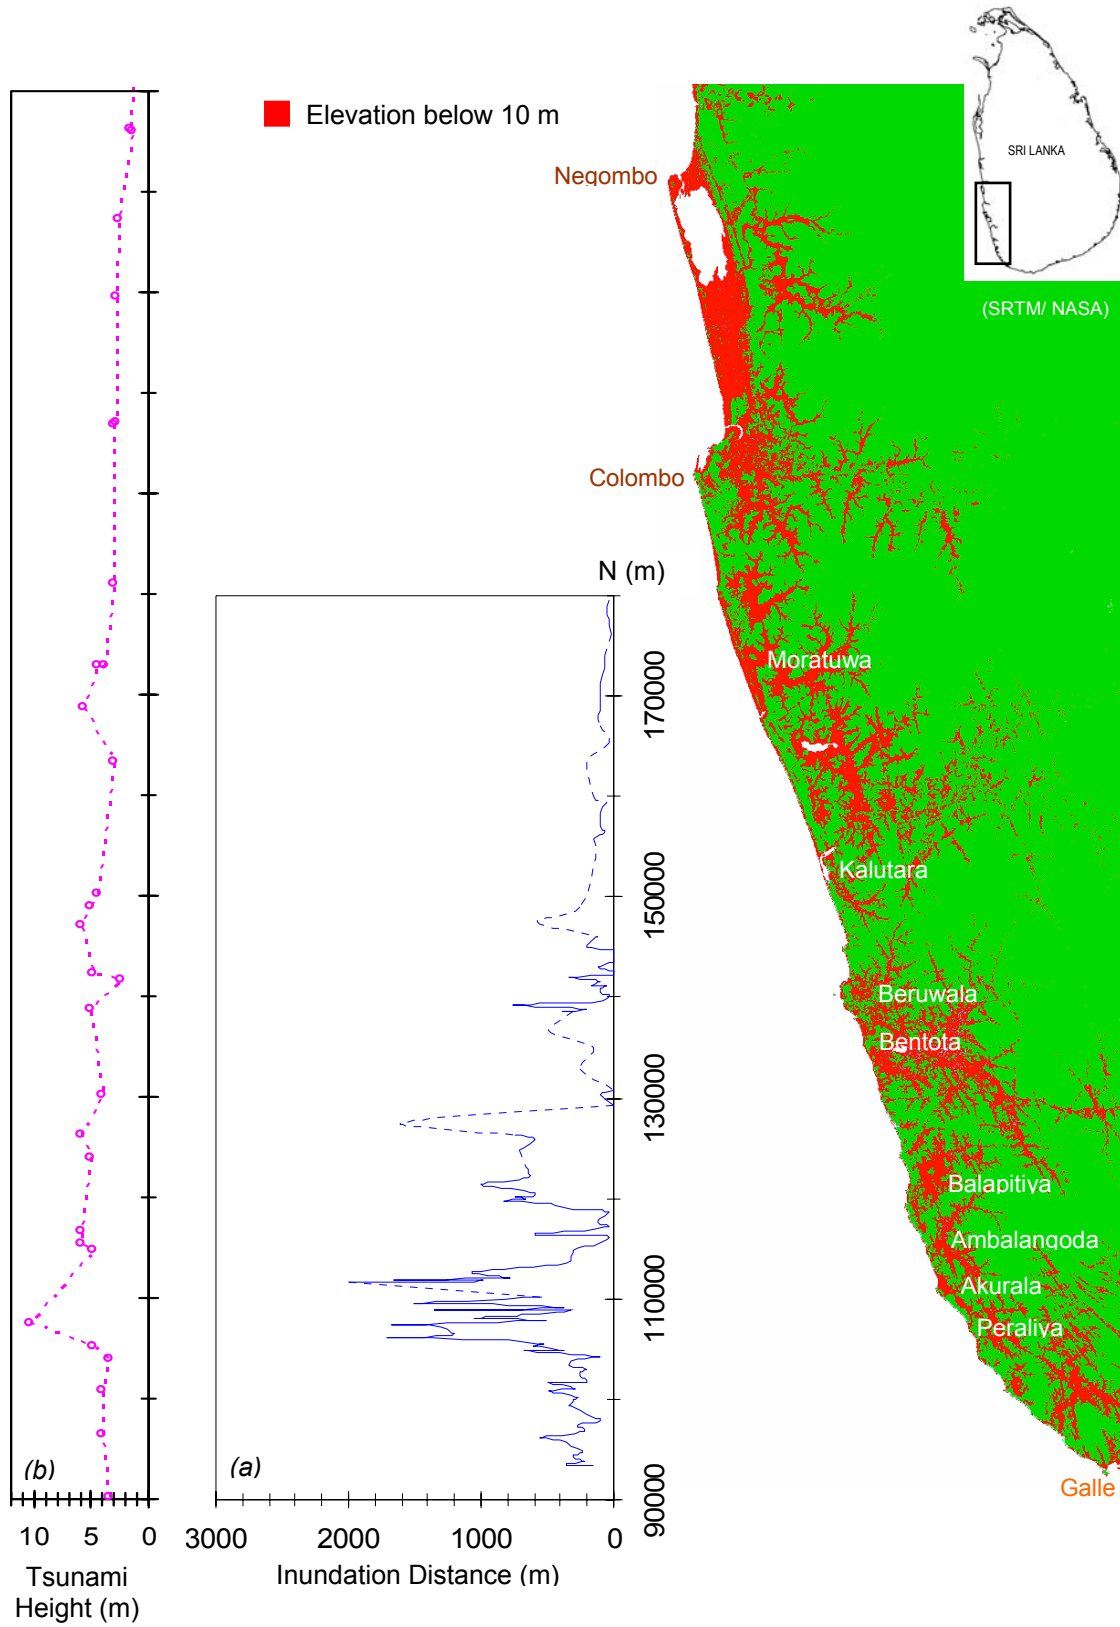
The extent of inundation as well as the measured tsunami heights for the west coast of Sri Lanka from Galle to North of Colombo are shown in Figs. 10*a* and 10*b*, respectively. On the west coast, we see a lessening of tsunami inundation, albeit with intermittent peaks, as we go from Galle to Kalutara and further up. Predominant inundation peaks on this stretch of the coast appear near Paraliya-Telwatte, Akurala, and Balapitiya. Of the several peaks, the most noteworthy is the one near Peraliya where the tsunami surge overturned and submerged a Galle-bound locomotive (see Fig. 11) killing over thousand people. The railway line from Balapitiya to Galle too suffered heavy damage (see, for example, Fig. 12.).

Figure 10. Spatial distribution of (a) inundation, and (b) tsunami height for the west coast of Sri Lanka.

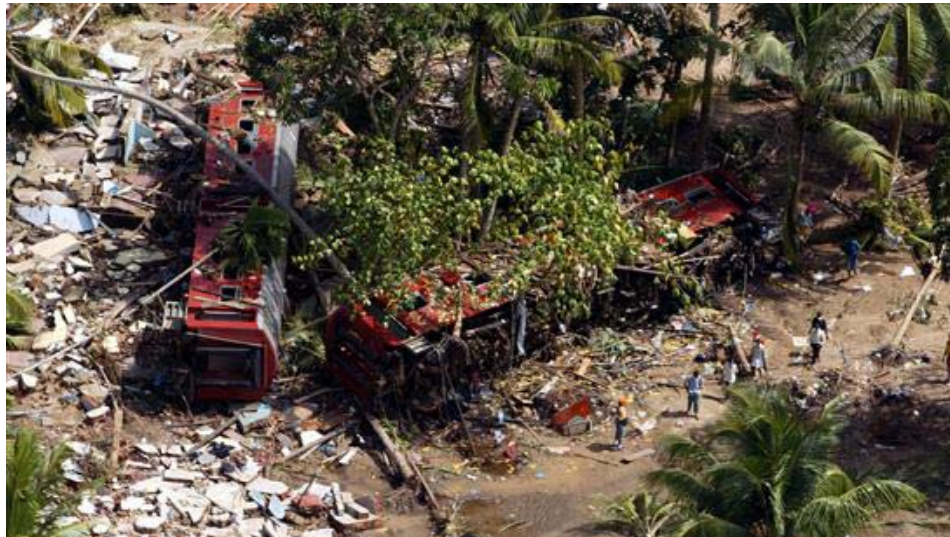
Figure 11. Overturned rail carriages near Peraliya on the south-west coast.

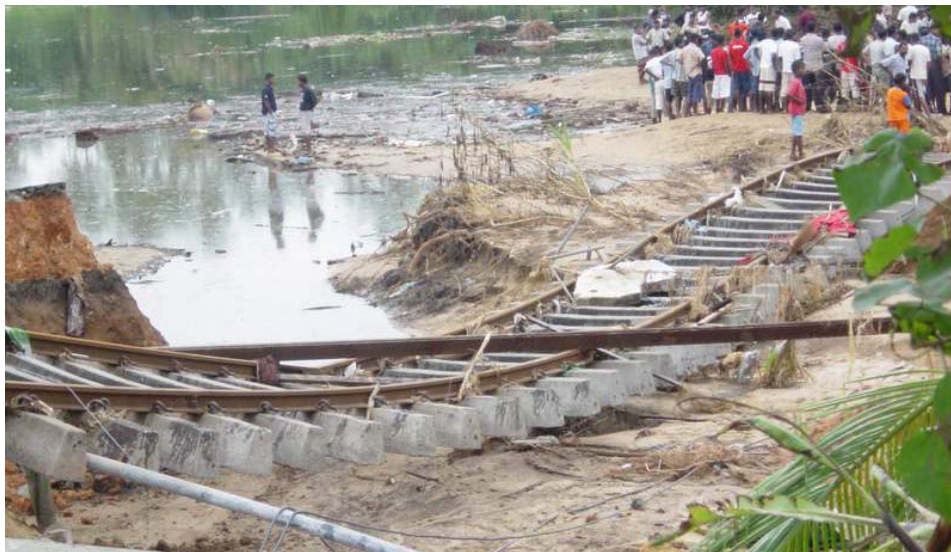
Figure 12. Heavily-damaged southern railway near Akurala.
