UAV AND COMPUTER VISION, DETECTION OF INFRASTRUCTURE LOSSES AND 3D MODELING

KEY WORDS: 3D modeling, Structure from Motion, Infrastructures, Civil buildings, Degradation of buildings, Monitoring, UAV

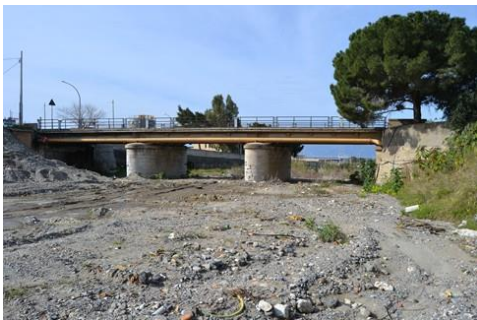
Figure 2. Detail of the San Gregorio Bridge

For this contribute three distinct works have been acquired by nature and complexity. First, was surveyed a bridge in reinforced concrete located in San Gregorio in the town of Reggio Calabria. It consists of three spans in reinforced concrete, each of which consists of five longitudinal beams of 13.75 m long, with a section of 0.40 mx 0.70 m, of 1.40 m which are connected by traversers having a section of 0.15 mx 0.30 m spaced at a distance of 2.75 m (Figures 1 and 2). The artefact has several problems both with regard to metal reinforcements, in advanced oxidation state and in concrete, characterized by important and diffused areas affected by the separation of the concrete cover. It is therefore evident that there is a need for interventions aimed at the restoration and consolidation of all structural elements of the bridge (beams, traversers and slats), which cannot ignore the knowledge of the geometry of the various structural elements and the determination of the position, number and the section of the metal armatures.

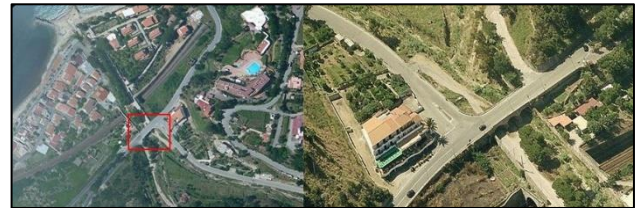
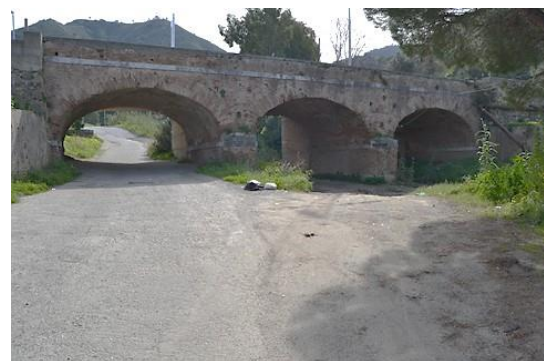
Figure 5. Bridge framing in Villa San Giovanni

The third surveyed work is a bridge located at km 517.20 of the SS 18 in the Villa San Giovanni municipality in the province of Reggio Calabria (Figure 5 and 6). The work was chosen in view of its particular design; in fact, it is made up of an original masonry structure consisting of three spans with 6.60 m light and two 1.50 m wide poles with a length and a width of 27 m each 6.30 m. This structure, following the adjustment and extension of the road section, was alongside a new in reinforced concrete, always at three lanes with lights of 7.20 m, a width of 4.20 m, also, length of 27 m. They are commonly found in masonry work, missing or broken elements, efflorescence traces and a general degradation due to time spent and poor maintenance. The part in reinforced concrete has traits with concrete dilution, efflorescence, expulsion of the cover, spraying of the casting, losers, these, from a misalignment of the work.

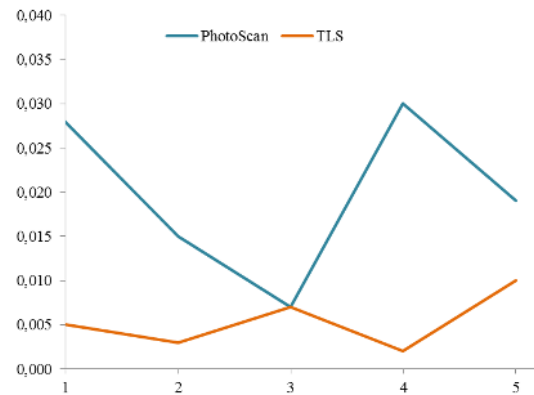
Figure 15. Error comparison (cm) in the two systems

The evaluation of the precisions was based on the 5 survey target placed on the deck facades and on the comparison of the results obtained with a traditional topographic survey with the Leica TCRA 1201 high precision automated station (Figure 15) (Barrile, Meduri, Bilotta, 2014a), (Barrile, Meduri, Bilotta, 2014b).
