UAV-based urban structural damage assessment using object-based image analysis and semantic reasoning

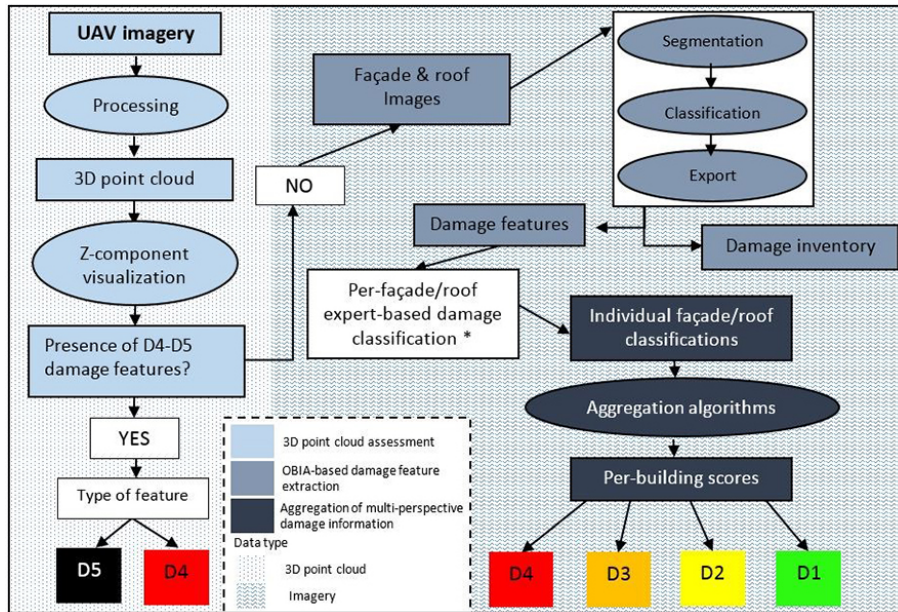
Figure 1. Overview of the methodology. * Fernandez Galarreta (2014).

This study aimed at generating per-building damage scores based on oblique, multi-perspective, highly overlapping and very high resolution imagery. Those were primarily acquired with a UAV, and partly with a camera attached to a pole, (details on image acquisition are given in Sect. 3.1). From the multi-view imagery, 3-D point clouds were generated to allow experts to visually identify the most affected building: D4–D5 (Sect. 3.2). Subsequently, the façade and roof images of the buildings that were still standing were analyzed with OBIA, where damage features were extracted (Sect. 3.3). In a separate experiment by Fernandez Galarreta (2014) the image data of buildings for which the 3-D point clouds did not reveal extensive damage, or the damage features were not visually identified, were subjected to expert assessment. Each image with overlaid information from the OBIA damage-feature extraction being assigned to an EMS-98 score and a certainty measurement. The process of aggregating the individual scores at building level, and thereby simulating the understanding of the expert surveyors on the ground, is described in detail in Sect. 3.4. Figure 1 provides an overview of the methodology.

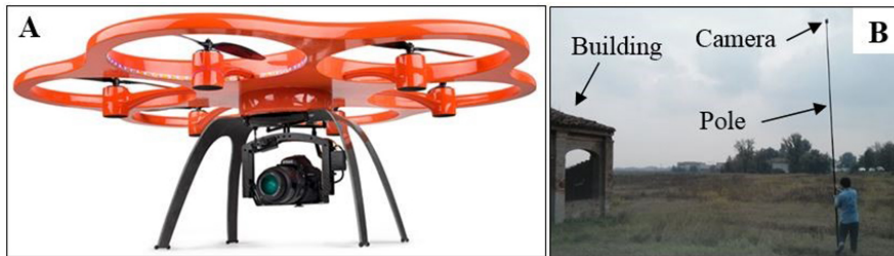
Figure 2. The two platforms used to collect data. (a) Aibot X6 V1 UAV, (b) camera attached to a pole.

The data for this study were collected with an Aibot X6 V.1 UAV (Fig. 2a), and with a camera attached to a 7 m pole (Fig. 2b). Several acquisition campaigns were made: Gronau (Germany), Enschede (The Netherlands) and several loca-

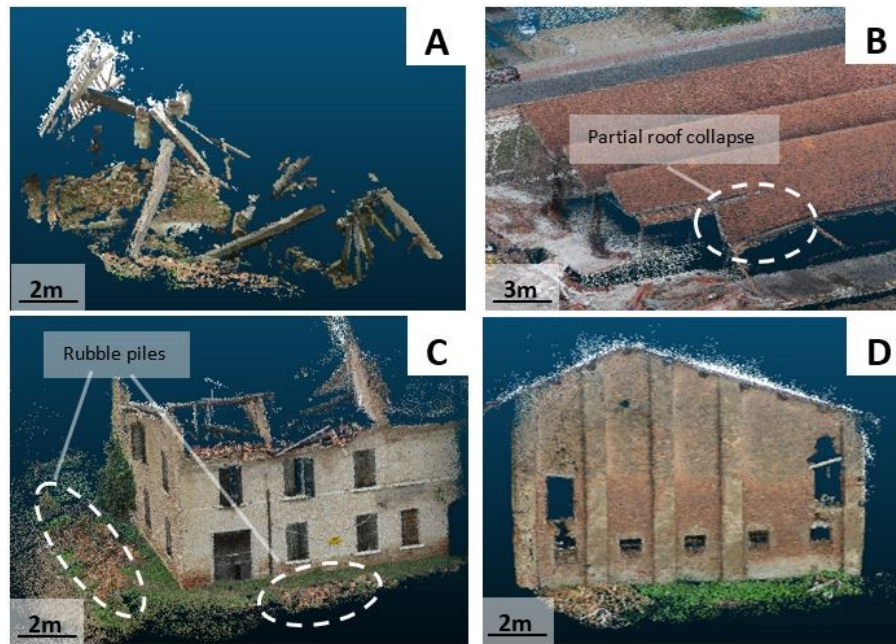
Figure 3. The 3-D point clouds used to identify the mentioned damage features. (a) Total collapse (Italy: pole-based), (b) partly collapsed roof (Germany: UAV-based), (c) rubble pile (Italy: pole-based), and (d) frontal view of an inclined wall (Italy: pole-based). Scale approx.

The test data set used to identify the damage features comprised four 3-D point clouds (Fig. 3) generated from the oblique overlapping images as explained below.

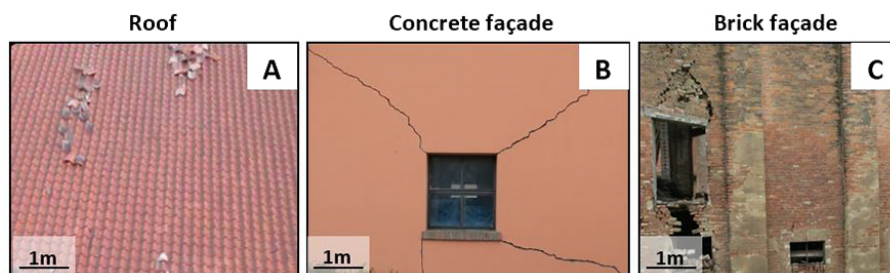
**Figure 4.** Examples of the different images used in this section. (a) Roof with dislocated tiles, (b) cracks in concrete façade, and (c) cracks and hole in brick façade. Scale approx.

The data set used in this section comprised 11 VHR images that represented roofs and two different types of façades: concrete and brick (Fig. 4). The selection of the images was done manually due to the complexity of the scenarios. For each of the three types, a rule set was created to extract the damage features.

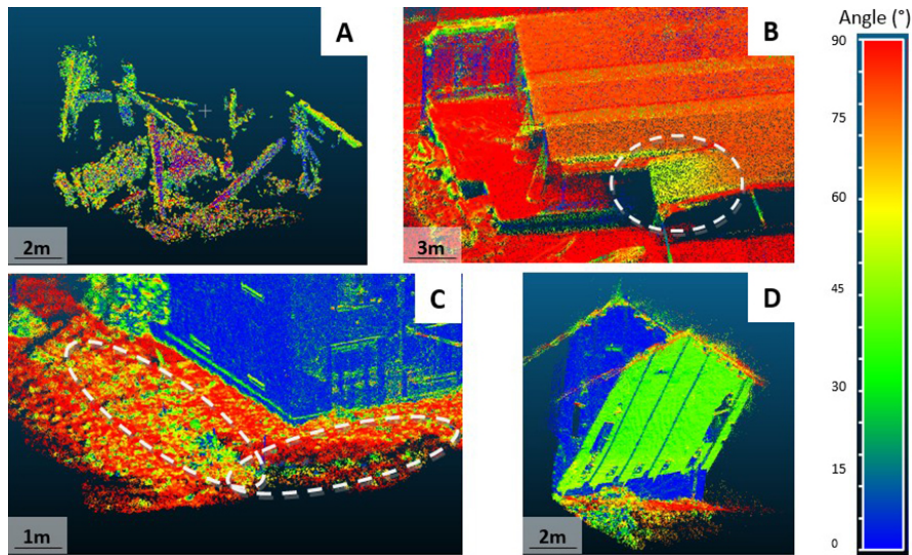
Figure 6. Z component visualization of target damage features: (a) collapsed building, (b) partially collapsed roof (outlined in white), (c) rubble pile (outlined in white), and (d) vertical façade (blue) compared to a simulated inclined façade (green). Scale approx.

The visual assessment of the 3-D point cloud’s *z* component allowed the identification of the previously listed damage features to classify a building as D4–D5 (total collapse, collapsed roof, rubble pile and inclined façade; Fig. 6).

We aimed at assessing whether a 3-D point cloud allows the identification of damage features indicative of D4 or D5 damage. Except for the identification of rubble piles (Fig. 6c) in situations where the grass around a building partially masked rubble presence, the results demonstrated that the visual assessment of the point cloud's z component was very useful to identify those damage features. In addition, it allows experts to identify subtle damage signatures, such as inclined walls (Fig. 6d), that are difficult to recognize in traditional BDA approaches. Nevertheless, the 3-D point-cloud assessment was not focused on the actual data processing and automatic analysis of the data sets, because of its expected complexity and novelty. Thus it focused on generating the 3-D point-clouds using existing approaches, before proceeding with a visual assessments of the data sets to identify the cited damage features.

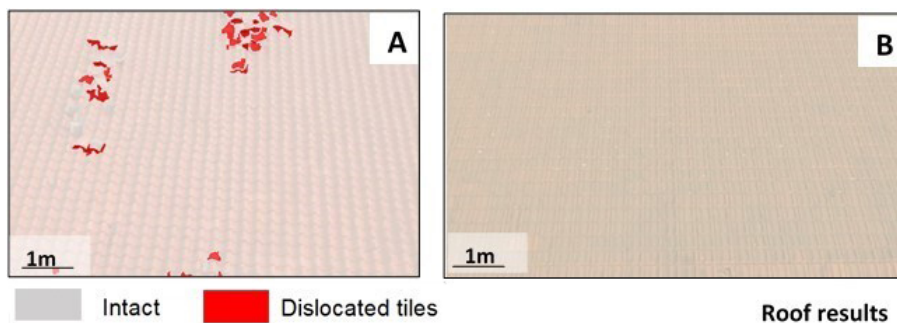
Figure 7. Result of applying the roof rule set on two roof images. Scale approx.

Accuracy parameter	Fig. 7a dislocated tiles	Fig. 7b intact façade	Fig. 8a Cracks	Fig. 8b Cracks	Fig. 8c Cracks	Fig. 8d Cracks
Correctness	66.6 %	100 %	65.7 %	25.9 %	87.2 %	84.8 %
Completeness	32.9 %	100 %	62.4 %	50.6 %	64.2 %	38.2 %
Accuracy parameter	Fig. 8b' Intact	Fig. 8c' Intact	Fig. 9a Cracks	Fig. 9b Cracks and holes	Fig. 9c Cracks and holes	
Correctness	100 %	100 %	57.0 %	53.6 %	72.4 %	
Completeness	100 %	100 %	45.5 %	79.1 %	89.8 %

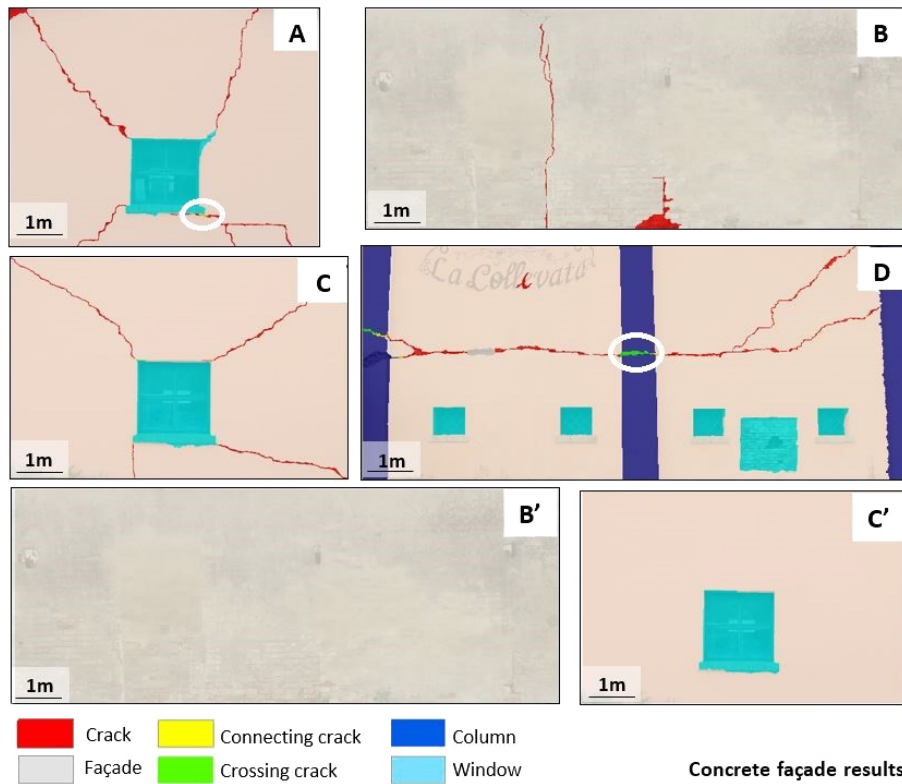
Figure 8. Results of applying the concrete rule set on six concrete façade. (b') and (c') were edited in order to remove the damage feature. (a) and (d) highlight cases of connecting and crossing cracks. (a) highlights with a circle the location of a connection, the small nature of a crack connecting with a window makes it hard to visualize it in the illustration. (d) illustrates a crack crossing a column as a green object (highlighted by circle). Scale approx.

The images shown in Fig. 8b and c were edited to remove visible damage features. The rule sets were re-run on those images to test their performance in a damage-free environment. The results are shown in Fig. 8b’ and c’.

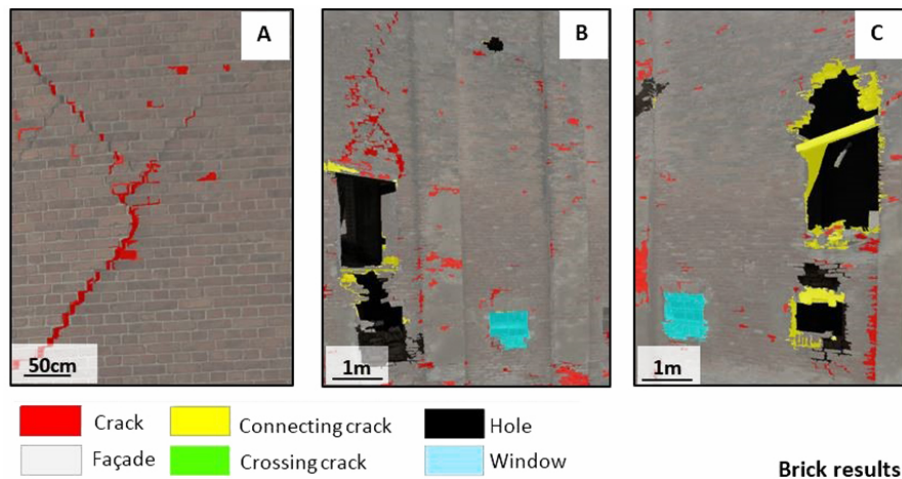
Figure 9. Results of applying the brick rule set on three brick façade images. Scale approx.

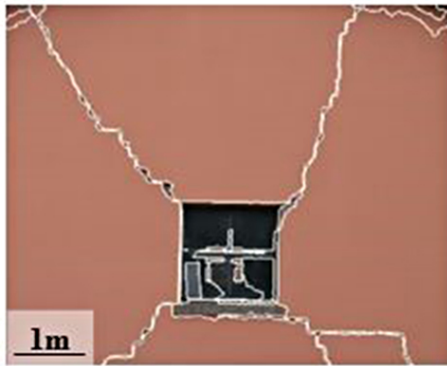
Figure 10. Result of the two-step segmentation of a concrete façade. Scale approx.

The two-step segmentation aimed at generating large homogeneous non-damage objects, whilst highlighting smaller damage features, and was largely successful throughout the different scenarios (e.g. Fig. 10). This set the theoretical approach for the OBIA-based damage-feature extraction.

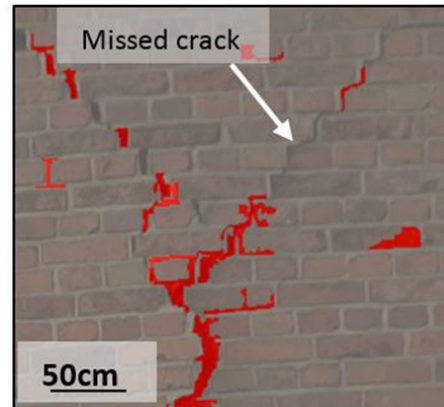
Figure 11. Example of misclassified crack due to segmentation problems. Scale approx.

(Fig. 11). Resulting segmentation errors propagated into the analysis stage, leading to misclassifications.

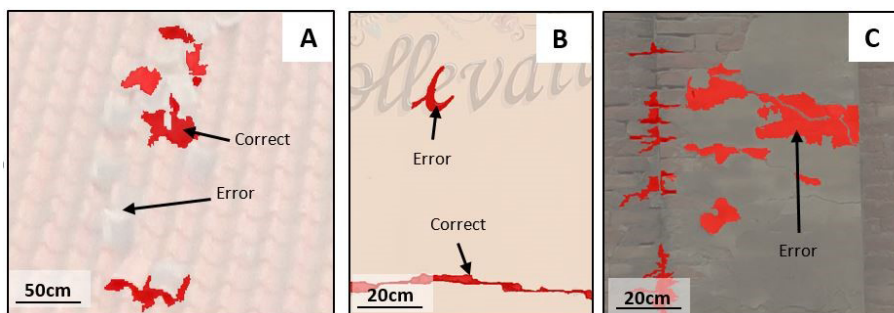
Figure 12. (a) Example of misclassified roof tiles (false negative), (b) example of a letter classified as a crack in a concrete façade (false positive), and (c) example of non-related objects classified as cracks in a brick façade (false positive). Scale approx.

The classification part of the rule sets had to deal with complex scenarios, many target damage features and a range of different images, leading to limited, but unavoidable errors. They included both false negatives (Fig. 12a) and false positives (Fig. 12b and c). This particular concentration of errors in the brick façades has to do with the actual pattern that the façade presents. The complex pattern presented in the brick façades challenges the segmentation algorithm that creates small non-damage related objects that during the classification process are mistakenly classified as cracks. Con-

Further, traditional accuracy assessment approaches do not address the semantic dimension of the extracted features. According to the feedback obtained after the expert-based per-façade / roof classification (Sect. 4.3.5 in Fernandez Galarreta, 2014) errors such as the one in Fig. 12b are flagged as FP, yet to an expert analyzing damage based on the OBIA

damage features this type of misclassification posed no problem. For the specific case of Fig. 12b, the expert knowledge allows an easy recognition of such an object as an artefact of the façade, a letter. It is directly understood as a non-damage related object despite its erroneous classification.

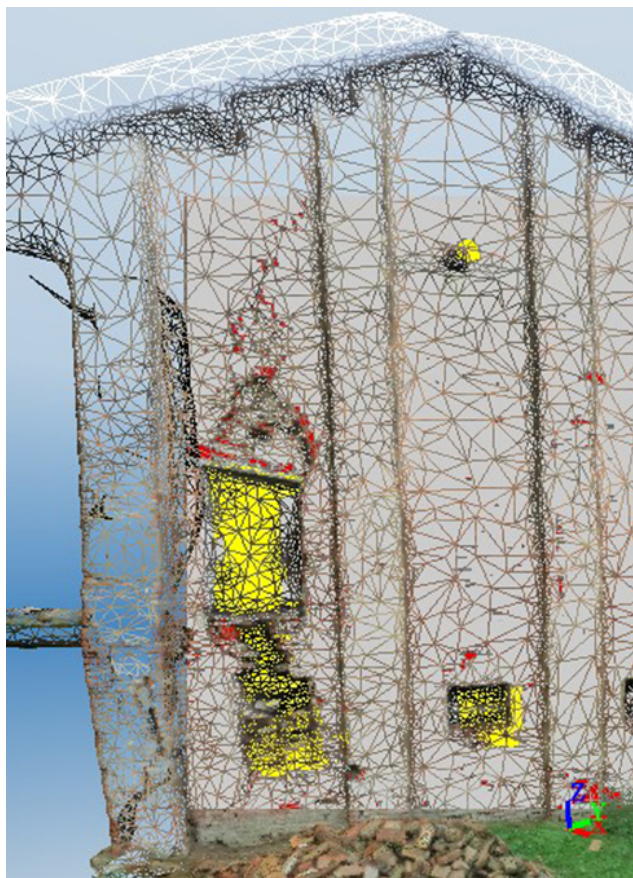
Figure 13. Example of the wire mesh with OBIA extracted information overlaid. Yellow indicated holes, and red indicated cracks in the façade (for better contrast, the color scheme was changed from the previous examples).
