## Ultrasonic NDT of wind turbine blades using contact pulse-echo immersion testing with moving water container

### Abstract

Wind turbine blades are complicated objects for inspection because they have a curved surface, are multi-layered, have variable thickness and are made from anisotropic materials. Ultrasonic contact pulse-echo immersion testing with moving water container has been selected for inspection of wind turbine blades, because this type of the inspection can be performed having access just from the one side of the wind turbine blade. The ultrasonic contact pulse-echo immersion testing technique with two types of ultrasonic transducers mounted into a moving water container was used for investigation of the artificial internal defects in a wind turbine blade. These defects (diameter 81 mm, 49 mm and 19 mm) were made on the internal side of the main spar. The contact pulse-echo immersion testing (using a moving water container) of the wind turbine blade was performed using two different transducers: focused 2.2 MHz and planar 400 kHz. From the ultrasonically obtained images it is possible to recognise the geometry of defects and to estimate their approximate dimensions

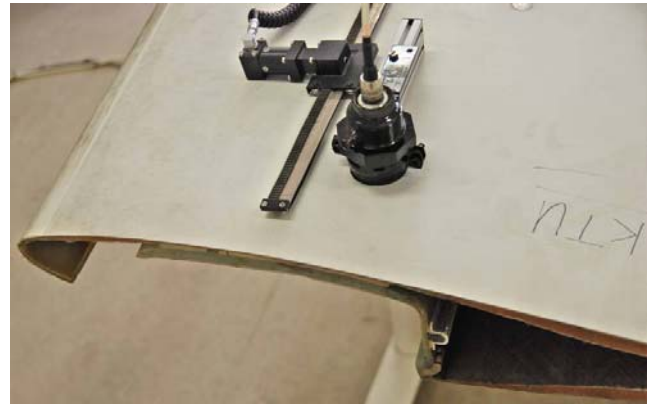
Fig. 3. The photo of the experimental set-up for testing of the wind turbine blade using 2.2 MHz focused transducer

The focused ultrasonic transducer used for investigation had the central frequency 2.2 MHz, the bandwidth  $0.3 f_c$ , the 22 mm diameter and the focal distance of 50 mm. The ultrasonic transducer was excited by one period burst. The photo of the experimental set-up for the pulse-echo immersion testing of the wind turbine blade using the 2.2 MHz focused transducer is presented in Fig. 3.

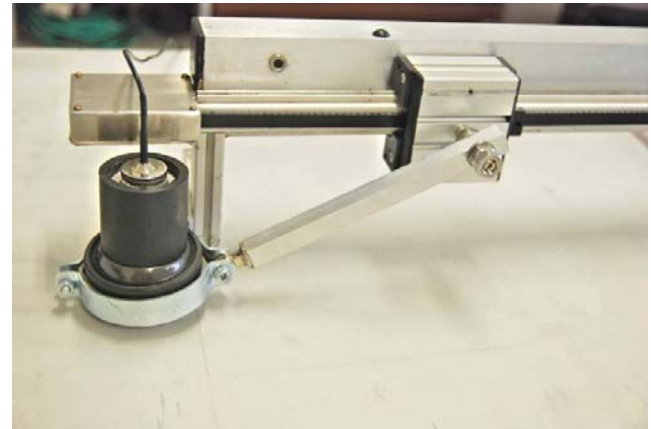
Fig. 4. The photo of the experimental set-up for testing of the wind turbine blade using planar 400 kHz transducer

The pulse-echo experimental set-up using the planar 400 kHz transducer with the bandwidth  $0.4 f_c$  is presented in Fig. 4. The ultrasonic transducer used for investigation had the diameter of 26 mm. It was also excited by one period burst.
