UNBONDED PRESTRESSED COLUMNS FOR EARTHQUAKE RESISTANCE

Abstract

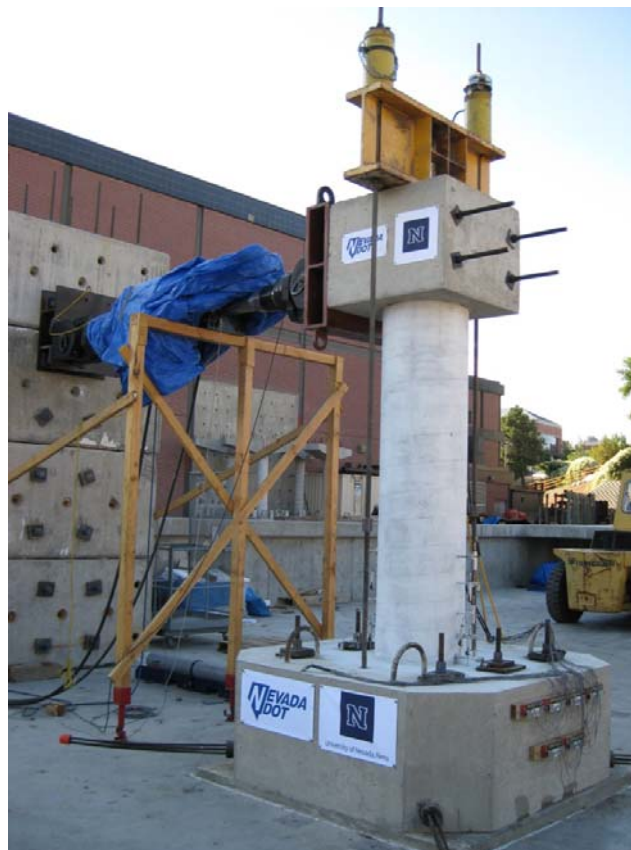
FIGURE 4: TEST SETUP

The test setup for each column consisted of a reaction wall, strong floor, and a 220-kip actuator to produce the cyclic loading protocol in Figure 3. The reaction wall was created by stacking two columns of three 4x4x8 foot (1.22x1.22x2.44 m) concrete blocks, with one additional block added to the top of the front stack to achieve the proper height for the actuator to meet the column head. The reaction wall was secured to the strong floor using 1.25 in. (31.75 mm) DywidagTM post-tensioned bars. The footing of each column was secured to the 3 foot (0.91 m) deep strong floor with six 1.25 in. (31.75 mm) DywidagTM post-tensioned bars. Each DywidagTM bar for the reaction wall and footing had a 100 kip (444.84 kN) force applied.

A steel spreader beam was bolted to the top of the column to apply the axial dead load. Two hydraulic rams were attached to the top of the spreader beam on each side of the column and two high strength 1.25 in. (31.75 mm) threaded rods ran through the hydraulic ram, load cell, footing, and attached to the bottom of the strong floor to apply the axial dead load. The axial dead load was maintained through an accumulator which held constant and equal load in each of the hydraulic rams throughout testing. The test setup is shown in Figure 4.

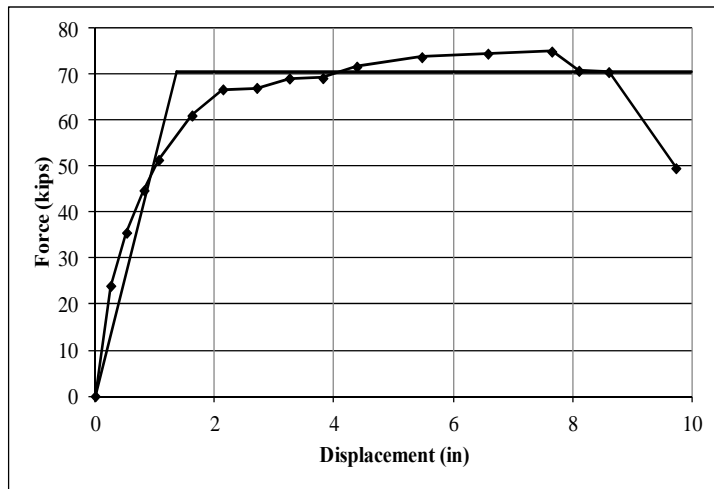
FIGURE 6: AVERAGE PUSHOVER PT-HL

The cyclic loading for each column produced a lateral force and displacement hysteresis curve. The hysteresis curve was broken up into the positive backbone envelope, considered the push cycle, and the negative backbone envelope, considered the pull cycle. The absolute values from the negative backbone envelope were superimposed with the positive backbone envelope and an average curve was taken from the two envelopes. The average curve is considered the pushover curve for the column. The pushover curve for columns PT-LL and PT-HL are shown in Figures 5 and 6 respectively.

Column PT-LL had a first bar yield displacement of 0.63 in (16.0 mm). This was determined by finding the displacement when the first longitudinal bar yielded. This value was used to plot a straight line on the pushover curve, beginning at zero displacement and zero force. A straight line was then plotted across the top of the curve, where the area under the straight line bounded by the top of the pushover curve was equal to the area under the pushover curve bounded by the straight line. The point at which these two straight lines intersect is the effective yield displacement (0.95 in. (24.2 mm)). The ultimate displacement was defined as the displacement at 80% of the peak lateral force in the column. The ultimate displacement of column PT-LL was 8.64 in (219.5 mm) at a drift of 8.0%, and a displacement ductility of 9.1. Column PT-HL had a first yield displacement of 1.0 in (25.4 mm) that lead to an effective yield displacement of 1.36 in (34.5 mm). The ultimate displacement for column PT-HL was 9.17 in (232.9 mm) at a drift of 8.5% resulting in a displacement ductility of 6.7.

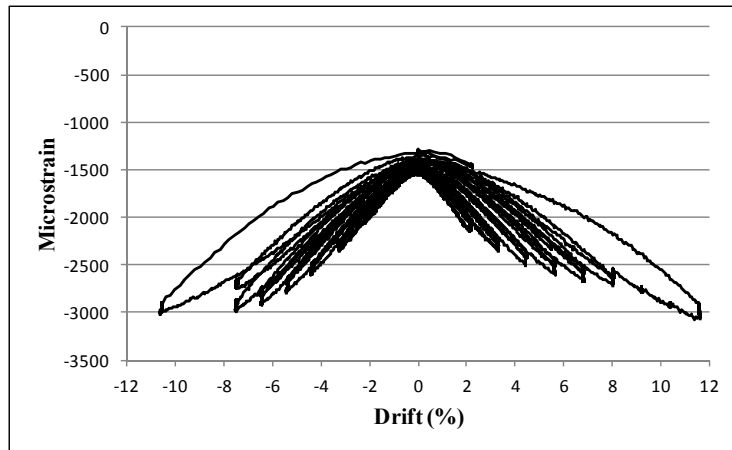
FIGURE 8: STRAIN IN TENDON 4 PT-LL

Each of the four tendons consisted of four 0.6" (15.24 mm) Grade 270 ksi (1862 MPa) 7-wire strands. Tendons 2 and 4 were located on the same axis that the column was rotated about. Tendons 1 and 3 were located on the extreme ends and felt the largest strains. The initial force in the tendons was carefully selected and kept within the lower elastic region so the tendons would not yield under large lateral displacements. Figures 7 and 8 show the microstrain in tendons 1 and 4 with respect to the drift ratio of the column. The outermost tendons (tendons 1 and 3) felt the largest strains as shown in Figure 7, compared with tendons located on the same axis the columns were rotated about (tendons 2 and 4) shown in Figure 8. The tendons do not begin to yield until a microstrain of at least 8000 is reached. It can be seen that even the most extreme tendons, such as tendon 1 did not reach their yield strains, even at very large drift ratios. Column PT-HL behaved very similarly to column PT-LL and did not reach a strain of more than 6500 microstrains, even at drift levels as high as 10%.
