Uncorrected land-use planning highlighted by flooding: the Alba case study (Piedmont, Italy)

Abstract. Alba is a town of over 30 000 inhabitants located along the Tanaro River (Piedmont, northwestern Italy) and is famous for its wine and white truffles. Many important industries and companies are based in Alba, including the famous confectionery group Ferrero.

The town suffered considerably from a flood that occurred on 5–6 November 1994. Forty-eight percent of the urban area was inundated, causing severe damage and killing nine people. After the flood, the Alba area was analysed in detail to determine the reasons for its vulnerability.

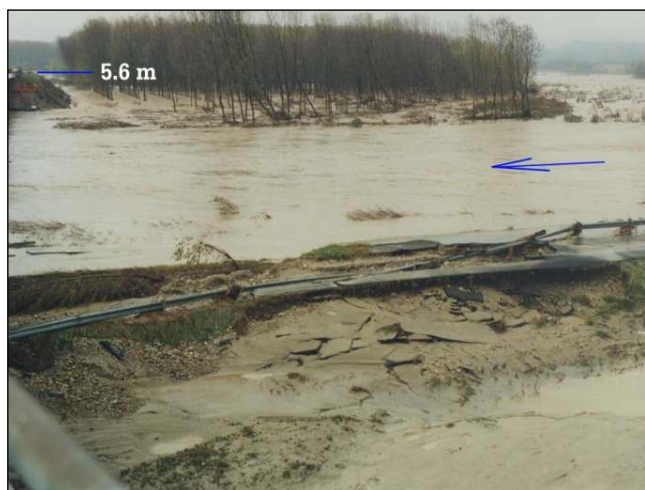
Fig. 3. 6 November 1994, 13:00 LT. The Tanaro River is still swollen. The effects of the flooding are evident. In the foreground, the link road of the Asti-Cuneo highway has been stripped by the violence of the waters. On the left, along the highway embankment, is the site where the deepest floodwaters (5.60 m) were measured (X in Fig. 2). In the background is a thick poplar forest recently planted in a natural area along the Tanaro.

The floodwaters spreading out on the Topino plain were dammed by the embankment of the Asti-Cuneo highway, where they reached 5.6 m in height (Fig. 3). After the embankment gave way to the waters along the lower stretch, the flood struck Alba. At 22:30 LT, violent waves burst into the Ferrero company plant, demolishing its external wall and inundating all of the buildings to a height of 2.80–3 m. Between 24:00 and 01:00 LT on 6 November, the water in the lower zones of the Vivaro quarter was approximately 3.25 m deep.

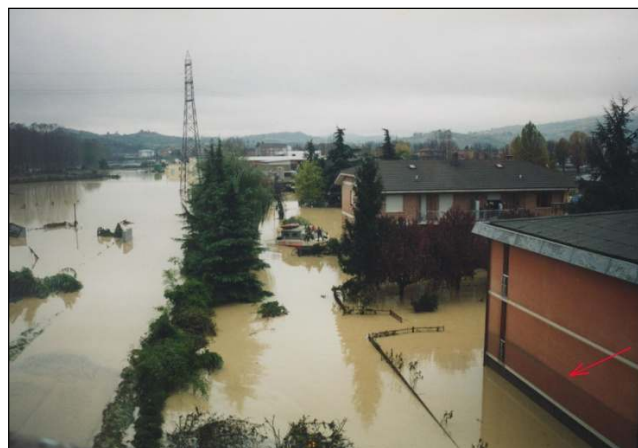
Fig. 4. The Mussotto quarter, close to the highway (W in Fig. 2). The neighbouring Asti-Cuneo embankment, acting as a dam, retained the Tanaro floodwaters, which reached the second floor of the houses (red arrow). In the centre, a fire department rescue boat is in action.

Meanwhile, on the left bank, the Tanaro waters overflowed the railway embankment to join the Riddone waters, reaching the Mussotto quarter (Fig. 4). Part of the Tanaro flow sought to return to the riverbed but was dammed by the highway embankment, raising the water level to 3.6 m. The stretch of

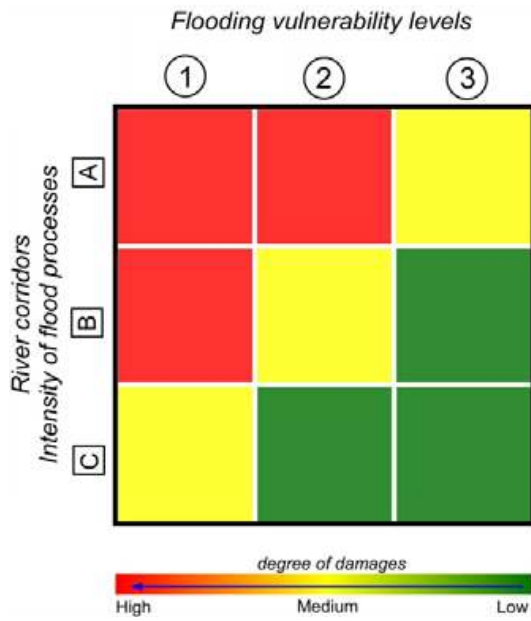
Fig. 10. A risk matrix with three different classes that identify the areas exposed to flooding: green (low degree of damage) to red (high degree of damage).

Using a simple risk matrix facilitates a correlation between the hazards of the three river corridors, defined by the Po River Basin Authority, and the exposure level of the land-use classes (Fig. 10).

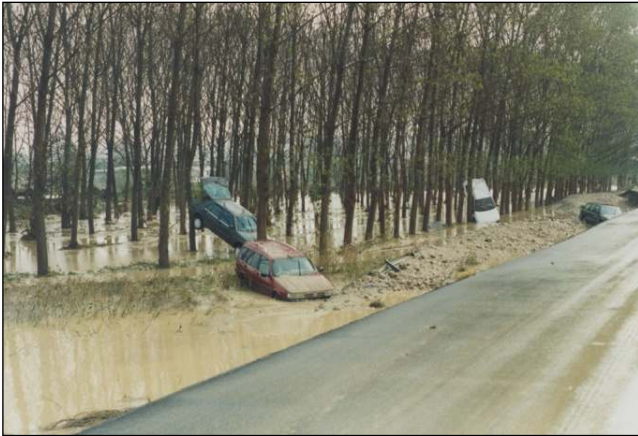
Fig. 13. Tanaro floodwaters swept away cars on the Asti-Cuneo link road, causing two deaths (Y in Fig. 2).

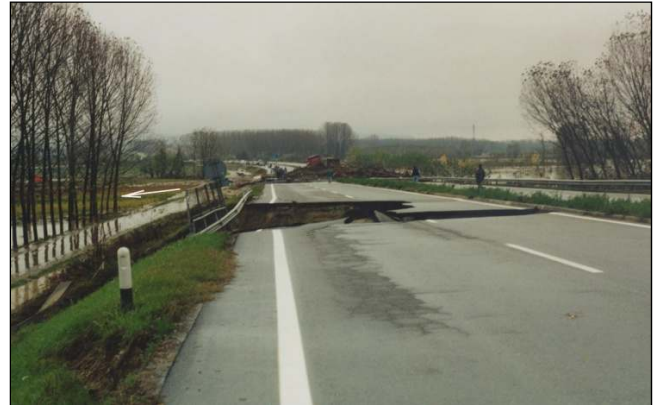
Fig. 14. A large failure caused by the undercutting floodwaters blocked the Asti-Cuneo Highway. In the background, the light subsidence of the highway where the waters overflowed (K in Fig. 2) left a large accumulation of uprooted trees.
