# Validation Ice Crystal Icing Engine Test in the Propulsion Systems Laboratory at NASA Glenn Research Center

The Propulsion Systems Laboratory (PSL) is an existing altitude simulation jet engine test facility located at NASA Glenn Research Center in Cleveland, OH. It was modified in 2012 with the integration of an ice crystal cloud generation system. This paper documents the inaugural ice crystal cloud test in PSL—the first ever full scale, high altitude ice crystal cloud turbofan engine test to be conducted in a ground based facility. The test article was a Lycoming ALF502-R5 high bypass turbofan engine, serial number LF01. The primary objective of the test was to validate the PSL ice crystal cloud calibration and engine testing methodologies by demonstrating the capability to calibrate and duplicate known flight test events that occurred on the same LF01 engine. Additional objectives were to generate engine data to support fundamental and computational research to investigate and better understand the physics of ice crystal icing in a turbofan engine environment while duplicating known revenue service events and conducting test points while varying facility and engine parameter

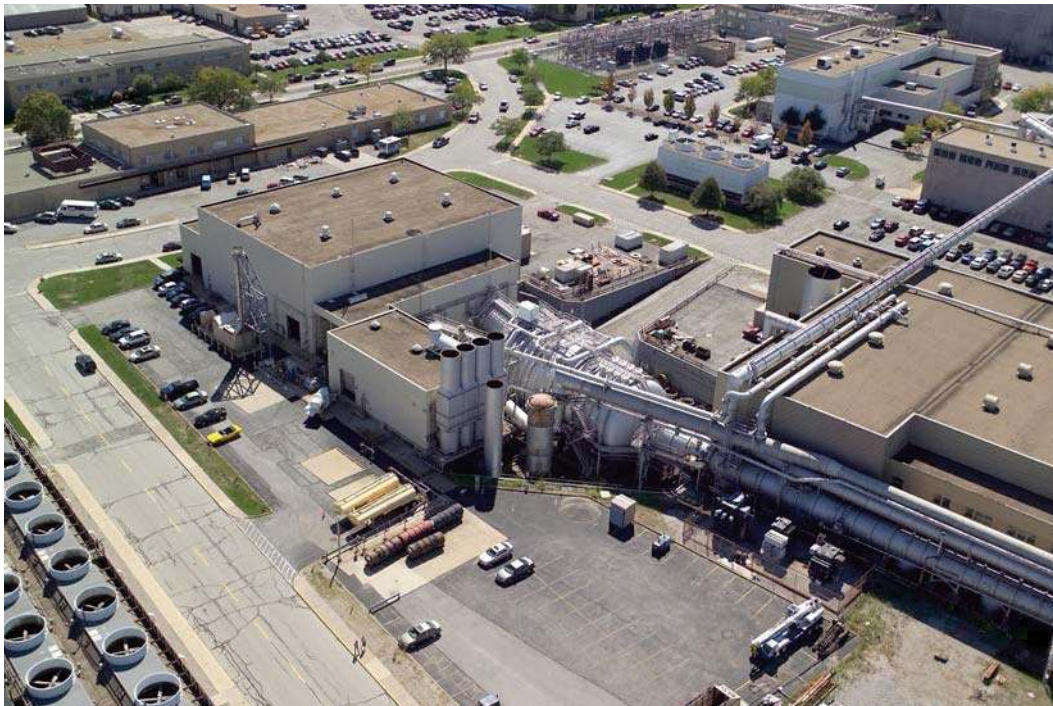
**Figure 1. The Propulsion Systems Laboratory, NASA Glenn Research Center, Cleveland, OH.**

The Propulsion Systems Laboratory (PSL) is located at NASA Glenn Research Center in the Cleveland Ohio Metropolitan Region (Brook Park), [Figure 1](#). There are two test cells contained within the main building; test cell 3 (PSL-3) and test cell 4 (PSL-4), [Figure 2](#). Both test cells are 24 feet in diameter and 39 feet in length and use common supply and exhaust supplied from a central equipment facility. The maximum altitude achievable in the facility is in excess of 90,000 feet. Cooling air can be supplied at a mass flow rate of 100 lbm/s. Various configurations of these test cells are capable of simulating direct connect or free jet testing environments for continuous run times.

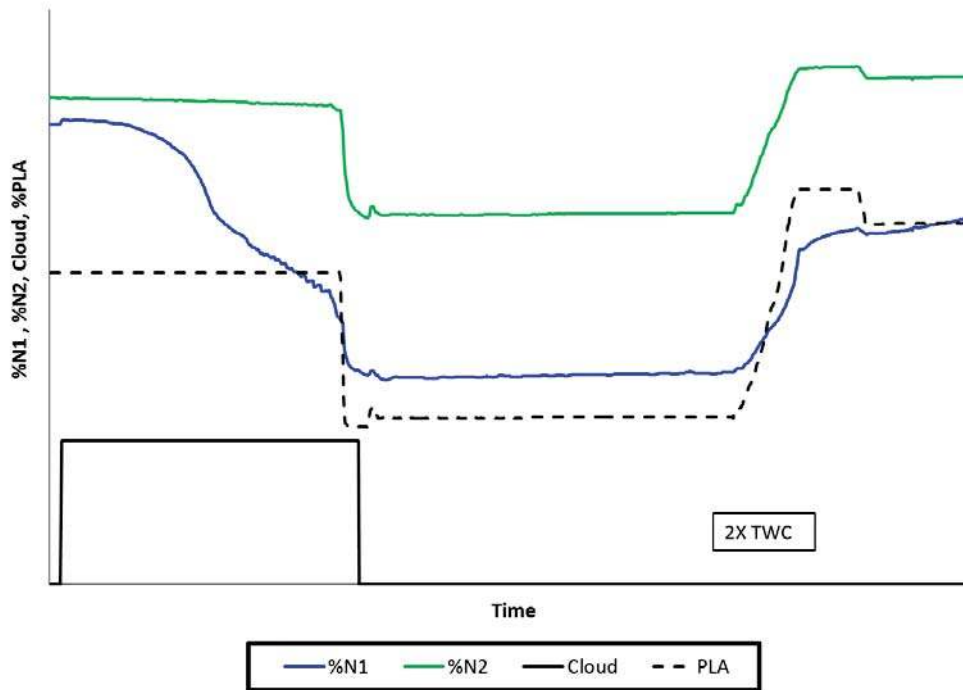
Once the full roll backs shown in [Figures 10 and 11](#) occurred, the engine needed to undergo a recovery process. The first step in the recovery process is to exit the cloud on condition. Two methods were tried. In [Figure 10](#) it is seen that the PLA was reduced prior to the cloud turning off. In [Figure 11](#) the cloud is turned off simultaneously with the PLA being reduced. This was an effort to develop a procedure to exit the cloud on condition in as safe a manner as possible to the engine.

Figure 10. Fan Speed (%N1) and Core Speed (%N2) Chart showing uncommanded roll back for the first ever FLT850 test point in PSL-3.

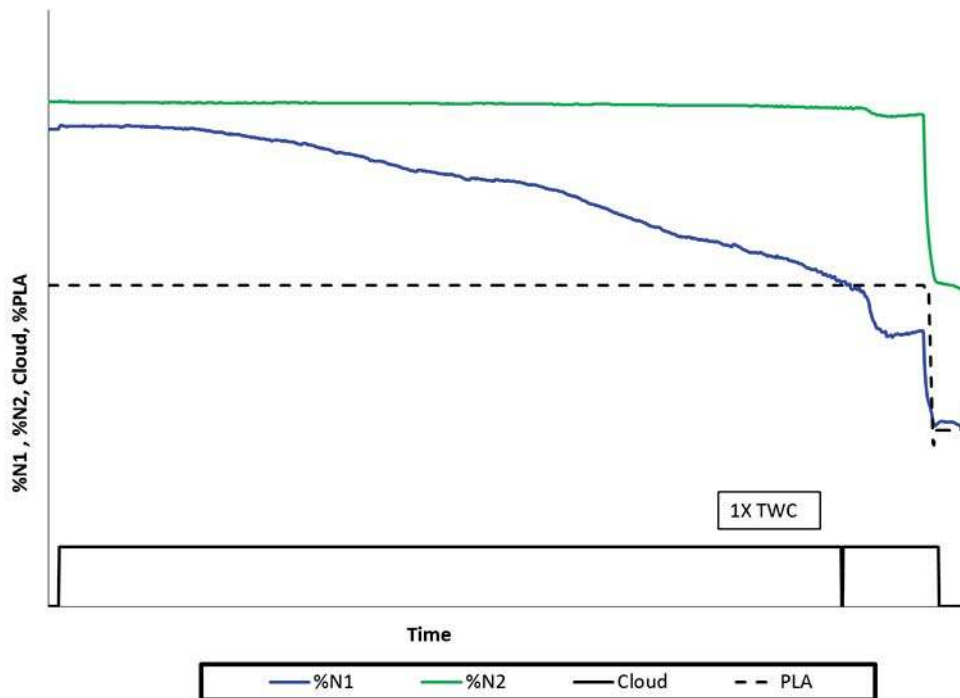
Figure 11. Fan Speed (%N1) and Core Speed (%N2) Chart showing uncommanded roll back for the second ever FLT850 test point in PSL-3.

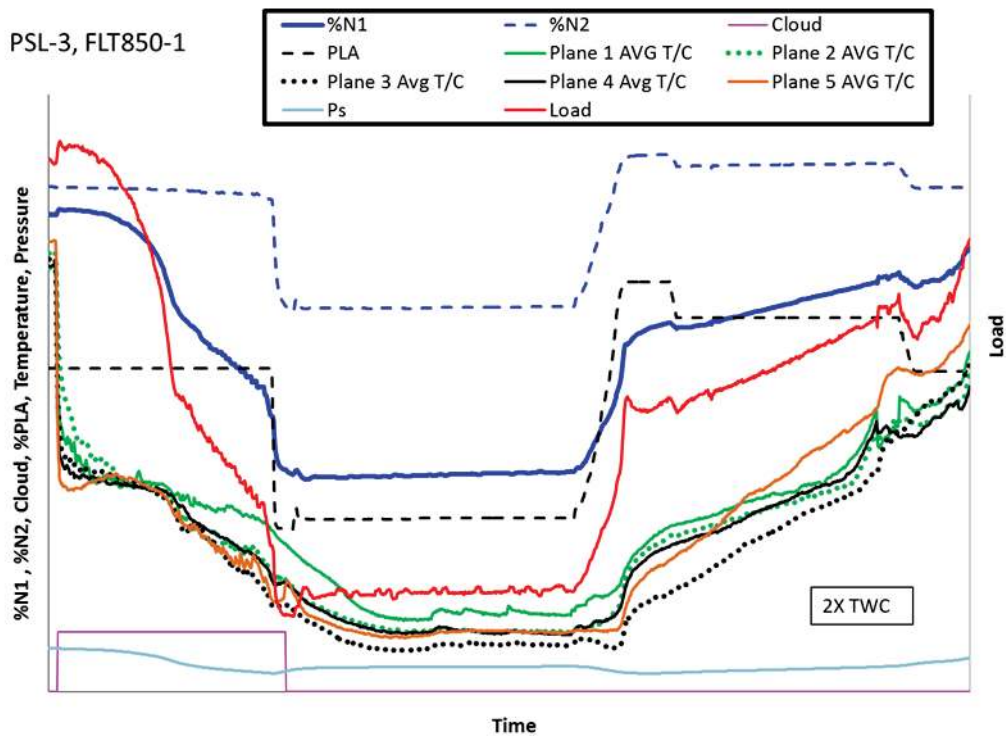
A “called roll back (CRB)” procedure was developed to minimize the risk of critical damage to the engine due to ice buildup and subsequent shedding. In order to develop this procedure, plots of several parameters measured during two separate full RB test points were analyzed: FLT850-1 and FLT850-2. [Figures 12 and 13a](#) show the RB indicating parameters plotted and analyzed for these test points. Note that the X and Y-axis scales are identical for both figures and TWC for the [Figure 12](#) test point is 2 times that of the [Figure 13a](#) test point.

Figure 12. Roll back indicators chart for first PSL-3 FLT850-1 full roll back test point

The plot trace labeled LOAD in the roll back indicator charts throughout the paper is an average of two load cell measurements made on the engine thrust stand. In [Figures 12 and 13a](#) LOAD is shown to increase at cloud on conditions and then begin decreasing as the RB test point ensues. This LOAD decrease occurs prior to the %N1 decrease in both figures. Note that the measured HPC inlet static pressure (Ps) also begins to drop before the %N1 decrease. This suggests that significant ice buildup has occurred and that RB is imminent. The LOAD increase at cloud on is due to an increased momentum change occurring as the engine ingests cloud particles entrained in the air flow.

The thermocouple plots in Figures 12 and 13a show delayed recovery or return to pre-cloud on values at cloud off. This is evidence that ice buildup occurred and remains on and/or around the flow path embedded thermocouples. The thermocouple traces return to pre-cloud on values after an engine recovery period in which this ice sheds. Note that in Figure 13a the full recovery is cut off to make the axis scale identical to Figure 12. In general the longer the time required for RB/CRB to occur, the longer the time required for engine (thermocouple) recovery to occur. Though the recovery time varied for different test points, this cloud off engine recovery period is typical for all RB and CRB test points conducted in PSL-3.

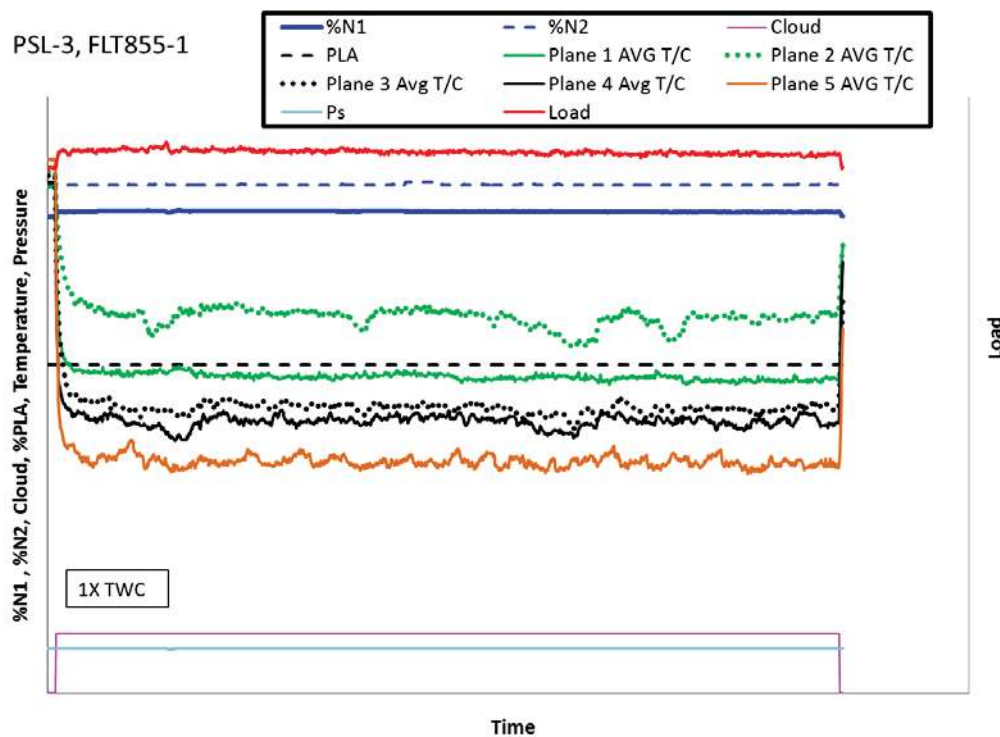
Figure 14. Roll back indicators chart for PSL-3 FLT855-1 no roll back test point

The FT FLT855 test point is represented by the yellow dot in Figure 8. It is the single documented NRB event from the 1997 flight test campaign within the PSL-3 cloud calibration envelope. It is interesting because it falls outside of but close to the grouping of the FT FLT850 and the documented RS RB events. Figure 14 shows the RB indicating parameters chart for test point PSL-3, FLT855-1. Note that there are no decreases in LOAD, Ps, N1 or N2 for this test point. The target TWC for this test point is identical to that of FLT850-2, Figure 13a. This PSL-3 test point was called as a no roll back test point after a certain time frame elapsed while observing minimal if any changes in the roll back indicators. Note that both the X and Y axis scales of Figure 14 are identical to those of Figures 12 and 13a. The only targeted difference beyond the Figure 8 location is that the FLT850-1 test point, Figure 12, has twice the TWC of the other two test points, FLT850-2 and FLT855-1. The average cloud on thermocouple measurements for the NRB point in Figure 14 are significantly higher than both the RB test points of Figure 12 and 13a for all instrumented planes. In Figure 14, it is shown that immediately upon cloud off all the average thermocouple measurements from P1 to P5 returned to pre-cloud on conditions. The engine required zero recovery time for this test point. The roll back indicators chart of PSL-3, FLT855-1, Figure 14, is typical for test points that are CNRB test points. This is indicative that little to no firmly accreted ice buildup occurred at these instrumented planes of the engine. For NRB test points, Figures 14, 15 and 18 unsteady thermocouple behavior was observed. This may indicate loosely accumulating and shedding ice buildup for NRB test points vs. firmly accreted ice buildup for RB/CRB test points.

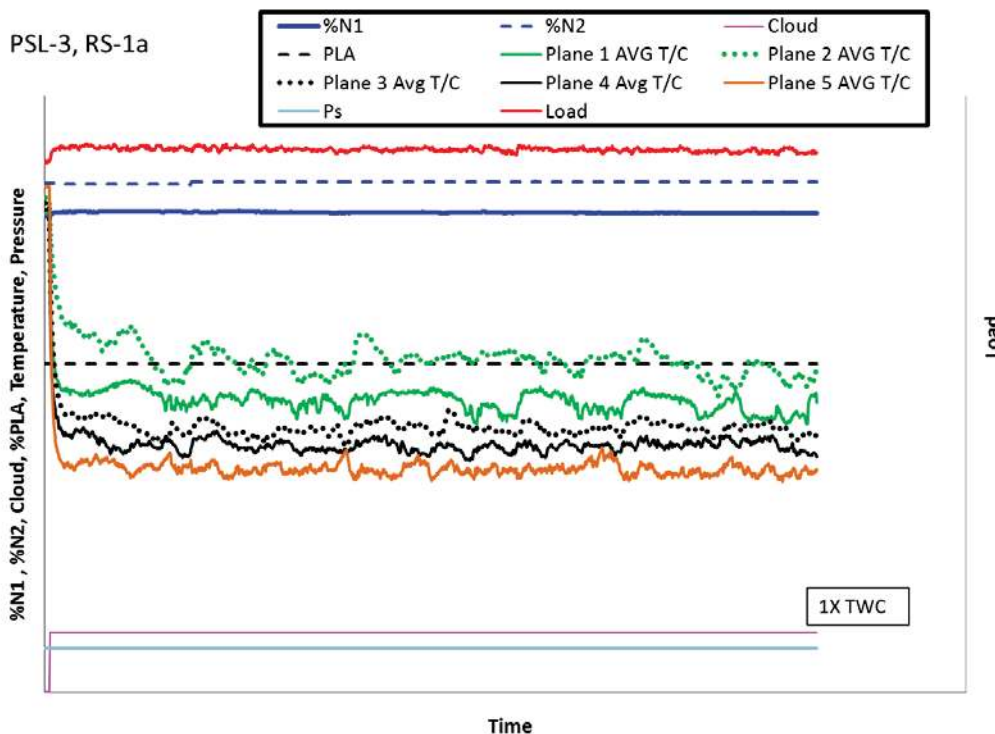
Figure 15. Roll back indicators chart for test point RS-1a, relative to Figure 16.

The test points labeled as RS-xx in Figure 8 are revenue service field events that were tested in PSL during the test period. They represent field events that span the altitude, temperature and engine operation calibration envelope of the PSL-3 cloud generating system for this inaugural ice crystal icing test. Since none of these events had similar data measured as that of FT FLT850, NASA and Honeywell Engines worked to develop a test methodology based on the ALF502-R5 cycle deck to determine engine operation at the specified ambient temperature, pressure altitude, cloud variation (centered on the FLT850 cloud parameters) and documented knowledge of the RS events. In general during testing, all RS test points started with the identical MVD and TWC as FLT850-2. Cloud TWC was increased incrementally as necessary to produce a CRB event for a given RS test point. Cloud MVD adjustment was not performed for any RS test point to produce the CRB event. The RS test points near the colder/higher as well as warmer/lower boundaries of the temperature, altitude envelope shown in Figure 8 required incremental TWC adjustments to produce a CRB. The CRB events that occurred near FT FLT850 conditions were characteristically similar to FLT850-2 with similar ice buildup rates, CRB and recovery times and cloud parameters. The roll back indicators for selected RS test points are shown in Figures 15 to 19. Figures 15/16 and 18/19 show how incremental adjustment of TWC caused the CRB event to occur. For RS-1b (Figure 16), 3b (Figure 19) the cloud TWC was targeted to be 1.3 times and 2 times respectively compared with RS-1a (Figure 15), 3a (Figure 18) to produce the CRB event.

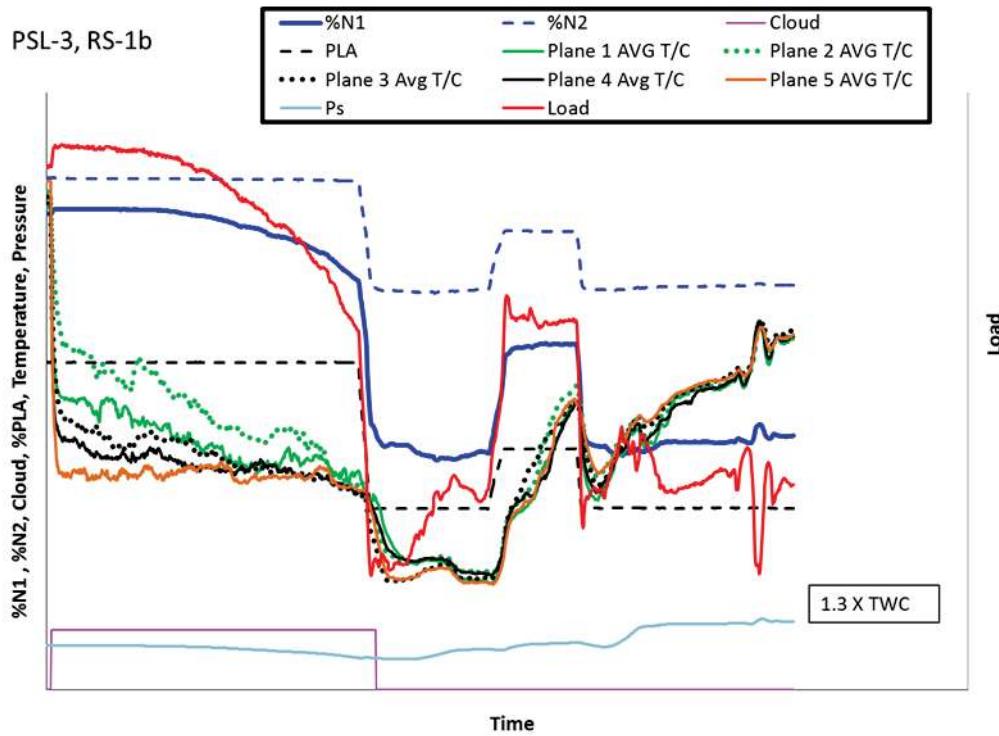
Figure 16. Roll back indicators chart for test point RS-1b relative to Figure 15.

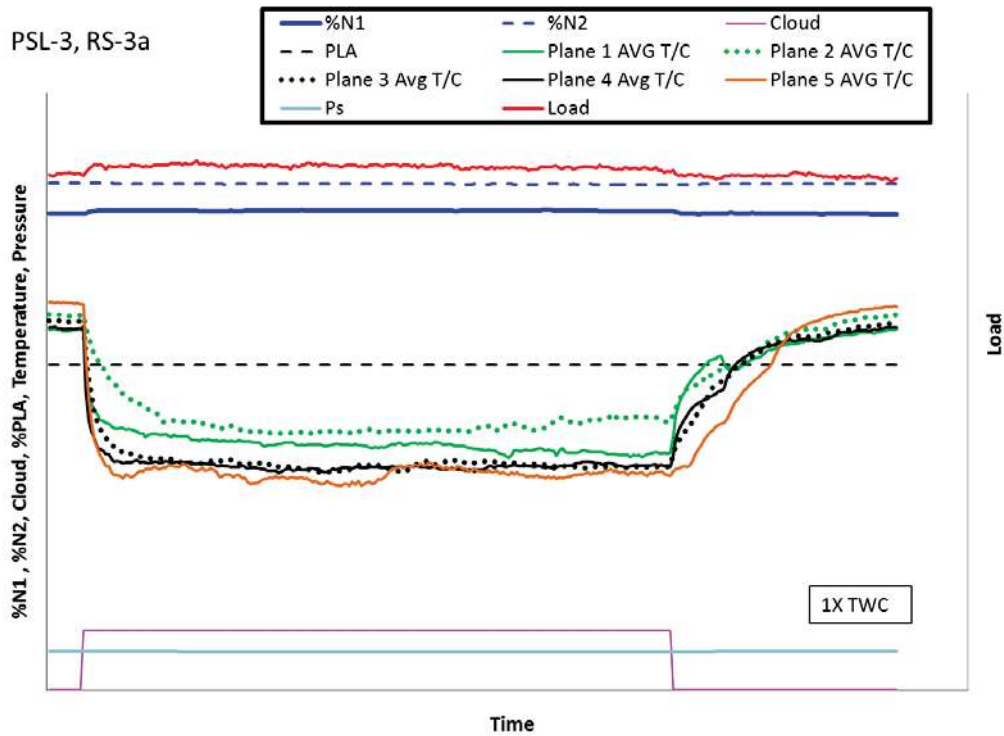
Figure 18. Roll back indicators chart for test point RS-3a, relative to Figure 19.

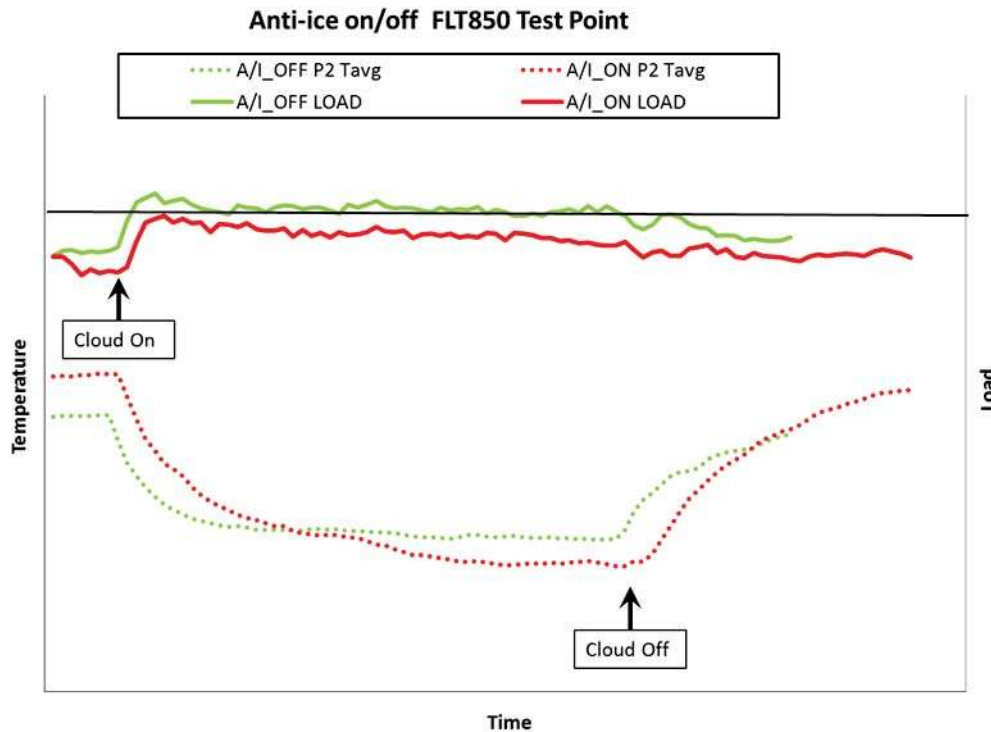
The result for a test point with FT FLT850 conditions conducted with and without the engine anti-ice system turned on is shown in [Figure 21](#). The engine anti-ice system works by allowing hot air from the high pressure compressor exit region to flow into the annular area cavity that surrounds the low pressure compressor outer flow path and down through the inlet guide vane. The individual P1 to P5 thermocouples are mounted in or on vanes that are bonded directly to the outer flow path of the LPC, [Figure 7](#). From [Figure 21](#) the cloud off P2 Tavg trace for the anti-ice on test point is shown to be higher than the anti-ice off trace. This is likely due to either anti-ice air heating the outer shroud from the back side, leaking into the flow path near the outer wall, air heating up as it passes over the heated IGV or some combination of the three. Note that the anti-ice off trace falls immediately and levels off

**Figure 21. PSL-3, FLT850 test points conducted with the engine anti-icing system turned on and off**

to a relatively steady value at cloud on condition and that there is no secondary temperature drop indicating ice buildup. The LOAD trace for the anti-ice off test point remains steady at the cloud on value. The P2 Tavg trace for the anti-ice on test point drops immediately to the same value as the anti-ice off test point at cloud on condition but undergoes a secondary temperature drop as the anti-ice on LOAD trace begins to drop. This is indicative of critical ice buildup and imminent RB.

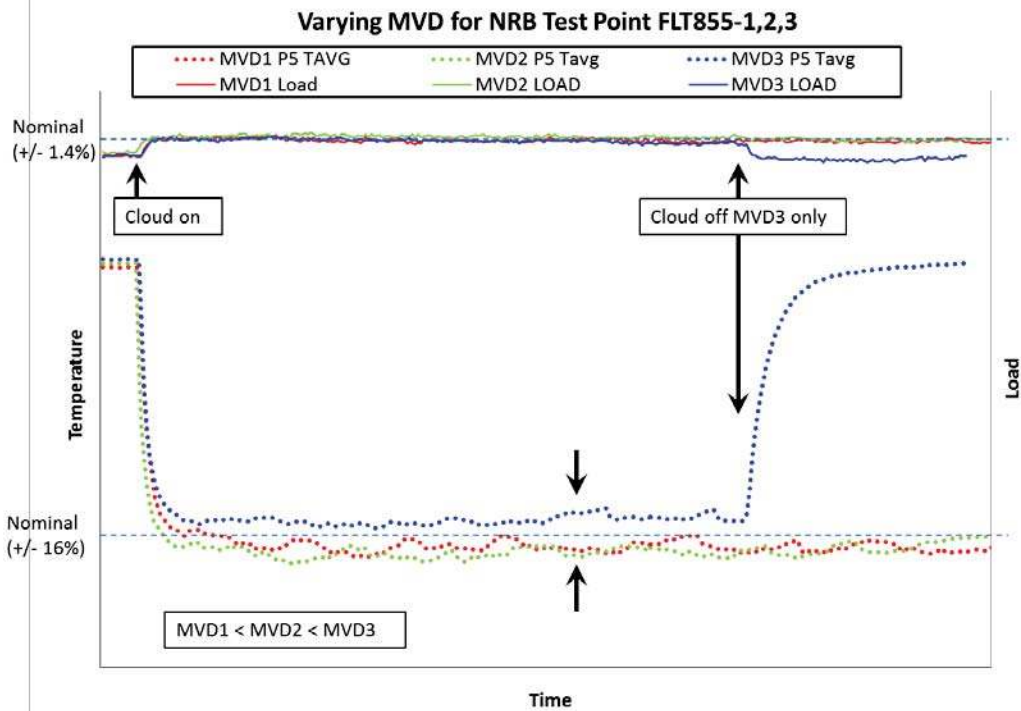
Figure 23. FLT855 NRB test points conducted implementing a cloud MVD sweep.

MVD sweeps were conducted for both a RB RS test point and a NRB FLT855 test point. Note that each MVD was investigated as a separate test point. The objective was to investigate the influence of cloud particle size on one RB and one NRB condition. The RB indicator charts showing the results of an MVD sweep for the RS RB and NRB (FLT855) test points are shown in [Figure 22](#) and [23](#) respectively. For the RS RB test point in [Figure 22](#) the particle size does not appear to affect the on-set of IBUA. All loads appear to begin decreasing at a similar time after cloud on condition. Note that the rate of LOAD decrease is greater for the larger MVD cloud test point and is least for the smallest MVD cloud. For the NRB series of test points the only difference is a significantly warmer P5 Tavg trace. This is likely due to the larger MVD cloud not being fully glaciated. It appears that while cloud particle size does not influence the onset of ice buildup it does influence the rate of ice buildup if it is occurring for a given test point.

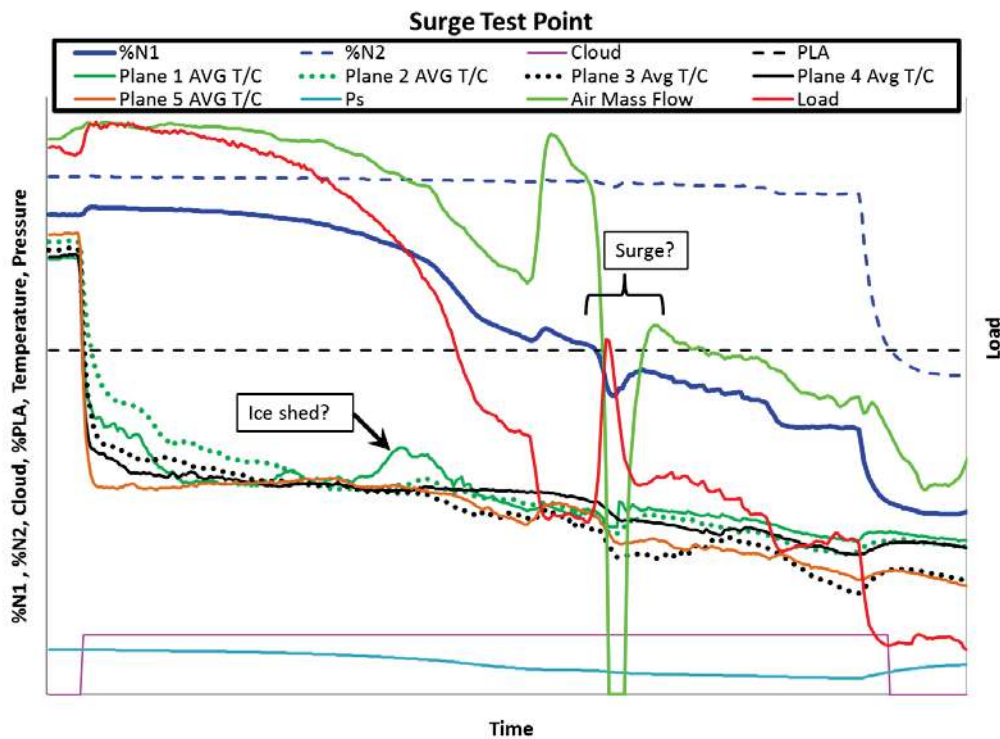
In [Figure 25](#), the air mass flow trace shows a distinctive movement suggesting a sudden disturbance in the air flow. This is interpreted as an engine surge for this test. The facility airflow parameter is calculated using an averaged series of static pressure transducers in the PSL-3 plenum. These are not dynamic pressure sensors and the nature of how the pressure sensors function resulted in the “drawn out” representation of the surge as compared to a spike and return that would be expected as the engine surges and recovers. Note that the label for non-uniform ice shed in [Figure 25](#) suggests an ice shed occurred in P1 prior to the surge behavior. [Figure 26](#) shows the non-uniform behavior of the individual thermocouples in P1. This suggests that a non-uniform circumferential ice shed occurred and entered the HPC and resulted in the stall/surge.

Figure 25. FLT850-3 full roll back test point RB indicators chart. The thermocouple traces shown are averages for each plane of interest.

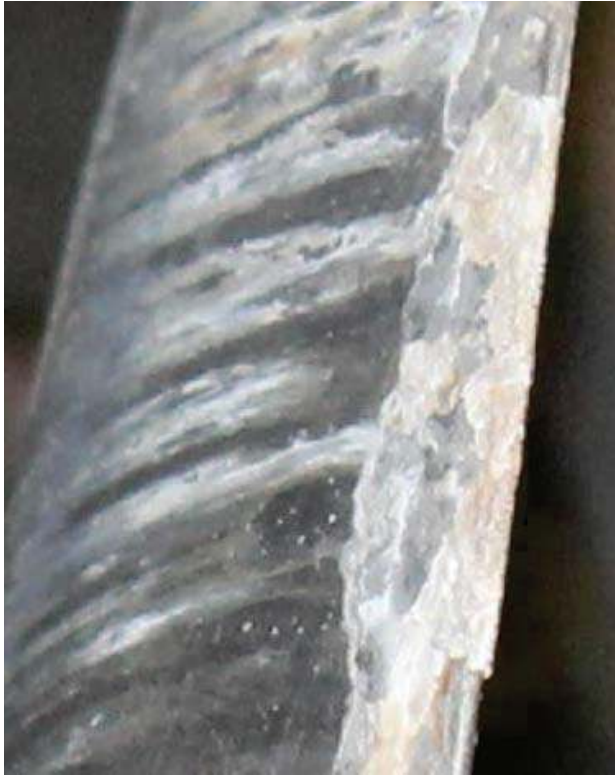
1. There was chronic engine degradation (in the form of turbine exit temperature rise) throughout the test believed due to mineral deposits, Figure 32, from the use of filtered (not demineralized) city water for the ice crystal cloud. This was done to use small particulate in the city water as nucleation sites for ice crystal formation. This degradation would recover somewhat on low altitude high TWC cloud test points.

**Figure 32. Mineral deposits on LF01 engine core flow path hardware.**

Filtered city water used in the cloud generation nozzle system to provide ice crystal nucleation sites resulted in mineralization forming on flow path hardware that led to a chronic degradation of engine performance during the month long test.

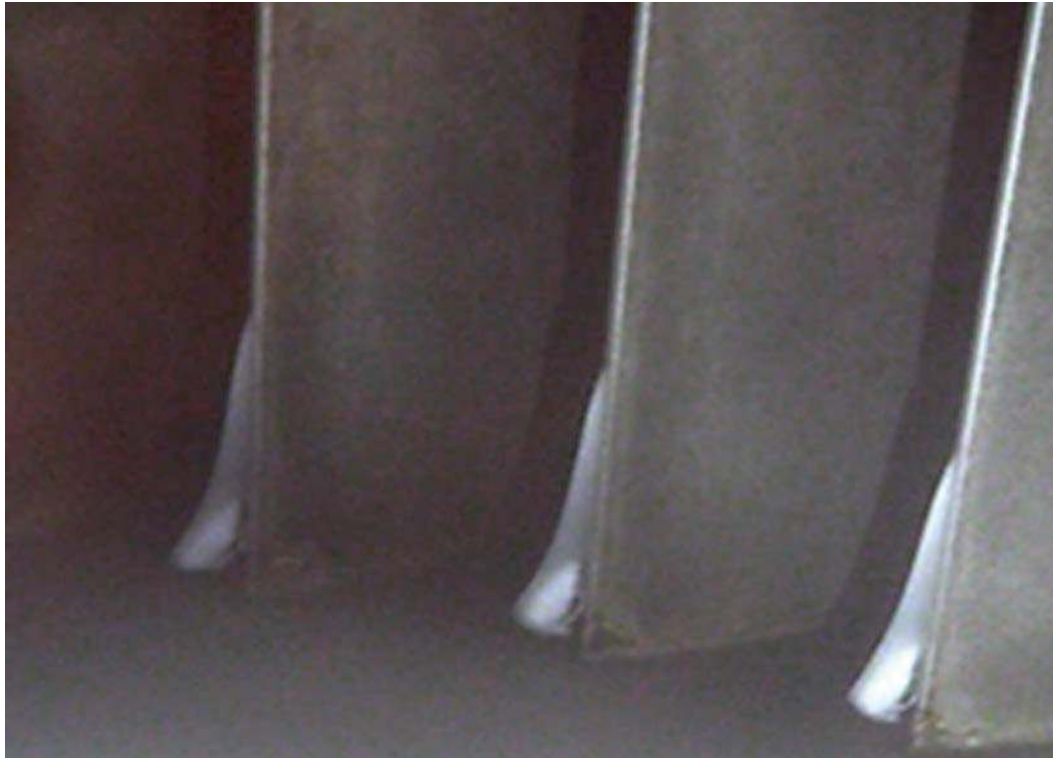
2. The heated spinner was a source of liquid water for all cloud on conditions, Figure 33. During anti-ice off test points this liquid water formed ice accretion on the lower third of the IGV, Figure 34.

Figure 34. Ice accretion forming on bottom leading edge of LPC IGV during anti-ice off cloud on conditions.

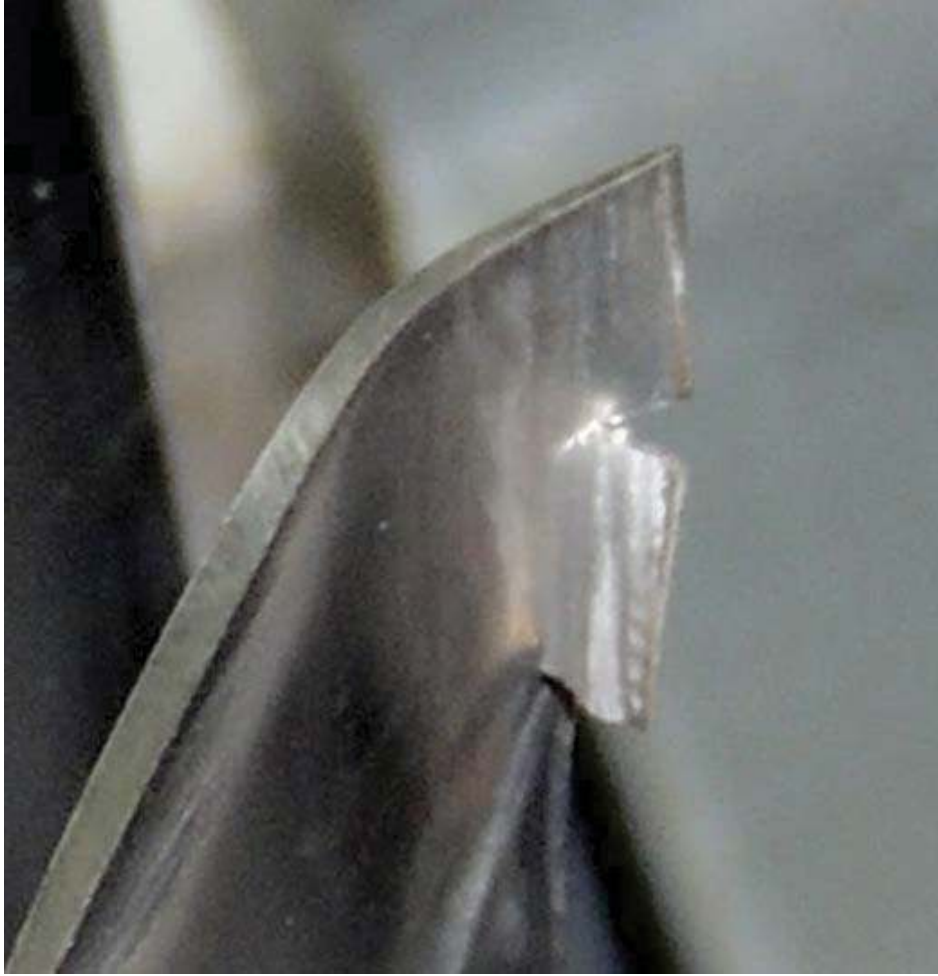
3. Reverse flow of liquid water was observed on the LPC IGV for RB test points, Figure 35.
4. Flow path hardware was damaged during a full roll back test point. This is suspected to be a result of an ice shed impacting the rotating hardware during cloud off engine recovery, Figure 36.

**Figure 36. HPC Rotor 1 mechanical damage.**

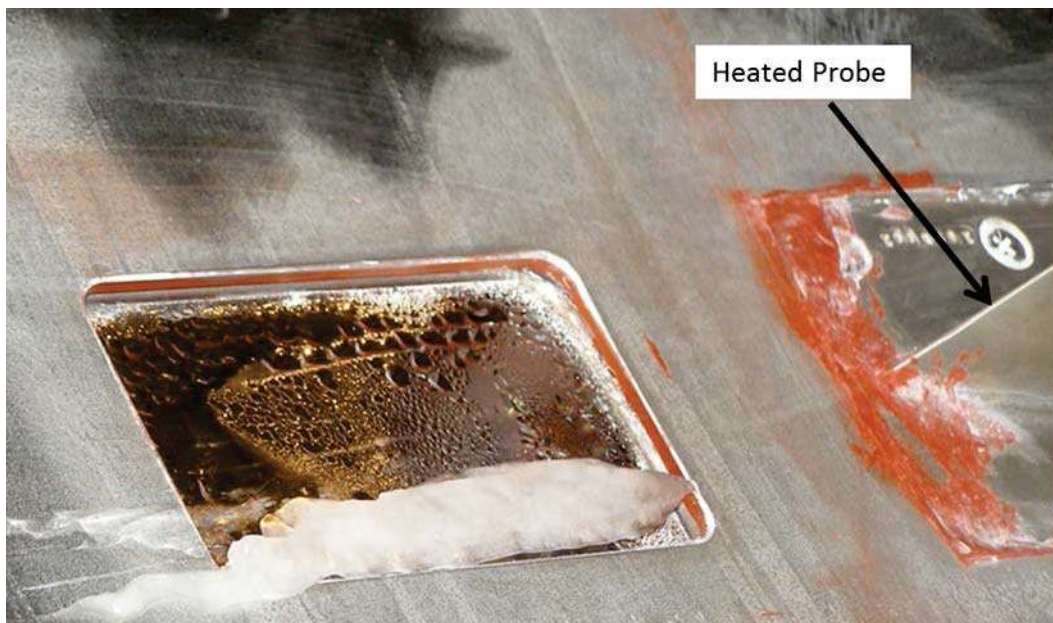
7. The PSL-3 tunnel walls were all grounded to successfully prevent the static cling of ice crystals.
8. During integrated systems testing heated pitot tube probes were used during ice crystal cloud on operation. A rivulet of water ran back and froze to the tunnel side wall approximately 6 to 8 inches downstream of the heated probe, [Figure 37](#).

**Figure 37. Ice mass accreting to side wall downstream of heated pitot probe.**
