“VALUE ENGINEERING...?” – CHANGES DURING CONSTRUCTION

Maral Papazian Bedian, P.E.
PERINI Corporation, Civil Construction
Peekskill, New York, USA

“Value Engineering” is a frequently found clause in Construction contracts in the USA, allowing contractor-initiated design changes. Misleading is the interpretation of “value engineering” to imply cost savings shared with the owner, and its implementation during construction, is problematic. It is not surprising that such a clause would simply be ignored because it involves changes in design, often major changes in very short time; and change is feared and vehemently resisted by all parties, owner, designer, and contractor. The problem may lie in the divergence and separation of the designer/engineer and builder/contractor; their priorities and incentives are very different. The engineer spends years, even decades, in design and prepares contract documents often without a deep-seated understanding of construction methods, including geotechnical construction. Even worse, given extensive computational advancements, the designer submits exaggerated code-based designs with excessive safety factors. As for the contractor, he often builds wi

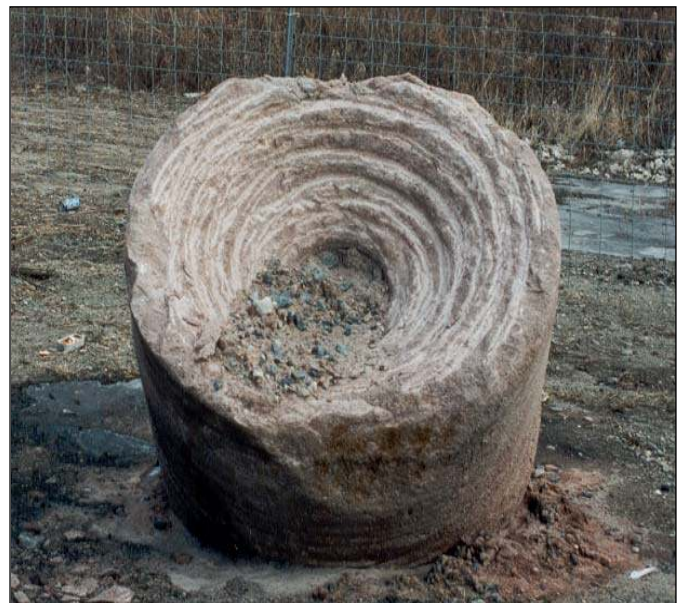
For this project, the O-cell loading test was conducted on one of the central (2.15 m in diameter) drilled shafts, which was prepared as a production caisson. The subsurface profile at the test location, as determined from a nearby test boring and as observed from the drill cuttings, consisted of 4.6 m thick granular fill, over 5.5 m marine clay, underlain by 10.8 m glacial deposits of silty sands with gravel. What had been described in a nearby boring as “completely weathered rock” at about 21 m depth below the existing grade, was recovered as a 1 m diameter solid sandstone core (Photo 1.1), immediately underlain by soil-like, completely weathered rock. The test shaft was advanced about 3 m into the weathered sandstone. The total length of the test shaft was about 24 m below the ground surface.

Photo 1.1 - Recovered 1m diameter Core from the “Completely Weathered Rock” zone

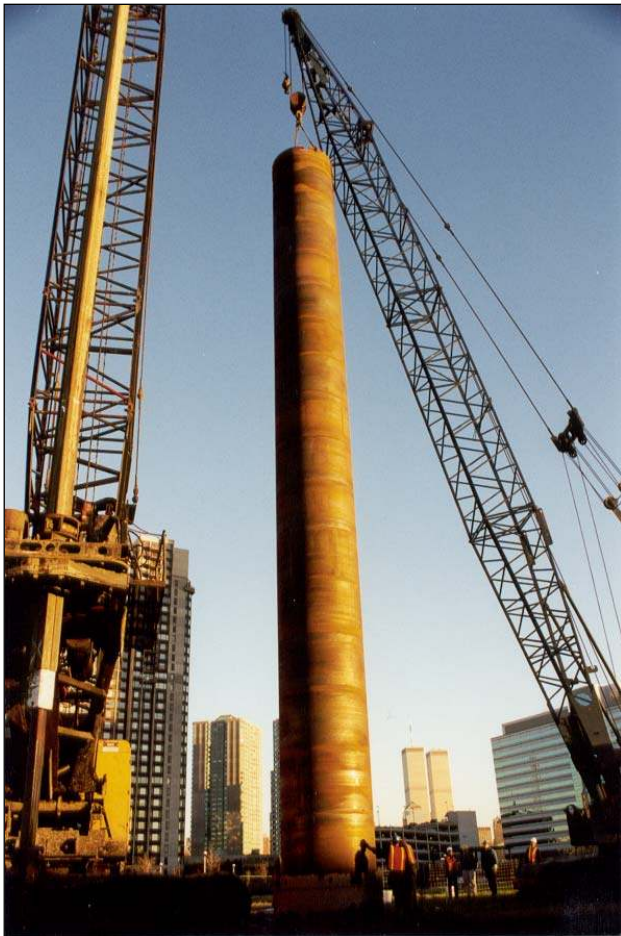
Once weathered rock was reached, a permanent steel casing (Photo 1.2) with welded teeth was inserted into the shaft and twisted for about 0.3 m into the weathered sandstone. Drilling below the permanent casing was then continued at slightly reduced 2 m diameter using rock augers, sometimes assisted with core barrels to core the harder rock. For the test shaft, the length of the socket extending into the weathered sandstone was 2.5 m. The sides of the socket were scraped to remove softened material. At the end of drilling, the bottom of the socket was cleared of cuttings and accumulated sediments were removed using a clean-out bucket. It was estimated that approximately 25 mm of sediments remained at the base of the test shaft before beginning the O-cell static loading test.

Photo 1.2. – Installation of Permanent Steel Casing

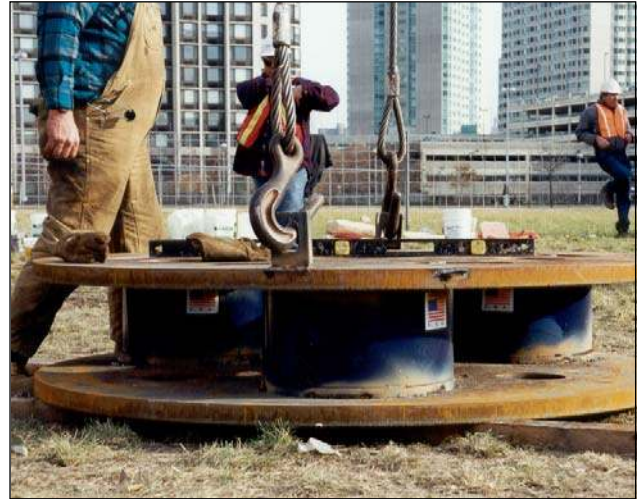
Following drilling and clean-out of the test shaft, three 533 mm (21 inch) diameter sacrificial O-cells (welded and contained between two circular steel plates, and mounted on a steel frame), were lowered to the bottom of the test shaft (Photos 1.3 and 1.4).

Photo 1.3. – Three O-Cells between two steel plates

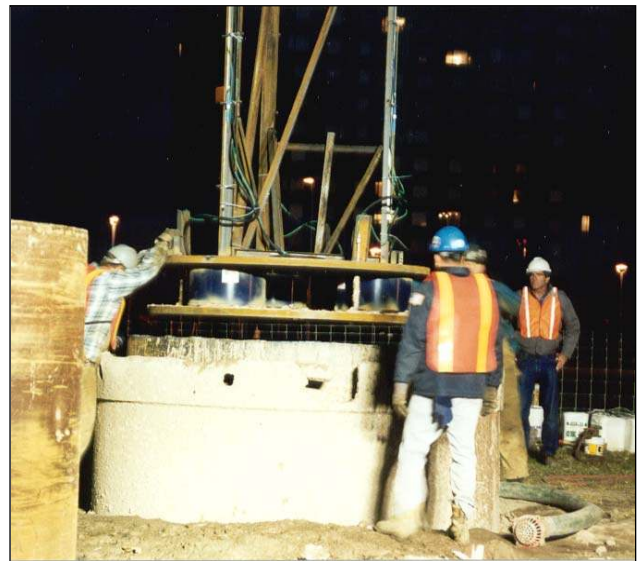
Photo 1.4. – The O-Cell assembly, complete with Instrumentation being lowered to the bottom of the prepared Drilled Shaft (before concreting)

The three O-cells were capable of applying a total combined load of 34,200 KN (3,845 tons). The O-cell assembly was complete with instrumentation including sister bar vibrating wire strain gages at three levels along the shaft, to measure the shaft resistance (side shear load transfer) in the various layers.

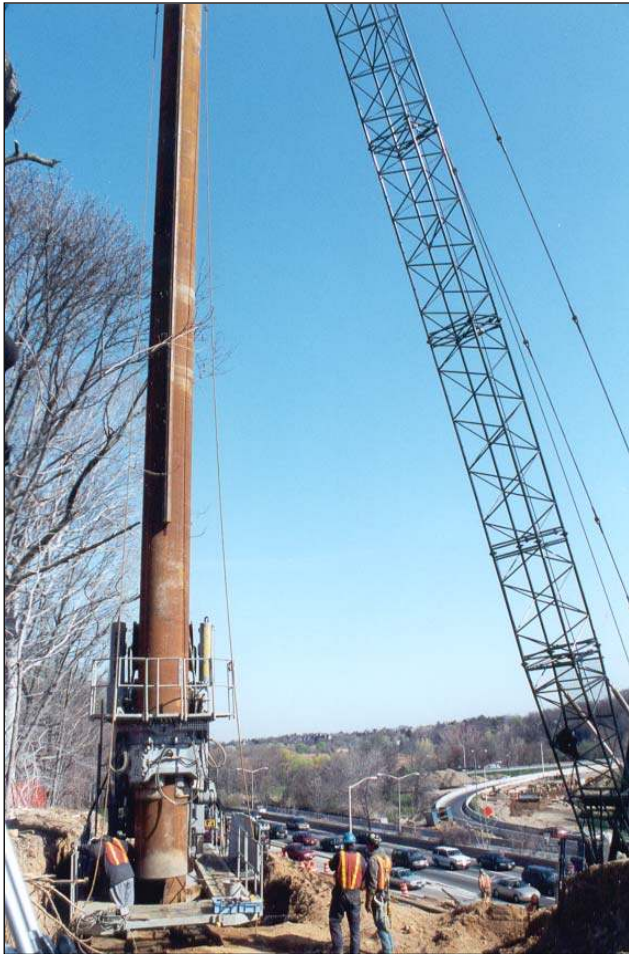
Photos 4.1 and 4.2 below show the Giken piler during installation of the LIE retaining wall SP-1.

Photo 4.1. – Begin of Installation of Pile with Giken Piler

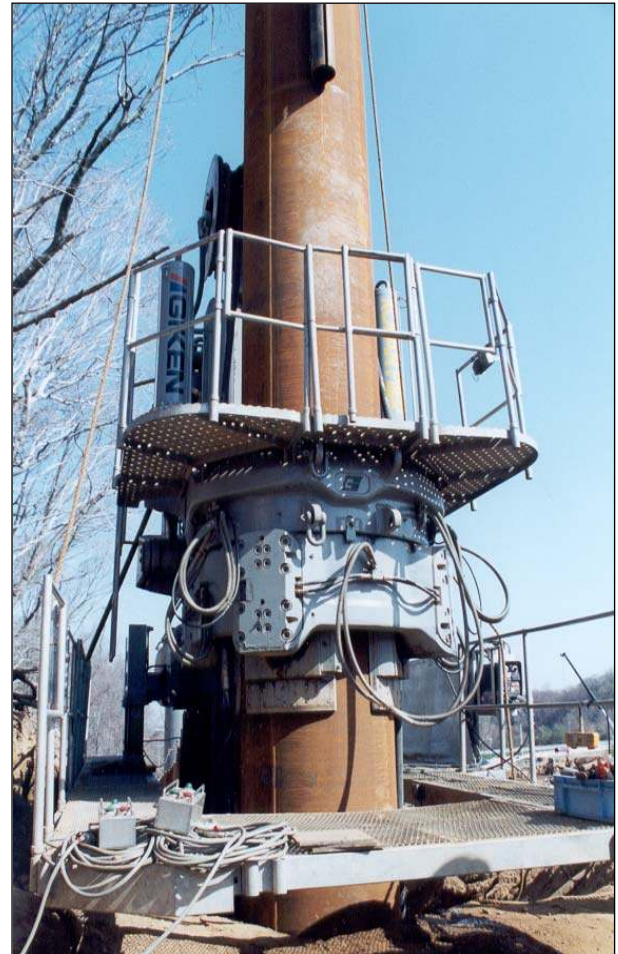
Photo 4.2. – Close up of Giken Piler with Pile

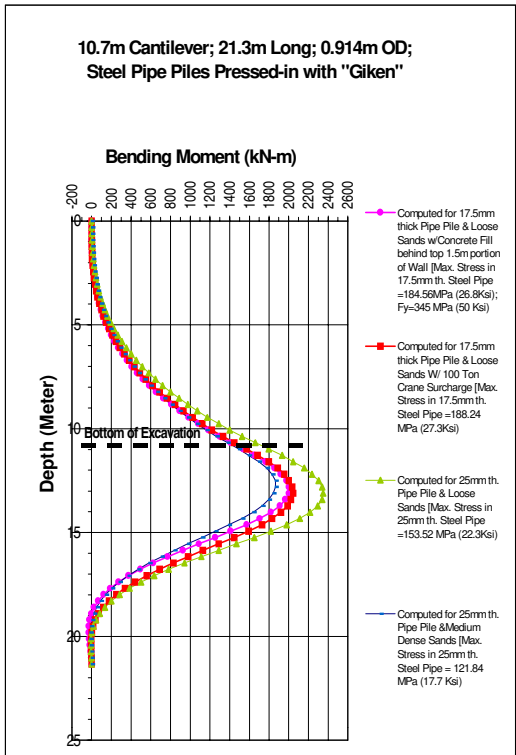
Figures 4.2 and 4.3 below present the computed pile moment and mobilized soil reaction diagrams, respectively.

Fig. 4.2. – Computed Pile Moment Diagram

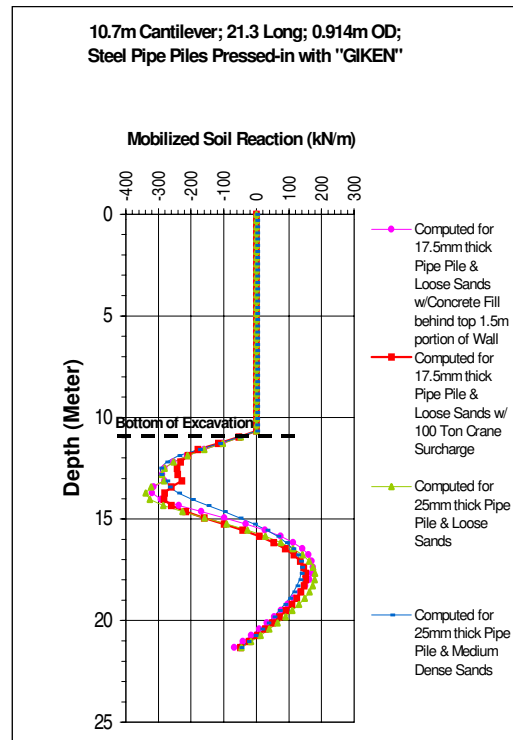
Fig. 4.3. – Mobilized Soil Reaction below Excavation

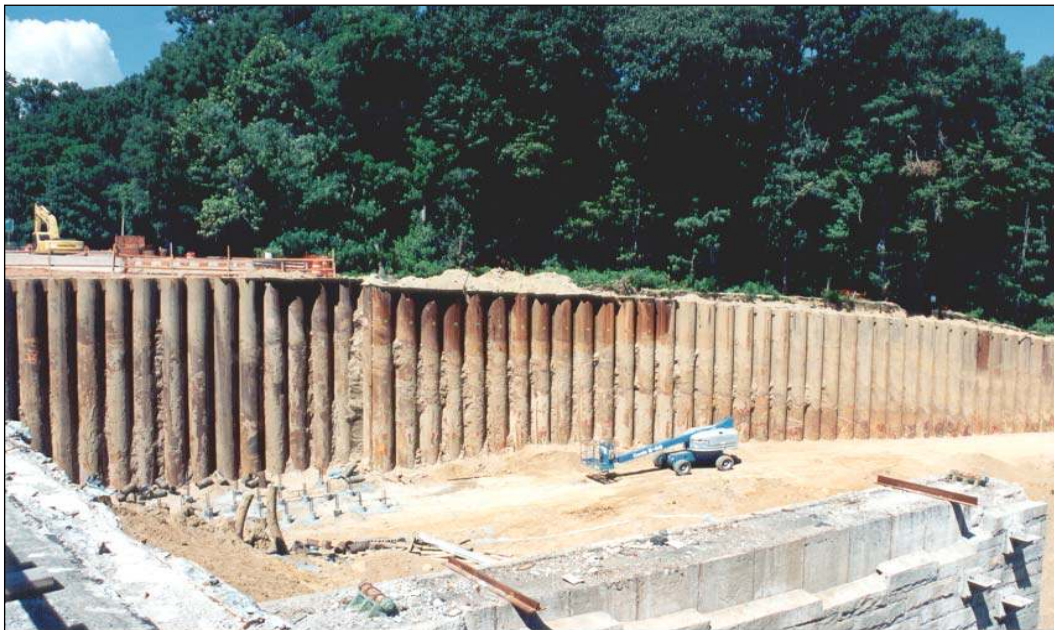
Photo 4.3 below shows an impressive view of the completed retaining wall in full cantilever at 10.7 m (35 foot) height, with average pile embedment of 10.7 m.
