US Army Corps
of Engineers®
Engineer Research and
Development Center

Vegetation and Channel Morphology Responses to Ordinary High Water Discharge Events in Arid West Stream Channels

May 2009

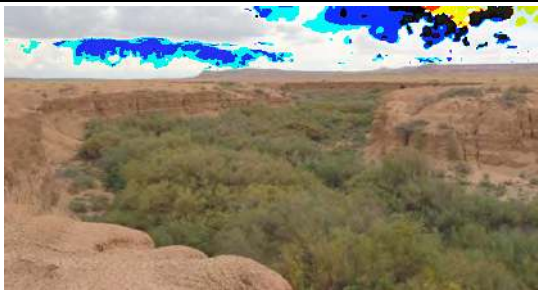
<ul style="list-style-type: none"> - Alternating erosional and depositional reaches - Headcuts that form at downstream end of sheet flood zones and migrate upstream - Cycle of arroyo formation, widening, and backfilling into the valley floors - System in equilibrium as long as length of channelized areas relative to sheet flood zones remains constant
Compound channels

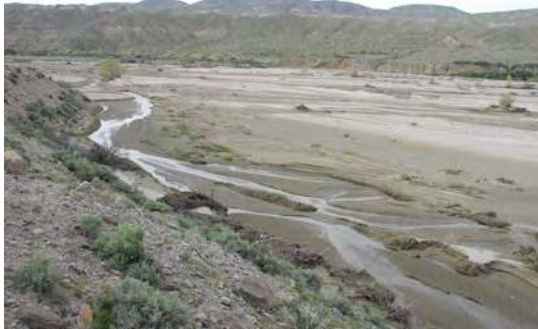
<ul style="list-style-type: none"> - Rapid widening in response to increase in sediment transport capacity during extreme, brief discharge - Activation of braided channels after extreme flow events - Meandering form that develops after long sequence of low to moderate discharges
Alluvial fans

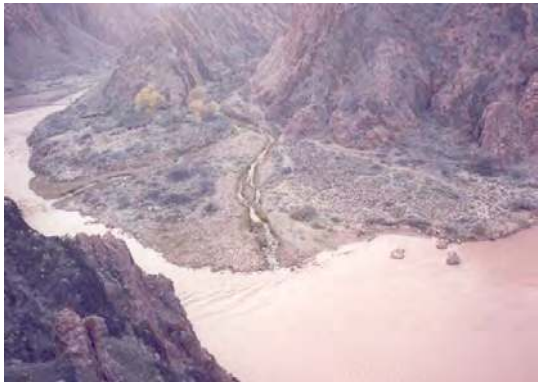
<ul style="list-style-type: none"> - Fans that emerge from upland areas into zones of reduced stream power and are maintained by distributary flow - Enhanced deposition because of decreased stream power from headwaters to valley bottom, loss in flow confinement, and loss of discharge - Channel avulsions resulting from overbank flows emanating from channels on fan surface

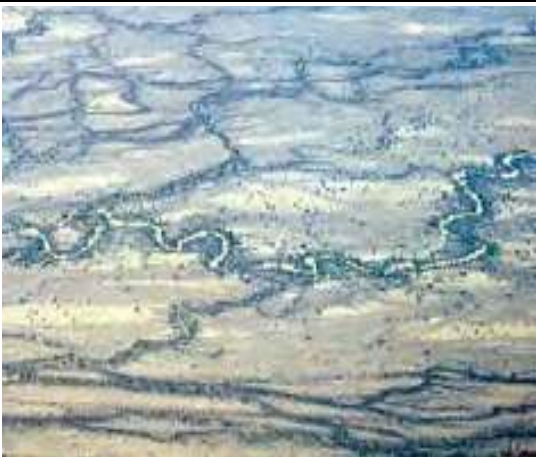
<p>(Copyright, Colin P. North, University of Aberdeen, Scotland; used by permission)</p>	<ul style="list-style-type: none"> - Frequent channel avulsions - Smaller anabbranch channels that grow headward towards the main channel in response to overbank flows emanating from aggrading main channel
Single-thread channels with adjacent floodplains

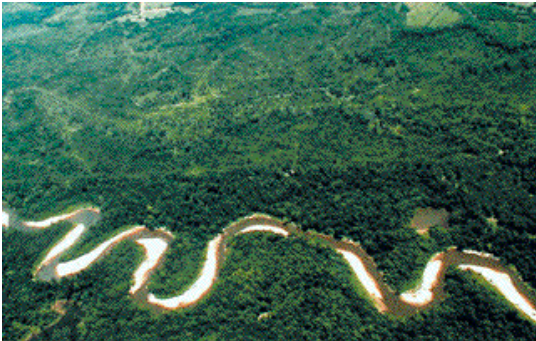
<ul style="list-style-type: none"> - Meandering that develops to minimize amount of change at any point along river - Channel incision when sediment transport capacity of reach is elevated relative to sediment supplied to reach - Channel widening with bank destabilization - Aggradation due to decrease in capacity to transport sediment

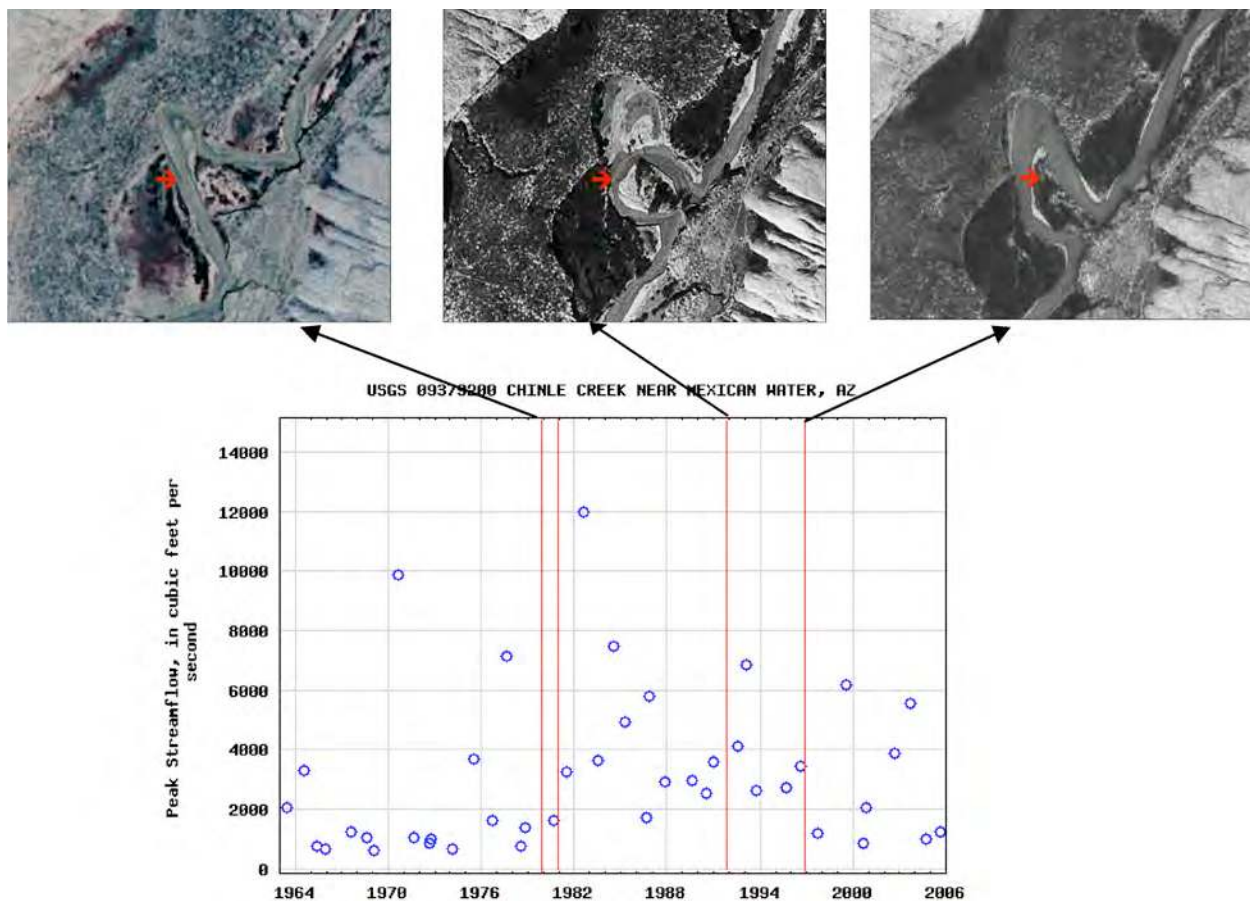
Figure 4. Chinle Creek near Mexican Water, AZ. The red arrow shows the shift in the channel from 1981, 1992, and 1997. The second two photos were used in this analysis.

To assess the impact of a discharge event on the eight chosen sites, we determined the change in the channel upstream from the stream gauge by viewing one aerial image prior to a discharge event and one aerial image after that discharge event (Figure 4). For each site, both before and after the flood event, riparian corridors were delineated for various channel features using the digital imagery within ArcView GIS (geographic information system) 3.2 and ArcMap 9.2. All mapping was done at a scale of 1:2,400 representative fraction. To better locate and identify surfaces, we used support spatial databases, including topography maps from the U.S. Geological Survey and contour lines that were created within ArcMap.

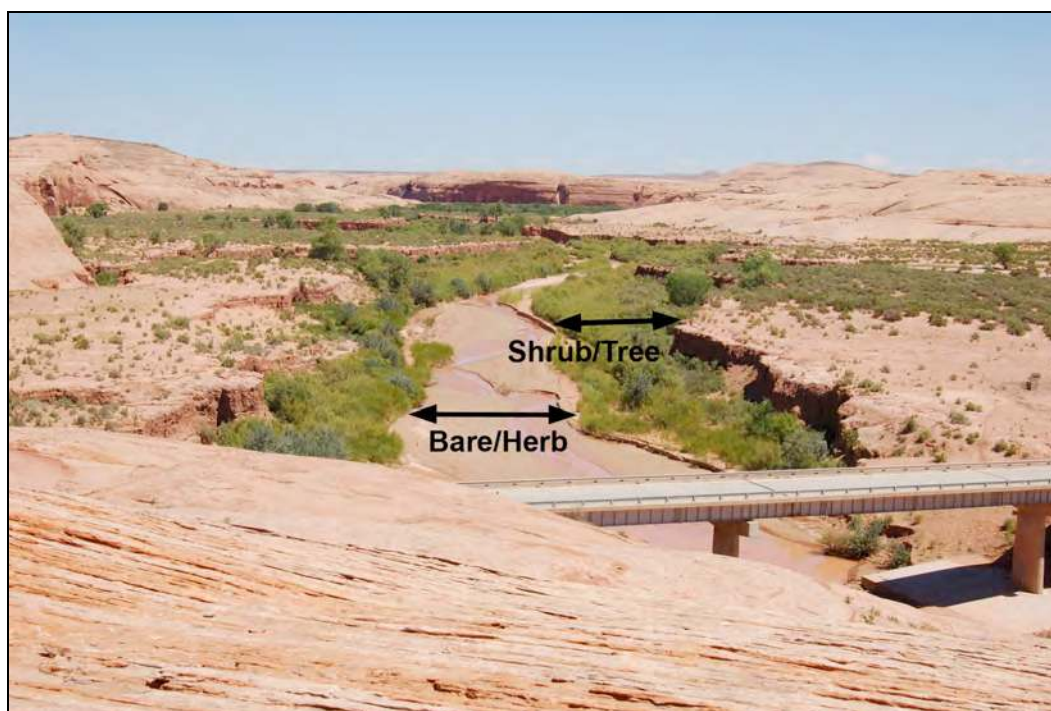
a. Chinle Creek

b. Agua Fria

Figure 5. Vegetation categories at two sites.

We mapped the hydrogeomorphic surfaces representing the bankfull channel and the active and terrace floodplains on the aerial images. The bankfull channel and the active floodplain contain features associated with frequent flooding, including high-flow channels, unvegetated surfaces, bed and bank, and a break in slope. The terrace floodplain is above the active floodplain and contains features associated with infrequent flooding and seasonally wet areas, including increases in vegetation cover, surface relief, and surface rounding. Often there is a distinct change in vegetation at the boundary between the active and terrace floodplains (Figure 5). Within these hydrogeomorphic surfaces, the vegetation was mapped and characterized as either bare/herb or shrub/tree. The vegetation type could not be determined more specifically because of the quality and scale of the images.

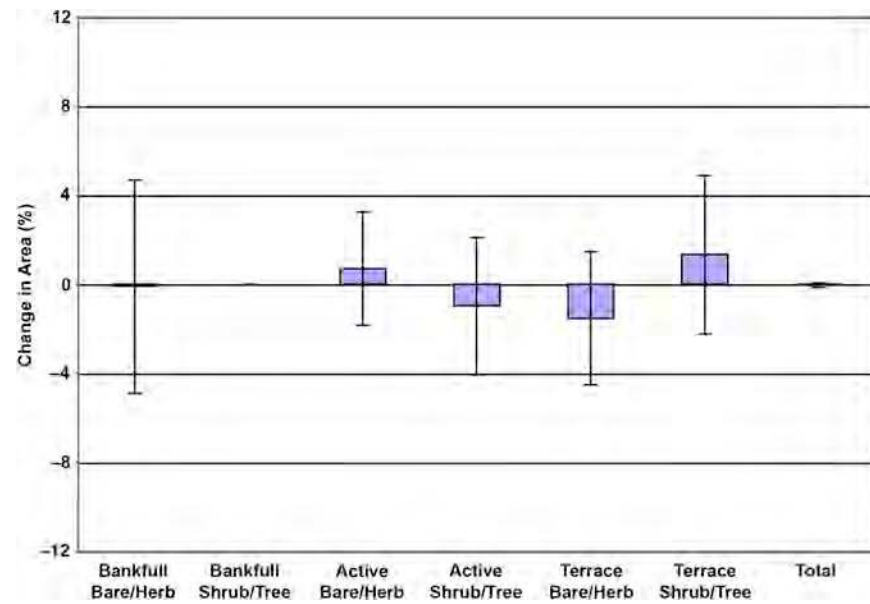
a. All sites.

b. Sites with <5-year discharge events.

Figure 7. Mean changes in vegetation for all sites (\pm one standard deviation).

c. Sites with >5-year discharge events.

Figure 7 (cont.) Mean changes in vegetation for all sites (\pm one standard deviation).

The aerial photos and the hydrogeomorphic and vegetation delineations are shown in Appendix C. Appendix D contains the data extracted from the delineations. Figures 6 and 7 and Table 2 show summaries of the data for all sites, for sites with low-discharge events, and for sites with moderate-discharge events.

The amount of variability, as indicated by the size of the error bars in Figures 6 and 7, is consistent with our understanding of the dynamics of

ephemeral/intermittent channels in the Arid West. Figure 6 shows, for channel morphology, high variability for the area of the bankfull and active zones and low variability for the terrace. Since there was only one discharge event larger than 10 years, this is as expected; the events had little effect on the morphology of the terrace. For vegetation (Figure 7), the variability in the various categories was similar (except for shrub/tree in the bankfull zone, which makes sense because there were very few shrubs or trees in that zone).

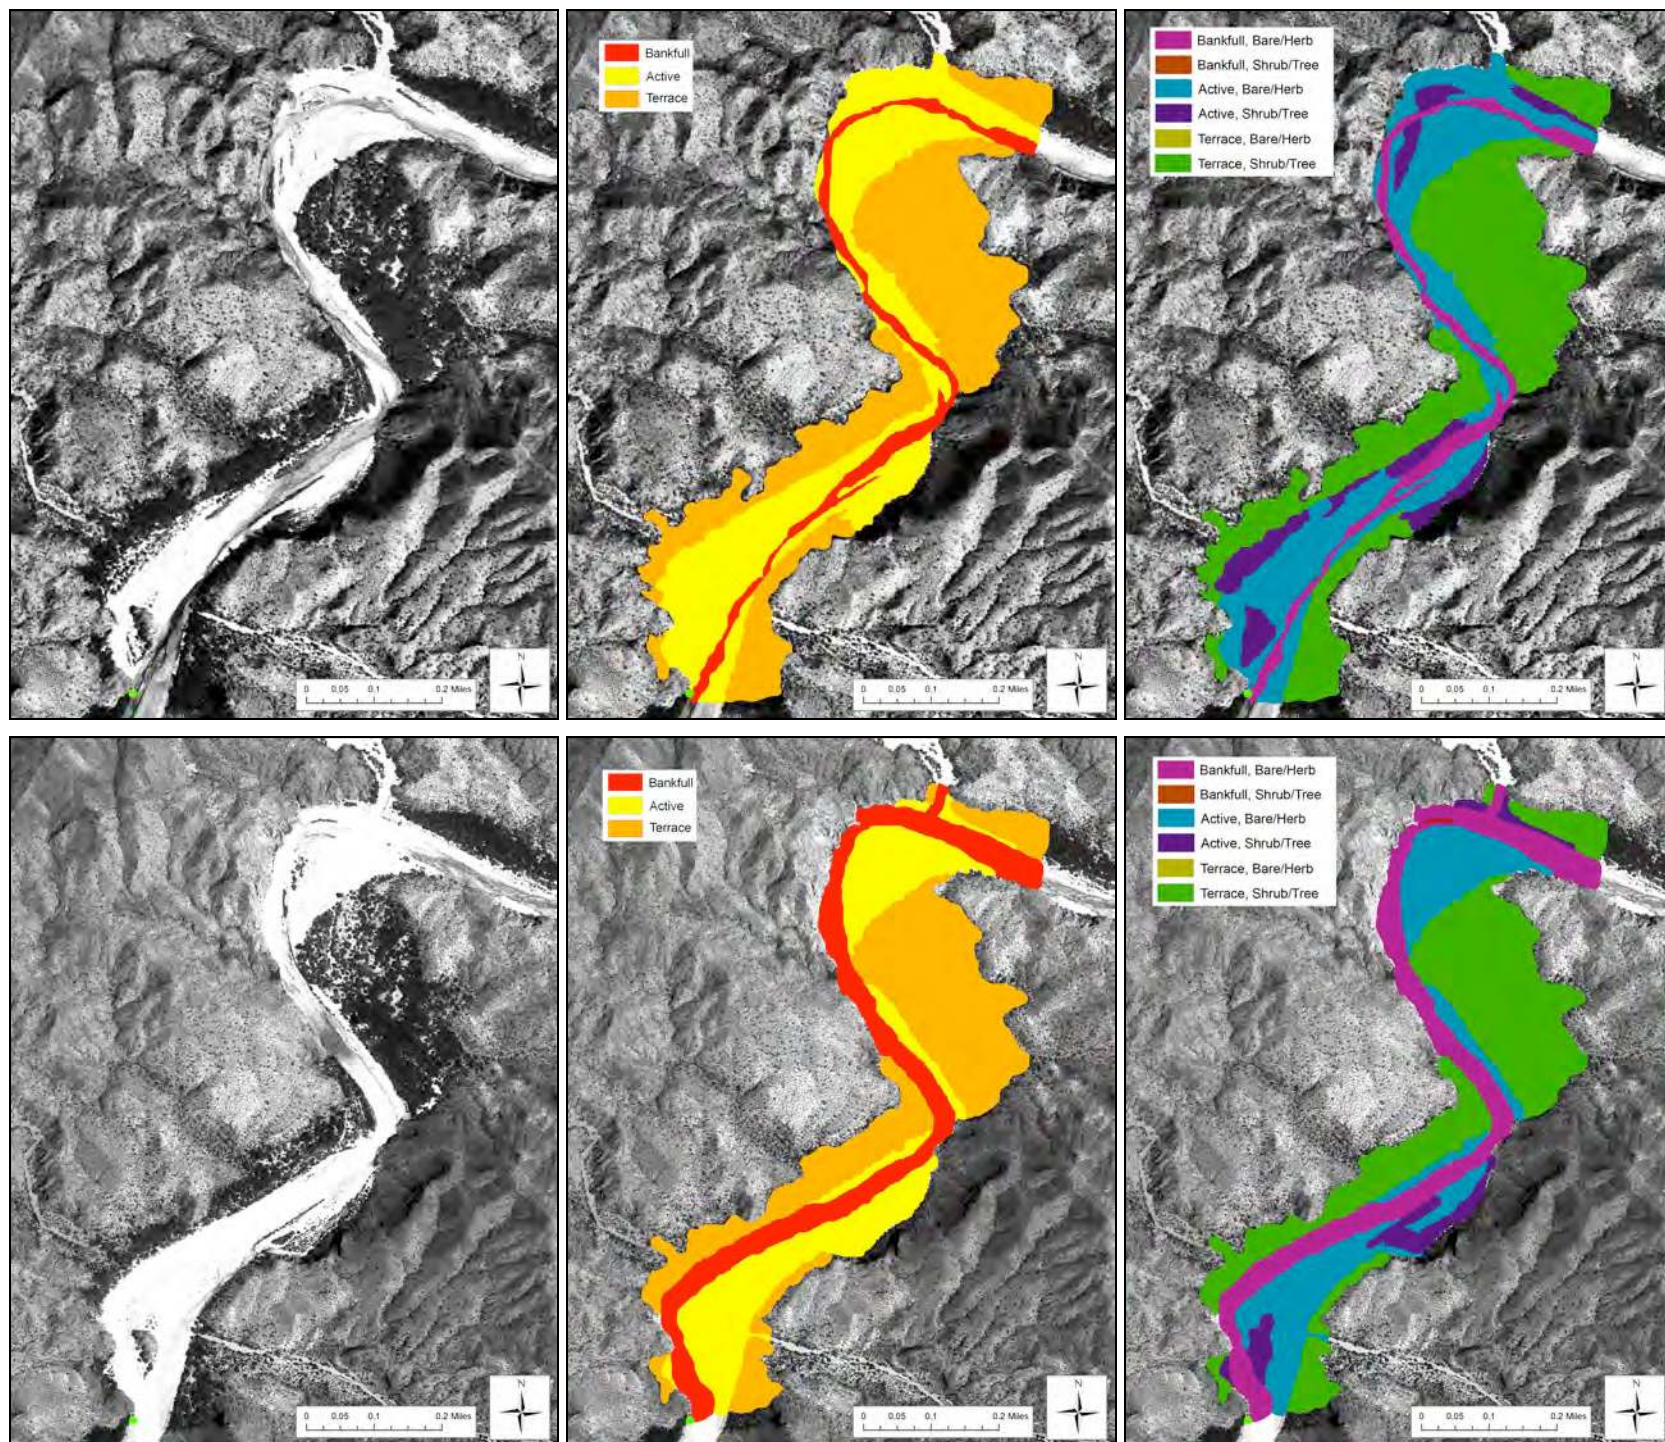
Figure C7. Santa Maria River in 1992 (top three) and 1997 (bottom three) showing the change in channel morphology and vegetation.

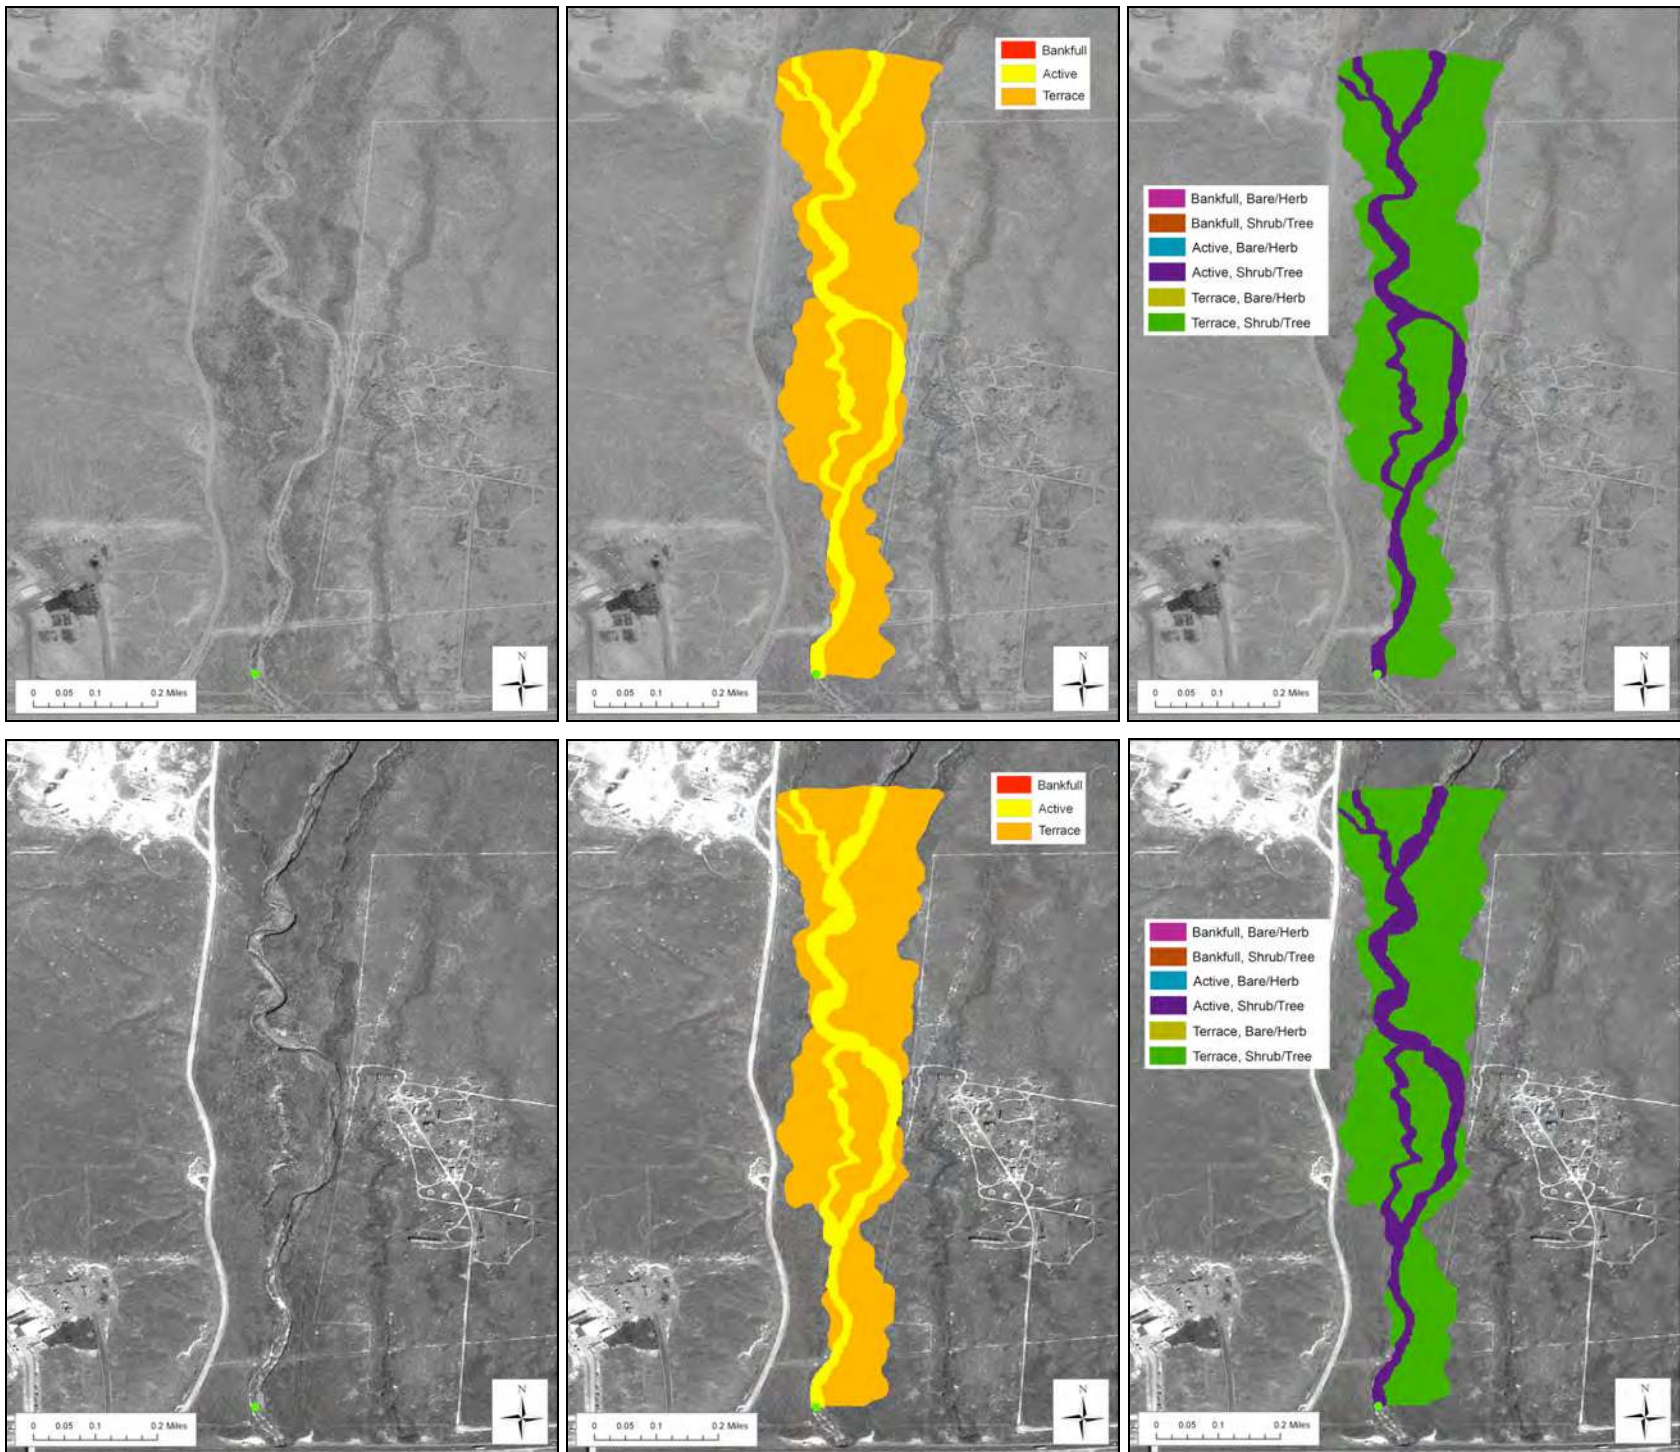
Figure C8. Susie Creek in 1994 (top three) and 1999 (bottom three) showing the change in channel morphology and vegetation.

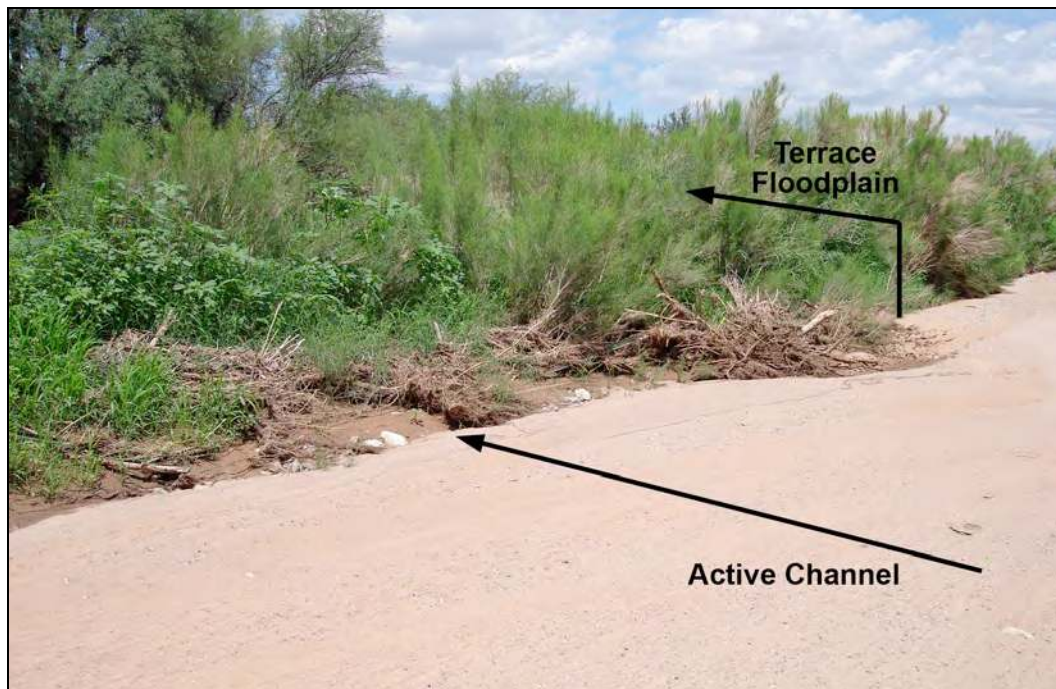
Figure E2. Drift at boundary of active channel, Altar Wash.

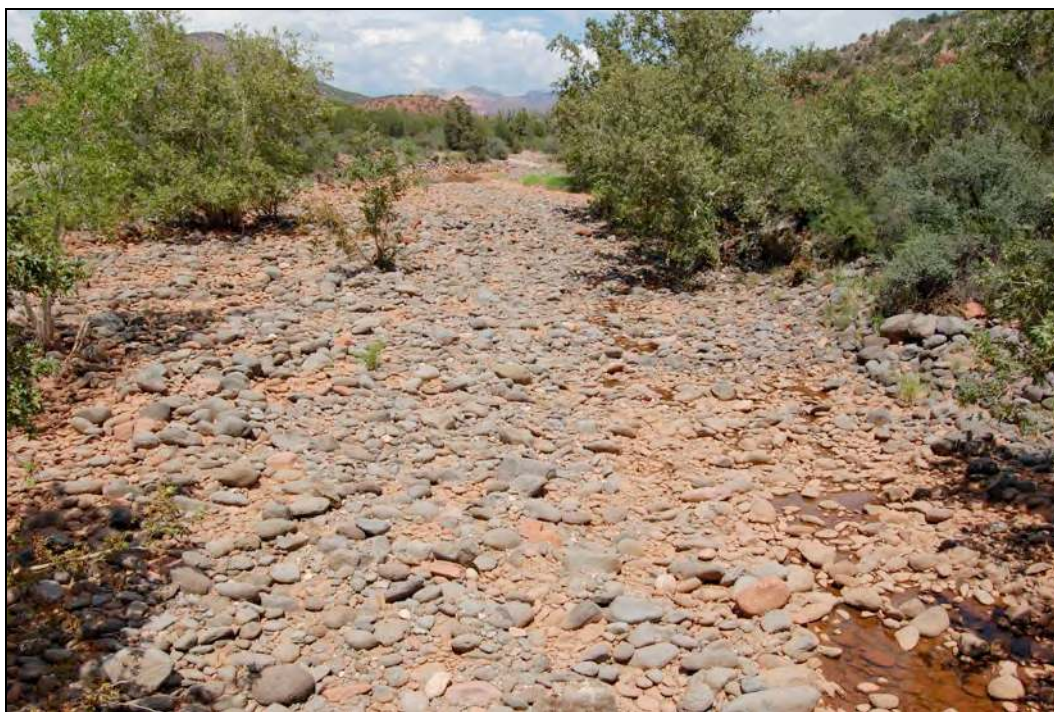
Figure E5. Active floodplain at Dry Beaver Creek.

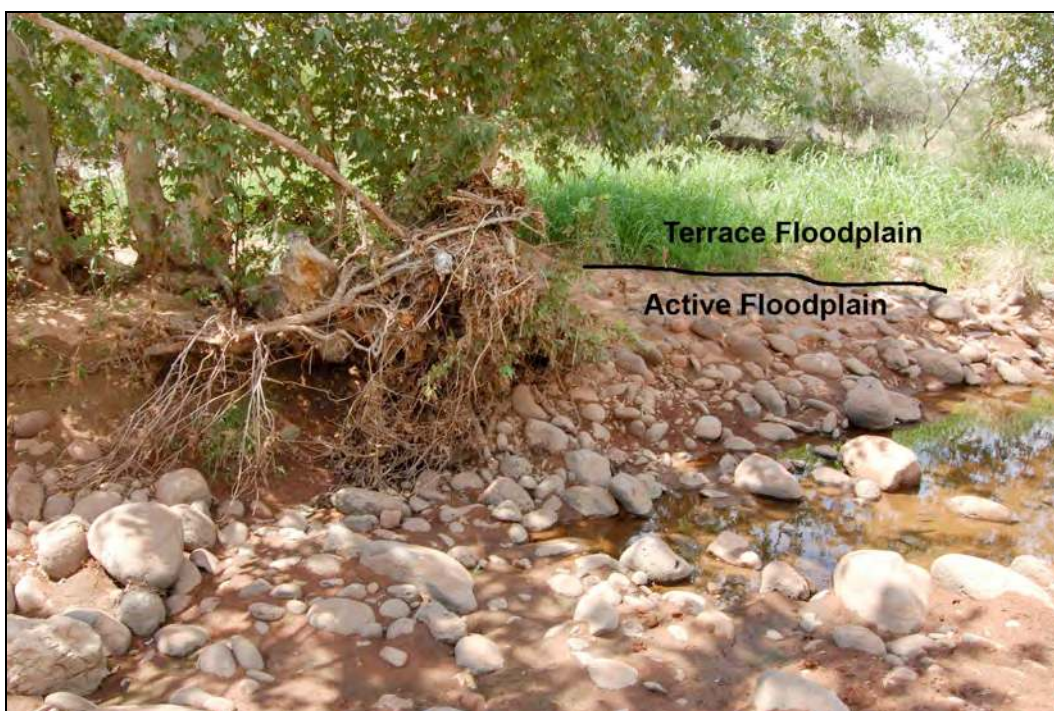
Figure E6. Boundary between the terrace floodplain and the active floodplain at Dry Beaver Creek.

The active/terrace interface margins were much more stable than the bankfull margins. Regardless of the size of the discharge event, the boundaries between the active and terrace zones remained relatively stable. (An exception is the Cristianitos site, where there's no bankfull channel and the active/terrace boundary changed in places, although the relative areas didn't change much.) Appendix E contains ground photos showing active/terrace boundaries at several sites.

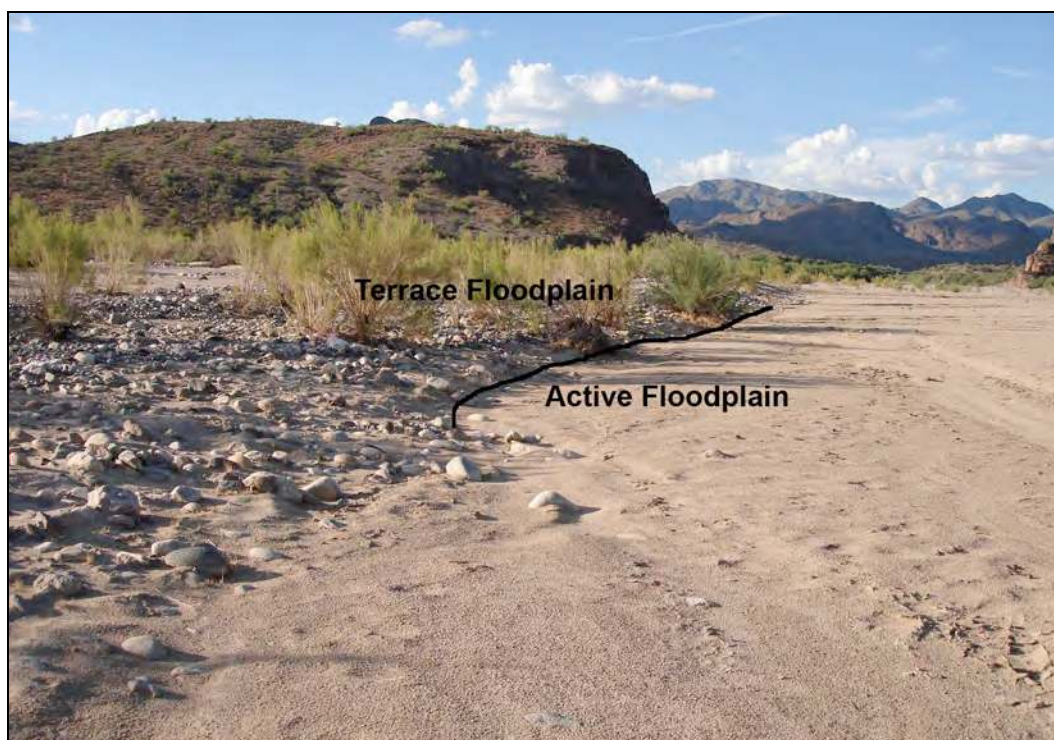
Figure E7. Boundary between the terrace floodplain and the active floodplain at Santa Maria Creek.

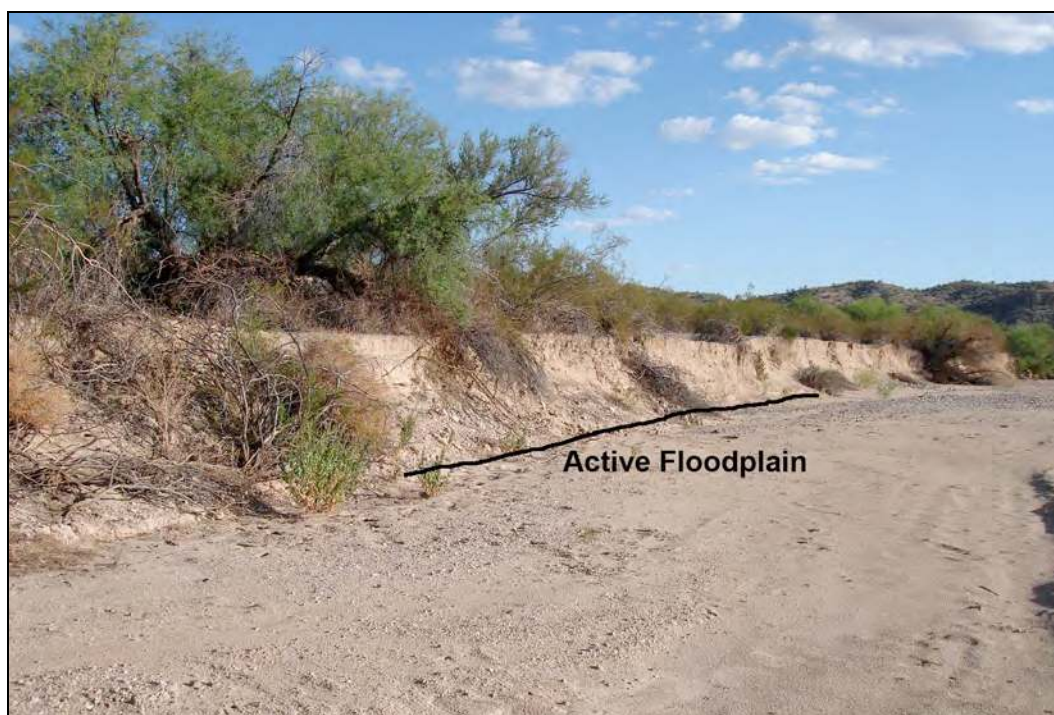
Figure E8. Active floodplain at Santa Maria Creek.

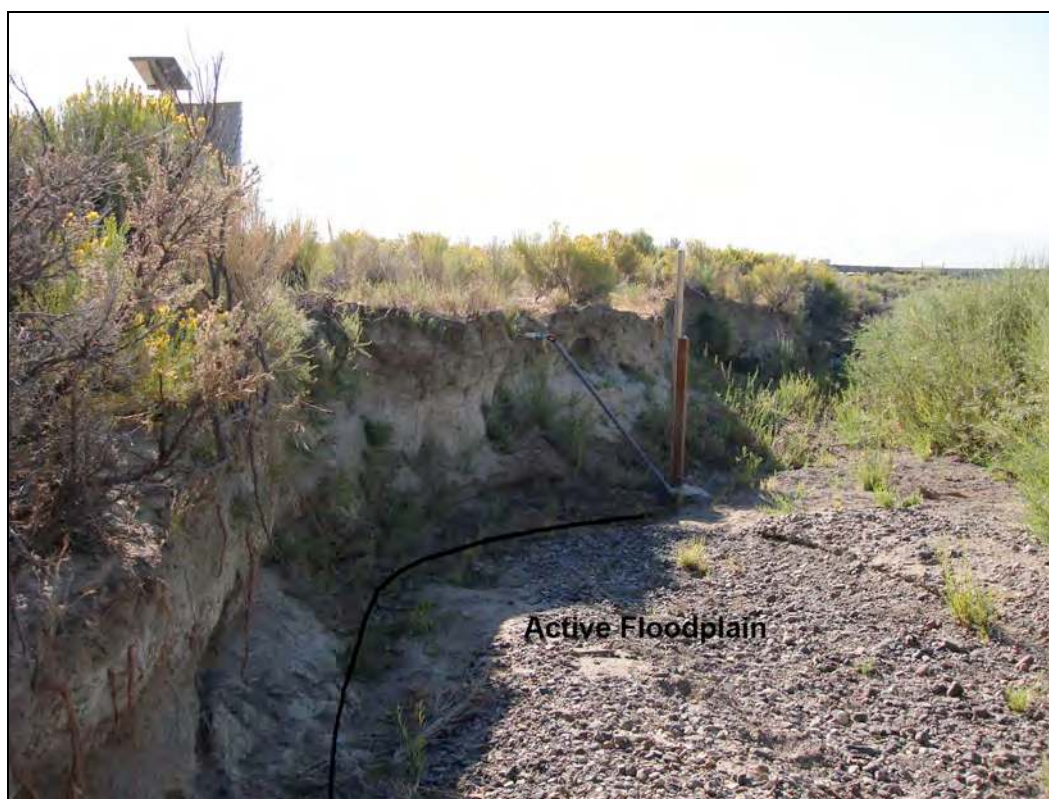
Figure E9. Active floodplain at the Susie Creek gauge.

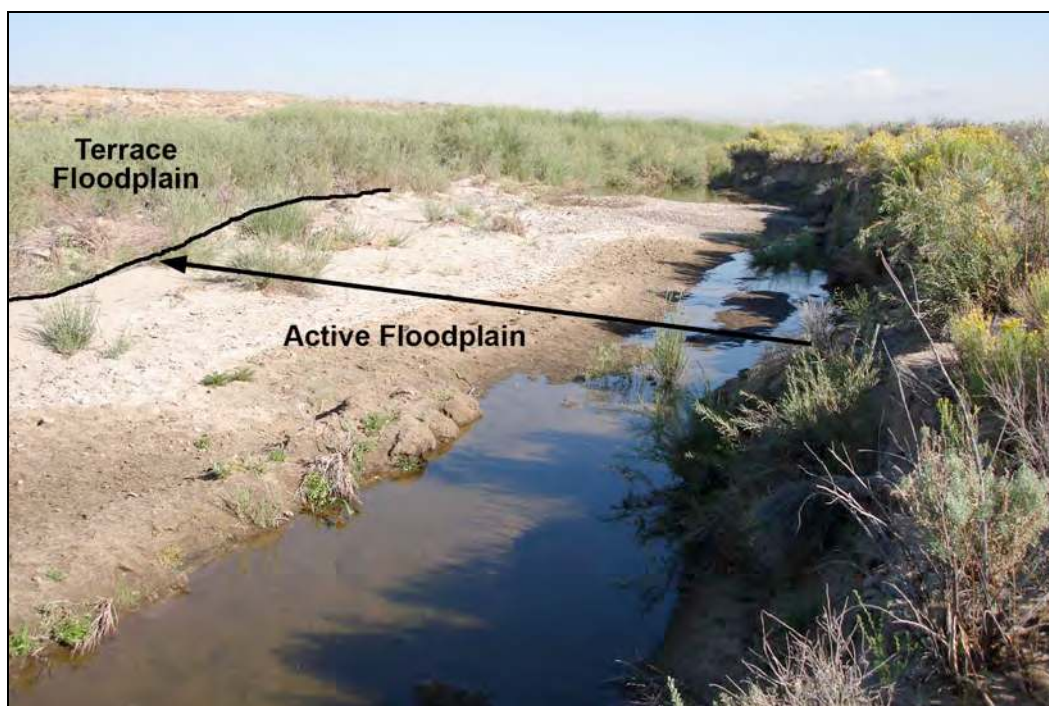
Figure E10. Boundary between the terrace floodplain and the active floodplain at Susie Creek.
