# Vegetation Monitoring Using UAV : a Preliminary Study

## Abstract

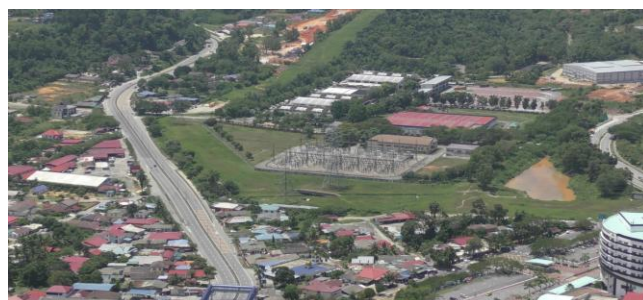
Fig. 6: Sample image capture by drone

Figure 6 is an image of a city with some main road and village houses around the city. While on the top right is where the industry area located that are surrounded with vegetation. The VARI result showed in Figure 7 proved that most of the vegetation been highlighted in the image. The dataset of the result with the minimum value of -1.25 and the maximum value of 0.9145.

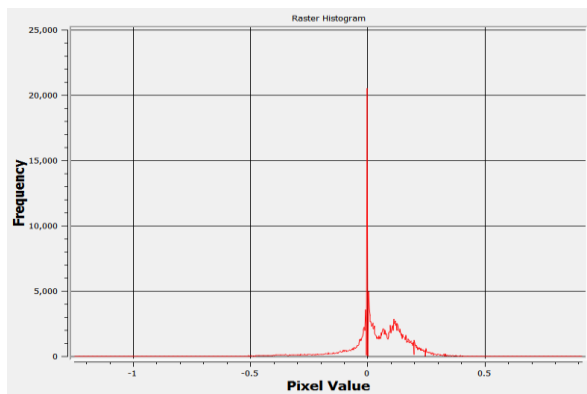
Fig. 8: Raster histogram of VARI data of image Fig. 6

The histogram above (Fig. 8) was generated by qGIS on the VARI dataset. It proves that most of the pixel value from the image figure 6 is around zero and above zero. This is due to the vegetation found from the image is slightly more than the non-vegetation.

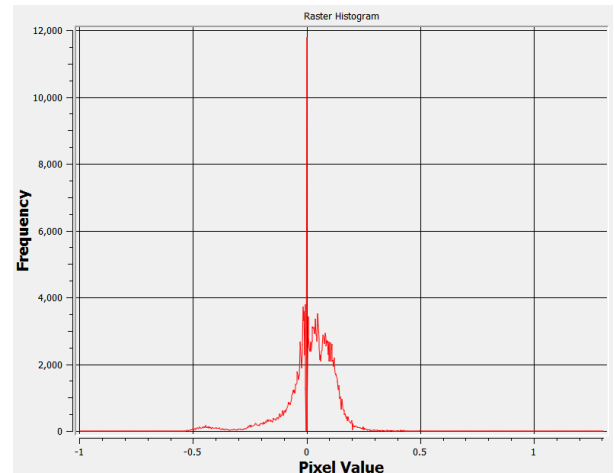
Fig. 11: Raster histogram of VARI data of image Fig. 9

Lastly is the raster histogram of the VARI image for figure 9 sample image. Similarly with image in Figure 6, it consists pixel value that is around zero

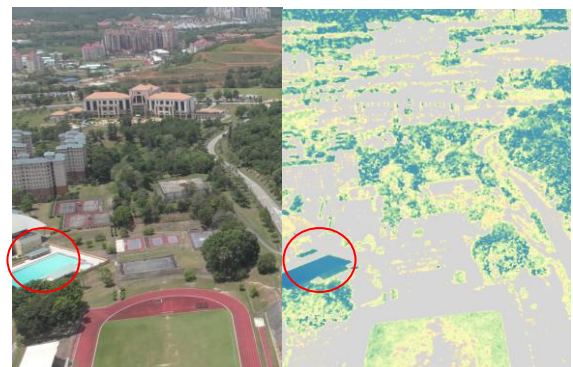
Fig. 12: Inaccurate detection sample image

Fig. 13: Inaccurate detection sample image

The figure above shows the areas of the inaccurate detection of vegetation, this is due to the color of the object that are closed within the vegetation range.

However, there is also some lack of accuracy with some image captured from the urban or city area because some object such as green colour object, swimming pool area detected as positive VARI value. Figure below show the example of the non-accuracy area.
