Ratnesh KUMAR
Somnath CHATTOPADHYAYA
Sergej HLOCH
Grzegorz KROLCZYK
Stanislaw LEGUTKO

WEAR CHARACTERISTICS AND DEFECTS ANALYSIS OF FRICTION STIR WELDED JOINT OF ALUMINIUM ALLOY 6061-T6

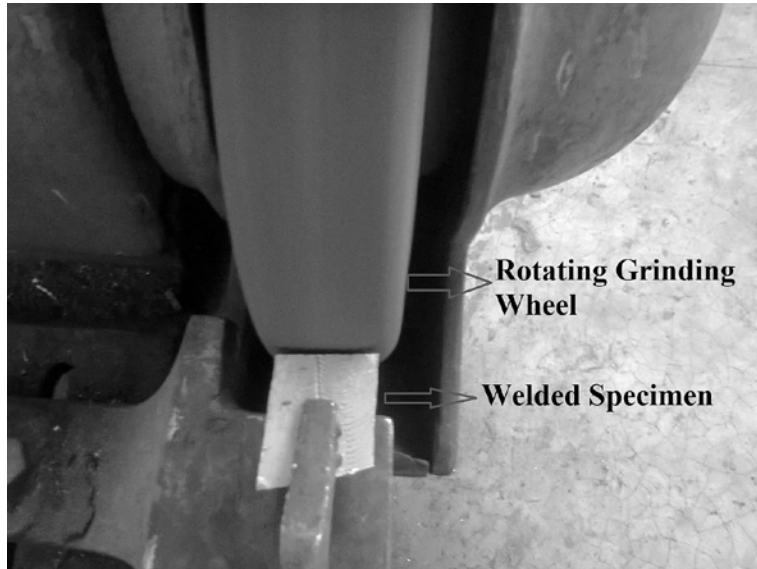
Fig. 2. Experimental setup

The friction stir welding set-up is developed on HMT 1U-make milling machine. SS 410 stainless steel was selected as FSW tool material and 6 mm thick AA 6061 T6 is chosen as working material. The welding samples are prepared at four process parameters as given in Table 2. Friction stir welded sample and base metal sample of dimension 30 mm X 25 mm are put in wear condition with the help of grinding machine for 120 s as shown in Figure 2. Specification of grinding wheel is shown in below Table 1.

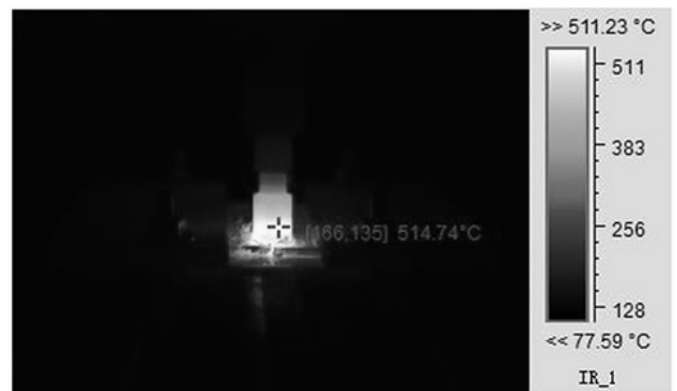
Maximum temperature during the process can be measured with the help of thermal images taken from infrared camera. Figure 3 shows the maximum temperature generated during the experiment for sample no 2. Table 3 gives the maximum temperature generated at all the four process parameters.

Fig. 3. Infrared image of FSW

From Table 3 it can be concluded that maximum temperature achieved during the process is maximum for sample 3. Hence it can be derived that temperature obtained during the process increases as rotational speed increases.

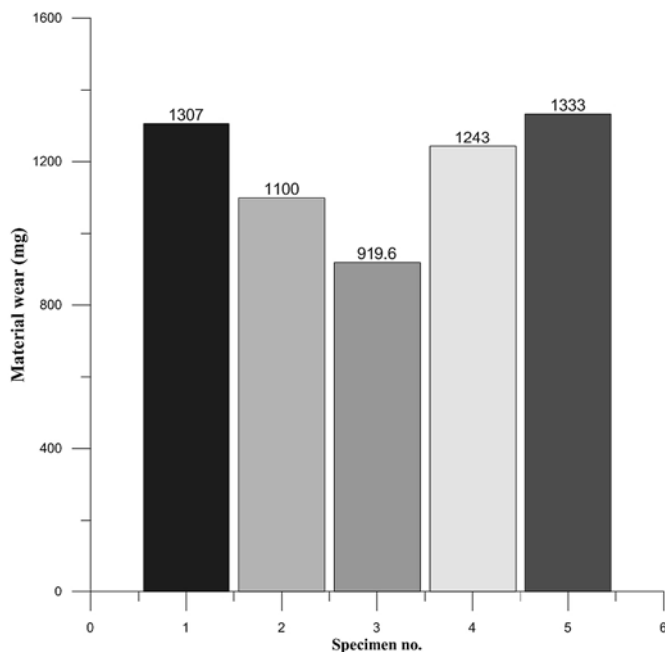
Material removal is obtained by measuring the weight of all five specimens before and after wear. Material wear from all five samples are plotted in Figure 4.

Fig. 4. Comparison of material removal of different welded sample with base metal

From the Figure 4 maximum material removals can be observed for sample no 5 i.e. base metals as compared to welded samples. Hence it can be concluded that wear resistant of welded material is more than that of base material. The reason for such variation is that friction stir welding occurs at a temperature below the melting point of material, so there is no chance of second phase formation. Hence material gets heat treated, so wear resistance property increases. From the above graph it can be observed that material removal is lowest in case of sample no 3 i.e. at 1000 rpm and 25 mm/min. It implies that best welding has occurred in this case. Since for higher rotational speed and lower welding speed, heat generated is maximum; as clear from Table 2, so material easily stirs and mixed. It is clear that material removal in case of sample no 4 is more than that of sample no 2. Hence it can be concluded that for same rotational speed as welding speed increases quality of weld decreases, since temperature developed reduces as given in Table 3.

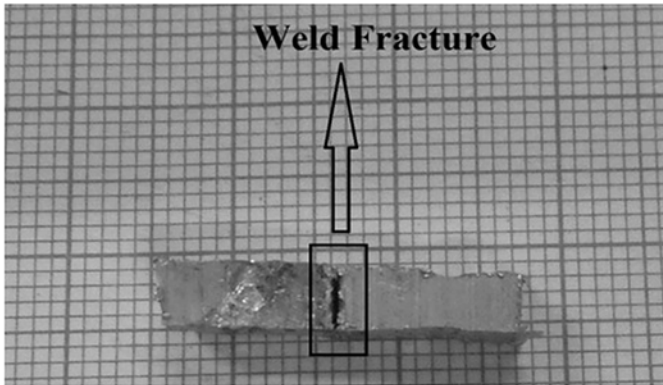
It is observed that when welded samples are put in the wear condition defects are noticed. A fracture is observed on the back side of plate along the welding direction for sample 1. It shows that at low

Fig. 7. Weld fracture

welding speed due to inadequate amount of heat generated, welded part may fail when put in severe working condition. Figure 7 shows the fracture in sample 1.

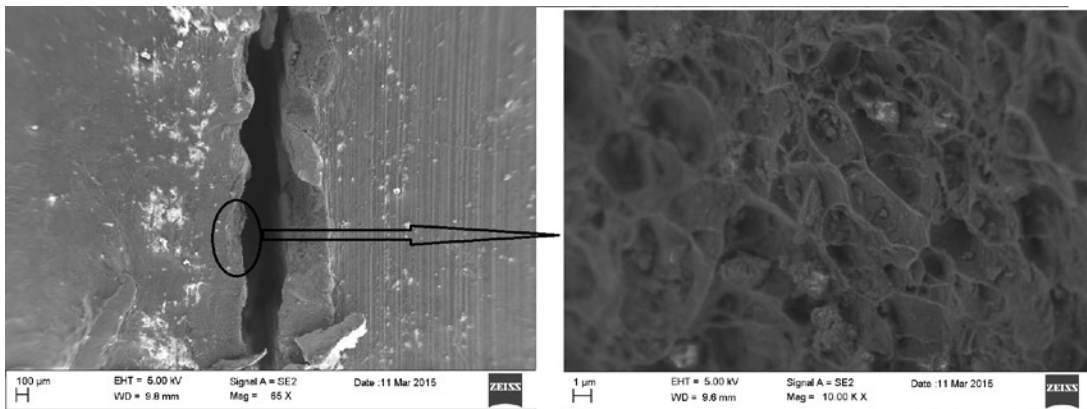
Fig. 8. FESEM image of fracture surface

Figure 8 shows the FESEM image of fracture surface shown in Figure 7. This clearly shows the failure of the welded part.

Circular part is further magnified and seen on the FESEM. It is clear that the fracture surface is charac-

terized with a lot of dimples, which clearly shows the ductile failure mechanism and ductile fracture morphology reveals that the metallic bonding is performed in this region [33].

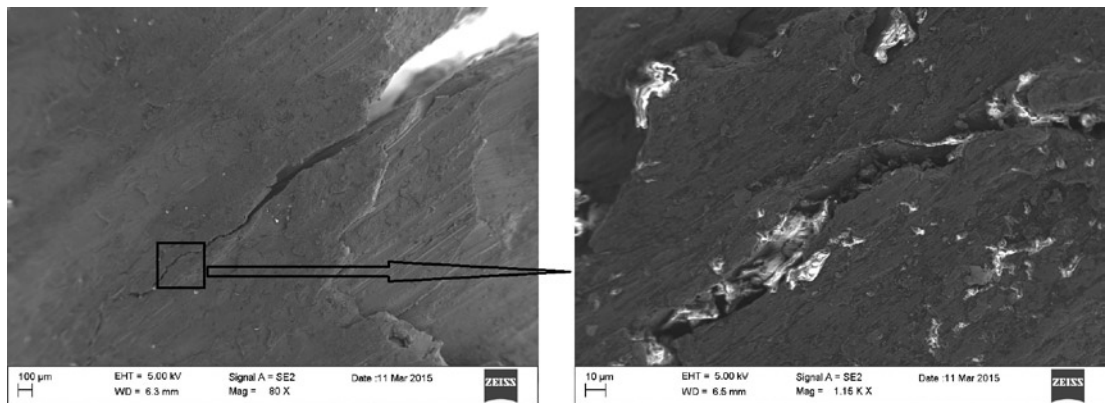
Fig. 10. FESEM image of weld crack

From Figure 10 it is clear that crack propagates along the thickness after wear. It is one of the major causes for the failure of any welded joint [1]. Rectangular part is further magnified and it is seen in the FESEM in the right figure. It can be observed that surface has broken into small particles and hence propagating the crack.

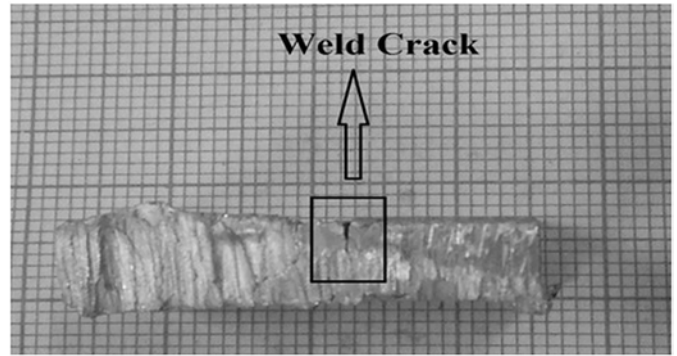
Fig. 9. Weld crack

Welded sample 4 put in wear condition, abrasive wear phenomena was observed. After the process when its cross-section was observed there is a propagation of crack along the thickness as shown in Figure 9. FESEM image of the crack is taken and it is shown in Figure 10.

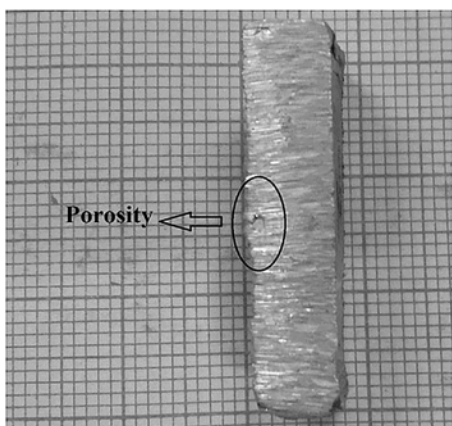
In sample 2, porosity is observed near the surface as shown in Figure 11.

Fig. 11. Porosity

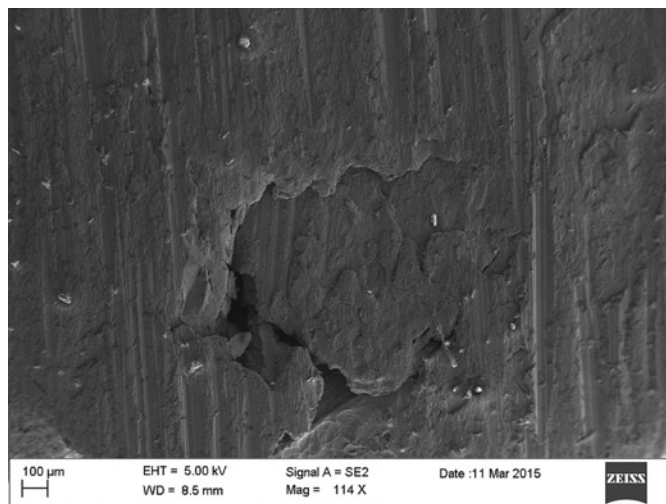
Porosity is being observed under FESEM as shown in Figure 12.

Figure 12 shows the porosity on the wear surface. It can be observed from the Figure that due to grinding wear surfaces are overlapped to one another. Here also it can be observed that surfaces are broken into segments to form the pores.

Fig. 12. FESEM image of porosity

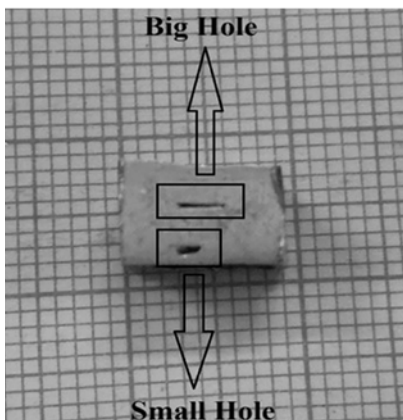
Fig. 13. Holes on weld surface

When welded sample 2 is cut to see their cross section there is no defect like hole is observed. But when the surface is further polished to prepare samples for microstructure evaluation, two holes are observed i.e. one is small hole and another is big hole as shown in Figure 13. These are also known as tunnel defect in friction stir welding process [21].

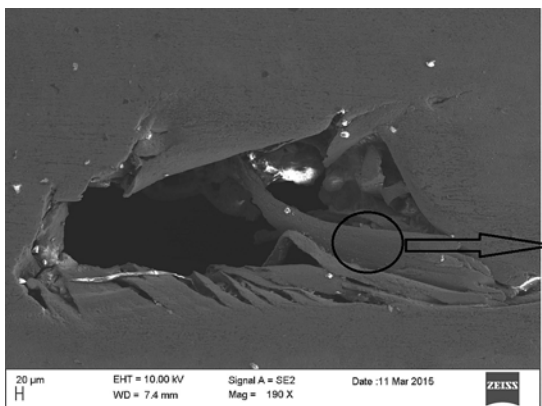
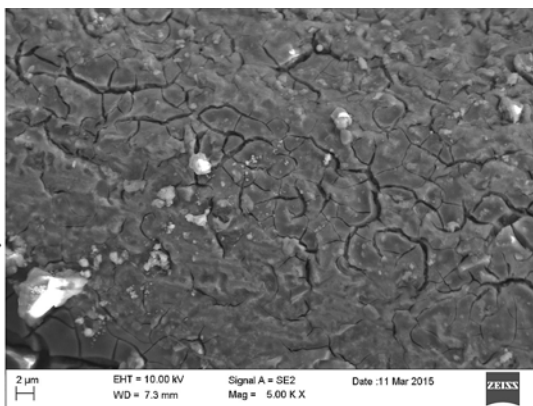
FESEM image of small hole is shown in Figure 14.

Left image of Figure 14 shows the FESEM image of small hole. It can be observed from the image that it is a through hole. Hence the reason for such hole is that no proper heating of welding material, so that tool is not able to stir the work piece properly. Right image of Figure 14 shows the magnified view of the circular part as shown in left image. Here irregular cracks are observed on the surface.

Fig. 14. FESEM image of small hole

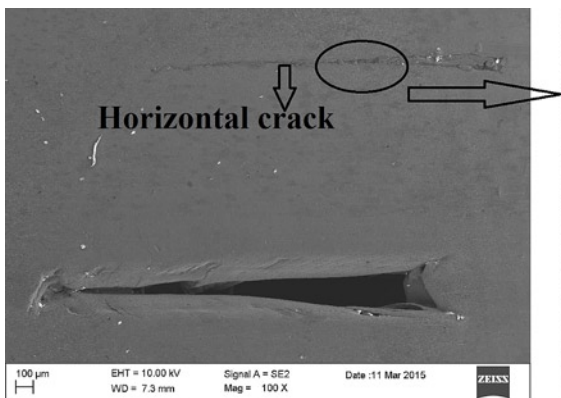
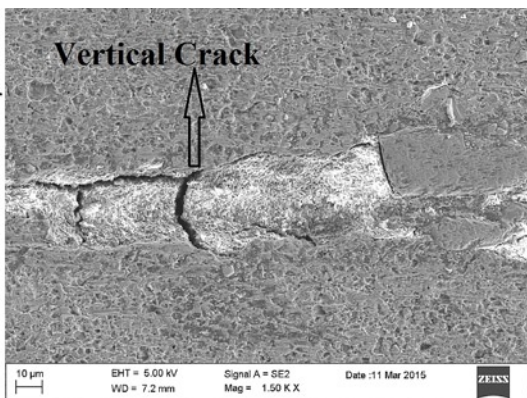
Fig. 15. FESEM image of big hole & crack

While observing bigger hole through FESEM a crack is spontaneously observed as shown in Figure 15.

On the left image of Figure 15 big hole along with the horizontal crack can be observed. Big hole is also a through hole like small hole. Right image of Figure 15 is the magnified view of the circular part at crack shown in the left image. Further vertical cracks are observed in the horizontal crack. These type of cracks are the main reason for the hole generation and failure of welded parts under wear condition.
