Wear Problems of High-Speed Wheel/Rail Systems: Observations, Causes, and Countermeasures in China

Wear problems of wheel/rail systems occurring on the Chinese high-speed railway network in the last decade are summarized and explained together with the corresponding experience of treating them. Focus is placed on uneven wear because even wear is not an urgent issue due to its very low wear rate for the Chinese high-speed railway systems. Two typical problems of longitudinal uneven wear, namely, wheel polygonization and rail corrugation, are introduced in terms of their characteristics, consequences, causes and initiation mechanisms. Next, wheel hollow wear and flange/gauge side wear, as typical problems of lateral uneven wear, are similarly discussed. Validated countermeasures against all these problems are presented at the end of this paper together with further proposals under testing or consideration. This work is principally based on first-hand data collected from field observations, monitoring tests and dynamic measurements, but typical numerical approaches and results are also presented to help explain the observed phenomena. [DOI: 10.1115/1.4048897]

Keywords: High-speed ra

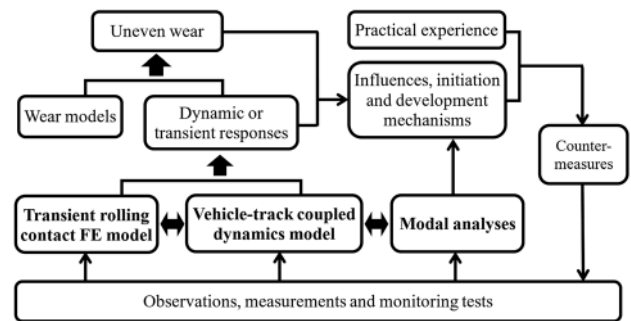
Fig. 5 Three main types of numerical models employed in studies of uneven wear

To identify the eigenmodes resulting in or excited by the uneven wear, modal analyses have also been conducted using methods like FE, and the obtained eigenfrequencies have been compared with those measured in hammer and dynamic tests [22–25]. Such analyses could provide important information for better understanding of the problems of uneven wear and their consequences. For clarity, the three main types of numerical models mentioned above and their functions are summarized and illustrated in Fig. 5.

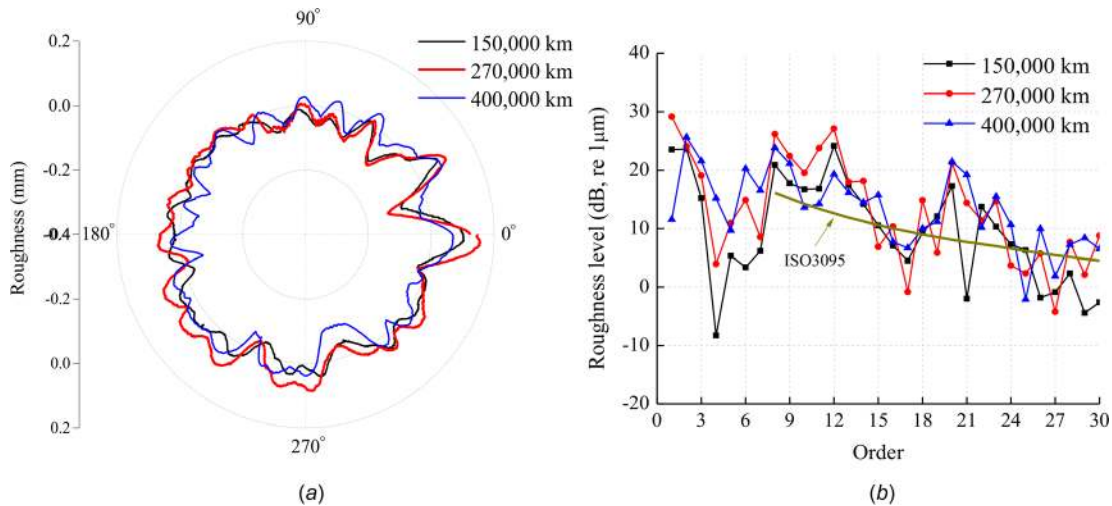
Fig. 9 Development of polygonization on a wheel ($\Phi 920$ mm) of a 350 km/h EMU running on Beijing-Shanghai high-speed line [42]. Measurements were carried out in July 2011, March 2012, and September 2012, respectively. The maximum speed was 350 km/h before July 2011 and 300 km/h thereafter. The wheel was reprofiled at the running distance of 300,000 km. (a) In a polar coordinate system, and (b) roughness spectra.

4.1.2.2 Polygonization observed earlier and their origins. As early as 2011, wheel polygonization was found on the wheels of some 350 km/h EMUs in China. Figure 9 shows the development of the out-of-roundness on a wheel during monitoring tests in 2011 and 2012. The figures show that first-, sixth-, eighth-, 12th-, and 20th-order polygonizations co-existed with none of them dominating the out-of-roundness, in contrast to the data in Fig. 7. Further, the polygonization gradually grew in amplitude with the running distance, as seen from the measurements at 150,000 and 270,000 km, while the patterns remained quite similar. At 300,000 km the wheels of the EMU were reprofiled for the first time, after which very similar out-of-roundness re-occurred at the running distance of 400,000 km or 100,000 km after the reprofiling (see Fig. 9).

It should be noted that Fig. 9 shows a worst case scenario observed during the monitoring test, and that most of the monitored wheels (of four 350 km/h EMUs) were much better in terms of roundness. No significant consequences had been reported at that time [43]. Careful examinations showed that the polygonization components on most wheels were of relatively low orders, and two main origins were isolated. First, the 1st- and 3rd-order polygonization, which was found on many new wheels, was understood to originate from the production process of wheels. The 3rd-order was attributed to the fixation of wheels during machining, as mentioned in Sec. 4.1.1. Second, polygonization of the 4th- to 6th-order and 10th- to 13rd-order was caused by the noncircular drive disks on turning lathes, as confirmed by measurements of newly reprofiled wheels and those after small running distances. Figure 10(a) shows the measurement of a newly reprofiled wheel of a 350 km/h EMU, in which polygonization of 4th- to 6th-order, 10th- to 13th-order and 18th-order was recognizable (note that their amplitudes were far below the ISO3095 line). The concrete order of such polygonization is determined by the diameter ratio and the slip between the railway wheel and the drive disks, i.e., an eccentric drive disk (1st-order polygonization) may lead to 4th- to 6th-order polygonization on the newly reprofiled wheels, as indicated in Fig. 10(b), and higher orders are expected if the two drive disks are both eccentric and contacting the wheel with different phase angles.

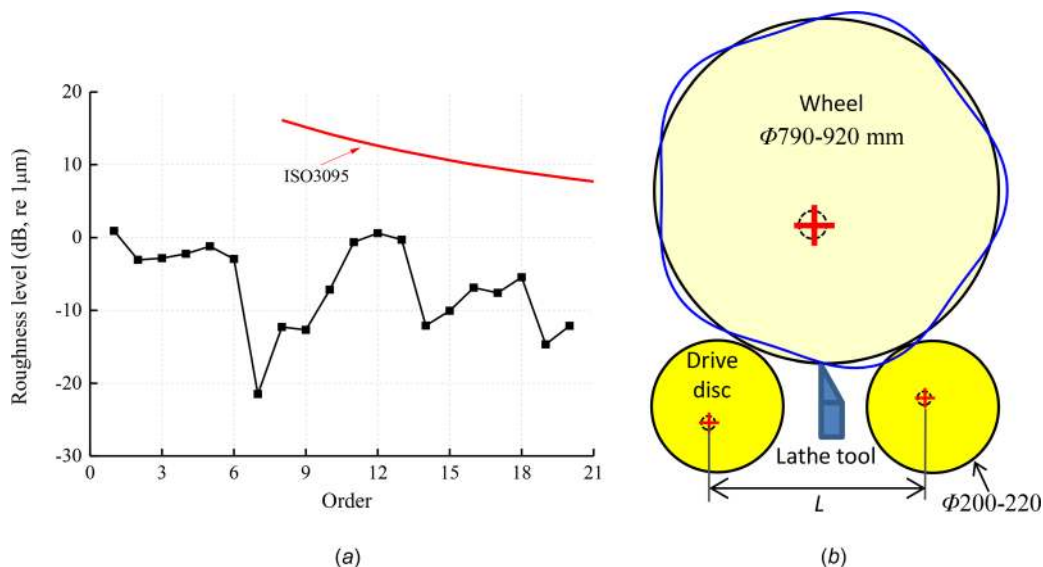
Fig. 10 Polygonization resulting from the reprofiling process on a typical turning lathe used in China [43,44]. (a) The roughness spectrum of a newly reprofiled wheel of a 350 km/h EMU in 2011. (b) A schematic diagram of the lathe, in which the out-of-roundness of the drive disks (with eccentricity) is indicated by exaggerated positions of their centers.

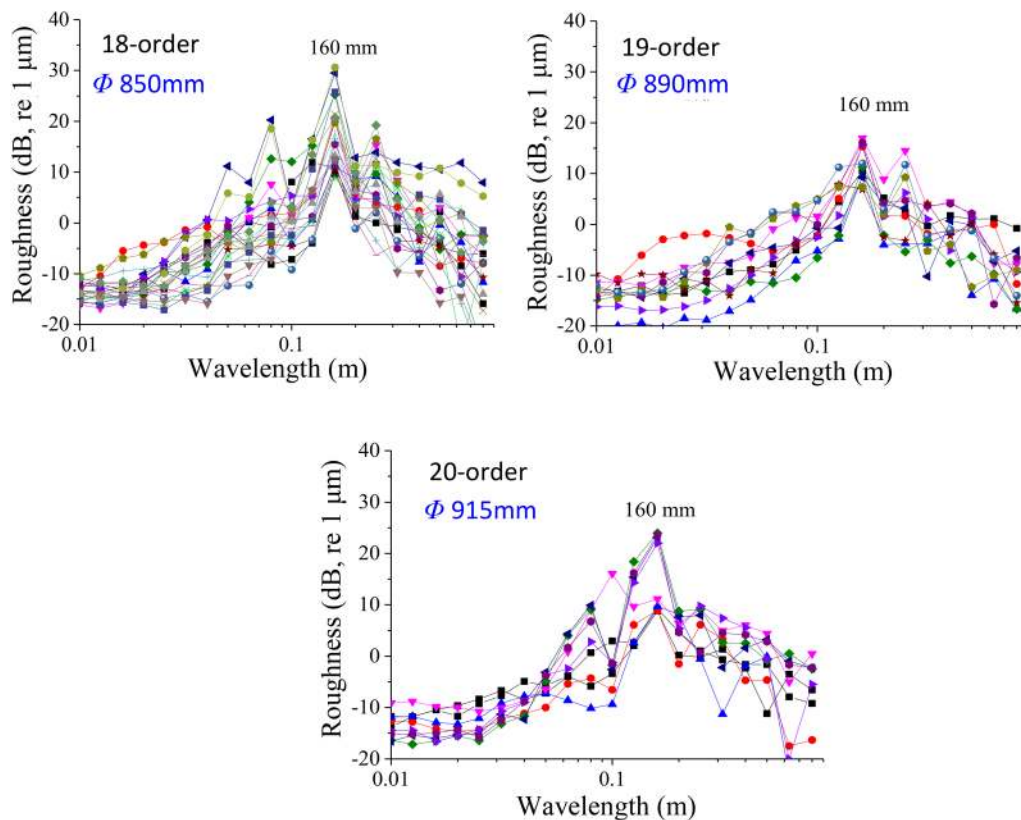
Fig. 11 Reduction of the polygonization order as the wheel diameter decreases, observed on a 350 km/h EMU running at speeds up to 300 km/h in 2015 and 2016. Each curve represents one wheel, and the wavelength is about 160 mm.

4.1.2.3 Typical high-order polygonization. A large number of measurements have shown that high-order polygonizations are typically of 18th- to 23rd-order. The reasons for such range of orders are threefold: (1) the diameters of wheels continuously decrease due to wheel/rail wear and reprofiling, leading to a lower polygonization order for a fixed wavelength, see Fig. 11 for examples; (2) the eigenfrequency corresponding to polygonization changes with the EMU type, resulting in different wavelengths and further different orders under the same speed and wheel diameter (for example, the wavelength is about 160 mm for the EMU in Fig. 11, but 145 mm for that in Fig. 12); (3) the fixed

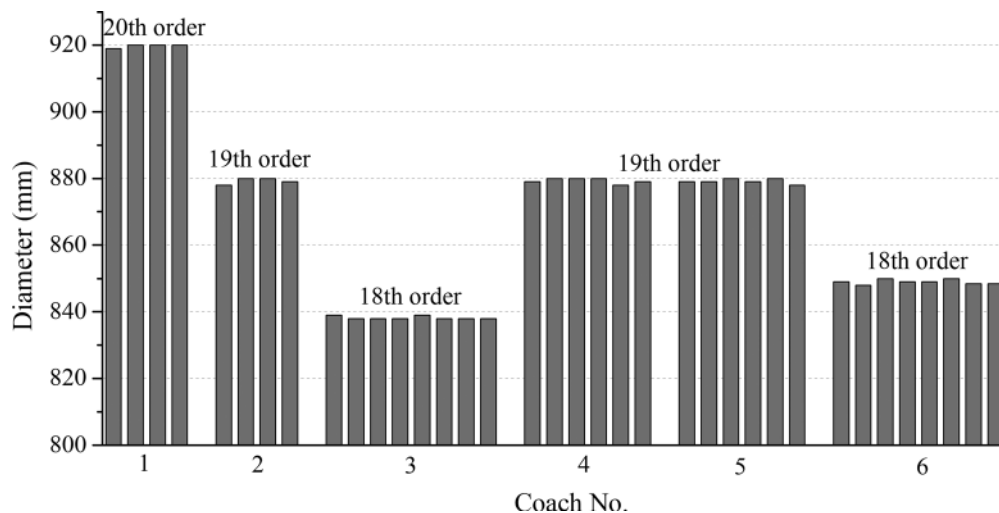
Fig. 12 Polygonization orders observed during a specially designed test carried out on a commercial line in 2017 using a 350 km/h EMU equipped with wheels of different diameters and running at 300 km/h. Every column corresponds to one wheel infected by the high-order polygonization with the wavelength of about 145 mm. This test was specially arranged by China Railway.

eigenfrequency results in varying wavelength and polygonization order as the speed changes. Figure 12 shows the polygonization orders observed during a specially designed on-line test carried out on a commercial line in 2017, for which a 350 km/h EMU equipped with wheels of different diameters was used to run at an almost constant speed of 300 km/h. Such results confirmed that the wavelength of the occurring polygonization was indeed approximately fixed and the resulting order increased with the diameter. As a supplement, Fig. 13 shows additional examples of measured high-order polygonization in a polar coordinate system.

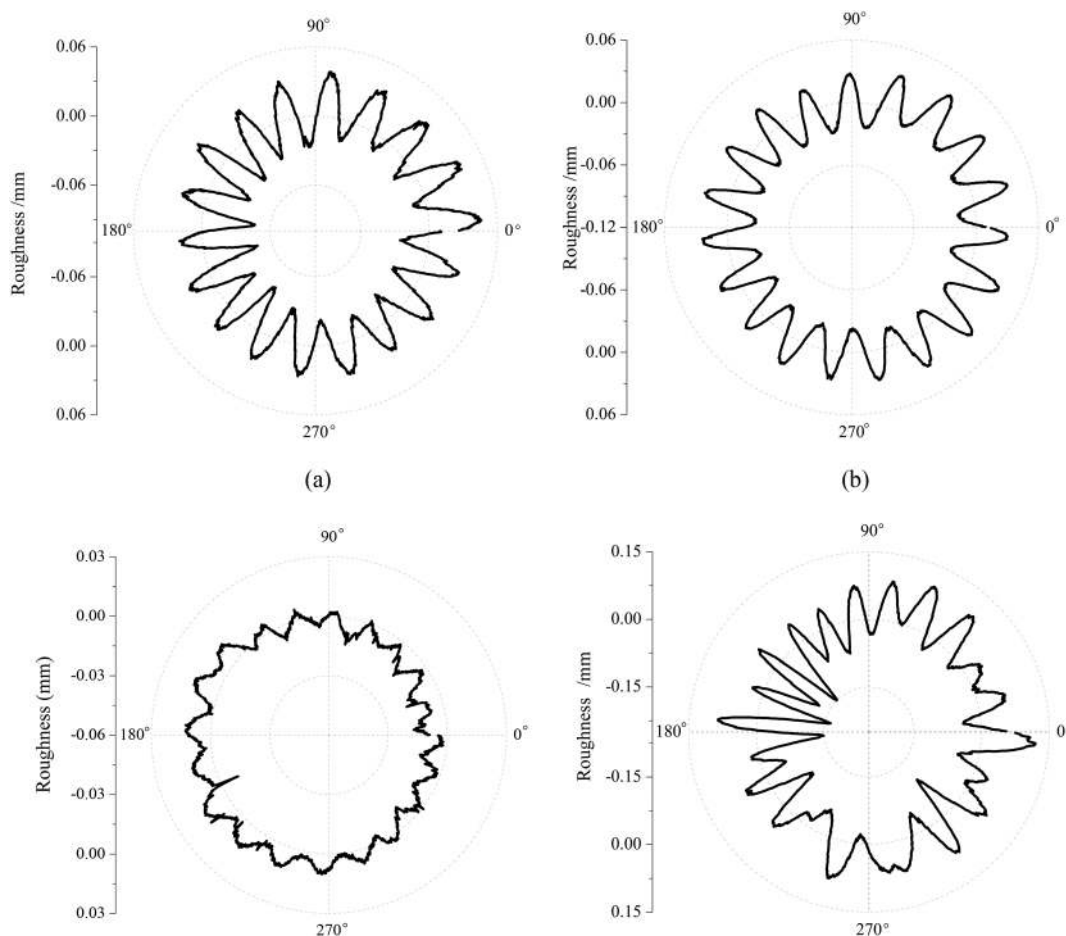
Fig. 13 Additional examples of high-order polygonization occurring on wheels of Chinese high-speed EMUs in 2014–2016. (a) 18th-order, running at 300 km/h, (b) 19th-order, running at 300 km/h, (c) 20th-order, running at 300 km/h, and (d) 22th-order, running at 250 km/h.

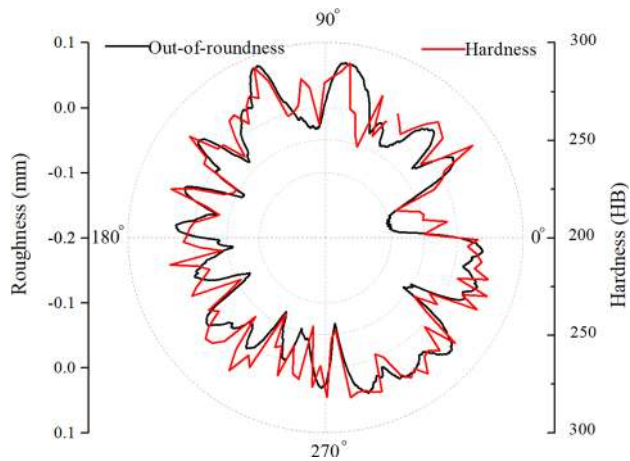
Fig. 14 Out-of-roundness and surface hardness around a wheel of the 350 km/h EMU in Fig. 9. Measured in March 2012 [43].

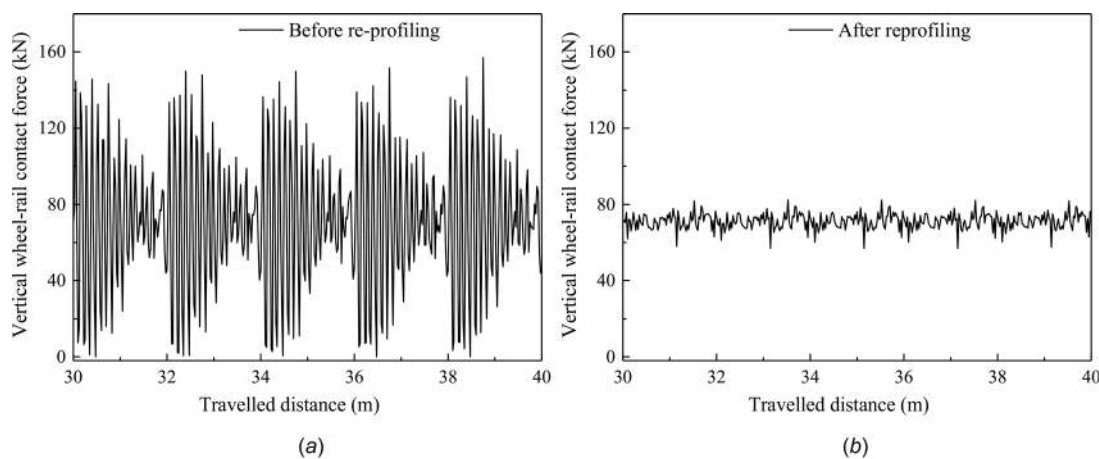
Fig. 15 The vertical wheel-rail contact forces caused by the polygonal wheel in Fig. 7(b) at 250 km/h. (a) Before and (b) after reprofiling [13].

the EMU in Figs. 7 and 8, the vertical dynamic wheel–rail contact forces were calculated in the presence of measured polygonization in Ref. [13]. From the calculated results shown in Fig. 15 it is seen that the peak forces caused by the wheel out-of-roundness shown in Fig. 7(b) are up to 157.0 kN, and decrease after reprofiling (polygonization removed) to 82.5 kN (the static wheel load 70.6 kN). Contact loss (i.e., the contact force vanishes or wheel and rail separate from each other) is expected at some instants when the polygonization is present. Based on a series of coupled dynamics analyses, Chen et al. [45] concluded that the influence of high-order polygonization was insignificant on safety and stability of running vehicles. Chen et al. [14] found that high-order polygonization did not affect the dynamic performance of the subgrade as severely as low-order ones. More studies on the wheel–rail interactions at high-order polygonization can be found in Refs. [25] and [46–49], where similar coupled dynamics models were employed.

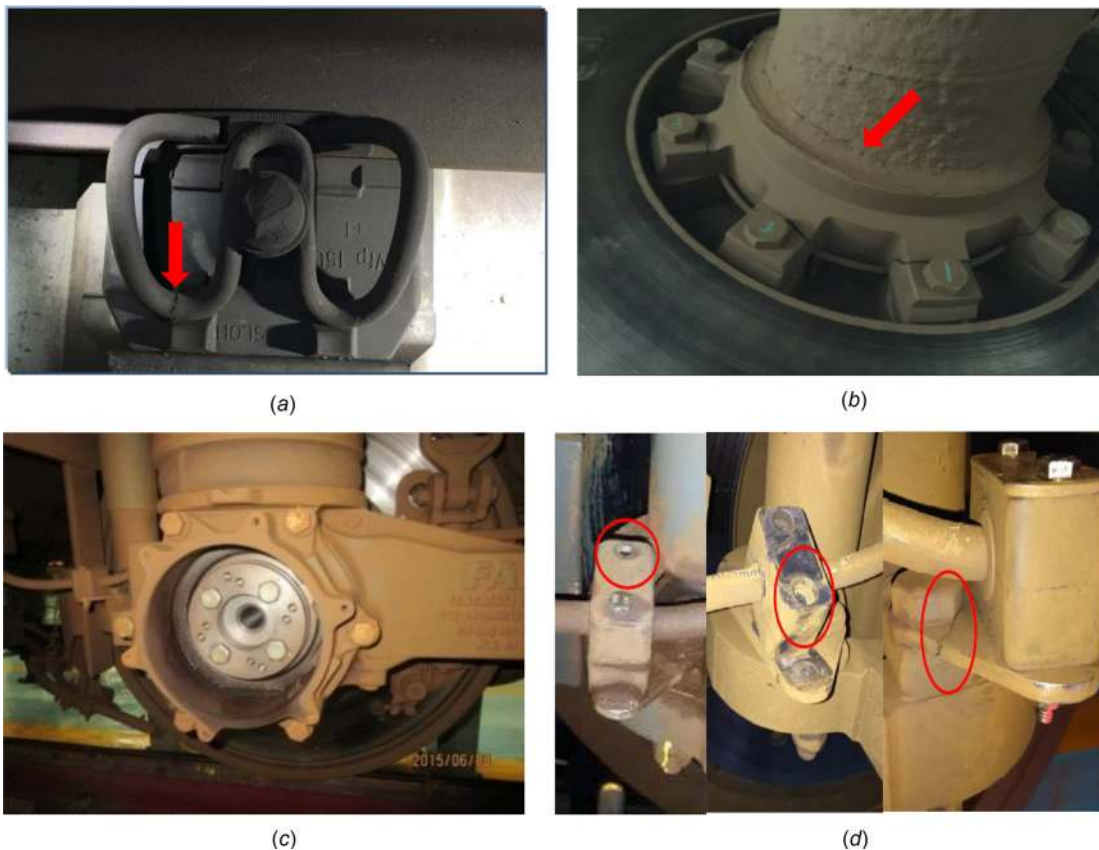
Fig. 18 Dynamic fatigue damage of vehicle and track components and accessories resulting from vibrations excited by high-order polygonization. (a) Fatigue of a clip, (b) a crack at the seat of a brake disk, (c) a missing axle box cover, and (d) missing bolts and cracks on auxiliary components of bogies.

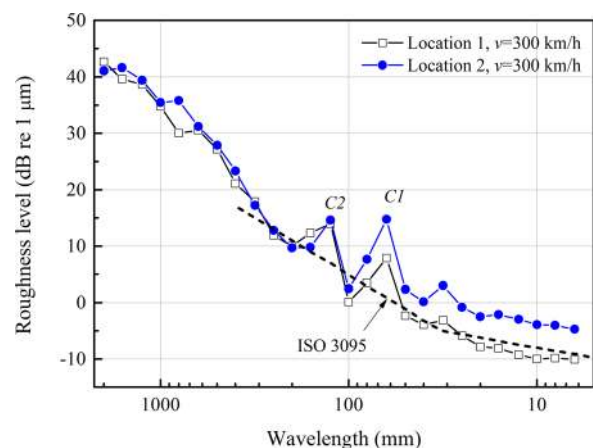
Fig. 23 Typical roughness spectra in 1/3 octave bands measured on a main high-speed line in China using a corrugation analysis trolley in 2011

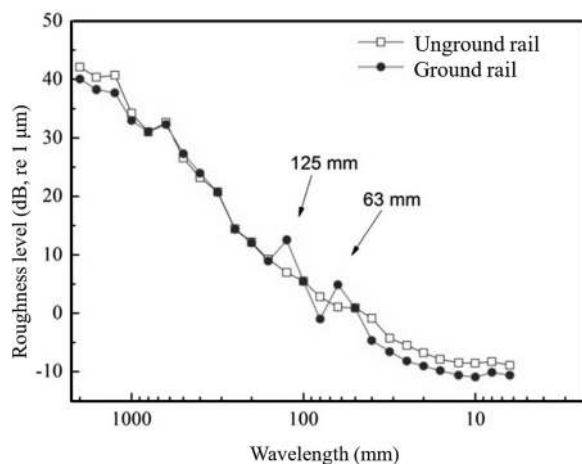
Fig. 28 Roughness spectra comparison of ground and unground rails close to a switch near which the grinders could not work [23]. An unground rail is typically 100–200 m long and the running conditions are almost the same as those on the ground rail close to it.

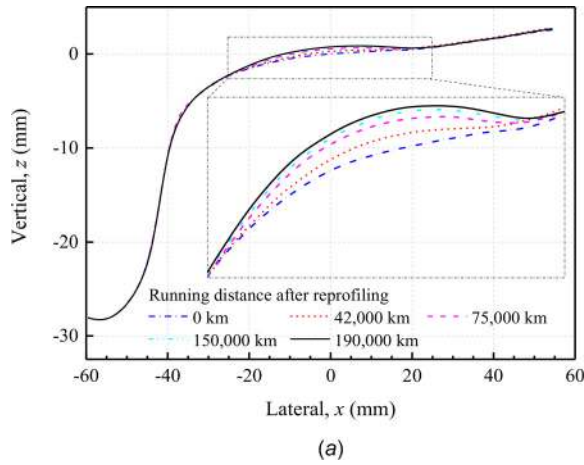
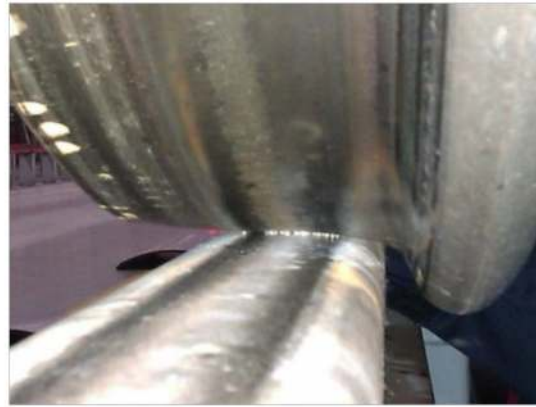
Fig. 29 Hollow wear on wheels of EMUs running in south China at a maximum of 350 km/h in 2011–2012 [42]. Laterally, $x = 0.0$ coincides with the NRC (also for similar figures later). (a) Profile development of a wheel and (b) light appearing in the contact gap between another hollow wheel and a rail.

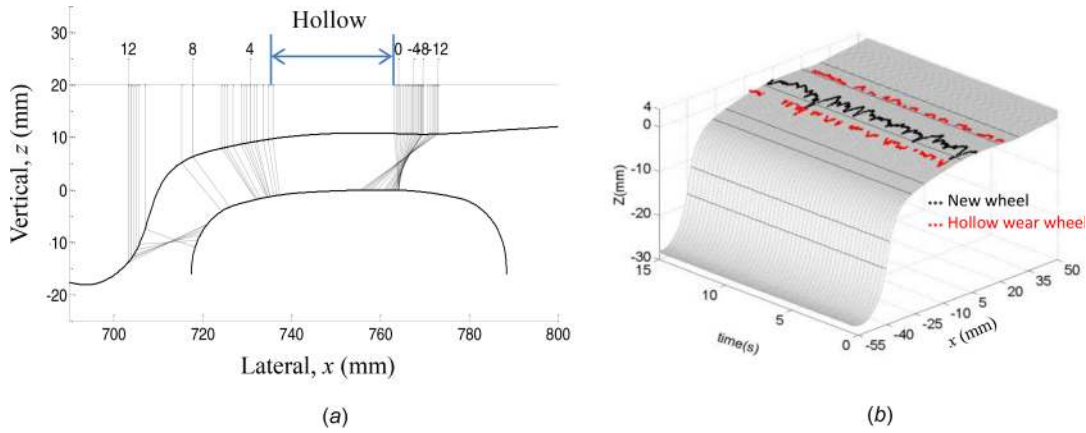
Fig. 32 Contact between a S1002CN wheel with hollow wear and a new CN60 rail. (a) Initial points of contact under different lateral shifts of wheelset (laterally, $x = 0.0$ coincides with the track center), and (b) traces of contact points on the tread calculated with a vehicle dynamics model at 350 km/h (a local coordinate system with the origin located at the rail top center is used for illustration), in which a typical irregularity of Chinese high-speed tracks was applied [60,61].

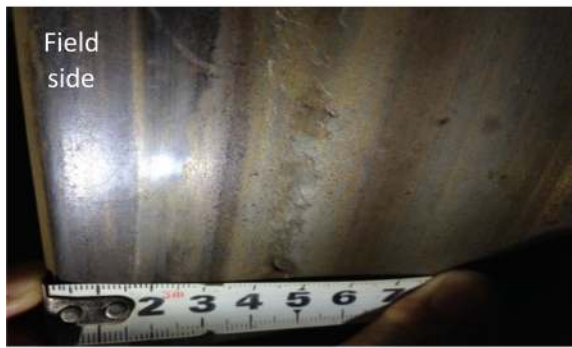
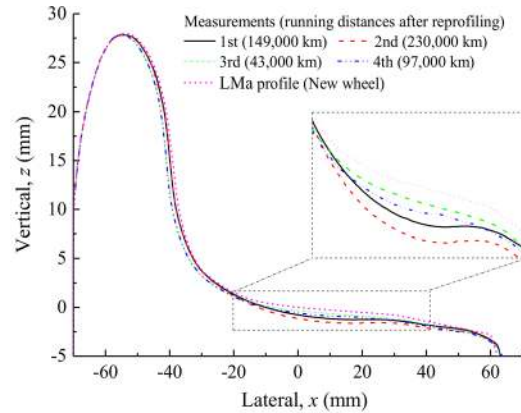
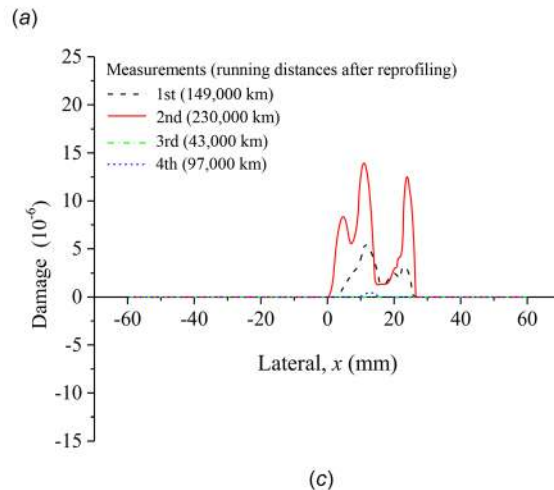
Fig. 34 Wheel RCF observed on 250 km/h EMUs and related numerical predictions [6,7]. (a) A typical RCF at a relatively late stage occurring on zone 1 defined by Deuce (close to the outer edge of the hollow), (b) measured tread geometry changes of a monitored wheel, and (c) predictions by T_T model based on vehicle dynamics analyses at 250 km/h by SIMPACK in consideration of a rail profile measured on a curve of R3500 m on a 250 km/h line in south China (positive damage means RCF in the figure). Note that the wheel in (b) and (c) was reprofiled between the second and third measurements.

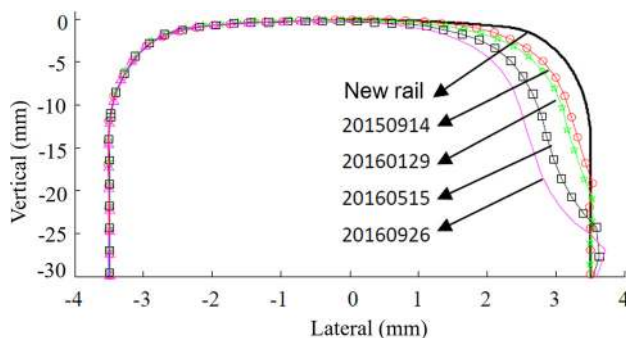
Fig. 35 The gauge side wear of the high rail on a R275 m curve in a yard

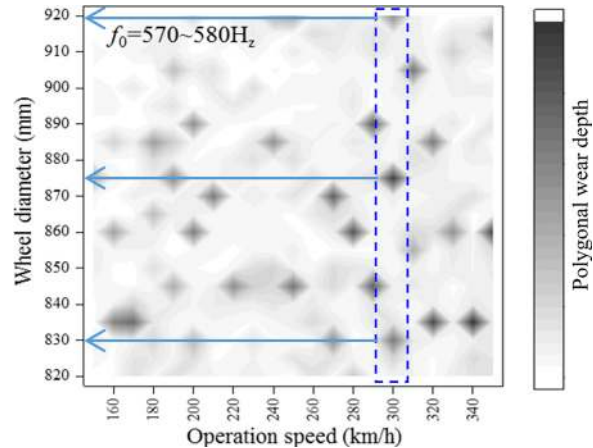
Fig. 40 Calculated critical diameters indicated in dark, at which high-order polygonization corresponding to a resonance frequency of 570–580 Hz develops at high rates [66]
