## **XRD AND TGA INVESTIGATION OF HARDENED CEMENT PASTE DEGRADATION**

**Abstract:** It is generally recognized that the environmental degradation of the concrete infrastructure is a serious, large scale and costly problem in many parts of the world. In this paper a deterioration of concrete by leaching of hardened cement paste due to aggressive water action is considered.

Concrete from a hydro-electric power plant's pipeline 30 years old was characterized with X-ray diffraction (XRD), and thermogravimetric analysis (TGA/DTA). The study highlights the capabilities of the methods for the analysis of concrete towards the determination of hardened cement paste degradation. On the basis of a visual survey of drilled cores, a number of representative spots were selected for detailed testing and verification of visual estimates.

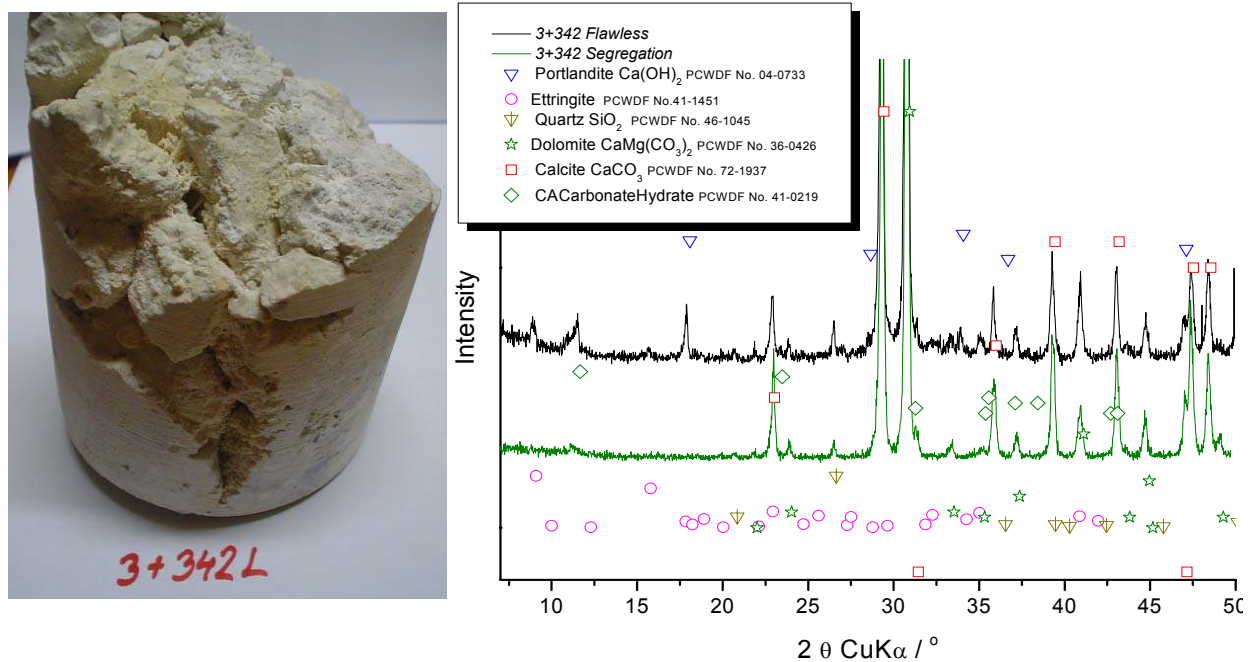
Figure 1. Photo and XRD diffractograms for samples *Flawless 3+342* and *Segregation 3+342*.

In sample *Flawless 3+342* diffraction peaks indicate presence of portlandite [Ca(OH)<sub>2</sub>], ettringite and carboaluminate hydrate and Friedel's salt (overlap near 2 $\Theta = 11$  °). However, sample *Segregation 3+342* shows no diffraction peak of portlandite [Ca(OH)<sub>2</sub>], and small quantity of ettringite, calcium carboaluminate hydrate and Friedel's salt (chloroaluminates) is identified.

Firstly, a visual survey of the pipeline water conduits in connection with a hydro-electric power scheme was conducted with categorization of flaws on the basis of outward appearance and samples were taken drilling a core, **Figure 1 - 4**. On the basis of a visual survey of drilled cores, a number of representative spots were selected for detailed testing and verification of visual estimates. Samples were taken from a *surface* concrete cover layer of few millimetres, and from flaws like *cracks*, *segregations* or *cold joints*. Samples were taken from these representative spots by carefully scraping and drilling concrete in powder. Powder samples were stored in sealed bags to prevent carbonation. Before analyses powder was additionally grind in corundum crucible.

**Figure 1 – 4** illustrate the XRD diffractograms for investigated samples. Each figure presents comparatively diffractograms of a sample taken from a *flawless* concrete spot (black top line) and a *surface* concrete cover layer of few millimeters, or from flaws like *cracks*, *segregations* or *cold joints* (green bottom line). The symbols on figures indicate the positions and peak intensities of the powder diffraction standard from JCPDS database. In samples *Flawless 3+342* and *Segregation 3+342*, **Figure 1**, XRD analysis indicates predominance of calcite [CaCO<sub>3</sub>] and dolomite [CaMg(CO<sub>3</sub>)<sub>2</sub>] peaks. In both samples Quartz [SiO<sub>2</sub>] is identified.

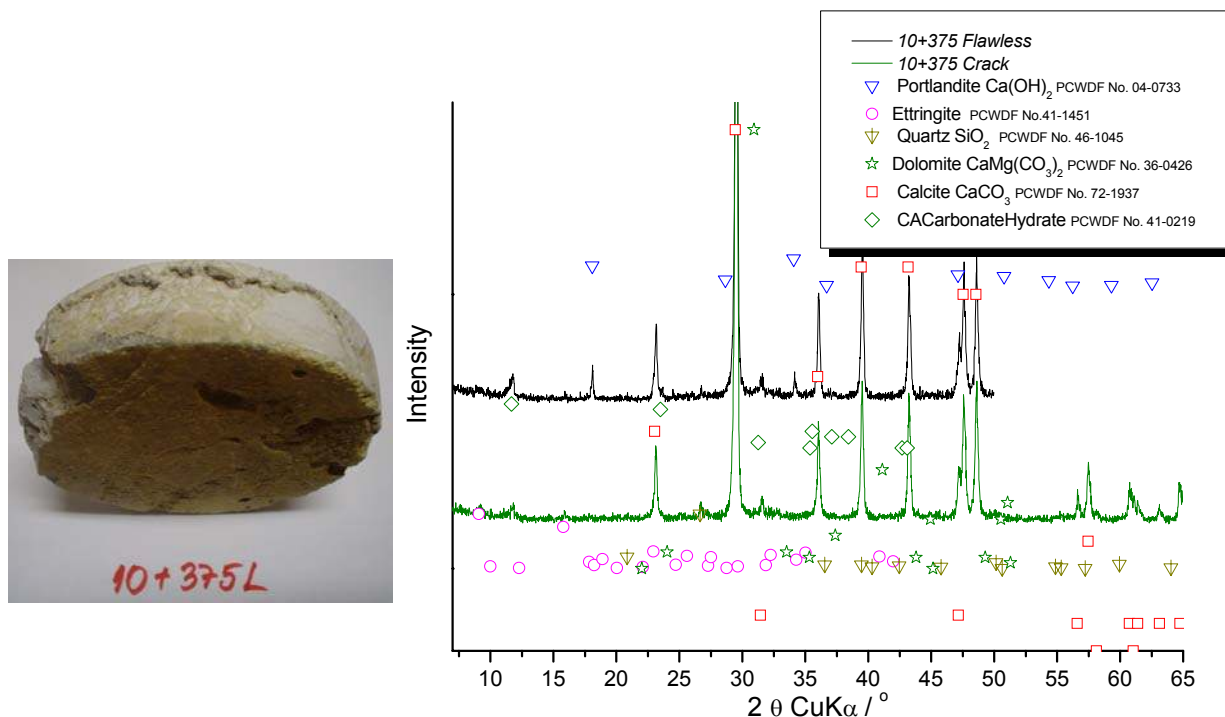
Figure 2. Photo and XRD diffractograms for samples *Flawless 10+375* and *Crack 10+375*.

In samples *Flawless 10+375* and *Crack 10+375*, **Figure 2**, *Flawless 10+250* and *Crack 10+250*, **Figure 3**, *10+210 D=11cm* and *Surface 10+210*, **Figure 4**, XRD analysis indicates

predominance of calcite  $[CaCO_3]$  peaks. In all *Flawless* samples diffraction peaks indicate presence of portlandite  $[Ca(OH)_2]$ , ettringite and carboaluminate hydrate and Friedel's salt. However, in both *Crack* samples and sample *Surface* XRD analysis shows no diffraction peak of portlandite  $[Ca(OH)_2]$ , and small quantity of ettringite, calcium carboaluminate hydrate and Friedel's salt is identified. In all samples small quantity of Quartz  $[SiO_2]$  is identified.
