International Conference on Case Histories in Geotechnical Engineering

Case Studies of Pile Foundations Undergoing Lateral Spreading in Liquefied Deposits

K. Ishihara
Chuo University Kiso, Tokyo, Japan

M. Cubrinovski
Kiso-Jiban Consultants, Tokyo, Japan

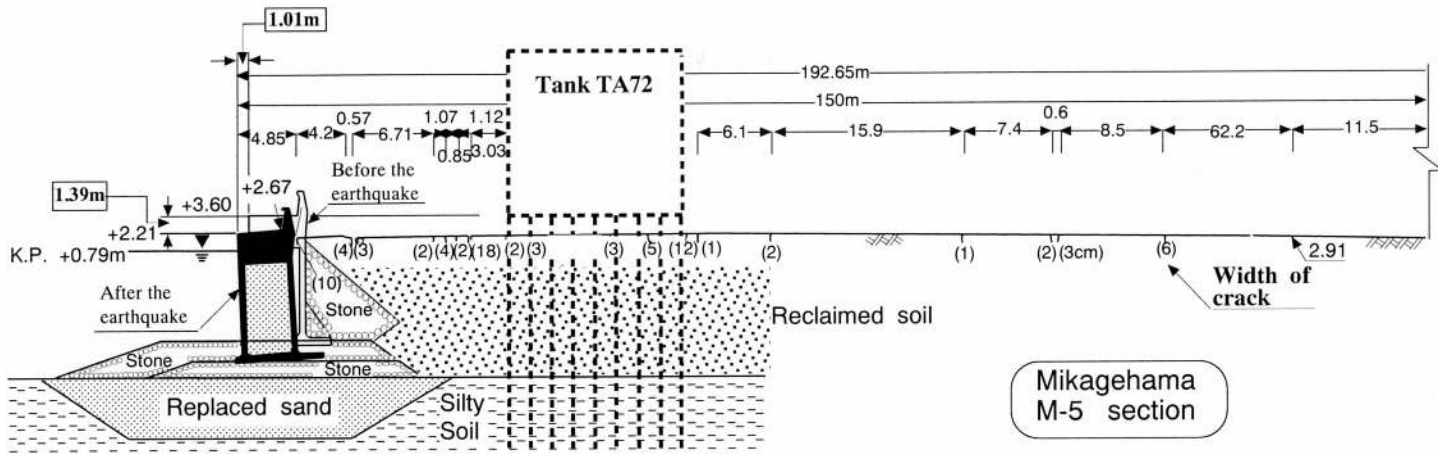
*Fig. 8. Detailed profile of the quay wall movement and ground distortion in the backfills at Section M-5*

along the M-5 section which is located in the vicinity of Tank TA72, as shown in Fig. 2. The results of the ground survey are displayed in Fig. 8 where it may be seen that the quay wall moved approximately 1 m towards the sea. The seaward movement of the quay wall was accompanied by lateral spreading of the backfill soils resulting in a number of cracks on the ground inland from the waterfront. By summing up the width of the crack openings measured along the M-5 section, the lateral ground displacement was obtained and it was plotted as a function of the distance from the waterfront, as shown in Fig. 9. As indicated in this figure, the permanent lateral ground displacement corresponding to the location of Tank TA72 is seen somewhere between 35 and 55 cm.

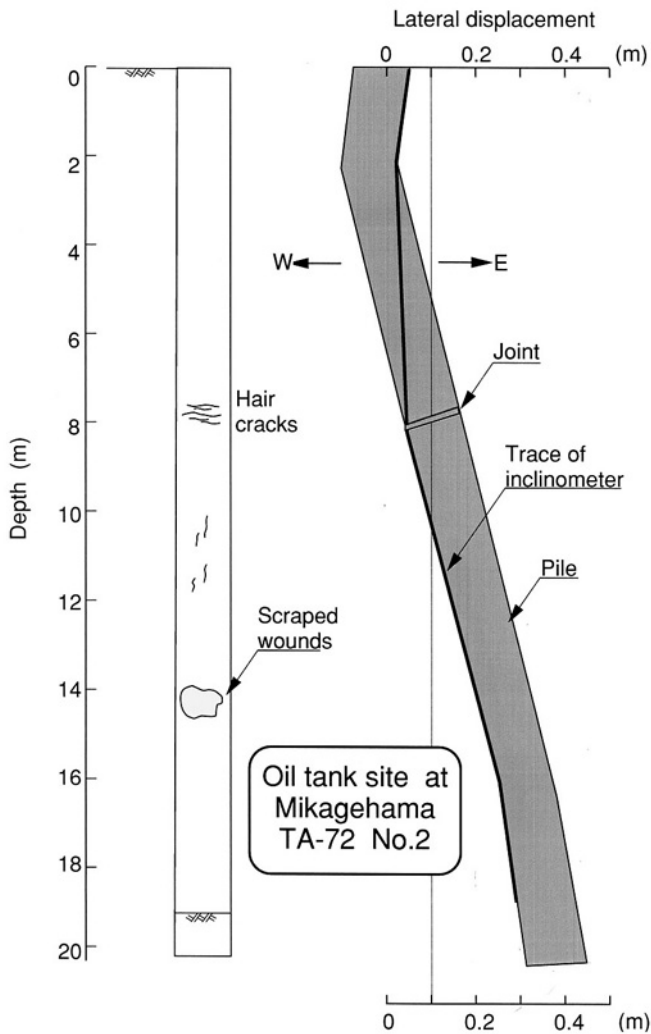
Fig. 11. Lateral displacement and observed cracks on the inside wall of Pile No. 2

To inspect the damage to the piles, a detailed field investigation was conducted on two piles of Tank TA72. The investigated piles No. 2 and No. 9 are indicated in Fig. 4. Trenches 70 cm wide and 1 m deep were excavated at 4 sections shown in Fig. 10, and the upper portion of the pile was exposed. The wall of the cylindrical piles was cut to open a window about 30 cm long and 15 cm wide. From this window, a bore-hole camera was lowered through the interior hole of the hollow cylindrical piles to examine the damage to the piles throughout the depth. The outcome of the bore-hole camera recordings is shown in Figs. 11 and 12 for the pile No. 2 and No. 9 respectively together with the inclination of piles measured by means of the inclinometer lowered into the central hole of the pile. It may be seen in these figures that the piles developed multiple cracks and suffered largest damage at a depth of approximately 8 to 14 m, which corresponds to the

The piles are known to have suffered largest damage at depths corresponding to the interface between the liquefied fill deposit and the underlying non-liquefied soil layer. The

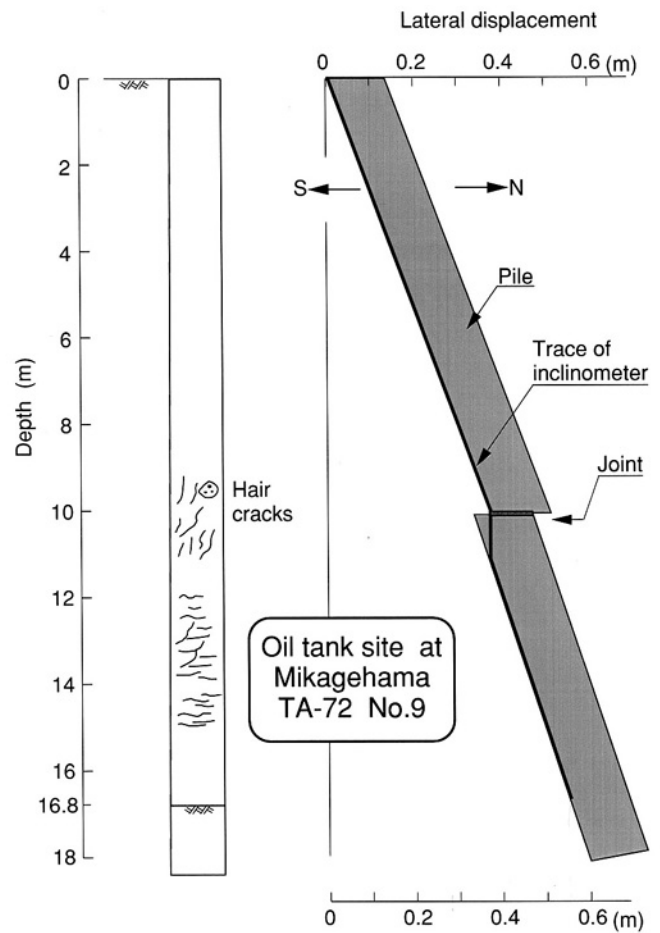
Fig. 12. Lateral displacement and observed cracks on the inside wall of Pile No. 9

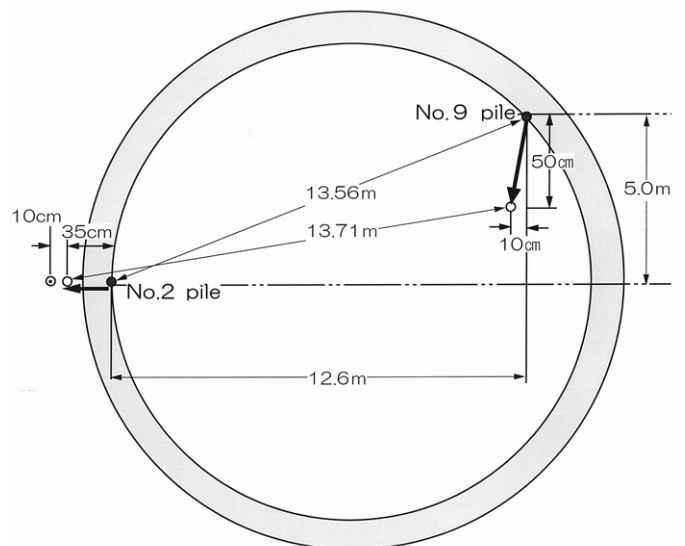
Fig. 13. Permanent lateral displacements of Pile No. 2 and Pile No. 9 at the head of the pile

depth of the interface zone between the liquefied fill deposit and underlying silty soil layer. The observed permanent horizontal displacements at the head of the piles are shown in plan-view of Fig. 13.

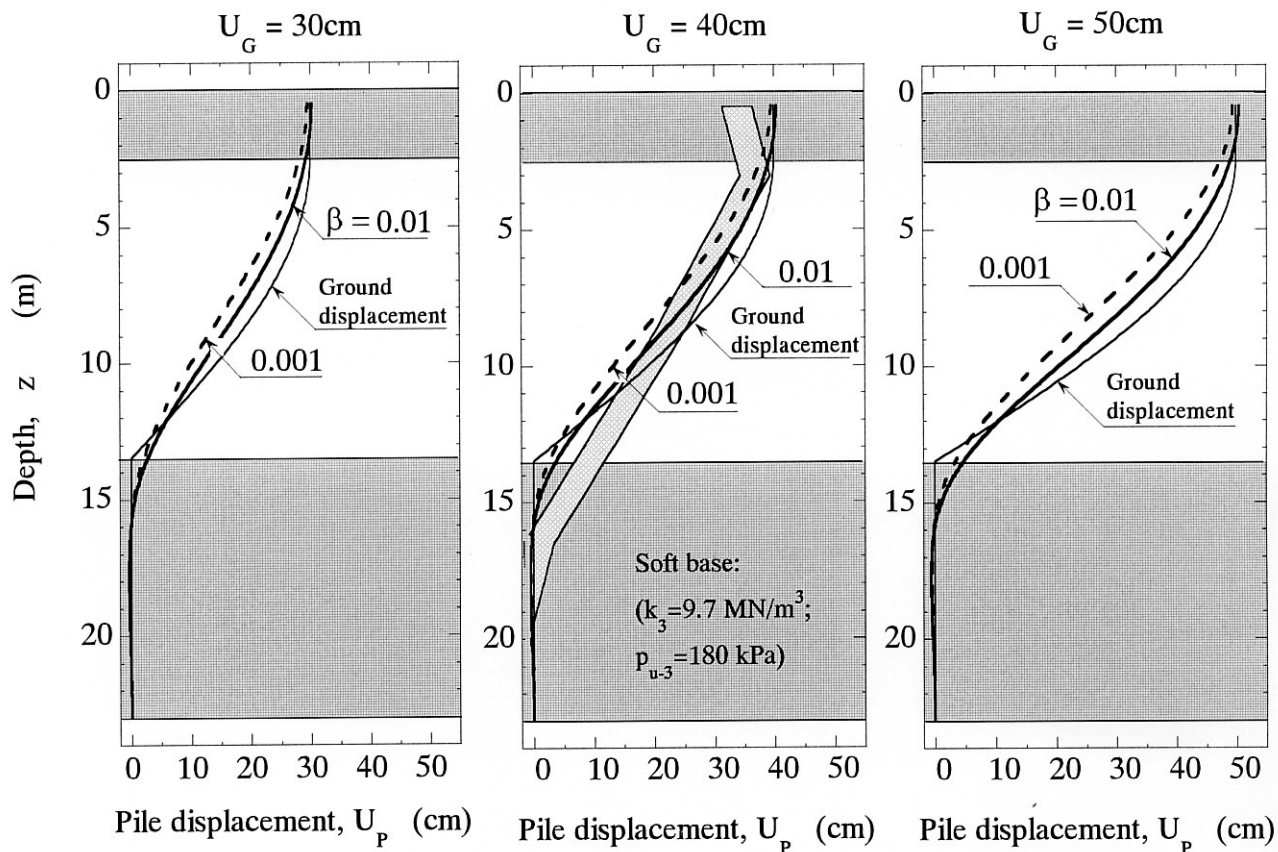
Fig. 18. Computed pile displacements in analyses with applied ground displacements of 30, 40 and 50 cm

18a through 18c for the three cases where the ground displacement was assumed as 30, 40 and 50 cm respectively. For purpose of comparison, the measured displacements of Pile No. 2 are quoted from Fig. 11 and superimposed in Fig. 18b. A reasonably good agreement between the computed and observed displacements of the pile is seen in this figure. The displacement of Pile 9 was directed almost perpendicular to the direction of the lateral flow as seen in Fig. 13. This appears to have resulted from complex interaction between the pile and the foundation slab atop.

Looking over the results of the back-calculation in Fig. 18, one can recognize that the computed displacement at the pile head is nearly equal to the applied displacement at the ground surface. The same scheme of analysis was implemented also for the case of $\beta_2 = 1/1000$. The result of this analysis is shown in Fig. 18 together with the case of $\beta_2 = 1/100$. It may be seen from the results of the analyses with $\beta_2 = 1/100$ and $\beta_2 = 1/1000$ that the pile response is not very sensitive on the value of β_2. It is important to recognize however that while the eventual pile displacements are similar for the cases of $\beta_2 = 1/100$ and 1/1000, the causative loads for the pile response are different between these two cases. Namely, in the case of $\beta_2 = 1/100$, even though the stiffness of the liquefied soil is reduced significantly, the major driving force on the pile comes from the soil in the liquefied layer. Therefore, the lateral load from

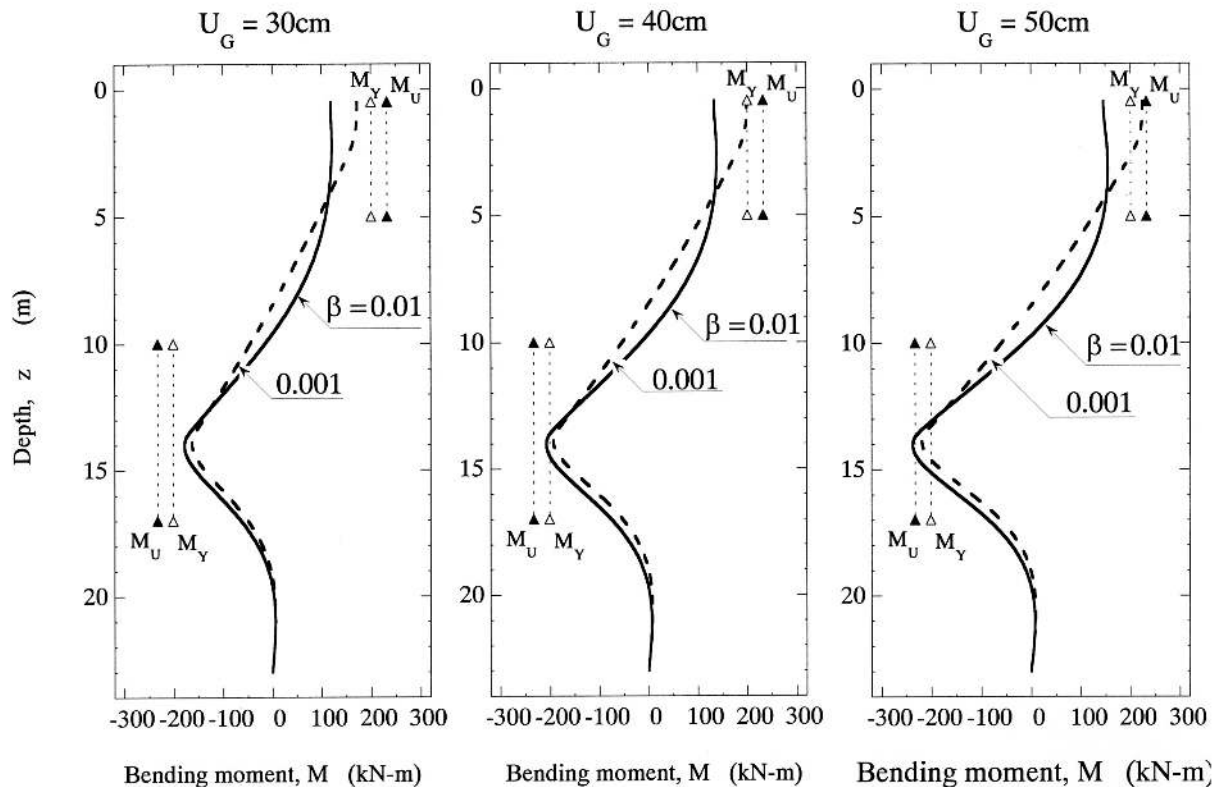
Fig. 19. Computed bending moments in analyses with applied ground displacements of 30, 40 and 50 cm

In accordance with the pile displacements as above, the computed bending moments are seen to increase with the increasing magnitude of the ground displacement as shown in Figs. 19a-19c. The maximum bending moment develops near the interface between the liquefied layer and underlying non-liquefied base layer, at depths of about 12 m to 15 m. The magnitude of the computed bending moments and their distribution throughout the depth are found to be in good correspondence with the damage to the piles observed in the field inspection as presented in Figs. 11 and 12.
