Title
Cryogenic Laser Ablation Reveals Short-Circuit Mechanism in Lithium Metal Batteries

Cryogenic Laser Ablation Reveals Short-Circuit Mechanism in Lithium Metal Batteries

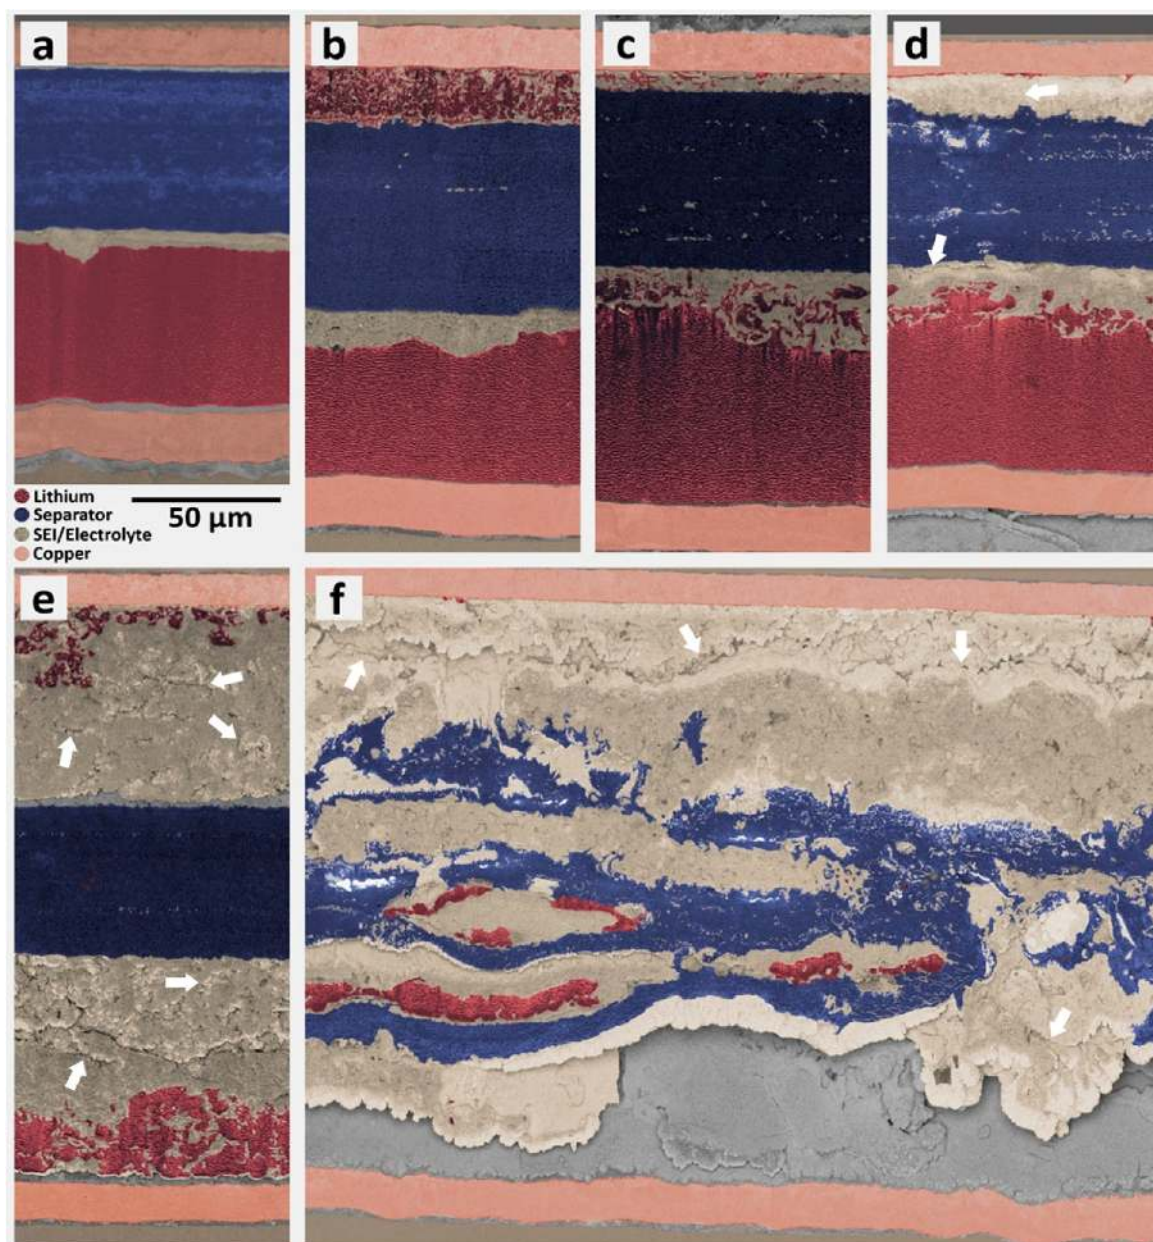
Figure 1. Scanning electron micrographs of intact angled-sections of high-rate cycled Li-metal half cells. (a) Uncycled cell, including: stainless-steel cap, Cu current collector, stack of two Celgard 2325 separators, Li metal, bottom Cu current collector, and lower stainless-steel disc, (b) 1st Li plating, (c) 1st Li stripping, (d) 11th plating, (e) 51st plating, and (f) 101st plating step. White arrows indicate cracks in the SEI matrix and gray regions indicate structures out-of-plane from the cut face.

Our results show that copious SEI growth occurs over relatively few cycles at high-rate cycling. Even the first Li plating cycle (Figure 1b) shows that a fraction of the dark Li layer has moved across the separator and deposited on the Cu current collector at the top. A fully dense Li film should be only 9 μm thick, so the newly deposited 16 μm thick Li film must be either porous (filled in with electrolyte) and/or composed of both Li and SEI. Notably, small SEI deposits can already be observed within the separator, presumably resulting from conductive pathways (unresolved in these SEM images) that allowed small Li deposits to plate and react with electrolyte, forming these SEI inclusions.[20]

The first Li stripping cycle (Figure 1c) shows that after the Li is driven from the top Cu electrode, roughly 7 μm of SEI/electrolyte/dead-Li-residue remains, filling the region between the top Cu electrode and the separator. More pronounced SEI deposits are seen in the separator. Below the separator, Li plates on top of the fully dense Li-metal surface as a low-density matrix, coated in SEI and filled with electrolyte. By the 11th Li plating cycle (Figure 1d), there are small Li deposits on the top Cu electrode, and the far denser SEI matrix now causes deformation of the separator. Inclusions of large SEI deposits appear within the separator (on the scale of several micrometers), above an increasingly thick SEI layer and the roughened surface of the fully dense Li-metal layer. At the 51st Li-plating cycle (Figure 1e), the plated Li on the top Cu electrode again forms a low-density matrix of Li grains mixed with an extremely dense SEI matrix, which comprises most of the gap between the top Cu electrode and the separator. Interestingly, the separator retains its margins and structure, with only a few SEI inclusions. Below the separator, the electrolyte-filled SEI film is now much thicker than the fully dense Li-metal layer, which is being converted into a coarse SEI-filled network. At this point, there is clear evidence that copious SEI has formed by consuming large amounts of bulk active Li and electrolyte, with small embedded fragments of dead Li encased in the SEI.[20] Catastrophic cell failure is seen in the 101st plating cycle (Figure 1f), where the separator is completely shredded by SEI and large Li-metal deposits can be

seen within the separator's interior boundaries. These images repudiate the long-held assumption that a single Li dendrite spans the cell and creates a hard short; instead, these images indicate that the primary failure mechanisms are widespread SEI inclusions and separator shredding.

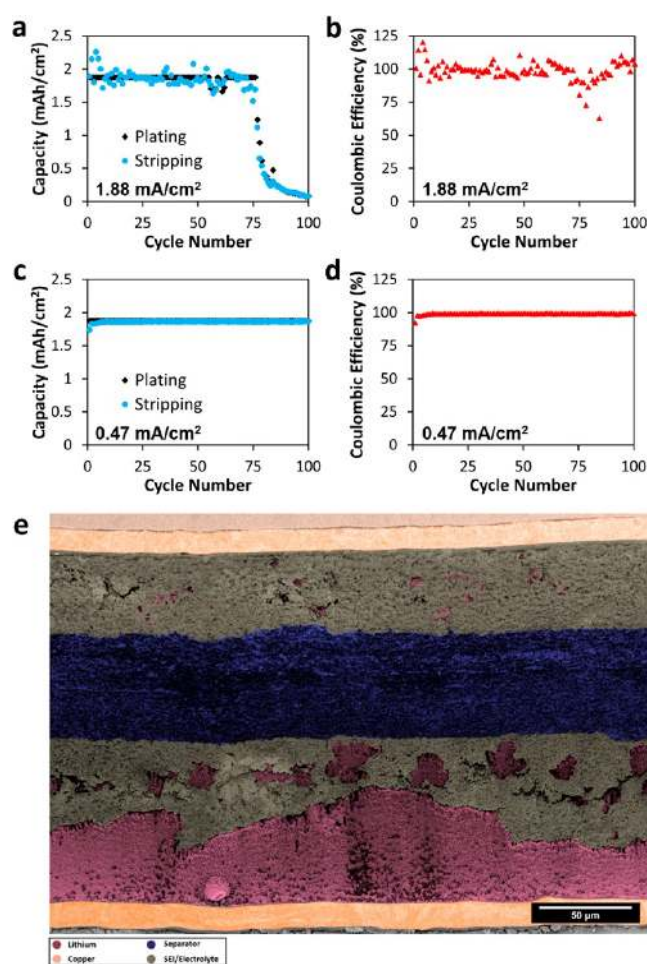
Our electrochemical data validates the structural/chemical maps, suggesting that the soft shorts formed during cycling caused the growth of SEI inclusions within the separator. As expected, the disintegration of the coin cell's internal structures coincided with the battery's obvious electrochemical failure, which we analyzed using chronopotentiometric data generated from cycling prior to Laser PFIB characterization (Figure S24, and replicates in Figures S26–S40). In the high rate cycled cells, the Coulombic efficiency measurements often exceed 100% and are likely indicative of soft short formation (Figure 2a,b). While random error or dead Li (stranding and reconnecting) could explain some of the variation shown

Figure 2. Electrochemical performance of the 101st Li plating sample. (a) Capacity of the plating and stripping cycles, for Li plating at a high rate of 1.88 mA/cm² up to the 101st plating step. (b) Coulombic efficiency of each full cycle, exhibiting the battery's ability to efficiently recapture Li, even after the quantity of plated Li significantly decreases at ~75 cycles. Capacity (c) and Coulombic efficiency (d) of the plating and stripping cycles at a low rate of 0.47 mA/cm² to a capacity of 1.88 mAh/cm². (e) Scanning electron micrograph of an intact angled-section of the 101st Li plating low-rate cycled half-cell. The brown layer at the top of the image is the stainless-steel cap, and the gray contrast indicates structures out-of-plane from the cut face.

above and below 100% Coulombic efficiency, the fact that the cumulative stripped capacity exceeds the cumulative plated capacity until cycle 46 strongly suggests that some of the charge passed is due to soft shorts. In the separator, widespread SEI inclusions indicate conductive paths (likely composed of small Li-metal fragments weakly connected in the SEI matrix),[20] which allow electron transport into the separator and enable the soft shorts.

A few cycles before the cell failed, the Coulombic efficiency dropped, likely indicating the cell's impending inability to plate to the specified capacity. However, after the cell began to fail, the Coulombic efficiency briefly recovered, which suggests that the loss in capacity is fundamentally decoupled from the loss in Coulombic efficiency. It should be noted that when the cell was unable to plate to the specified capacity, because of depletion of the accessible Li inventory (dead Li or blocked Li-transport pathways), the remaining Li inventory could still be efficiently cycled. This cell failed because of inaccessible or depleted Li inventory rather than from a hard short circuit caused by a dendrite.

Because most studies concentrate on low-rate cycling, the experiment was reproduced at 25% of the high-rate cycling to determine whether the same failure mechanisms pertained. Results (Figure 2c,d) demonstrate very steady capacity and Coulombic efficiency (>99%), even at high cycle numbers. At this lower current density, battery performance was very

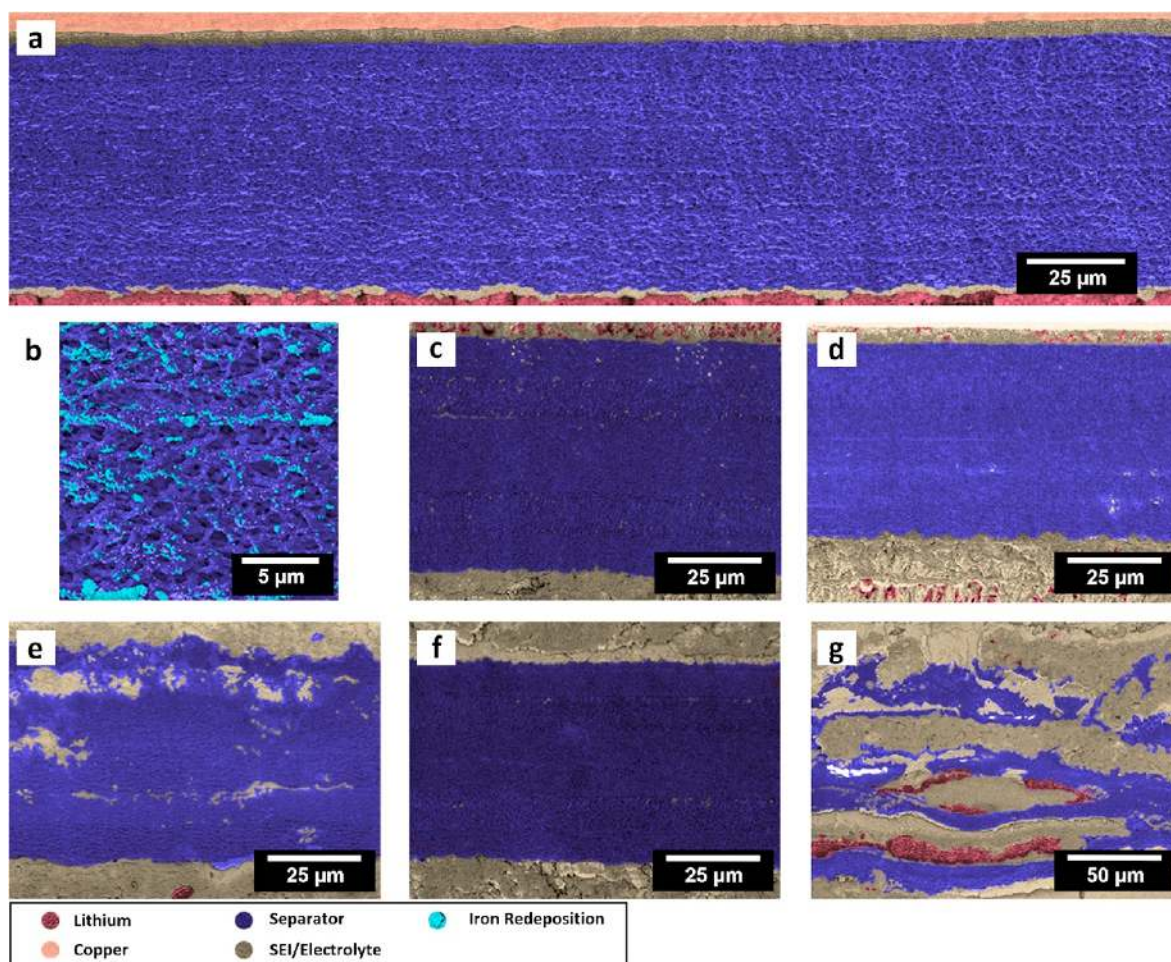
Figure 3. Scanning electron micrographs of high-rate cycled angled-sections showing failure within two stacked Celgard 2325 separators. (a) Uncycled cell and (b) higher-magnification image of the separator porosity (with the lighter contrast indicating iron redeposition from laser ablation), (c) 1st Li plating, (d) 1st Li stripping, (e) 11th plating, (f) 51st plating, and (g) 101st plating step.

Small SEI deposits protruding into the separator between the separator's polypropylene and polyethylene trilayers (Figure 3a,b) and small internal SEI inclusions (Figure 3c−f) can cause dramatic horizontal tearing along the trilayer interfaces (Figure 3g), creating compromised intertrilayer separator interfaces. This phenomenon demonstrates inadequate adhesion between the trilayers[24] and/or softening of the separator upon electrolyte saturation.[25] Large SEI inclusions also formed along the separator's top and bottom surfaces, punching vertically through the trilayers (Figure 3e), which resulted in further horizontal tearing. Because SEI formation can occur only with electrons at the required reduction potential, conductive paths (masked by SEI or too small to resolve in the SEM images) must be laced through the separator, providing all the components necessary to form SEI within the separator's trilayer structure (optical image in Figure S44). Under high-rate conditions, SEI formation in the separator can typically be observed very early in the Li-cycling process. Figure 3f (51st plating) shows few SEI inclusions compared to Figure 3e (11th plating), which demonstrates the stochastic nature of these processes, both within and among identically fabricated coin cells. However, while cell-to-cell variation was observed, many duplicate cells failed catastrophically between 75 and 100 cycles (Figures S13−S17 and S26−S40). Complete destruction of the trilayer separator before the 101st lithiation was evident in Figure 3g, clearly demonstrating that, for high-rate cycled Li-metal anodes, the trilayer separator was not mechanically sufficient to withstand SEI evolution.

alternative separator in Figures S47−S55). Once there is a complete conductive pathway through the separator, the cell-scale electronic bridge causes numerous soft shorts. More mechanically robust separators may mitigate this failure mode; however, uncontrolled SEI growth may still cause electrolyte redistribution and Li-ion transport blocking.

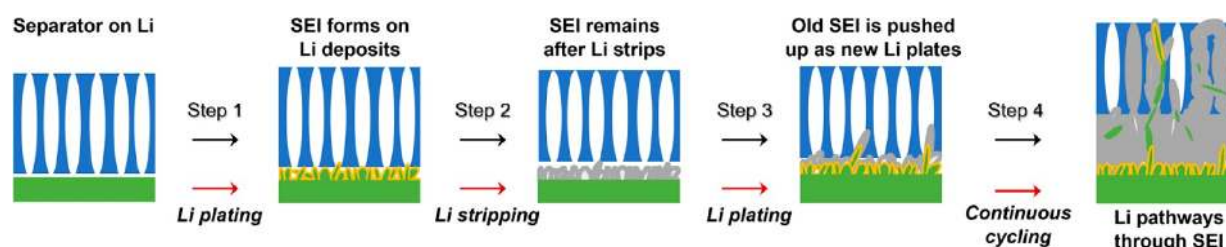
Figure 4. Schematic short-circuit mechanism for conductive Li pathways through the polymeric separator via SEI formation and subsequent deformation of the separator. SEI formed during the current plating step is colored yellow; SEI that formed in a prior step is colored gray.

Our full-stack nanoscale characterization points to a failure mechanism which had not been previously considered in theoretical modeling:[26] the SEI's mechanical properties create pathways that allow soft Li metal to penetrate into and tear the separator, with Li-metal plating providing the force for penetration (Figure 4). We believe that the extensive SEI formation is itself a product of the conductive pathways that form between the small Li-metal fragments embedded within the SEI. During the first plating step, some high-aspect ratio Li grains deposit and grow with a capping SEI film. We believe it is possible that the hard, sharp SEI tips can bore into the separator's small pores and even puncture the separator (results from carbonate electrolyte in Figures S45 and S46 and
