EVALUATION OF GFRP DECK PANEL FOR THE O'FALLON PARK BRIDGE

Guido Camata
P. Benson Shing

July 2004

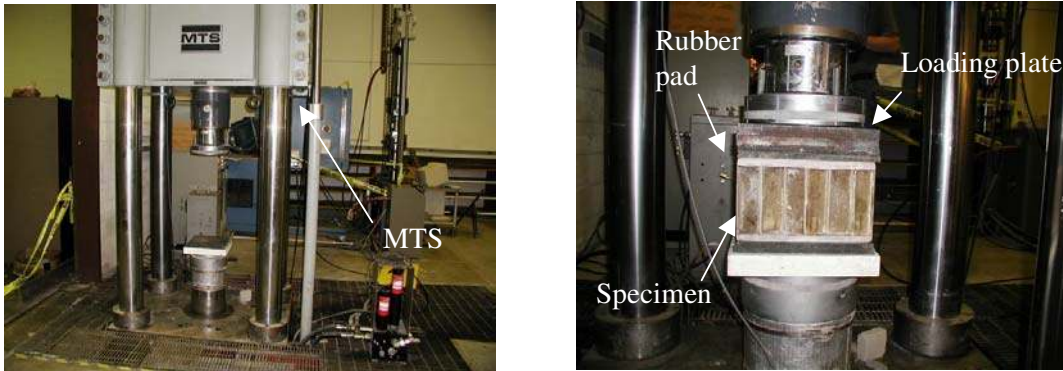
Figure 5-8 Crushing test setup

All the specimens failed in the same manner. The specimens emitted the first noise between 35 and 70 kips, and visual observation indicated that the core walls started to buckle between 120 and 130 kips. The crushing loads are shown in Table 5-2.

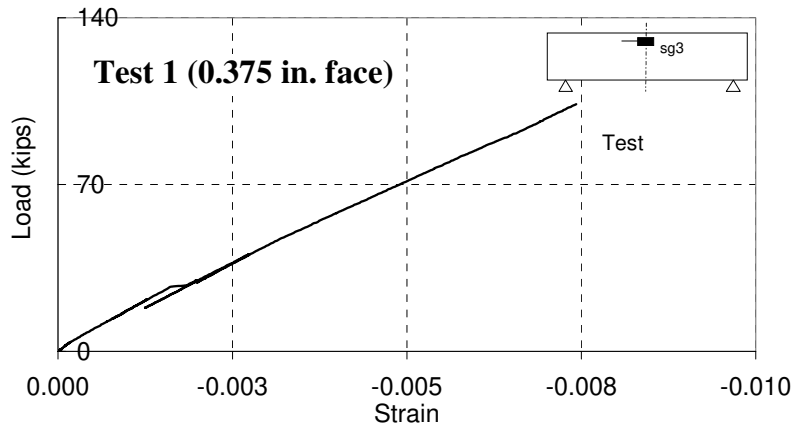
Figure 5-12 Load-strain curve for Test 1 (gage sg3)

Figure 5-12 shows the data obtained from the strain gage labeled sg3, glued on the side near the top face at the middle of the beam. In this case, the maximum compressive strain recorded at 103 kips was -0.007426. Considering that the gage was glued at 0.68 in. from the top surface, the calculated maximum compressive strain on the upper surface was -0.00912 using the plane-section assumption. This value agrees well with the maximum tensile strain recorded at the bottom face.

During the test, several types of damage occurred. At about 25 kips, a first noise was heard indicating that some fibers were breaking. In fact, the load-strain curve from strain gage sg3 exhibits some nonlinearity at about 27 kips as shown in Figure 5-12. Throughout the rest of the test, noises were heard indicating that fibers were probably breaking continuously during loading. Inspection of the beam after failure showed the presence of loose fibers. Finally, at a load of 103 kips, the top face started delaminating. The failure was brittle and released a large amount of energy. Debonding between the core and the upper face started under the load and propagated outward along the top core-face interface as shown in Figure 5-16. After that, the top face debonded. The core was subsequently subjected to a larger load which caused the local buckling of the core at both sides of the beam as illustrated in Figure 5-17. After failure, the top face and the core were completely detached as shown in Figure 5-18.

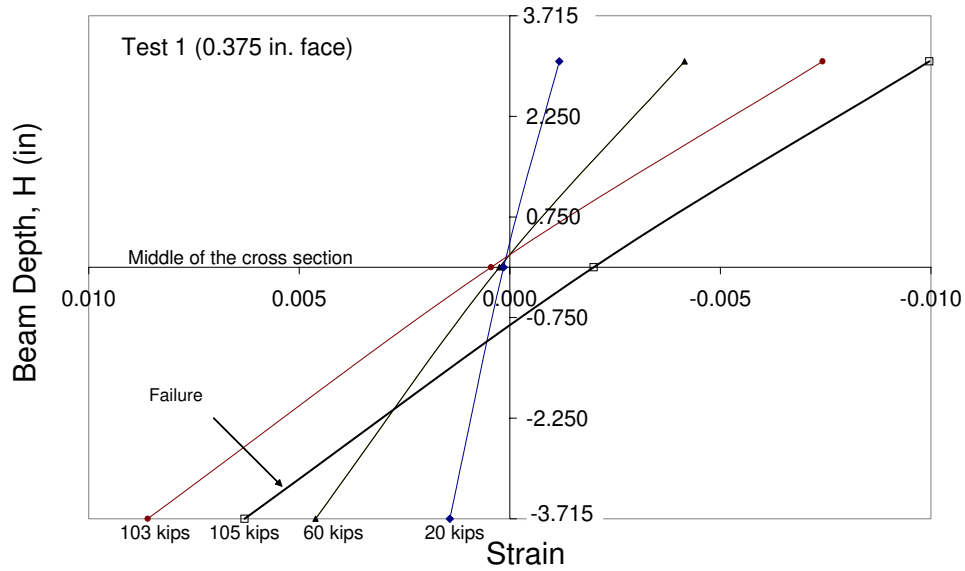
Figure 5-15 Strain profiles at different loading stages for Test 1 (midspan)

The strain profiles at midspan shown in Figure 5-15 indicate that plane sections remained plane during bending. Figure 5-15 shows that the neutral axis shifted down right after reaching the 103-kip load indicating the delamination of the top face from the core.

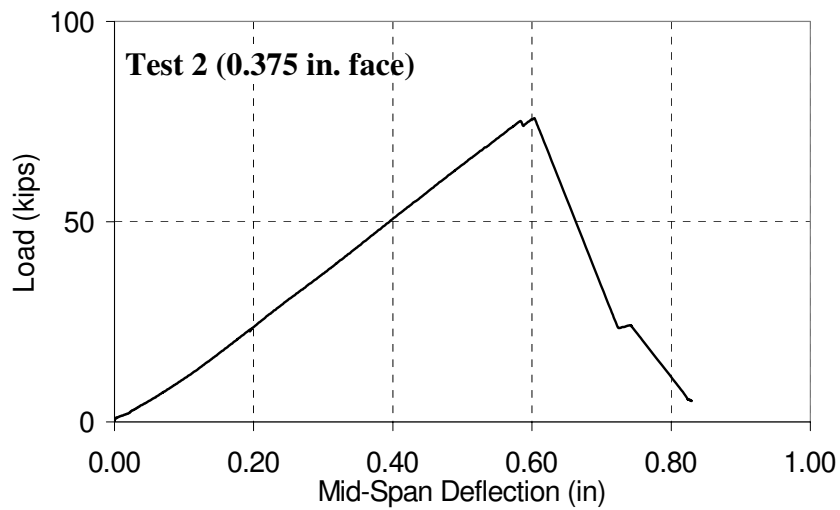
Figure 5-19 Load-deflection curve for Test 2

The load-deflection curve for Test 2 is shown in Figure 5-19. The figure indicates that the behavior is linearly elastic until close to failure. The specimen failed at a load of about 76 kips.

The failure in Test 2 was very similar to the failure reported in the first test. During the test, noises were heard indicating that some fibers were breaking during loading. At 75 kips, the load dropped slightly (Figure 5-19), probably because of a partial debonding between the top face and the core. Eventually, the partial debonding propagated and

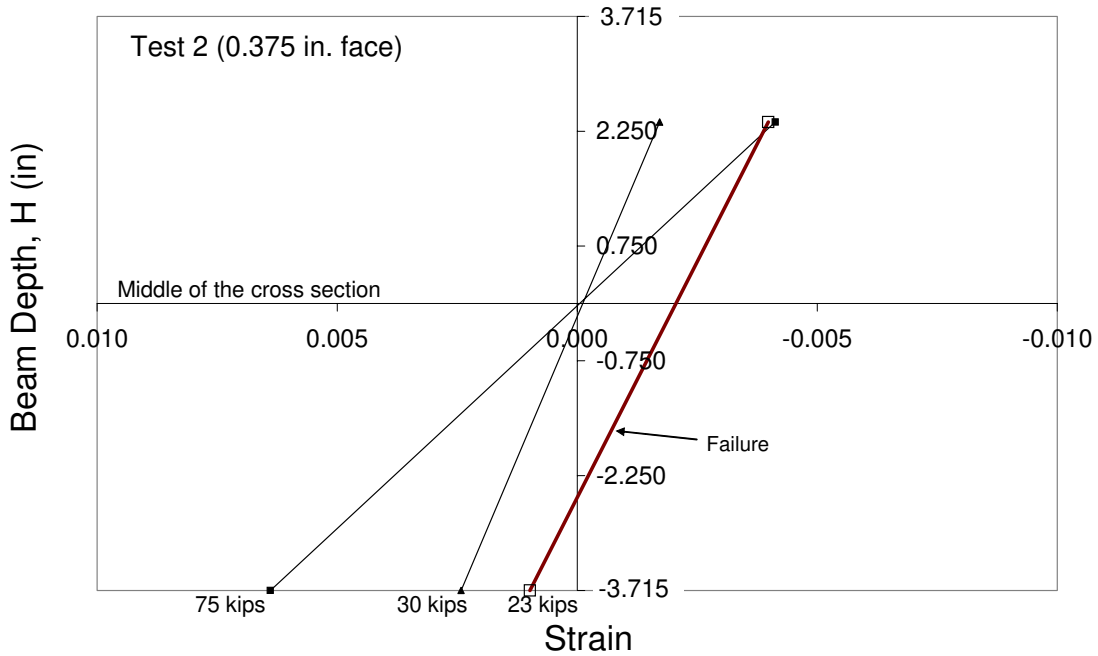
Figure 5-26 Strain profiles at different loading stages for Test 2 (midspan)

Figure 5-25 shows that the load-strain curve from strain gage sg6 is linear elastic up to failure. Figure 5-26 shows the strain profiles at midspan. After failure at 76 kips, the neutral axis shifted down indicating that the upper face had delaminated.

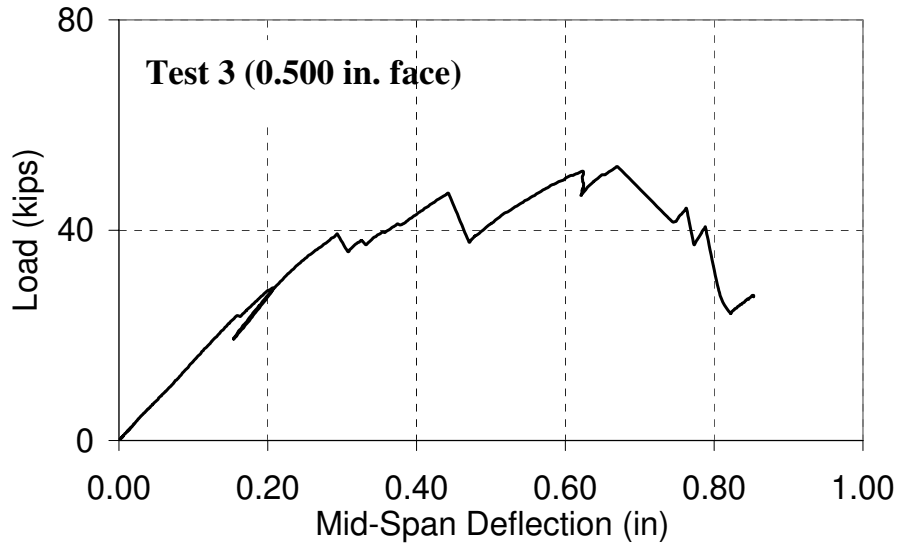
Figure 5-30 Load-deflection curve for Test 3

The load-displacement curve for Test 3 was linear up to about 23 kips as shown in Figure 5-30. At 23 kips and a deflection of 0.165 in, the upper face started debonding and the load-displacement curve became nonlinear. At 39, 47, and 50 kips, the load dropped suddenly indicating that the upper face continued to slip. This is well explained in Figure 5-31, which shows that, after the load dropped, the neutral axis at midspan shifted downward due to delamination of the top face. At 52 kips, the load dropped and the neutral axis shifted upward to the centroidal position, as shown in Figure 5-31, indicating that the bottom face slipped eventually causing the sudden failure of the beam.

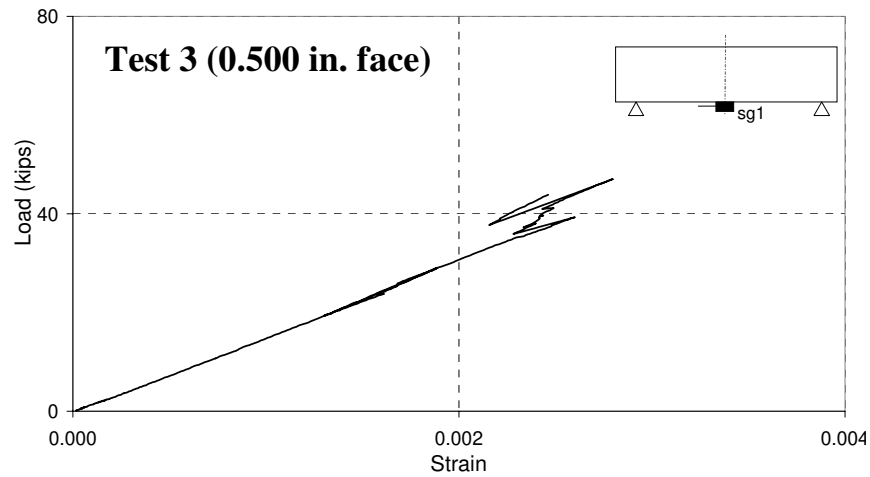
Figure 5-32 Load-strain curve for Test 3 (gage sg1)

The reading from the strain gage placed at the middle of the beam on the bottom face indicated that the face-core system lost the full composite action at 40 kips. This can be deduced from the sudden stiffness change in the load-strain curve in Figure 5-32. The

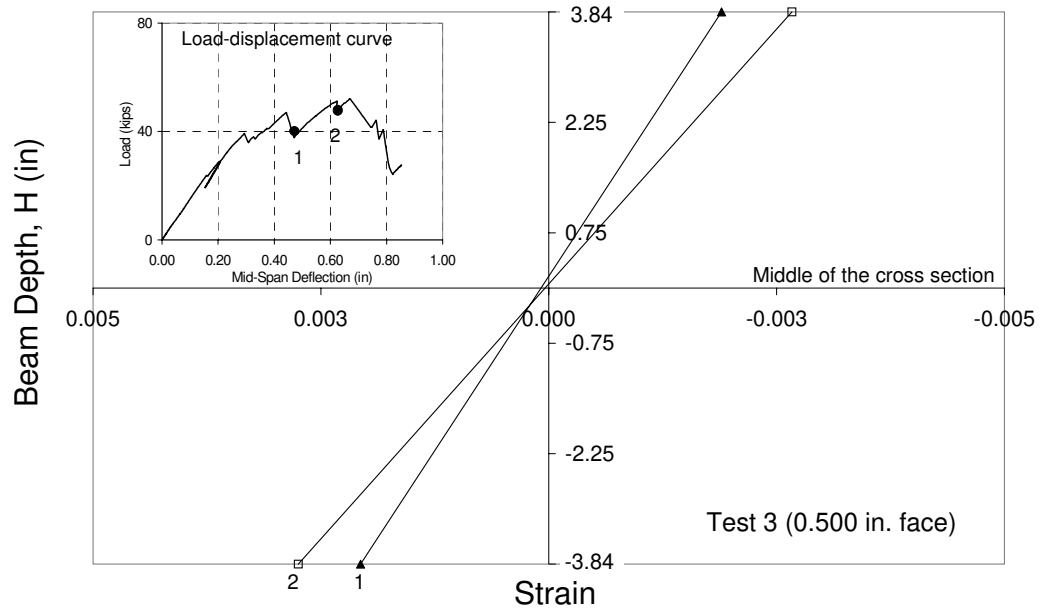
Figure 5-36 Strain profiles at different loading stages for Test 3 (sg3/sg4)

Up to about 39 kips, the load-strain curves for gages sg3 and sg4 show a constant stiffness, as for the gages sg1 and sg2. At the section were these gages were located, the neutral axis did not change position up to the peak load as shown in Figure 5-36. This indicates that, in the beginning, the slip was localized at the middle and, later, it propagated toward the end of the beam.

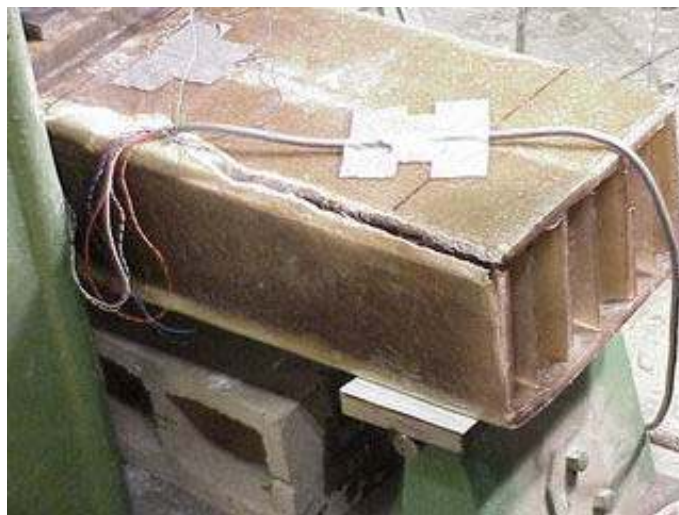
Figure 5-37 Failure mode in Test 3

The failure observed in Test 3 was different from the failures reported in the previous tests. The beam failure was pseudo-ductile. The face debonded from the core progressively starting at 36 kips. The delamination started at the top of midspan and propagated toward the end of the beam. The top face did not debond uniformly and only the back side of the core buckled as shown in Figure 5-37.

This failure mechanism is probably due to workmanship in the manufacturing process. The bond between the top face and the core was not of uniform quality and this induced the premature debonding. This decreased the strength of the beam as compared to the two previous beams. After the test, visual inspection of the beam showed that one side of the face was completely debonded from the core.

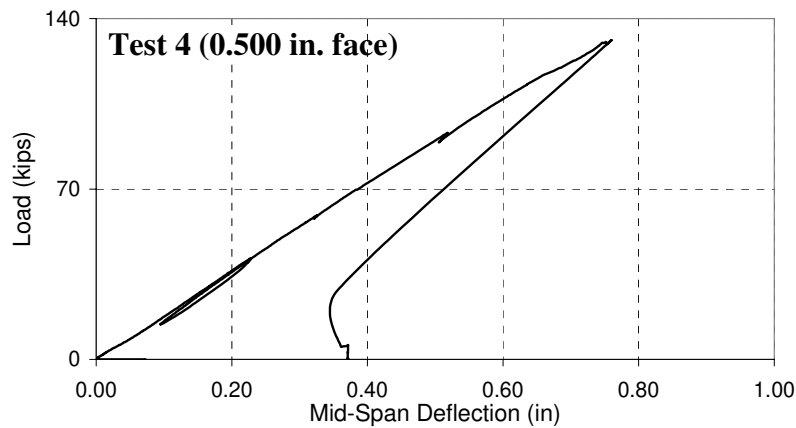
Figure 5-38 Load-deflection curve for Test 4

The load-displacement curve for Test 4 is perfectly linear up to 108 kips as shown in Figure 5-38. From 108 kips up to failure, the load-displacement curve becomes slightly nonlinear. The beam failed at 131 kips with a deflection of 0.76 in.

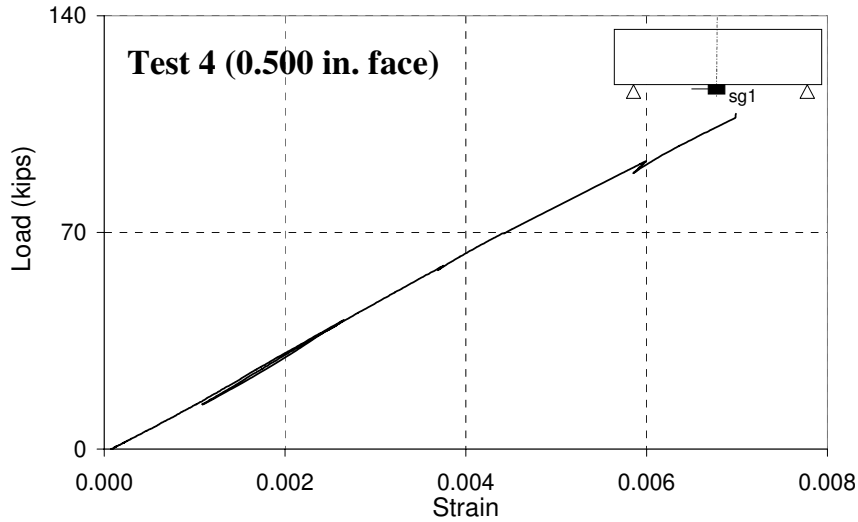
Figure 5-39 Load-strain curve for Test 4 (gage sg1)

The strain gage located at midspan under the beam indicated that the response was linear elastic up to 108 kips as shown in Figure 5-39. The gage probably failed at a smaller load level than the beam. This may be due to gage malfunctioning or a localized failure (some fibers might have broken at this location).

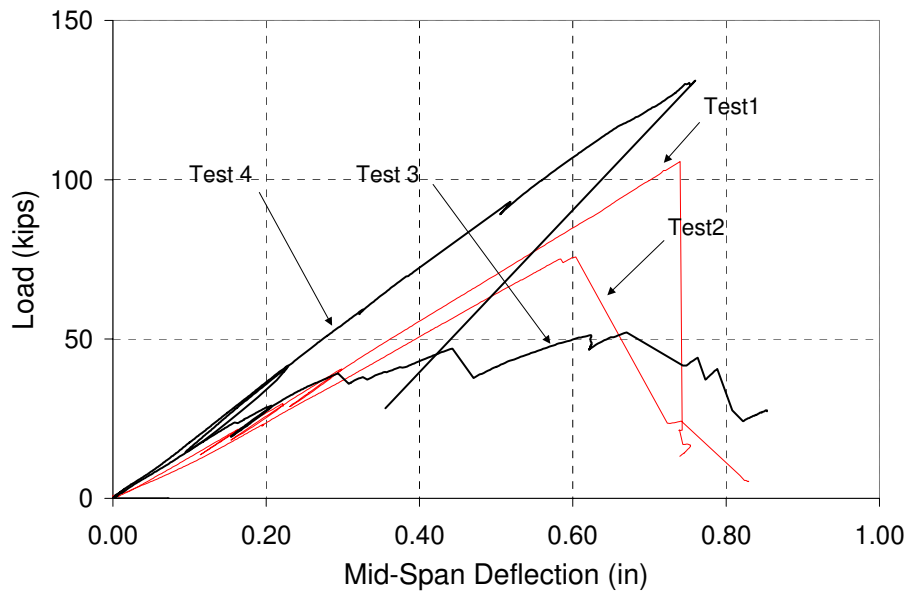
Figure 5-46 Load-displacement curves for the four tests

Figure 5-46 shows the load-displacement curves for the four tests. The figure shows that the face thickness influenced the stiffness of the beams as reflected by their moment of inertia shown in Table 5-3.

Section 600 of the City and County of Denver provisions requires that the midspan deflection shall not exceed 1/500 of the clear span for a one-foot-wide beam subjected to a 10-kip load. The span length, L, is 48.5 in. Therefore, $L/500=0.097$ in. For Test 1, the midspan deflection at 10 kips was 0.080 in. For Tests 2, 3, and 4, they were 0.093, 0.068, and 0.060 in., respectively. However, it should be mentioned that the beams in Test 1, Test 3, and Test 4 were 13-in. wide. The midspan deflection is directly proportional to the moment of inertia of the beams. A 12-in.-wide beam deflects about 8% more than a 13-in.-wide beam. For Tests 1, 3, and 4, the adjusted deflections for a one-foot-wide beam are 0.087, 0.074, and 0.065 in., respectively. Therefore, the beams satisfied the deflection requirement.

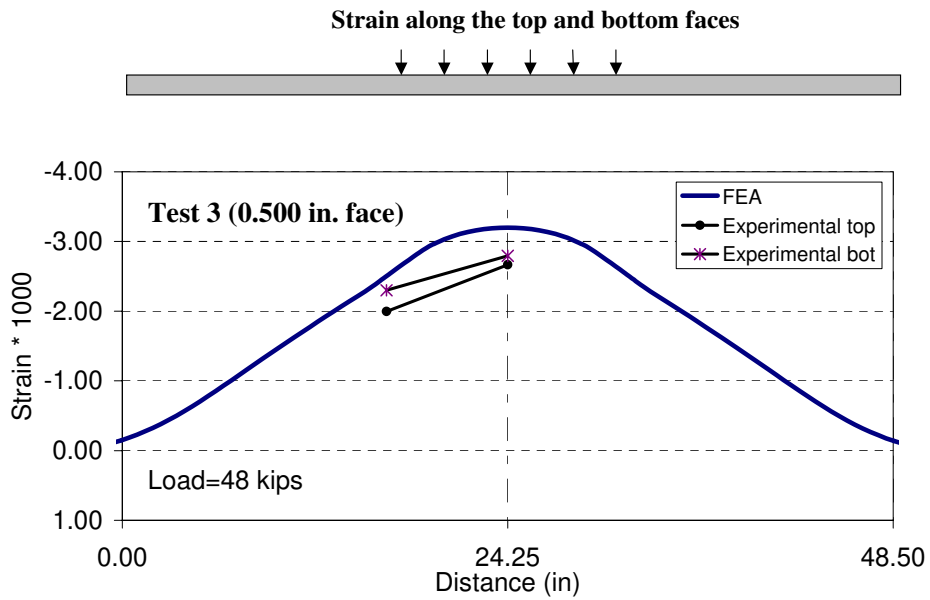
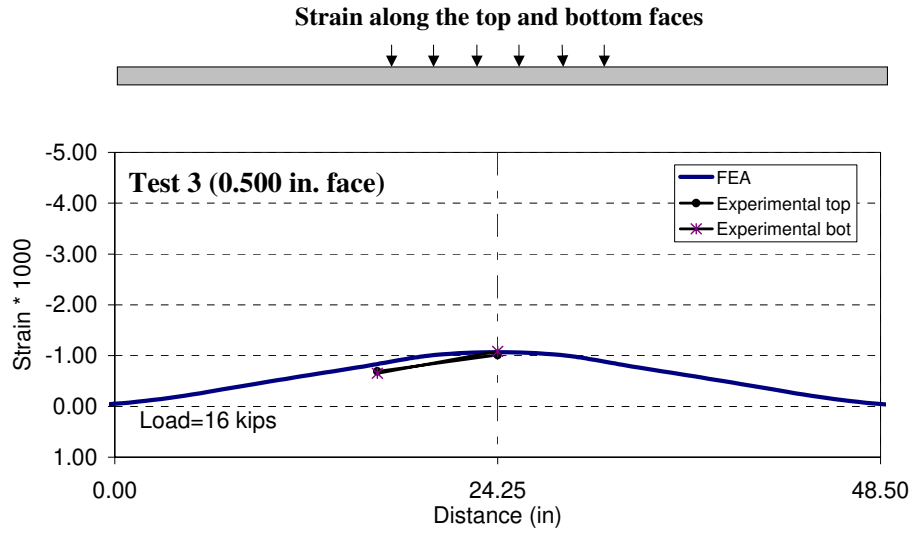
Figure 6-17 Strain distribution along the top and bottom faces of the beam in Test 3 at different loading stages (only the top stain is shown for the FEA)

In the third test, the face debonded early as the load increased. The face started to debond at 23 kips. Below this load level, the FE analysis agrees with the experiment well as shown for a load of 16 kips in Figure 6-17. This was a stage when the beam was still acting as a full composite. After delamination, the difference between the FE analysis and test results increases as shown for a load of 48 kips in Figure 6-17. This is due to the loss of the composite action. The experimental strain in the face is smaller than the calculated value because of the face slip. Furthermore, Figure 6-17 shows that at a load of 48 kips, the experimental strain in the bottom face is larger than that in the top face. This indicates that the top face had more severe debonding than the bottom face, probably due to the localized bending effect caused by the steel loading plate.

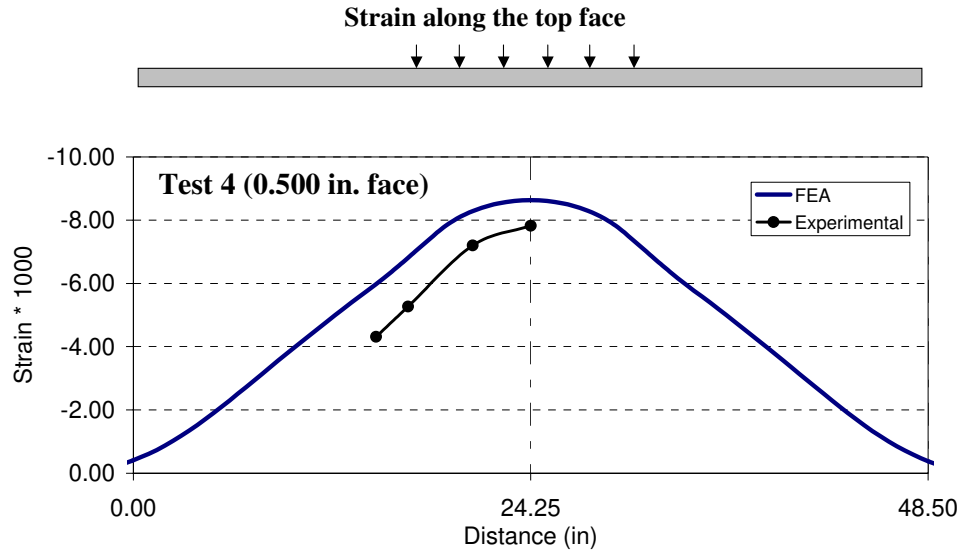
Figure 6-18 Strain distribution along the top face of the beam in Test 4

Figure 6-18 compares the numerical and experimental strain distributions along the top face of the beam in Test 4 at a load of 130 kips. Again, the experimental values are lower than the numerical results probably due to debonding.

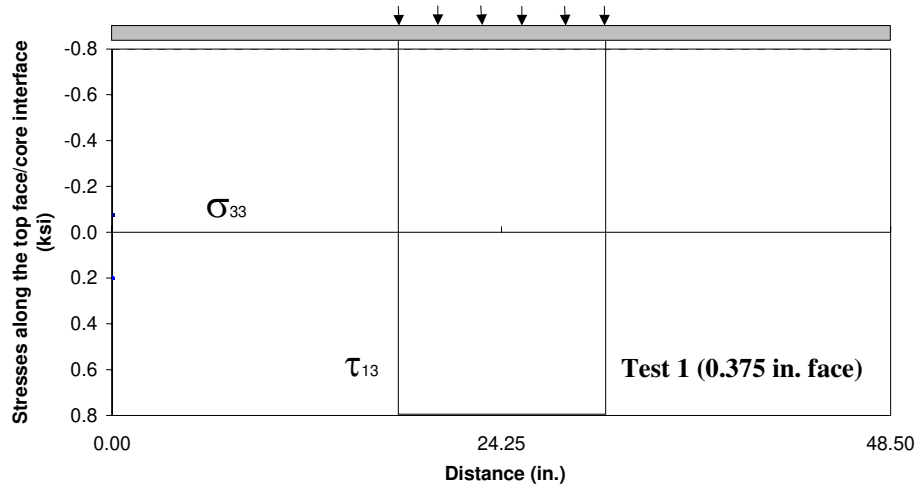
Figure 6-19 Stresses along the interface between the top face and the core of the beam in Test 1 from FE analysis

In the FE analyses, the faces of the beams are modeled by a single layer of linear triangular elements and the interface shear stresses are computed at the nodes. Figure 6-19 shows the peeling stresses (σ_{33}) and the shear stresses (τ_{13}) at the top face-core interface of the beam in Test 1 obtained by the FE analysis at a load of 100 kips, which is just below the failure load of 103 kips. As mentioned before, the peeling stresses are so small that they have little influence on the delamination. The shear stresses are predominant and exhibit a peak just outside the loading plate. In the aerospace research community, this stress concentration behavior is a well-known problem for sandwich panels and is called the indentation problem. It is associated with local plate bending and it is due to the local deformation of the loaded face into the soft core. Several researchers (Thomsen and Frostig 1997, Polyakov 2000, Lee and Tsotsis 2000) investigated this problem and showed that the stress predictions based on classical theories are incorrect. Figure 6-20 shows the maximum and minimum principal stresses for Test 1 just below the load of 100 kips. The arch mechanism is clearly shown by the pattern of the minimum principal stresses. The maximum principal stresses indicate a tension oriented at about 45 degrees just outside the loading plate.

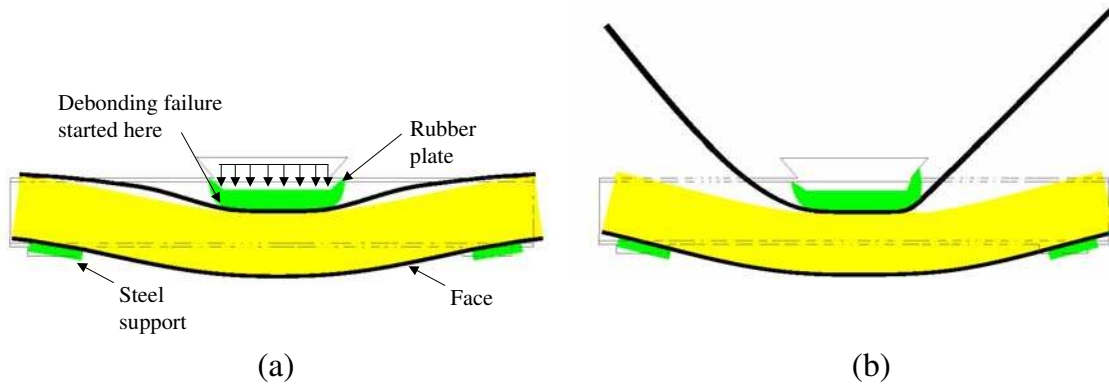
Figure 6-25 Deformed shape after failure (Amplification factor of 5)

Figure 6-25 shows the deformed shape at failure for Test 2. Debonding starts near the edge of the loading plate (Figure 6-25 (a)), and propagates toward the end of the

beam (Figure 6-25 (b)). This result matches the experimental observation.

Debonding failure
started here

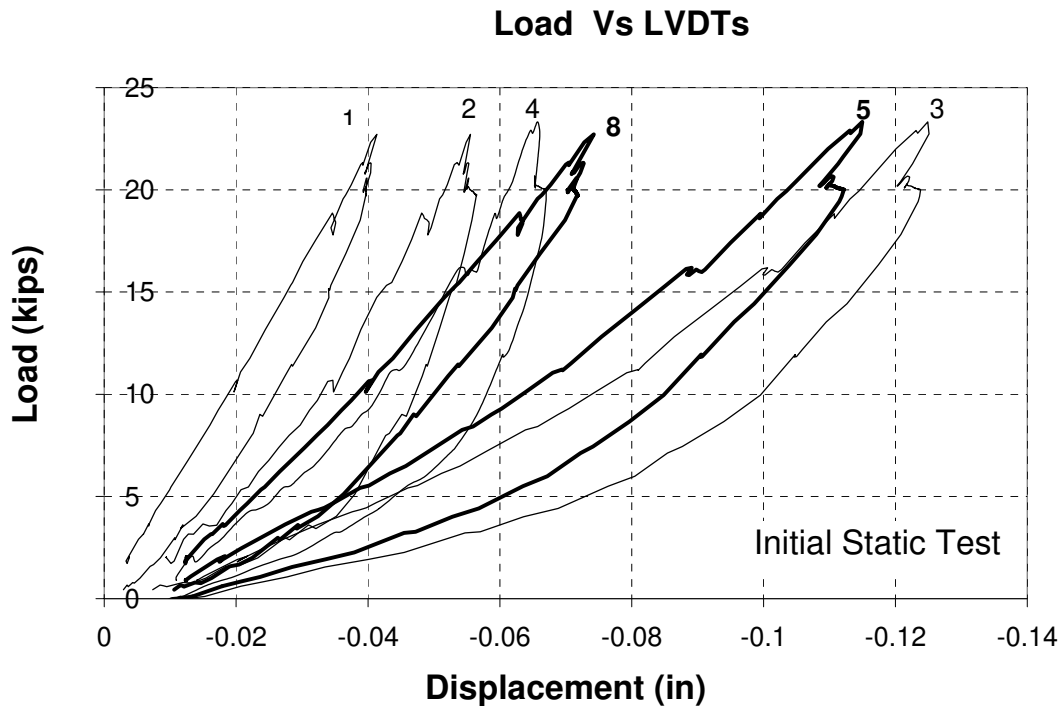
Figure 7-10 Load-displacement curves for the initial static test

The anchor bolts on riser R_1 (see Figure 7-9) slipped during the test. Visual inspection at the end of the static test showed that the bearing pad placed on riser R_1 moved from the initial position. The pad rotated and left a gap between the riser and the panel at the location of line C-C, and this explains why LVDT 3 registered a larger deflection than LVDT 5. The deformed shape of the panel at 22 kips, drawn with AUTOCAD 2000 using the LVDT readings, is shown in Figure 7-11. In this figure, a Bezier curve is used to approximate the deformed shape and estimate the actual deformation of the panel. A Bezier curve is a simple cubic equation and was originally developed by Pierre Bézier in the 1970's for CAD applications. A cubic Bezier curve is defined by four points: (x_0, y_0) is the origin point, and (x_3, y_3) is the destination point, and (x_1, y_1) and (x_2, y_2) are control points.

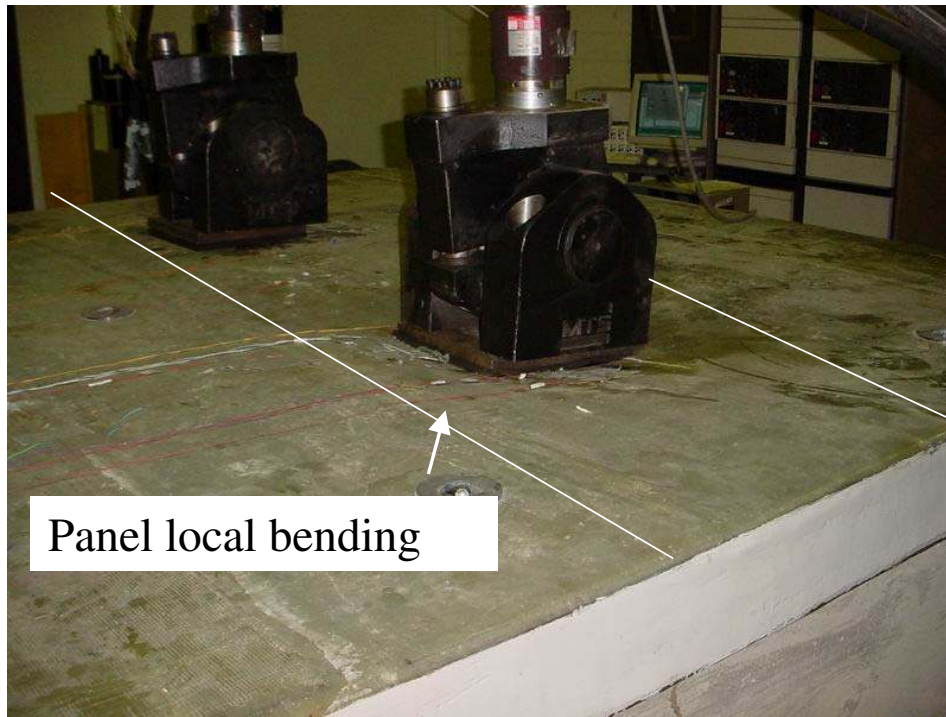
Figure 7-16 Picture of the panel local bending

Since no panel delamination was expected at this loading stage, the shift of the neutral axis was probably caused by the member tension exerted by the anchor bolts as the panel experienced excessive settlement at riser R_1, as illustrated in Figure 7-18.

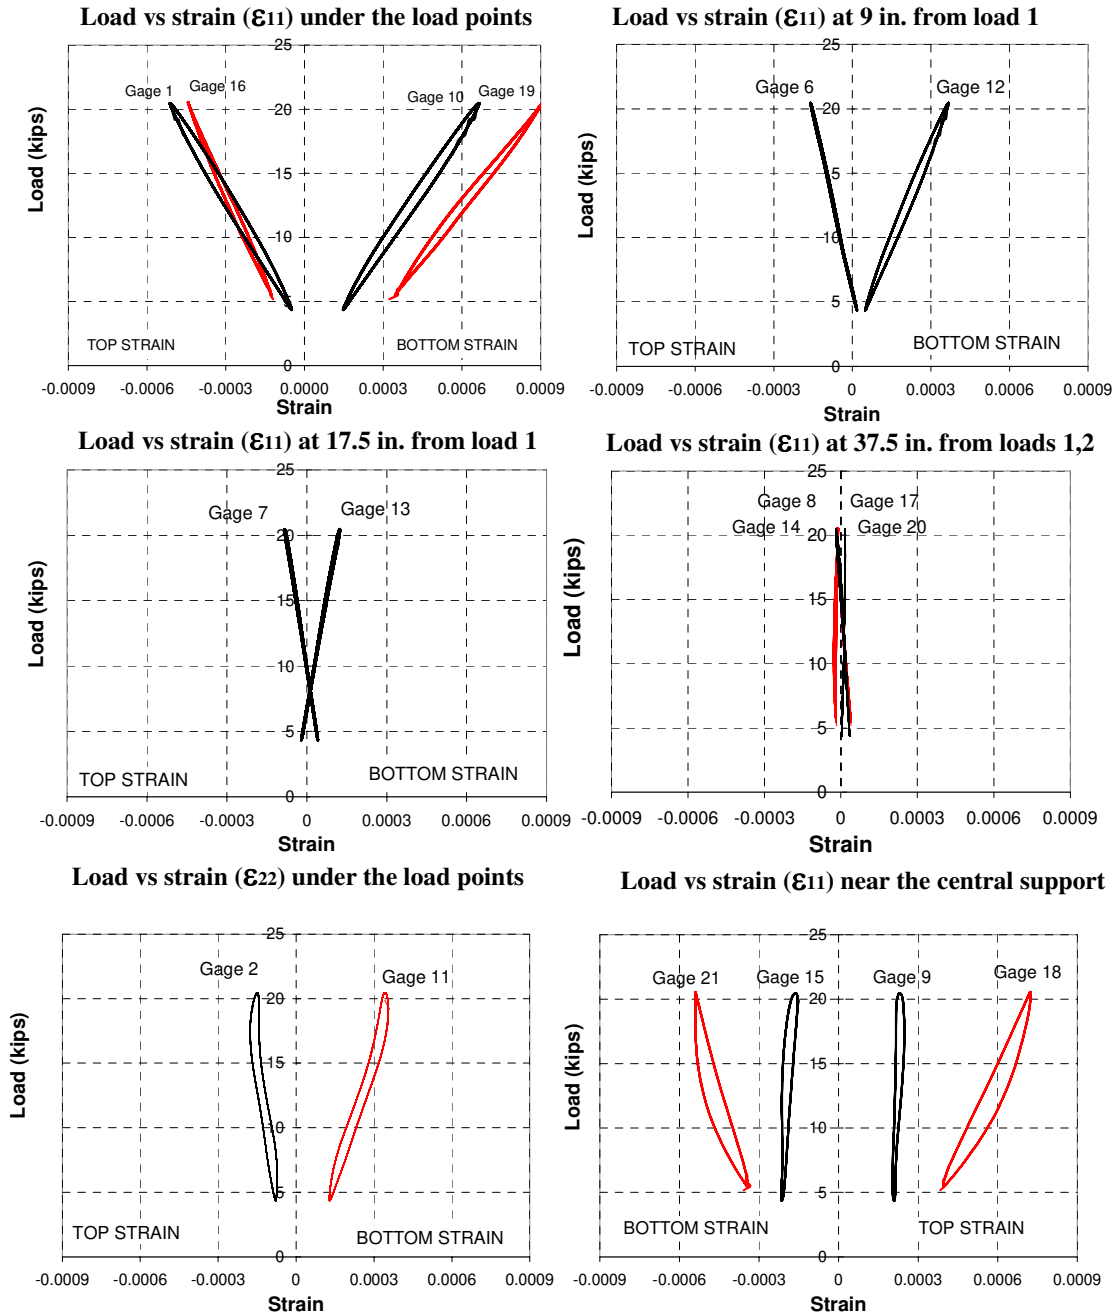
Figure 7-19 Load-strain curves for all the strain gages at 15,000 cycles

The two spans were loaded by two actuators with sine waves that were 180° off-phase and a maximum load of 40 kips in each actuator. At about 14,000 cycles, Span 2 started emitting a strong noise near the loading plate. Inspection of the panel did not show any external damage. The noise was very likely caused by the delamination of the upper face from the core. Between 15,000 and 15,200 cycles, data were recorded for 200 cycles (Cyclic data 1 in Table 7-2). The load-strain curves are shown in Figure 7-19.

Gages 16, 18, 19 and 21 glued on Span 2 show permanent deformation. Gages 16 and 19 were attached to the top and bottom faces of the panel right underneath the load in Span 2. Gage 19 showed a larger strain than gage 16. This was probably caused by the delamination of the top face. The gages glued at 37.5 in. from the loading point showed

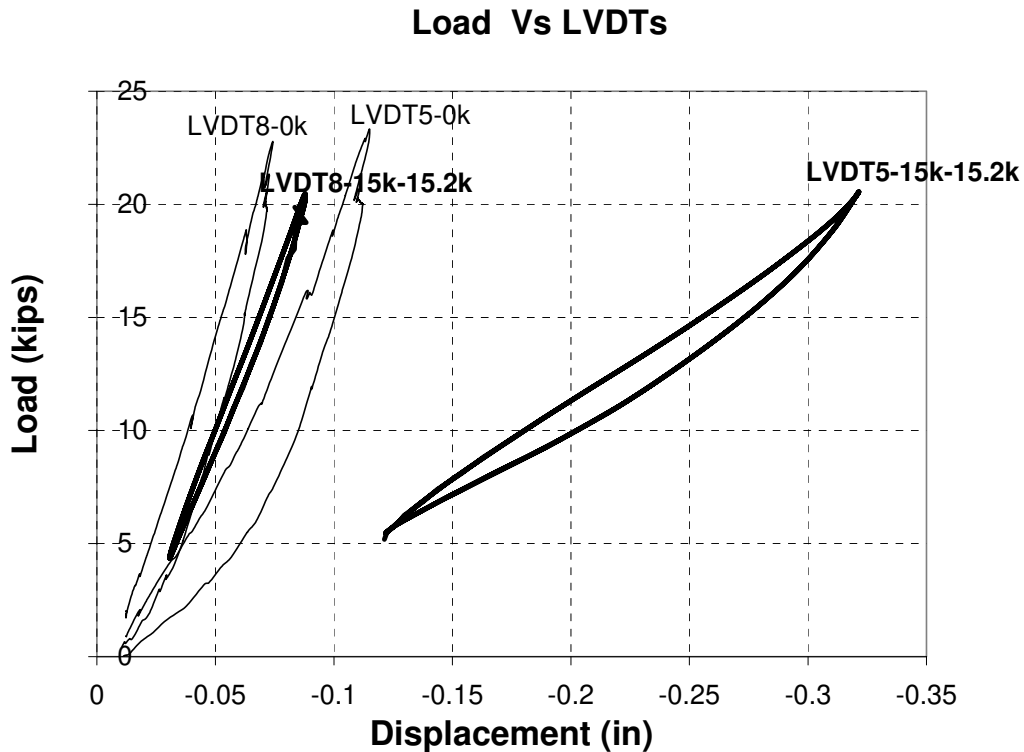
Figure 7-20 Comparison of the load-displacement curves at the initial static test (0k) and between 15,000 and 15,200 cycles

Figure 7-20 compares the load-displacement curves obtained from the midspan locations at the initial static test (0) and between 15,000 and 15,200 cycles. As indicated in Table 7-1, the loading schemes are different, and, therefore, the stiffnesses cannot be compared directly. However, LVDT 8 showed similar results at the initial static test and between 15,000 and 15,200 cycles, while LVDT 5 indicated a much larger deformation between 15,000 and 15,200 cycles than at the initial static test. This is probably due to the delamination of one of the faces from the core in Span 2.

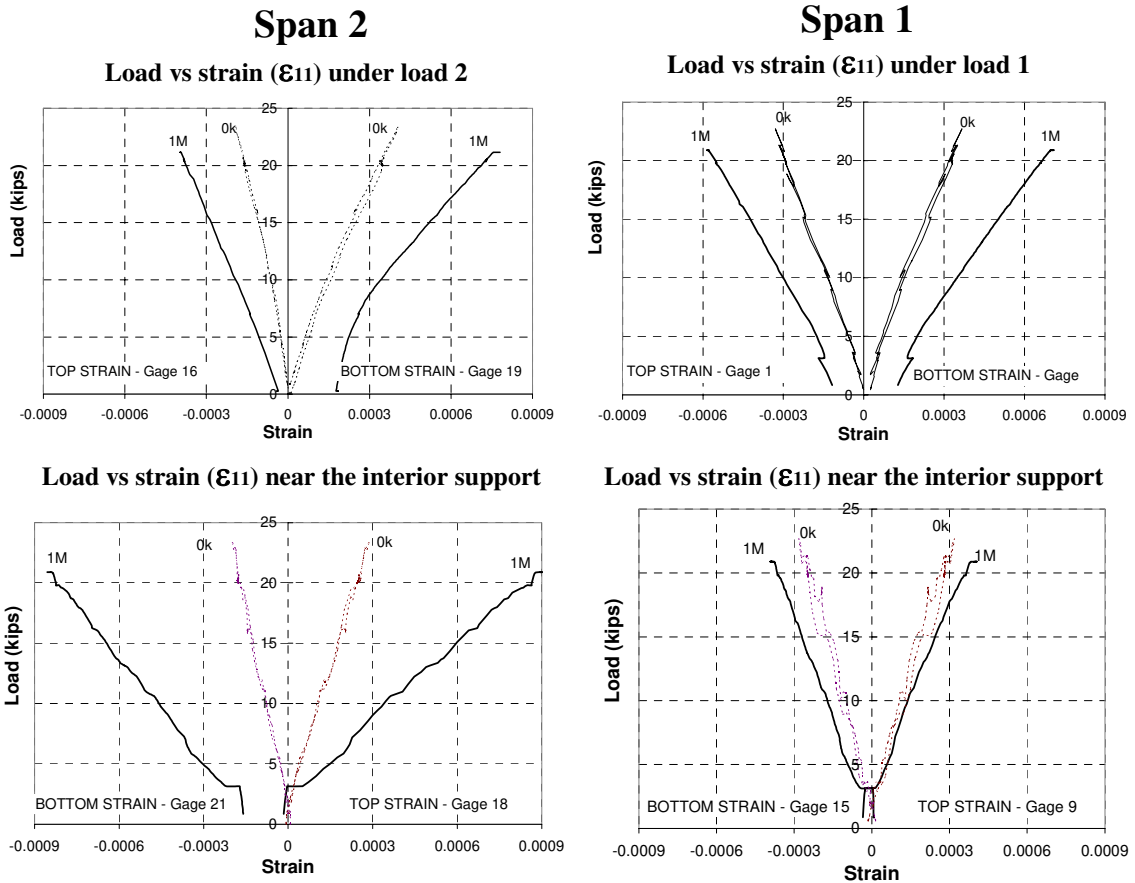
Figure 7-22 Load-strain curves at 1,000,000 cycles

At 370,200 cycles, the deck was examined and no damage was observed. The loading of Actuator 1 was increased to a maximum load of 31 kips for subsequent cycles. At 1,000,000 cycles, the test was interrupted to perform a static test to evaluate the panel behavior (Static Test 1M in Table 7-2). To compare the results with those of the initial static test, both spans were loaded at the same time up to 20 kips. Figure 7-22 shows that the strains under the loading plates and near the interior support, R_2, were larger at 1,000,000 cycles than at the initial static test for both spans under similar loads. The stiffness change is probably due to damage in the interface between the faces and the

core. In particular, in Span 2, the strain near the middle support (negative moment region) at 1,000,000 cycles is more than four times larger than the strain at 0 cycle.

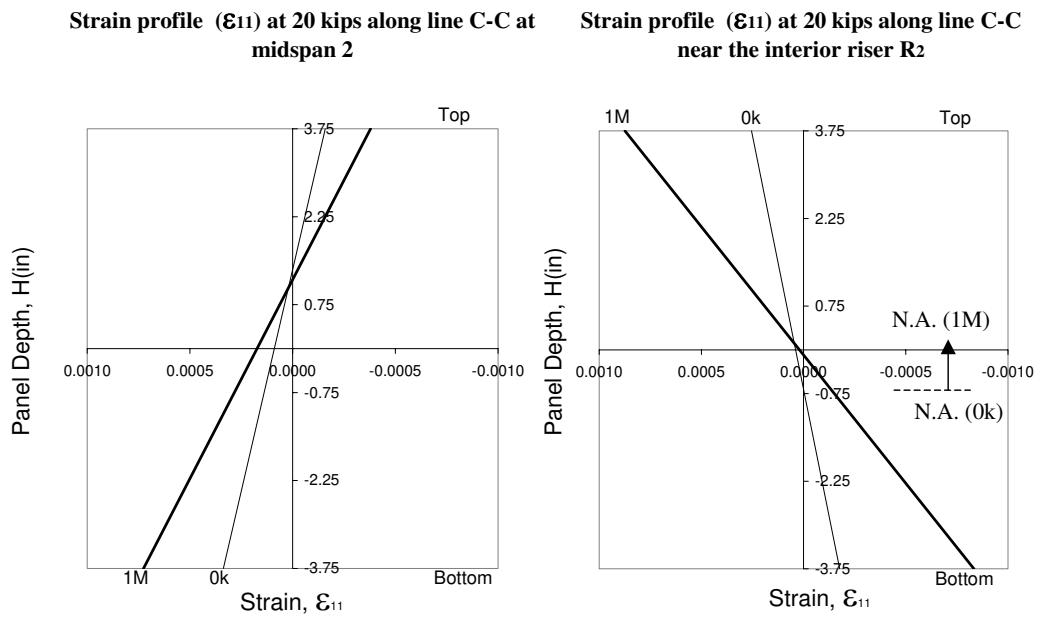
Figure 7-24 Strain profiles in Span 2

Figure 7-24 indicates that, near the interior riser, the top face was carrying less load than the bottom face at the initial static test and that the two faces were carrying the same amount of load at 1,000,000 cycles. This indicates that the bottom face could have delaminated after the fatigue load cycles.

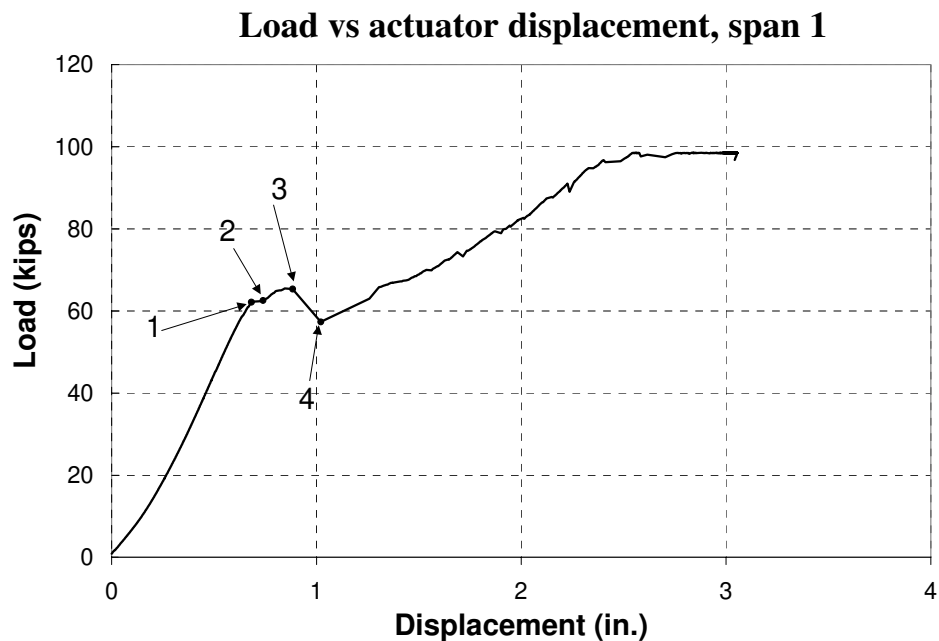
Figure 7-28 Load- actuator displacement curve for Span 1

After the fatigue test was completed, the two spans were loaded one at a time up to 100 kips. Figure 7-28 shows the load-actuator displacement response for Span 1. The beams that were tested previously and the panel behaved differently after delamination. For three out of the four beams tested, the failure was brittle. One beam showed a ductile-like behavior because the upper face was not glued uniformly to the core and had progressive delamination. The latter is similar to the panel behavior. In the panel, a crack formed in the face-core interface near the loading plate when the maximum shear stress exceeded the interface shear strength and the crack propagated gradually causing a ductile-like failure.

Between stages 3 and 4, the bottom face delaminated and the neutral axis shifted upward at the midspan and near the interior riser as shown in Figure 7-29 and Figure 7-30. The interface delamination was followed by a strong noise emission and a large load drop (stage 3 in Figure 7-28), which indicates a sudden energy release. A visible crack formed in the top face as shown in Figure 7-31. However, even when both faces delaminated, the panel did not collapse but was still carrying load because the damage was localized. This ductile-like behavior is desirable because it gives a warning prior to collapse.

After stage 4, as indicated in Figure 7-28, the load-actuator displacement curve shows small load drops, which were accompanied by noise emissions during the test. This means that the delamination propagated during the test. The figure shows that the damage propagation decreases the panel stiffness.

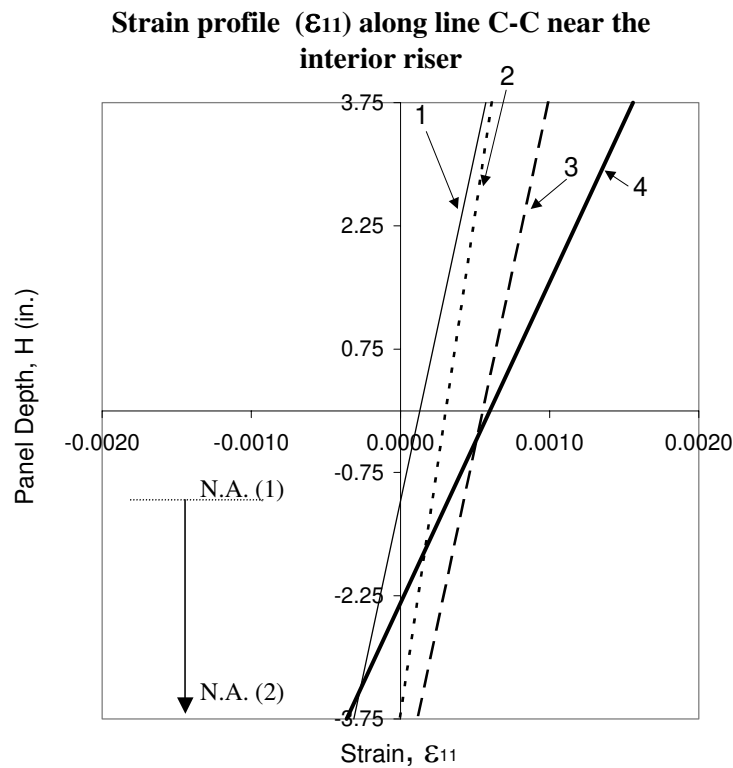
Figure 7-29 Strain profiles in Span 1 near the interior riser at 1,500,000 cycles

The strain profiles for Span 1 at different loading stages, 1, 2, 3 and 4 in Figure 7-28, are shown in Figure 7-29 and Figure 7-30. Both strain profiles show that the neutral axis moved downward between stages 1 and 2. This response indicates that the top face delaminated from the core.

Figure 7-29 shows that the strain at the bottom face near the interior riser was zero at stage 2, and the strain became positive at stage 3. Furthermore, at stage 3, the neutral axis near the interior riser was outside of the cross section. This is possible only if there was a horizontal tensile force acting on the panel (see Figure 7-18), which was probably caused by the anchor bolts as explained earlier. Figure 7-30 indicates that between stages 2 and 3, the neutral axis at midspan moved upward confirming that there was a horizontal force acting on the panel.

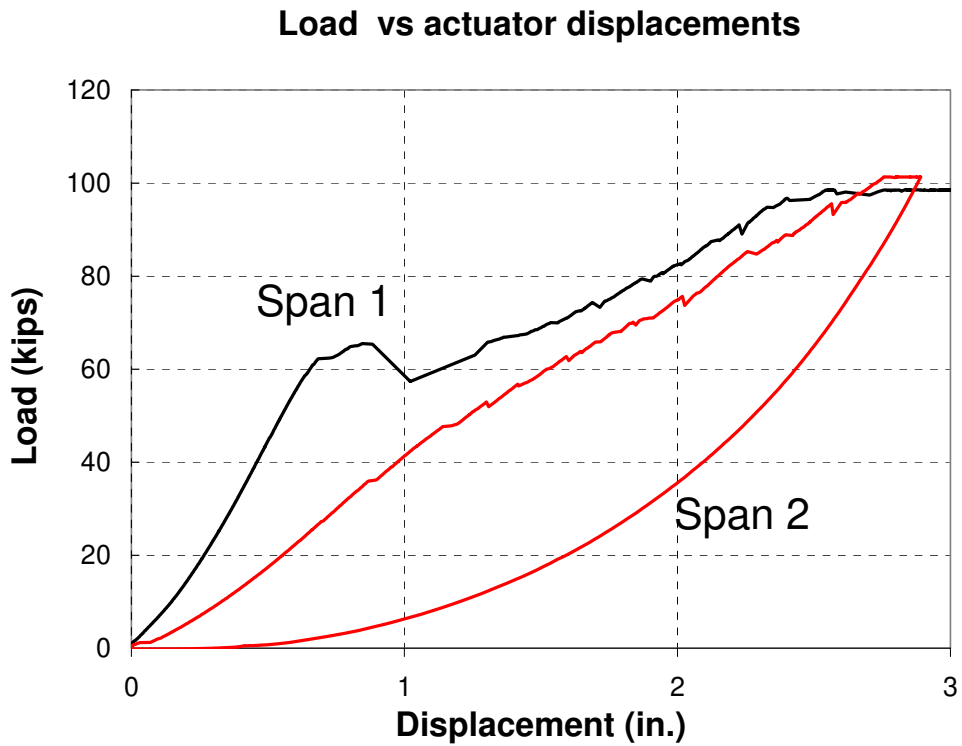
Figure 7-32 Load – actuator displacements for Span 1 and 2

Figure 7-32 shows the load – actuator displacement curves for both spans. The load – actuator displacement for Span 2 does not show as large a load drop as for Span 1. Probably, the delamination of both faces occurred during the fatigue test, and for this reason, the curve does not show a sudden large load drop. This prior damage caused stiffness reduction as shown in Figure 7-32. The unloading branch indicates that there was a permanent plastic deformation when the panel was completely unloaded.
