REPORT NO. FRA/ORD-77/14

FATIGUE CRACK PROPAGATION IN RAIL STEELS

BATTELLE COLUMBUS LABORATORIES
505 King Avenue
Columbus OH 43201

JUNE 1977
INTERIM REPORT

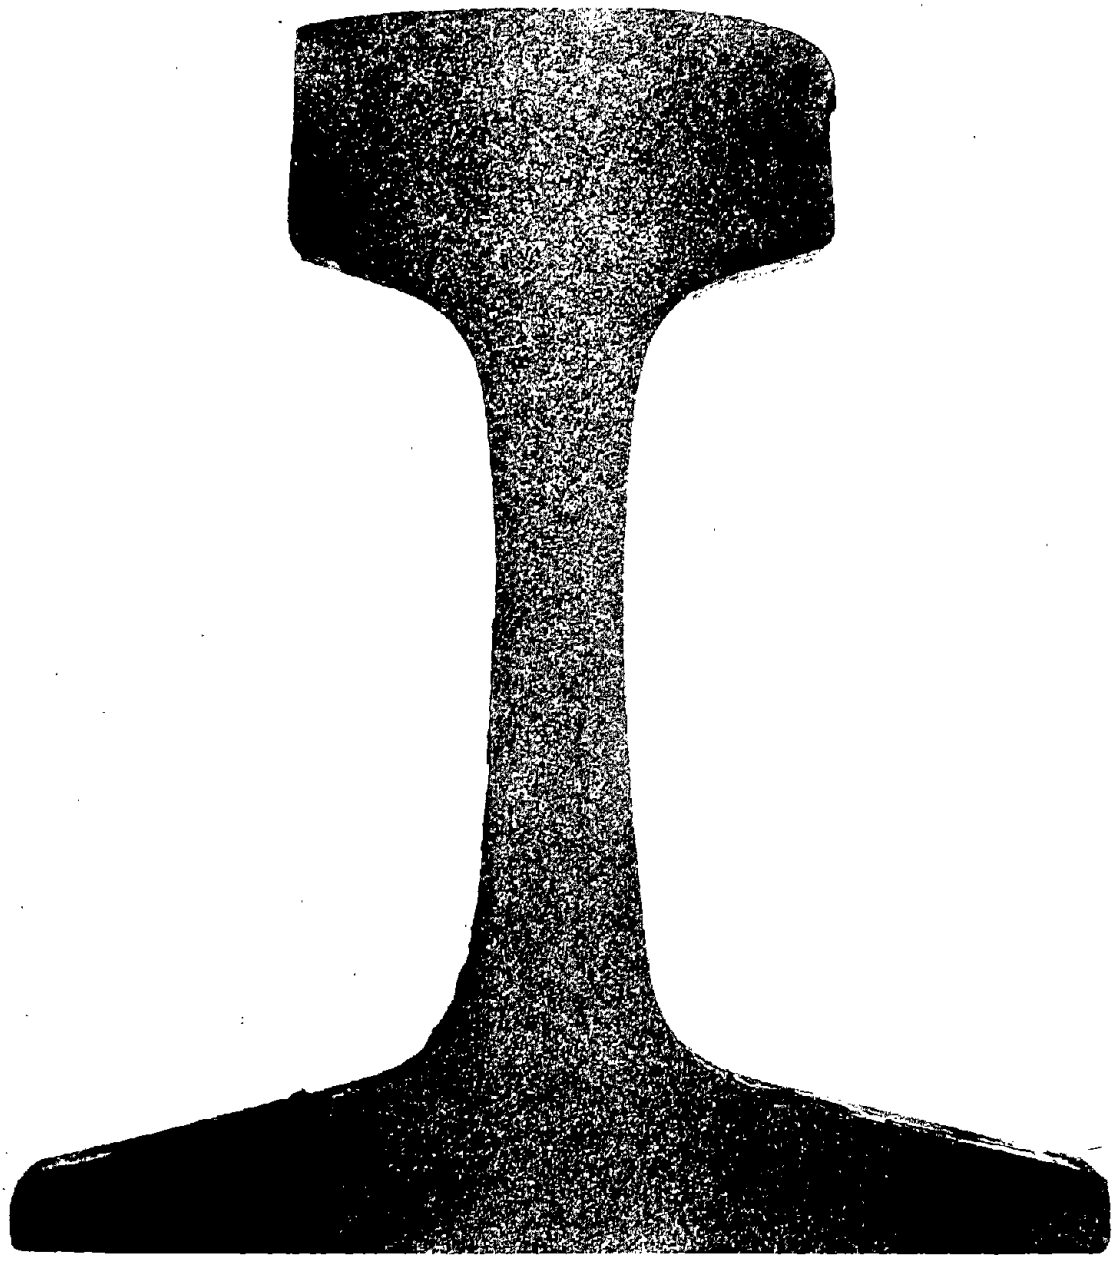
FIGURE 1. TYPICAL COARSE-TEXTURED MACROSTRUCTURE OF RAILS - SAMPLE 027

Most of the 66 rail samples exhibited uniform macrostructures throughout their full cross sections. The principle variances in the macrostructures among the rail samples were differences in fineness or coarseness. These differences may be related to the prior austenite grain size and/or the pearlite colony size. Typical macrostructures observed are exemplified by the photomacrographs in Figures 1 and 2, Samples 027 and 019, respectively. Figure 1 shows a typical coarse-textured macrostructure which was observed in 19 rail samples (Samples 007, 012, 014 through 018, 020 through 024, 027 through 032, and 042). Figure 2 shows a fine-textured macrostructure which was observed in the remaining 47 rail samples, except for Sample 058. Sample 058 had a macrostructure which exhibited very little of a structural pattern as shown in Figure 3.

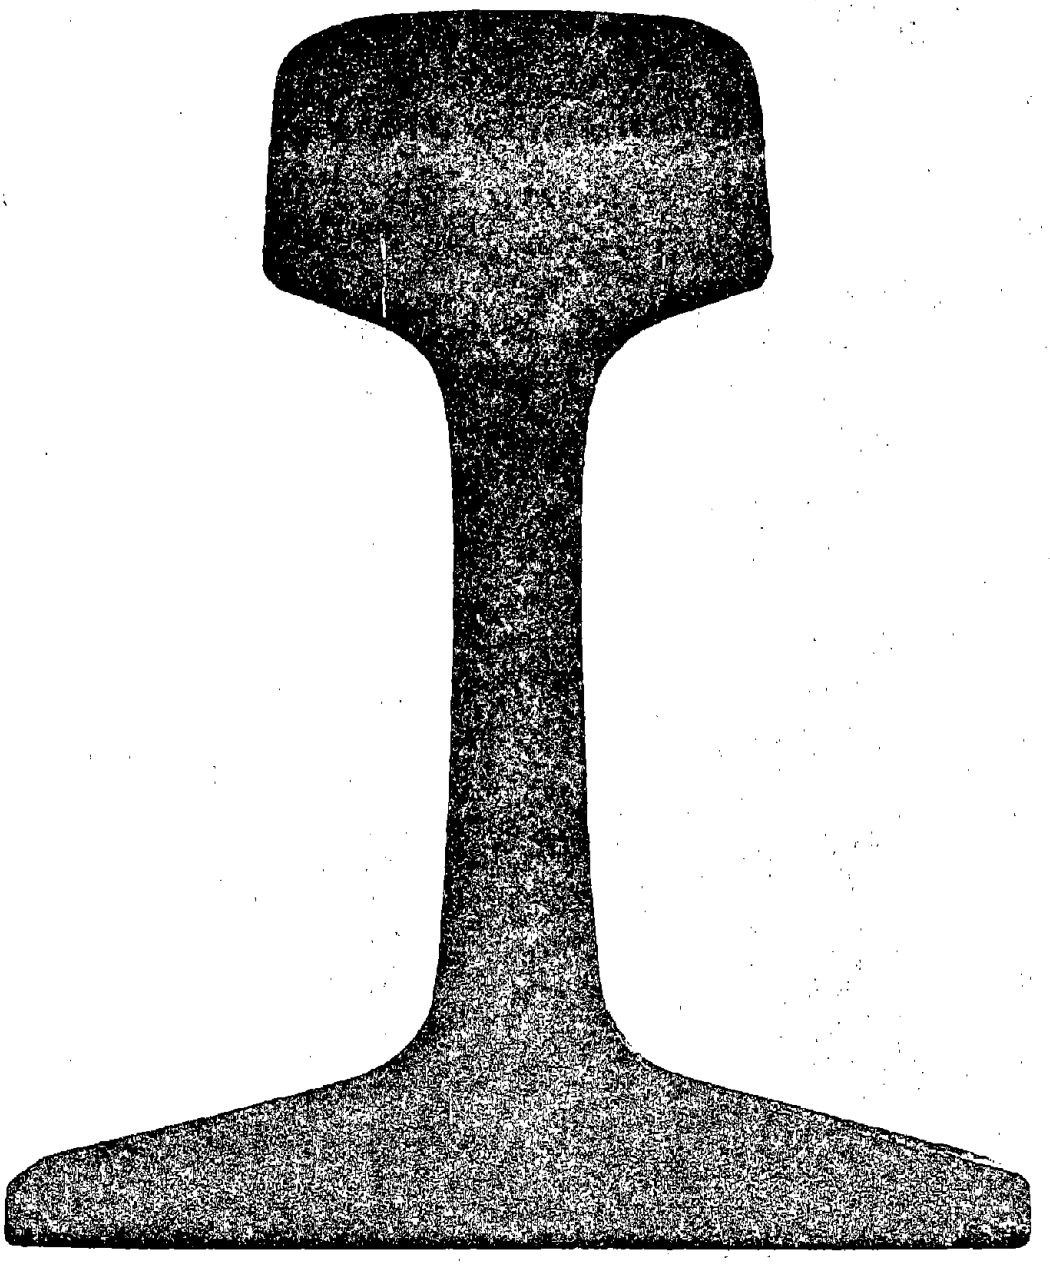
FIGURE 3. MACROSTRUCTURE OF RAIL SAMPLE 058
Note lack of any structural pattern.

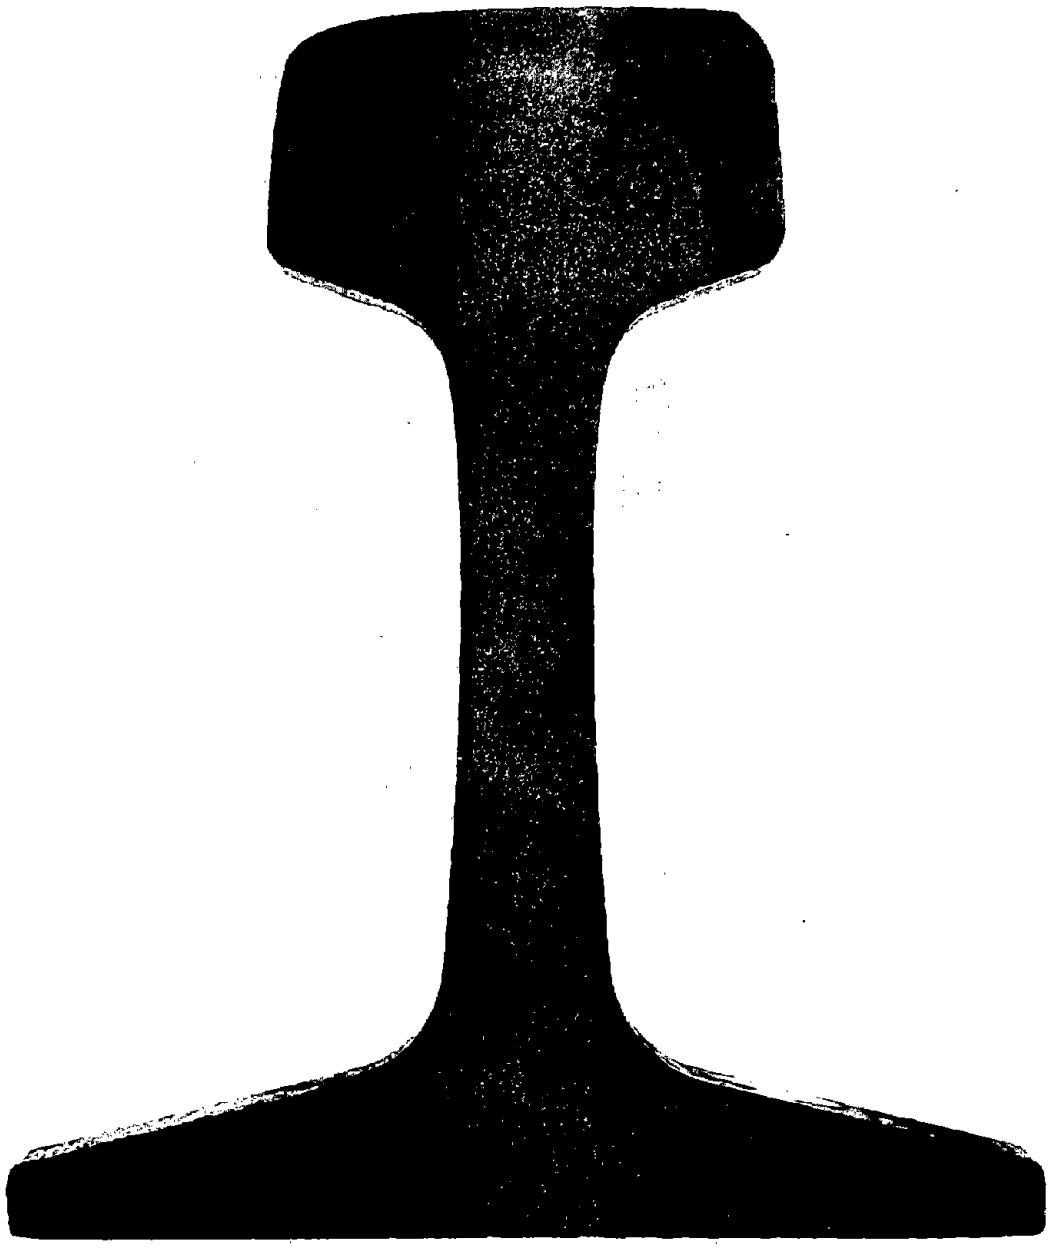
The macrostructures of Samples 046 and 059 showed that the running surfaces apparently had been heat treated. The heat-treated surface of Sample 059 is evident in Figure 4. The surface heat treatment suggested that these two samples were from the ends of rails that were end-hardened, a process commonly used to reduce wheel batter at the rail joint.

FIGURE 4. MACROSTRUCTURE OF A HEAT-TREATED RUNNING SURFACE - RAIL SAMPLE 059

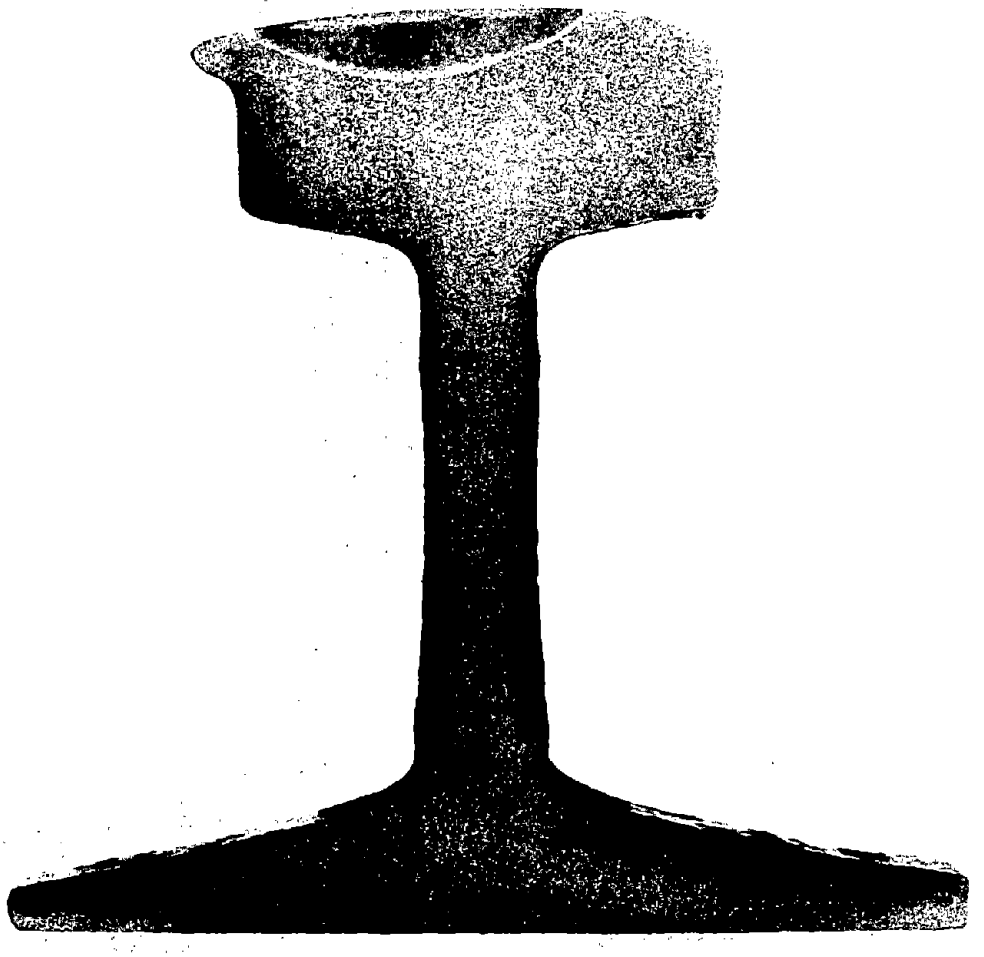
The macrostructure of Sample 002 showed that its running surface apparently had been repaired by the mechanical removal of surface damage and subsequent deposition of weld metal. The repair weld in this sample is evident in Figure 5.

FIGURE 5. MACROSTRUCTURE OF A REPAIRED RUNNING SURFACE - RAIL SAMPLE 002

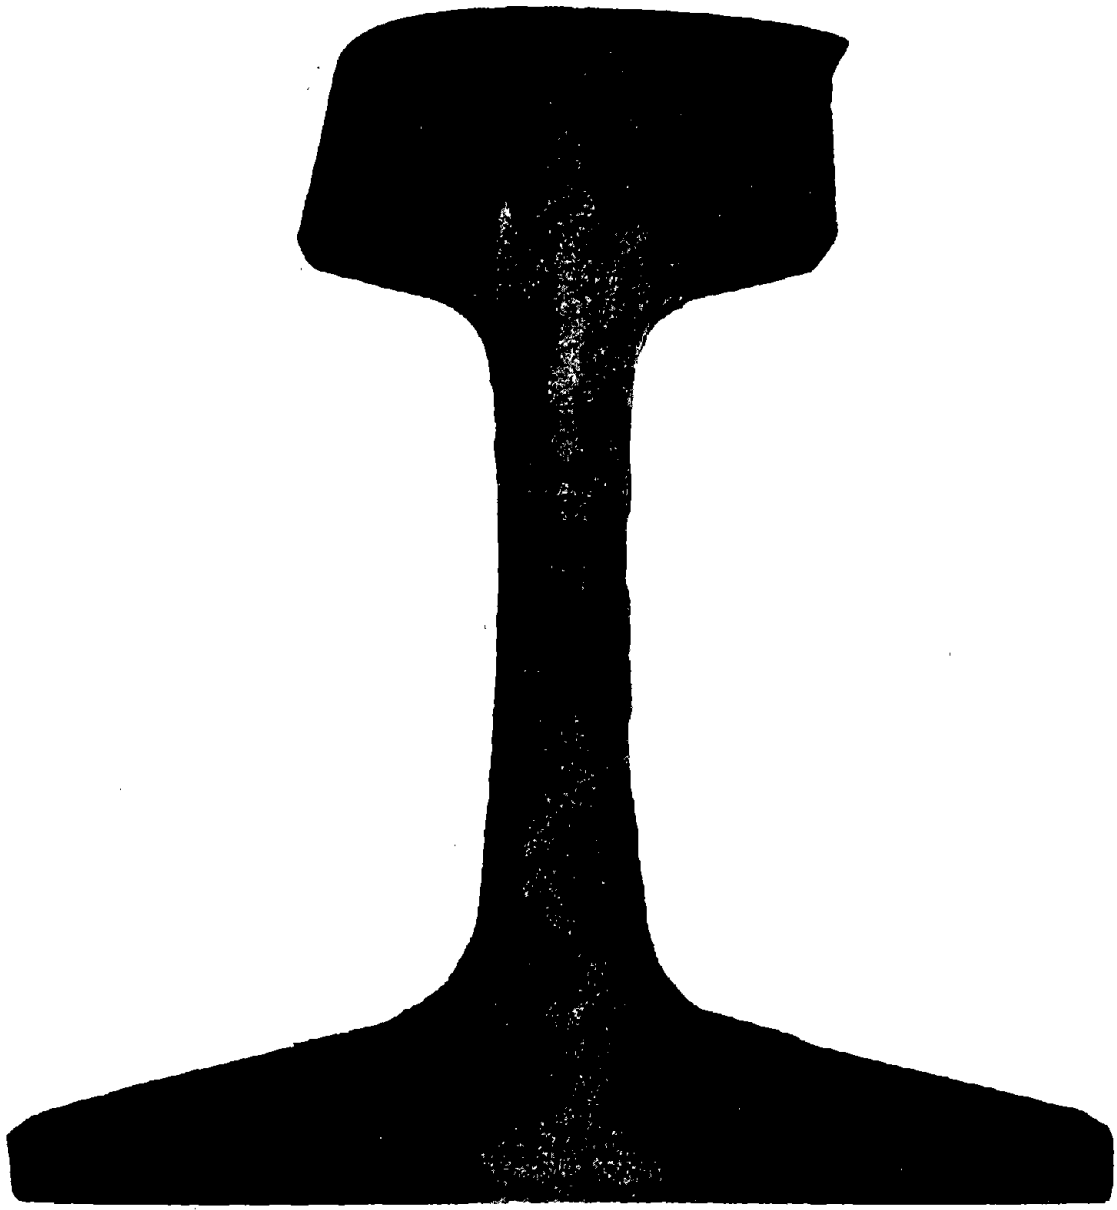
The macrostructure of Sample 001 showed evidence of a high inclusion content and internal fissuring, both conditions being located primarily in the web section and at the bottom of the head section. These conditions can be seen in Figure 6.

FIGURE 6. MACROSTRUCTURE OF RAIL SAMPLE 001
Note internal fissures.

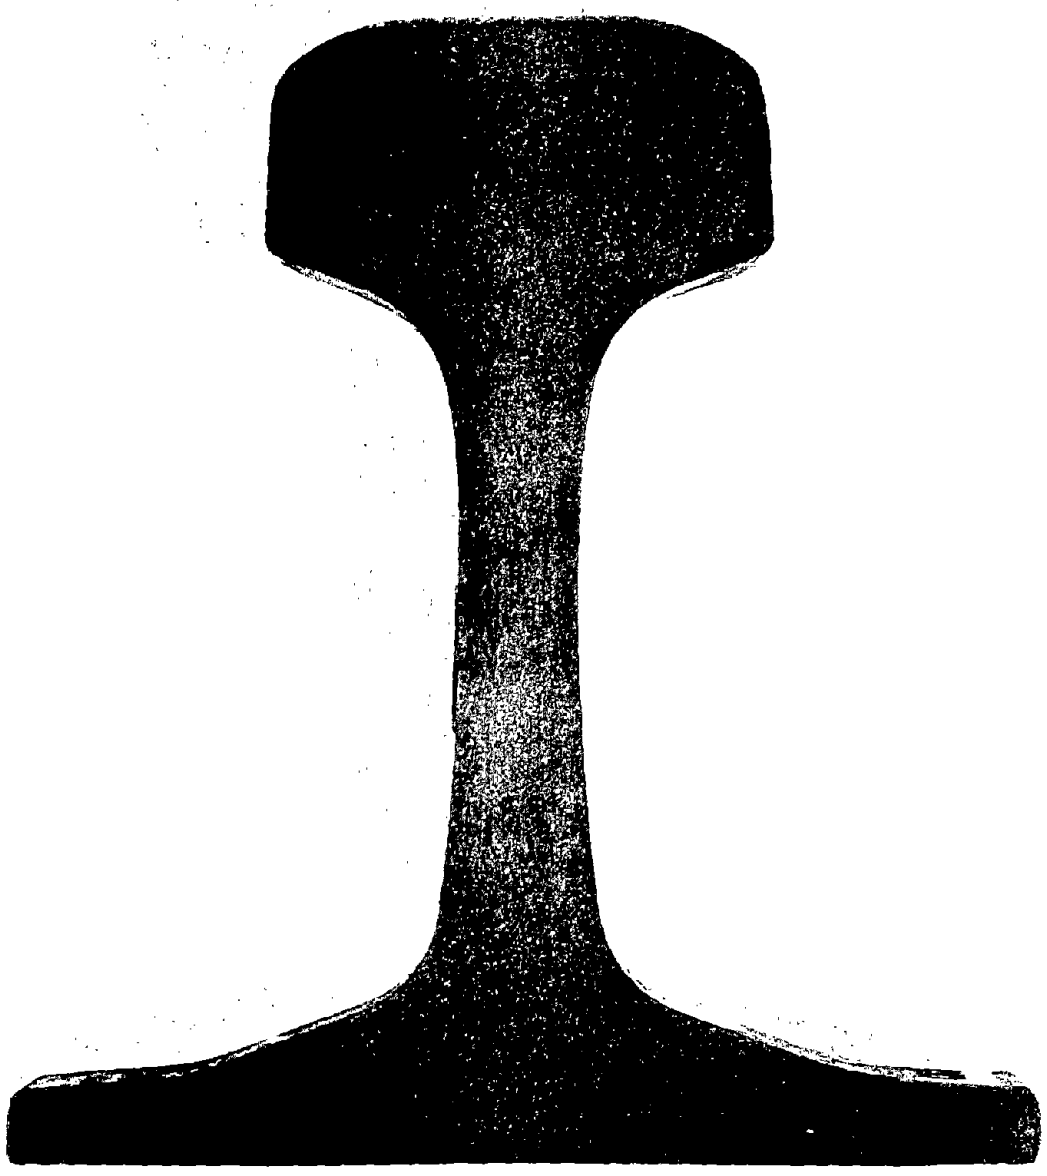
Cracks were observed in the macrostructures of Samples 061, 062, and 063. The cracks in these three rails were located centrally in the web below the rail head. All three cracks extended through the entire thickness (1 inch) of the transverse cross sections. The cracks are believed to be the remains of shrinkage porosity formed in the steels during solidification of the original ingots. The cracks are visible in the photomacrographs of Samples 061, 062, and 063 shown in Figures 7, 8, and 9, respectively. Sample 062 exhibited decarburization around the crack as indicated by the white zone in Figure 8.

FIGURE 7. MACROSTRUCTURE OF RAIL SAMPLE 061
Note crack in the web.

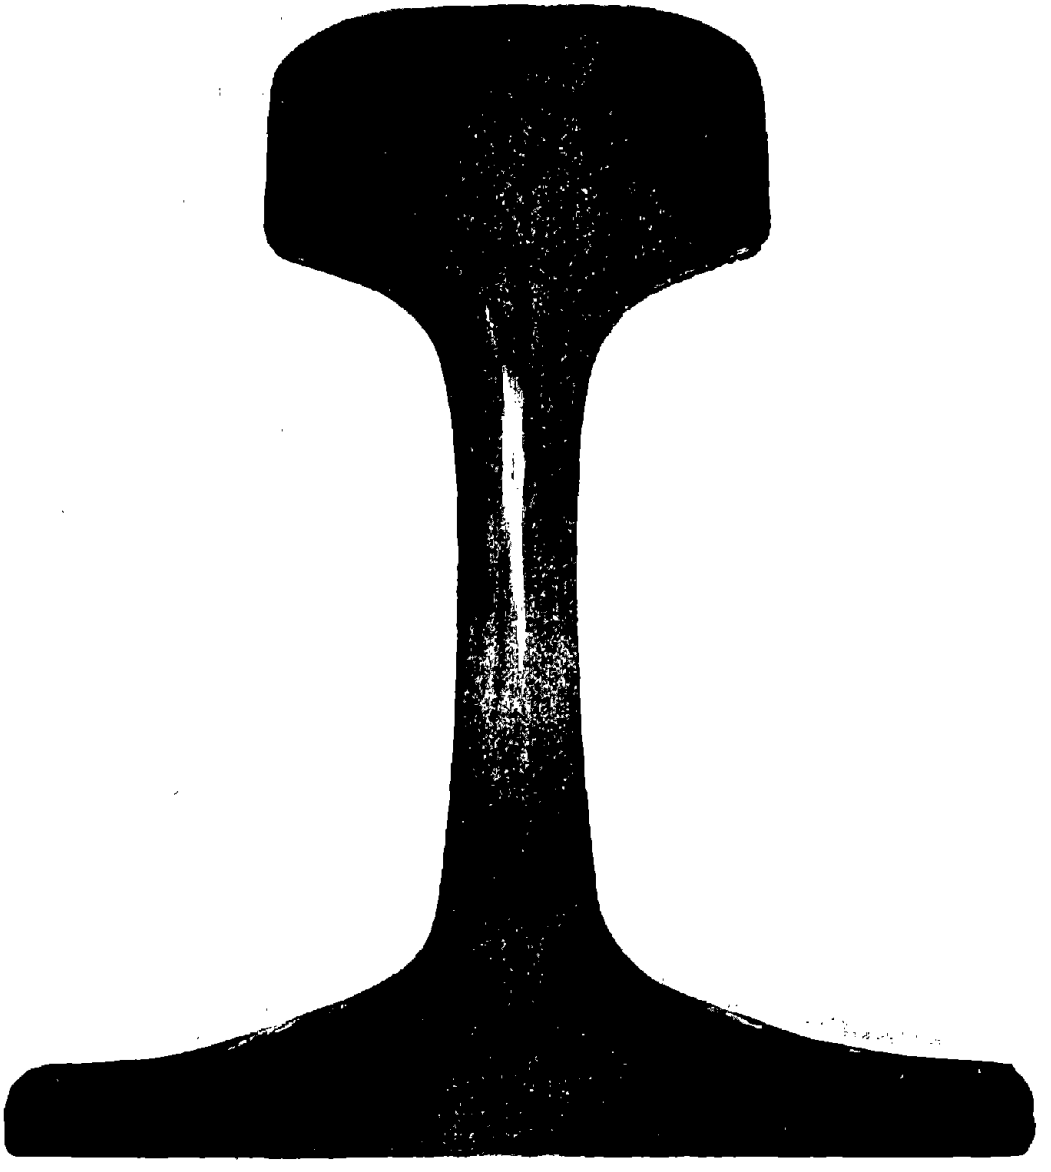
FIGURE 8. MACROSTRUCTURE OF RAIL SAMPLE 062
Note segregation and crack in the web.

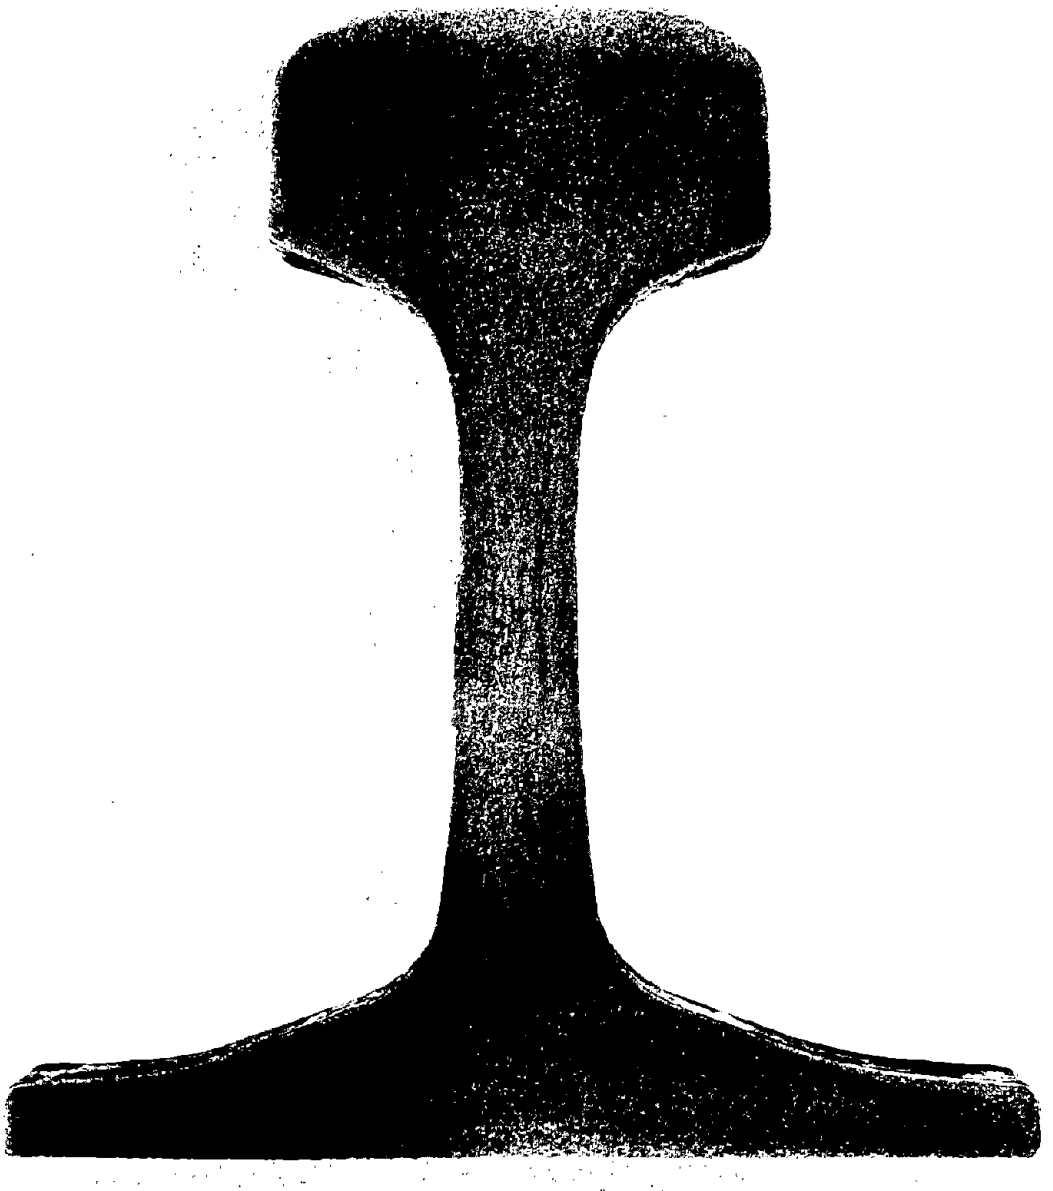
FIGURE 9. MACROSTRUCTURE OF RAIL SAMPLE 063

Note hairline crack in the central area of the web.

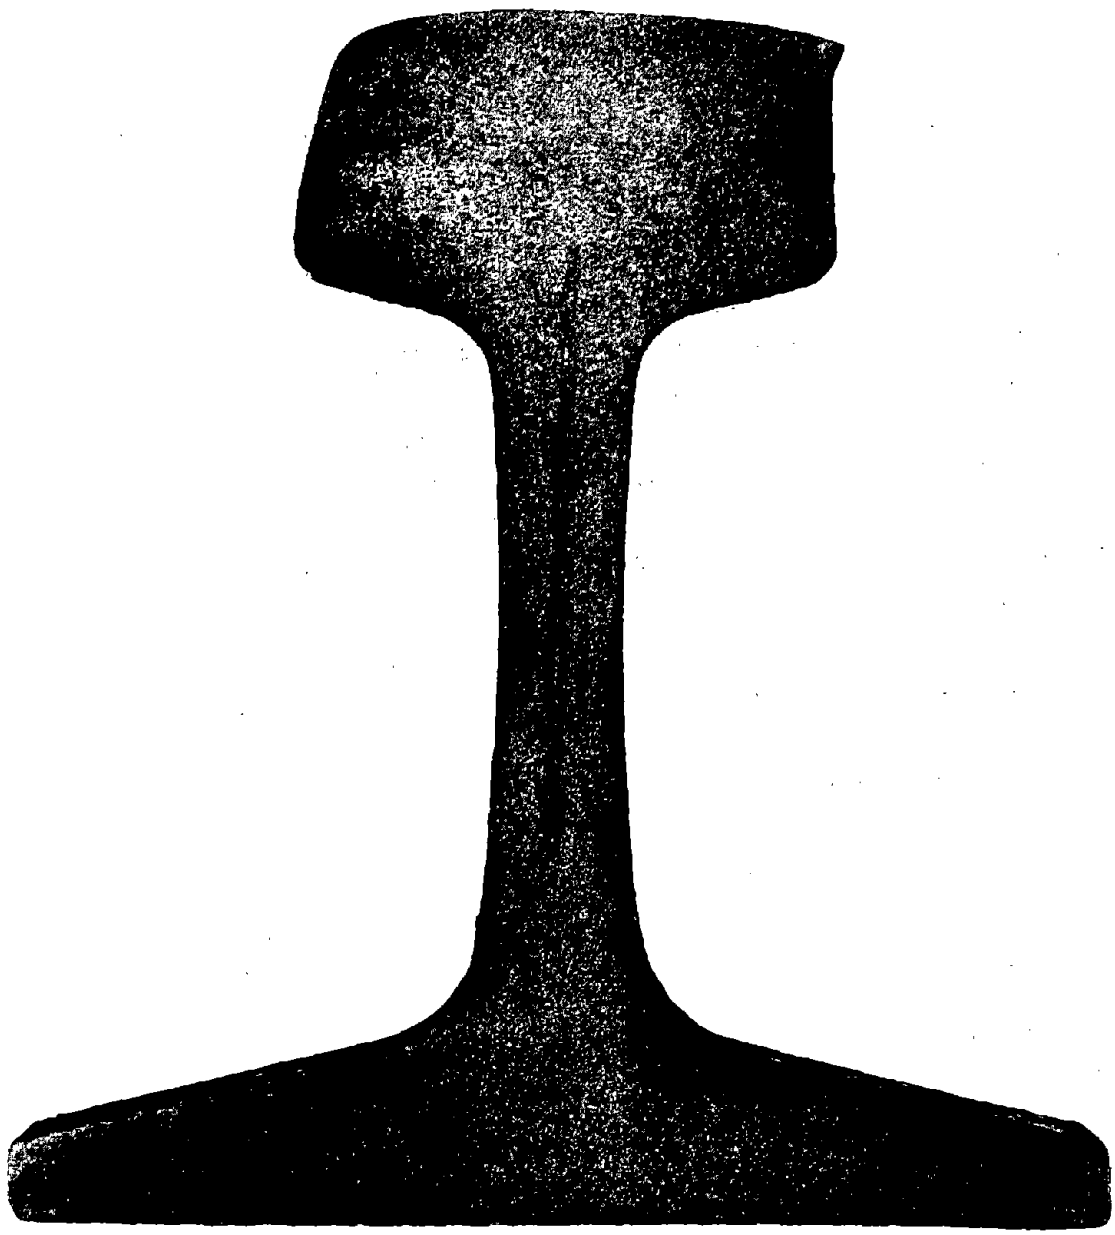
Some chemical segregation in the central zone of the web rail section was indicated by the macrostructures of Samples 003, 025, 040, 060, 061, 062, and 063. An example of this condition is shown by the photomacrograph of Sample 003 in Figure 10. Similar conditions of chemical segregation exist in Figures 7, 8, and 9.

FIGURE 10. MACROSTRUCTURE OF RAIL SAMPLE 003
Note segregation in the web.

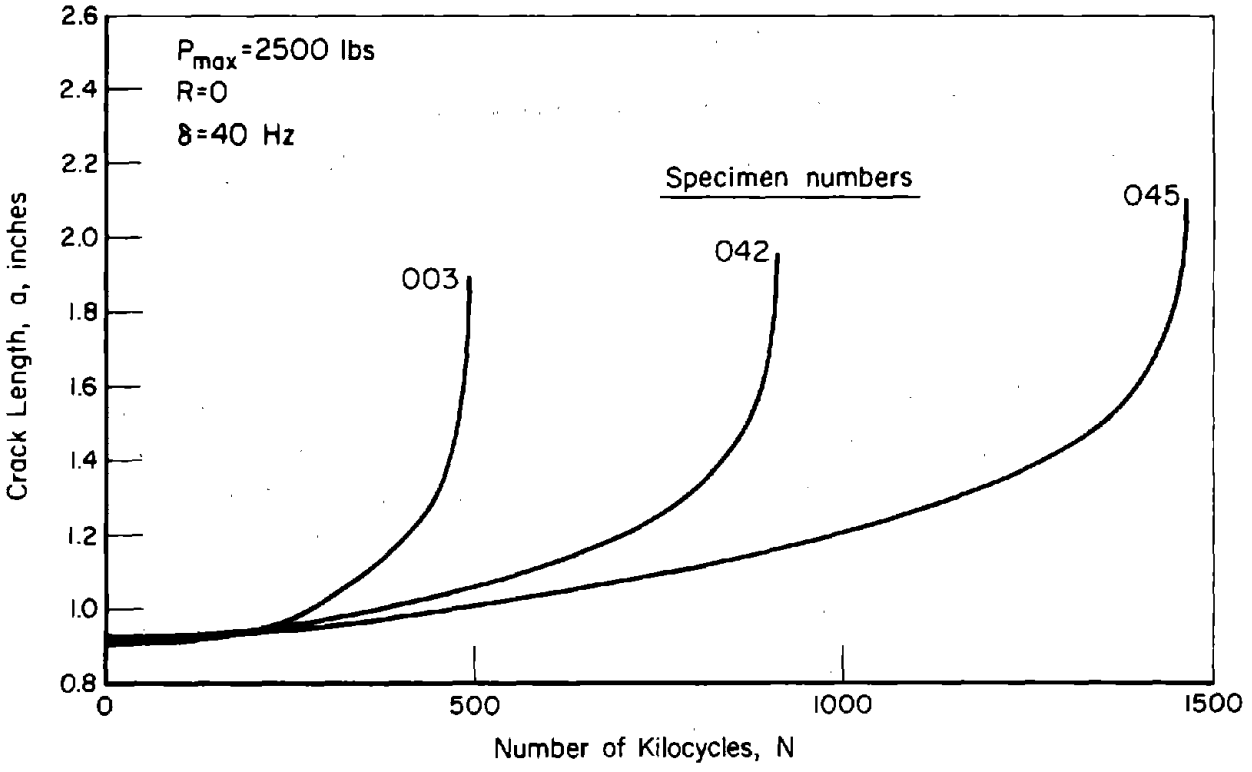
FIGURE 19. TYPICAL FATIGUE CRACK PROPAGATION CURVES

Some typical fatigue-crack-propagation curves are given in Figure 19. The curves show that the number of cycles to grow a 1-inch crack to failure showed a wide variation for the rails from which the specimens were taken. This will be reflected in the rate of growth, which is the basis on which the materials will be compared in the next section. Also the final crack size at failure showed quite a wide variation which will be reflected in the toughness number. The raw test data (crack size versus cycle number) of all specimens are given in Appendix A.

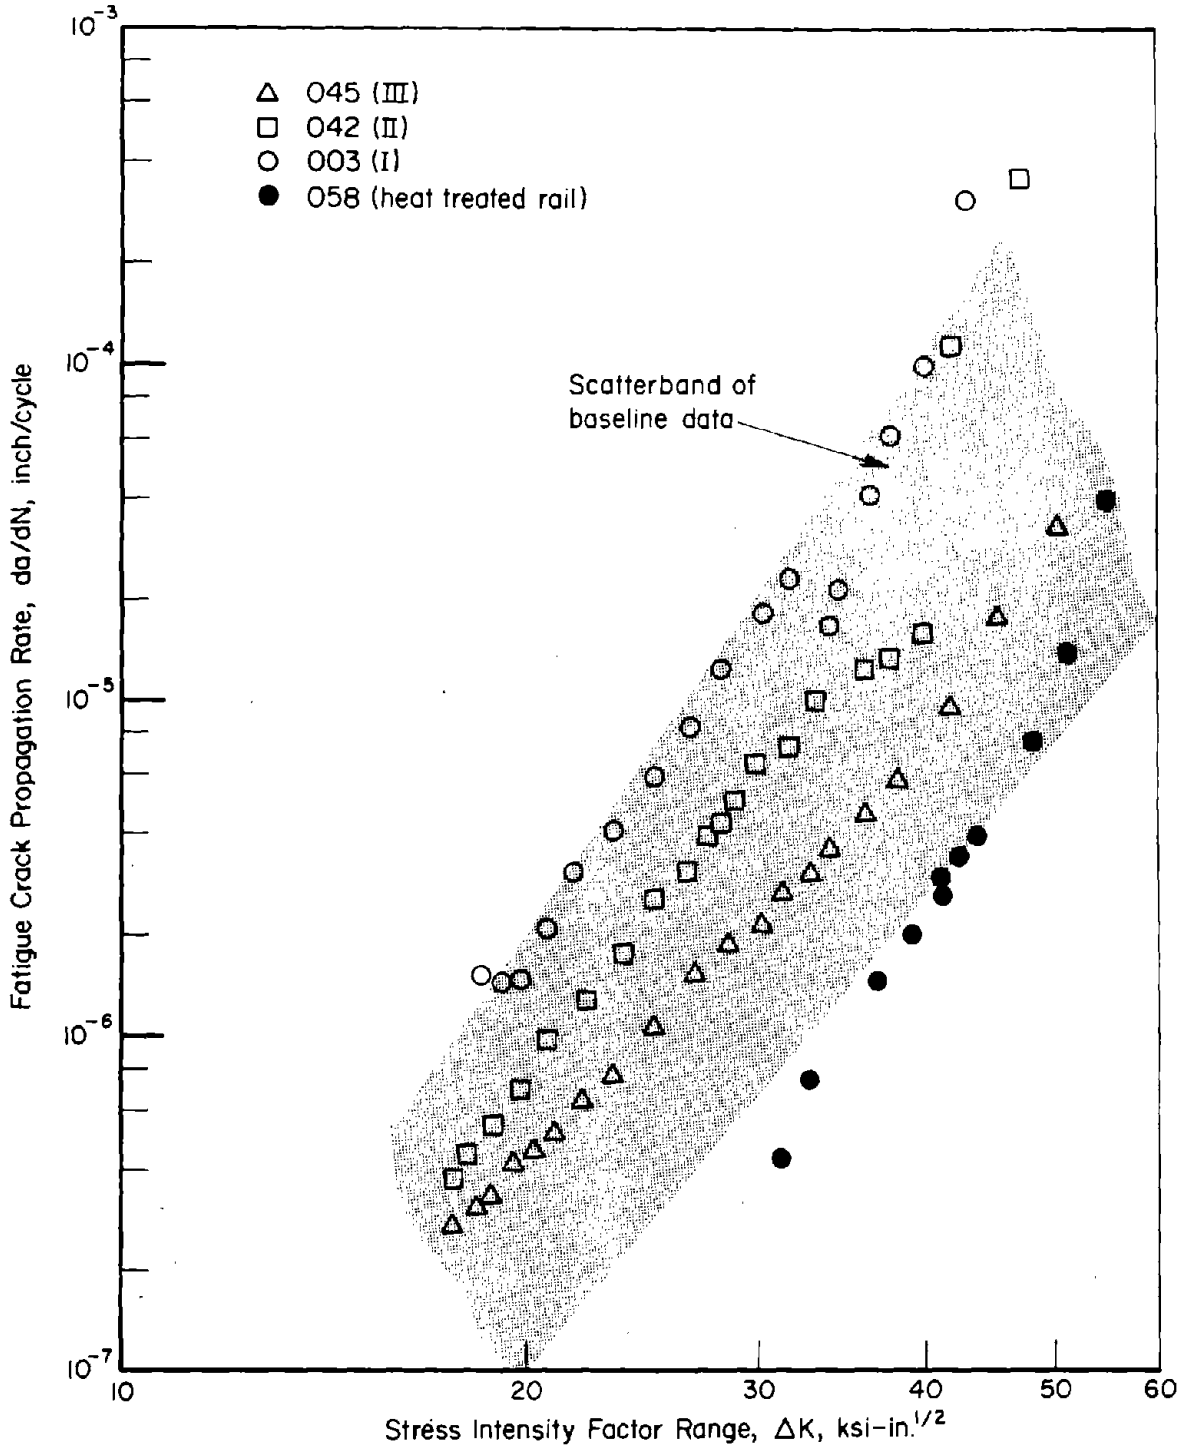
FIGURE 20. VARIABILITY OF FATIGUE CRACK PROPAGATION RATE BEHAVIOR

Examples of the resulting plots of da/dN versus ΔK are given in Figure 20. An example of a computer printout giving the basic crack-growth data, crack-growth rate, and the stress-intensity factor, is shown in Table 8. The variability of crack-growth rates in the 66 samples can be appreciated from Figure 20. The heat-treated rail appeared to have the lowest crack-growth rates. It did fall to the right of the scatter band containing all other samples. All the curve fitting data, in terms of C, n, and the correlation parameter, R^2, are presented in Table 9. The correlation parameter is generally close to unity which is an indication of the goodness of the fits. These results have been derived from the basic crack-growth data listed in Appendix A.

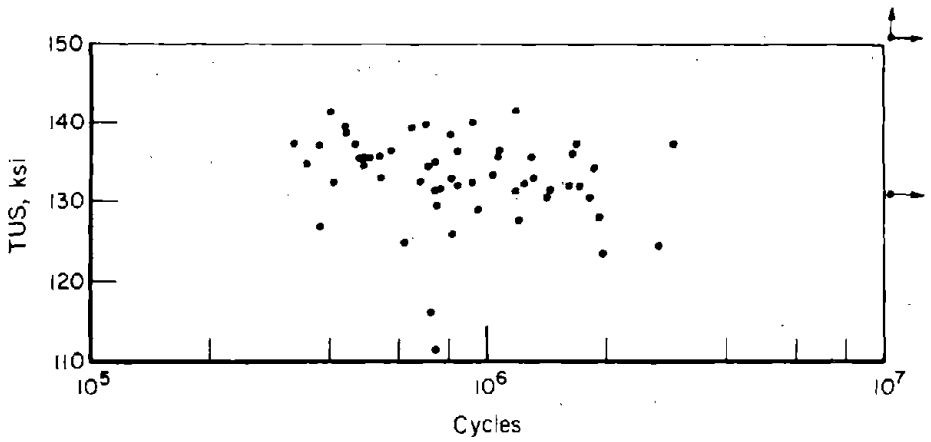
(a) Effect of Tensile Ultimate Strength

For the mechanical property category, the nearly equivalent dominance of strength and hardness is not surprising because of their well-documented interrelationship. However, the statistical impact is lessened when one then views the graphical relationship of strength and life as shown in Figure 22(a).

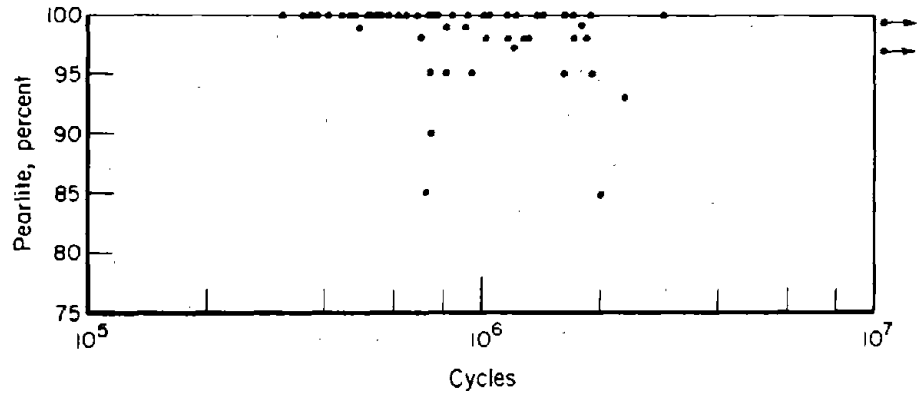
(b) Effect of Pearlite

A similar disillusionment is encountered when one observes the display of percent pearlite versus life in Figure 22(b). The latter part of the above tabulation suggested the consideration of a carbon equivalent (CE) which was expressed as

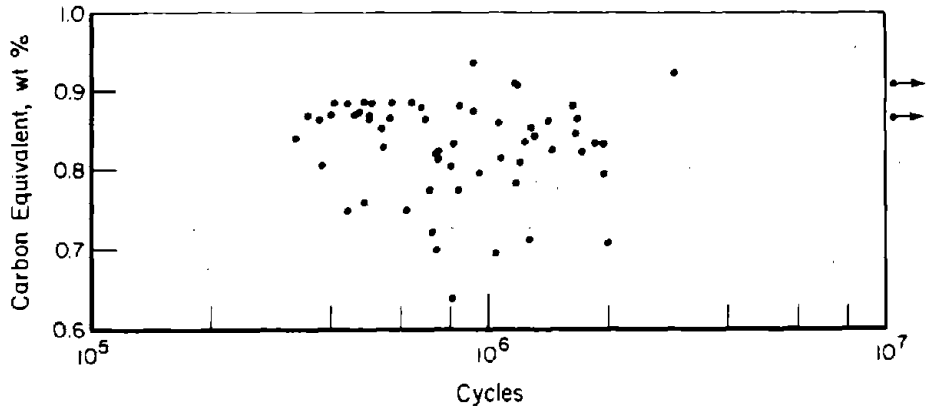
(c) Effect of Carbon Equivalent

has a similar, but less effective, strengthening effect as Carbon. This is reflected by the factor α. An AID analysis for incremental values of α was conducted from which a value of $\alpha = 0.1$ was obtained as providing a 21 percent contribution to variances. Again, however, the statistical analysis was poorly supported with the "shotgun" pattern of Figure 22(c).

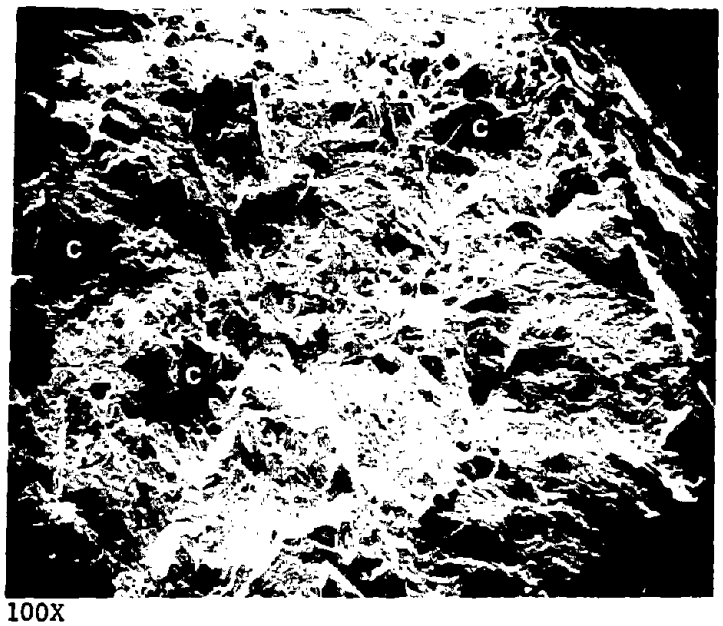
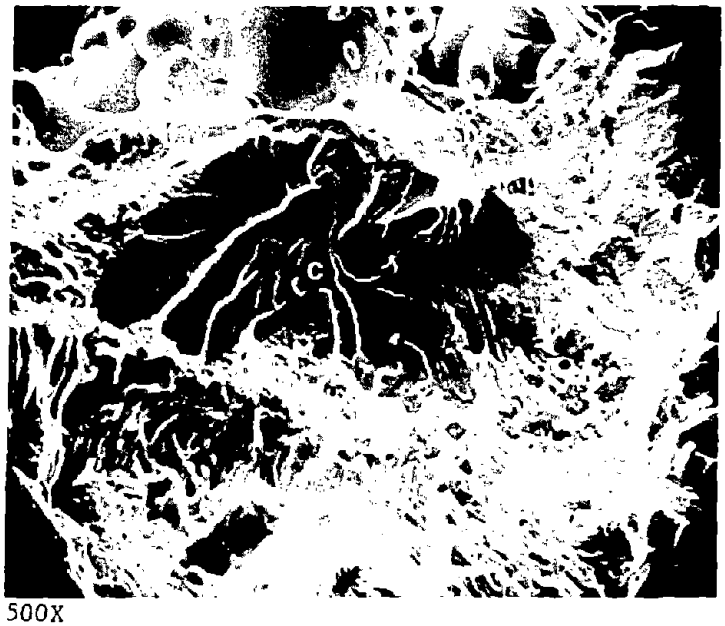
FIGURE 25. FRACTURE SURFACE OF SAMPLE 004 AT THE NOTCH TIP

"C" denotes cleavage fracture.
Tip of notch is at upper right.

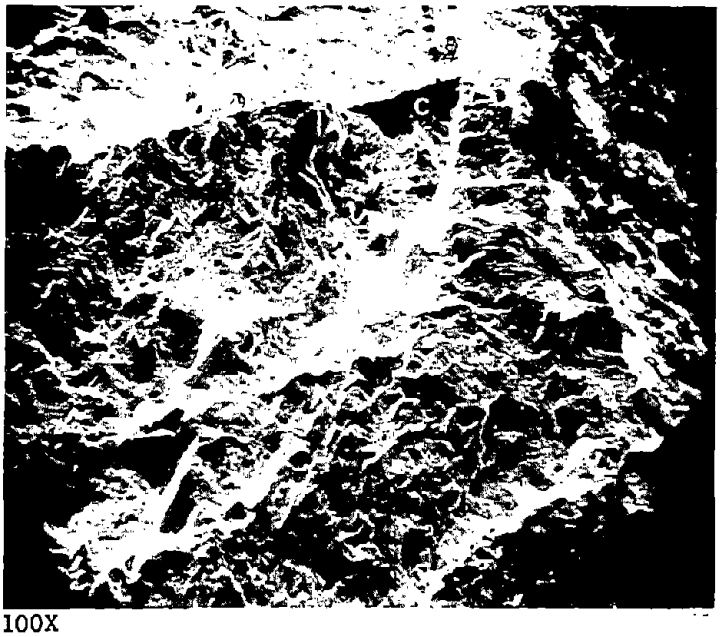
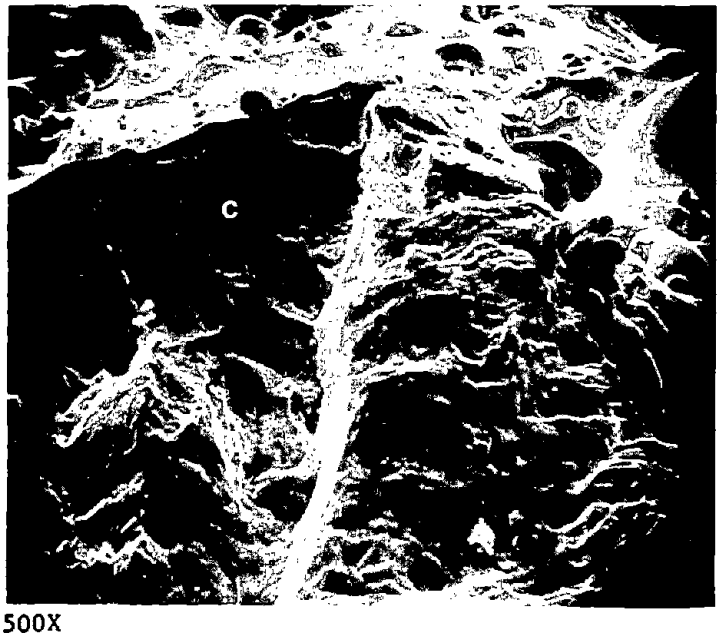
FIGURE 26. FRACTURE SURFACE OF SAMPLE 002 AT THE NOTCH TIP

"C" denotes cleavage fracture.
Tip of notch is at upper right.

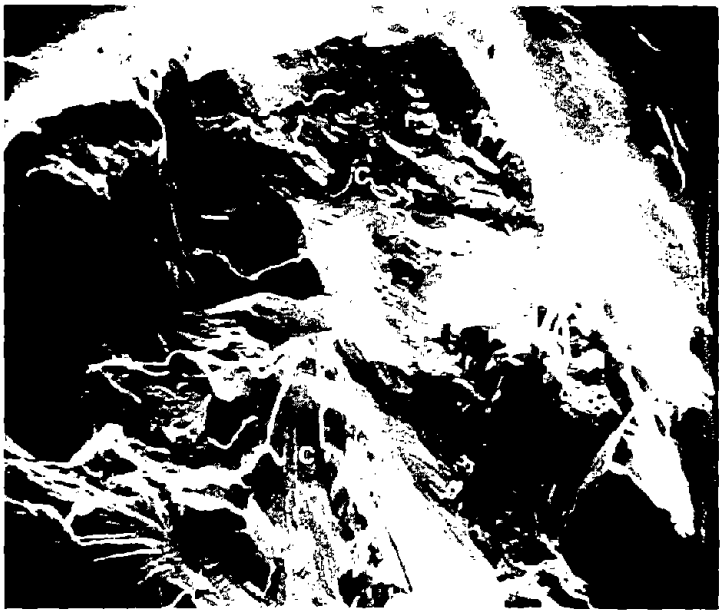
FIGURE 27. FRACTURE SURFACE OF SAMPLE 030 AT THE NOTCH TIP

"C" denotes cleavage fracture.
Tip of notch is at upper right.

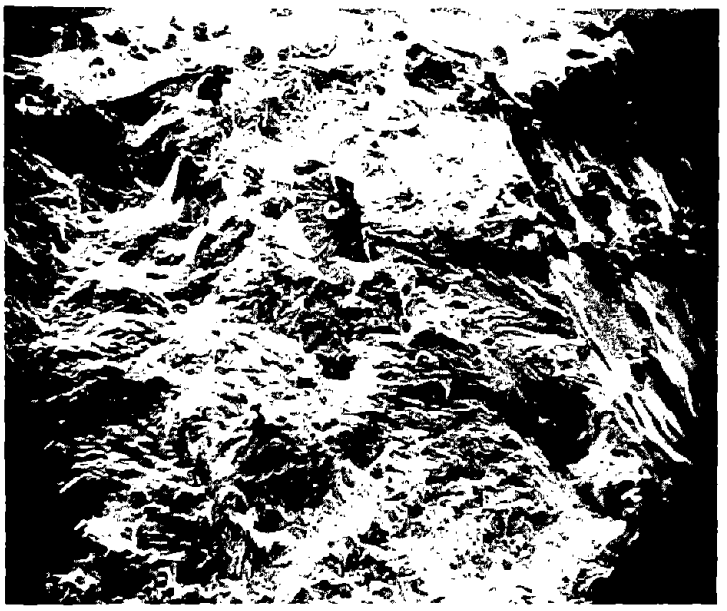
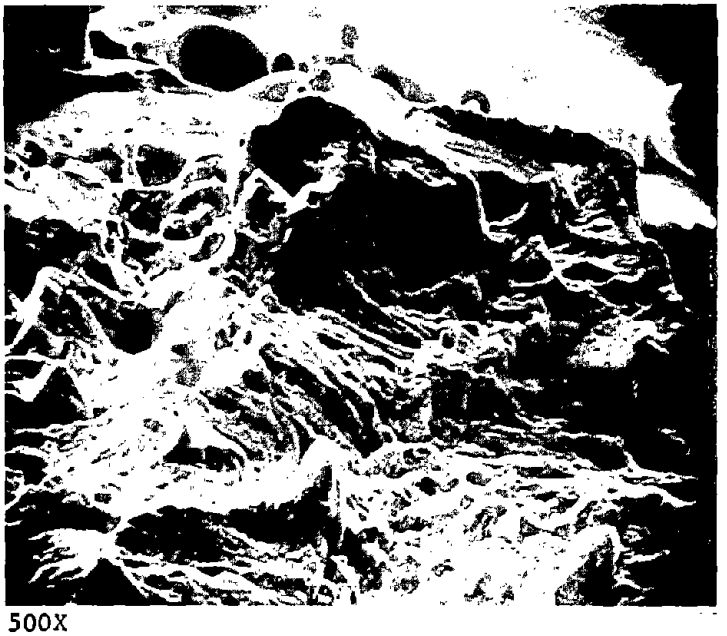
FIGURE 28. FRACTURE SURFACE OF SAMPLE 006 AT THE NOTCH TIP

"C" denotes cleavage fracture.
Tip of notch is at upper right.

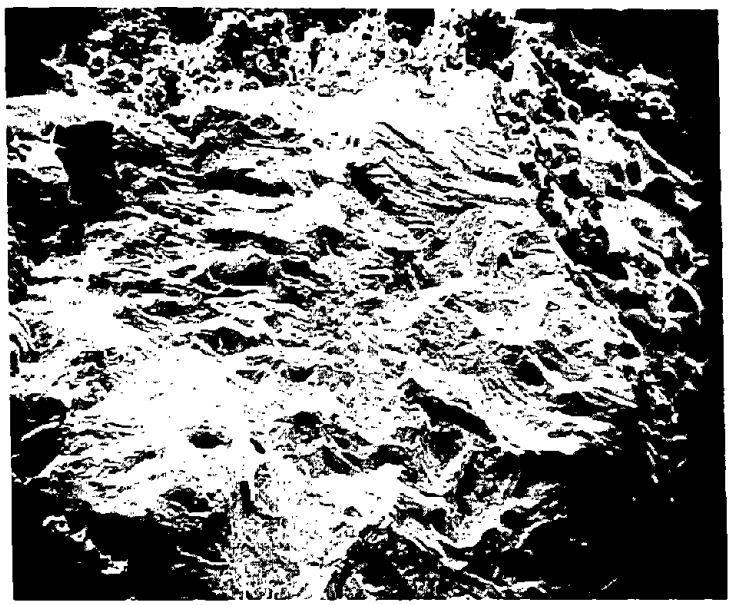
FIGURE 30. FRACTURE SURFACE OF SAMPLE 024 AT THE NOTCH TIP

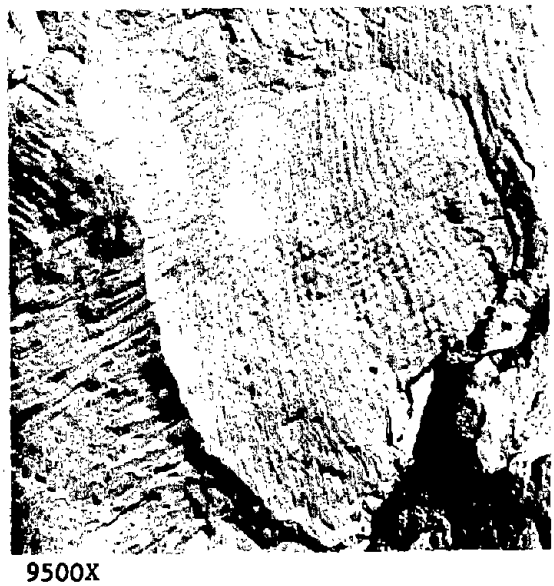
Occasionally, cross-hatched lines were observed as shown in Figure 34. Since the replicas were shadowed in a direction toward the crack origin, the lines in Figure 34 most nearly perpendicular to the direction of shadowing are likely to be fatigue striations. (These are the striations running approximately up and down in Figure 34.) The other lines, those that are parallel to the direction of shadowing, are likely to be pearlite lamellae.

FIGURE 34. CROSS-HATCHED LINE PATTERN - SAMPLE 024, 1.21 INCHES FROM NOTCH TIP, $\Delta K \approx 45$ KSI-IN.$^{\frac{1}{2}}$
