REPORT NO: NAWCADPAX/TR-2008/3

FOREIGN OBJECT DAMAGE BY STEEL BALL PROJECTILES IN A SiC/SiC CERAMIC MATRIX COMPOSITE AT AMBIENT AND ELEVATED TEMPERATURES

29 April 2008

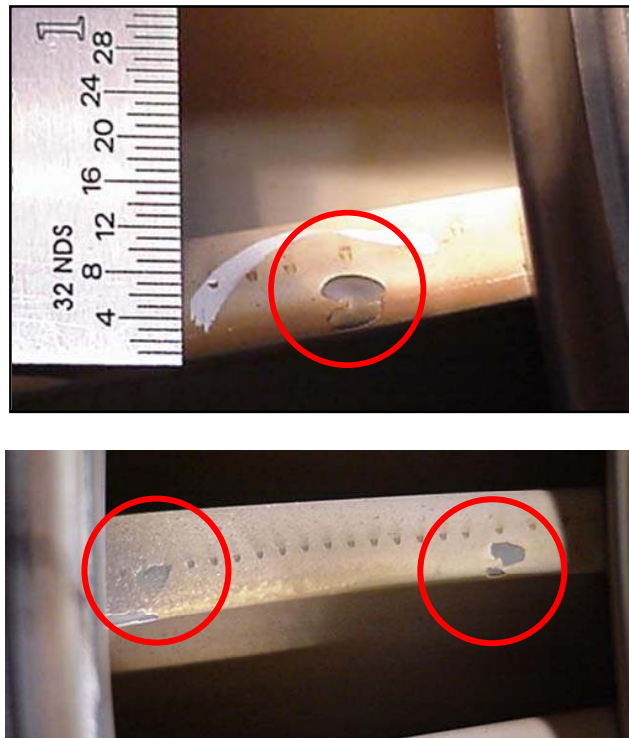
Figure 1: Examples of airfoils subjected to FOD by impacting particles.
(Courtesy: Joel Pratter, Jacksonville)

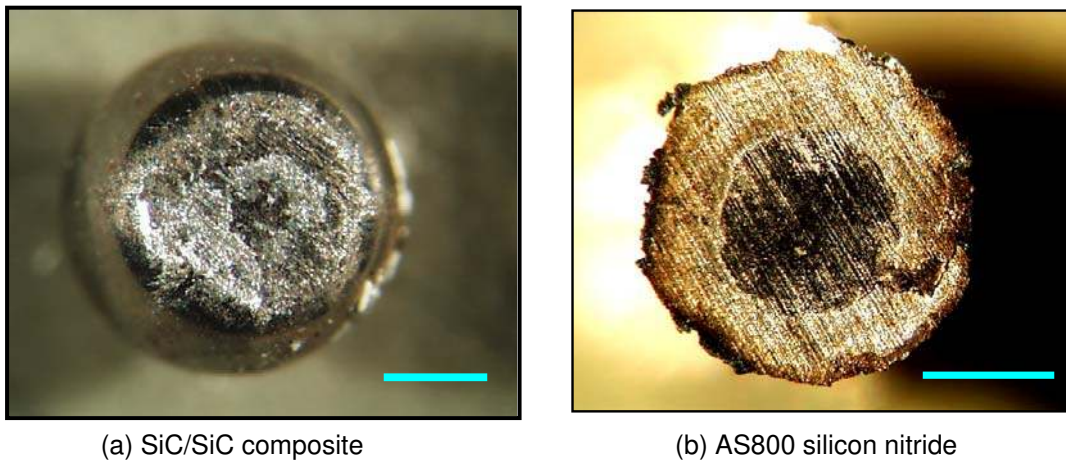
Figure 6: Typical examples of 1.59-mm steel ball projectiles showing plastic deformation (flattened) impacted at 350 m/sec at ambient temperature in: (a) SiC/SiC ceramic matrix composite and (b) AS800 silicon nitride (reference 15). Bar = 500 µm.

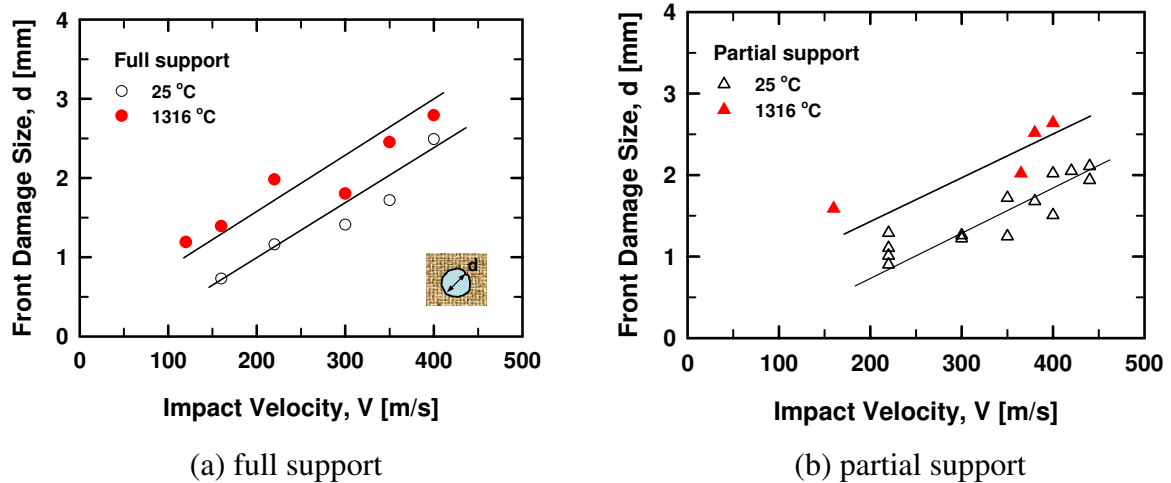
The front impact damage generated in target specimens was in a form of craters associated with breakage of matrices and fiber tows at impact sites. Figure 7 presents the front impact damage size as function of impact velocity. Front damage size was somewhat insensitive to the type of specimen support particularly at 1316^{o}C. However, in terms of temperature, front damage size was greater at 1316^{o}C than at 25^{o}C, regardless of the type of specimen support, attributed to a 'softening' effect of the composite at the elevated temperature. At higher impact velocities $\geq$350 m/sec, backside damage became significant for the partially supported specimens with a presence of severe backside cracking and delamination, due to the backside tensile

Figure 7: Front impact damage size as a function of impact velocity for SiC/SiC ceramic matrix composite impacted by 1.59-mm steel ball projectiles in: (a) full support and (b) partial support.

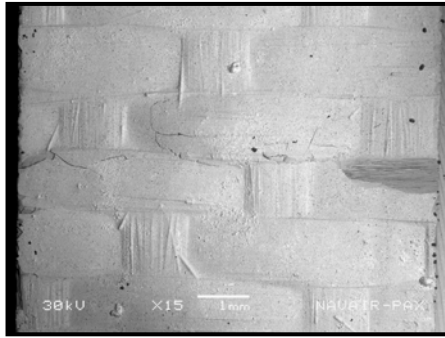
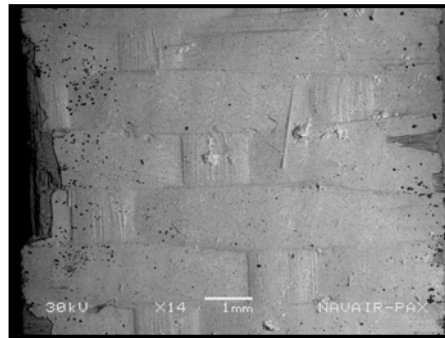
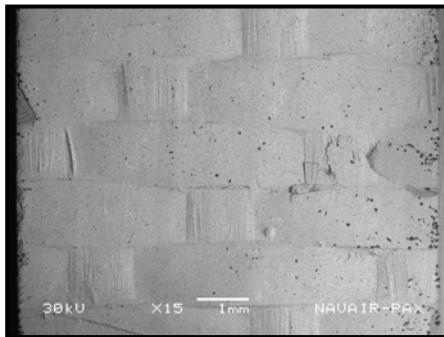
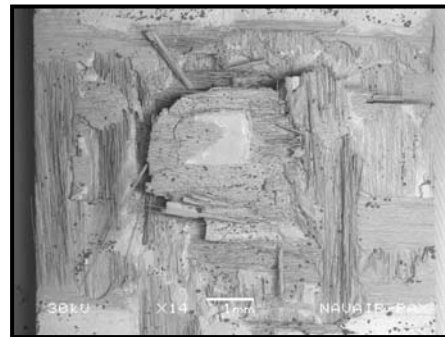
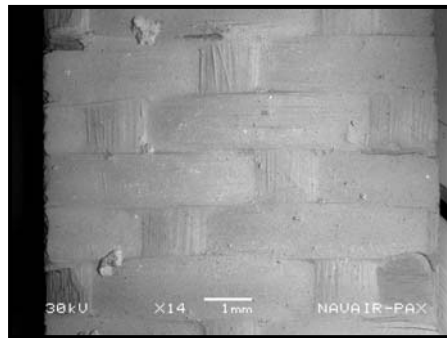
Figure 8: Typical examples of backside impact damages in SiC/SiC CMC impacted at low (160 m/sec) and high (400-440 m/sec) velocities by 1.59-mm steel ball projectiles at ambient temperature in: (a) full support and (b) partial support. Note difference in damage between two supports at high impact velocities.

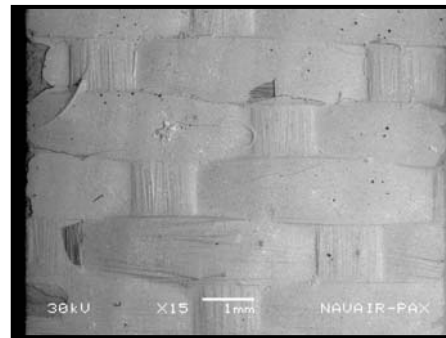
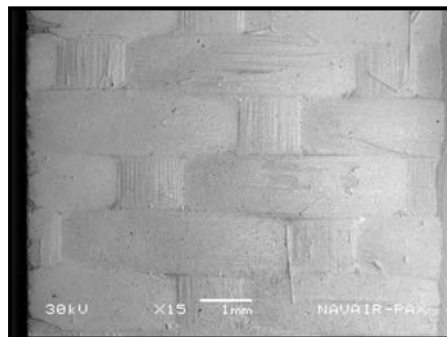
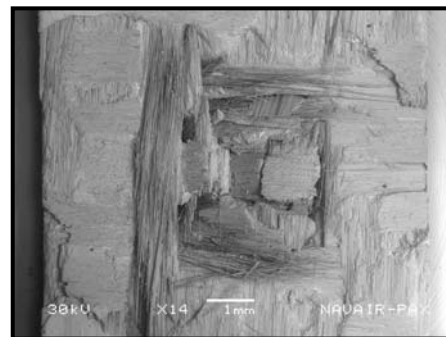
Figure 9: Typical examples of backside impact damages in SiC/SiC CMC impacted at low (160-220 m/sec) and high (380-400 m/sec) velocities by 1.59-mm steel ball projectiles at 1316°C in: (a) full support and (b) partial support. Note difference in damage between two supports at high impact velocities.

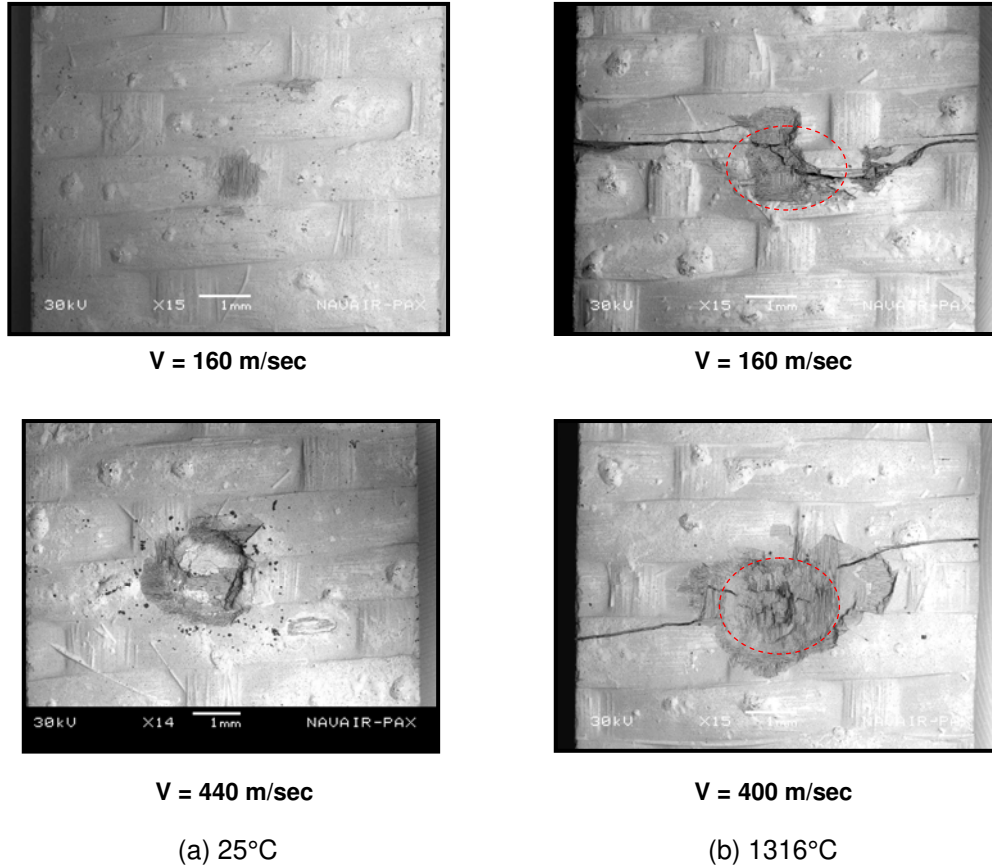
Figure 10: Typical examples of front impact damages in SiC/SiC CMC impacted at low (160 m/sec) and high (400-440 m/sec) velocities by 1.59-mm steel ball projectiles in full support at: (a) ambient temperature (25°C) and (b) 1316°C. Note that elevated-temperature target specimens were strength-tested thus showing the resulting failure cracks. The dotted circles indicate impact damages prior to post-impact strength testing.

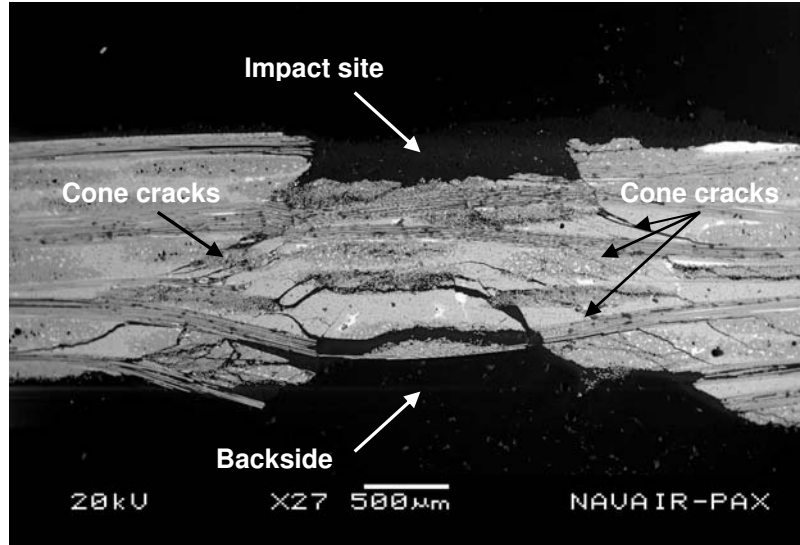
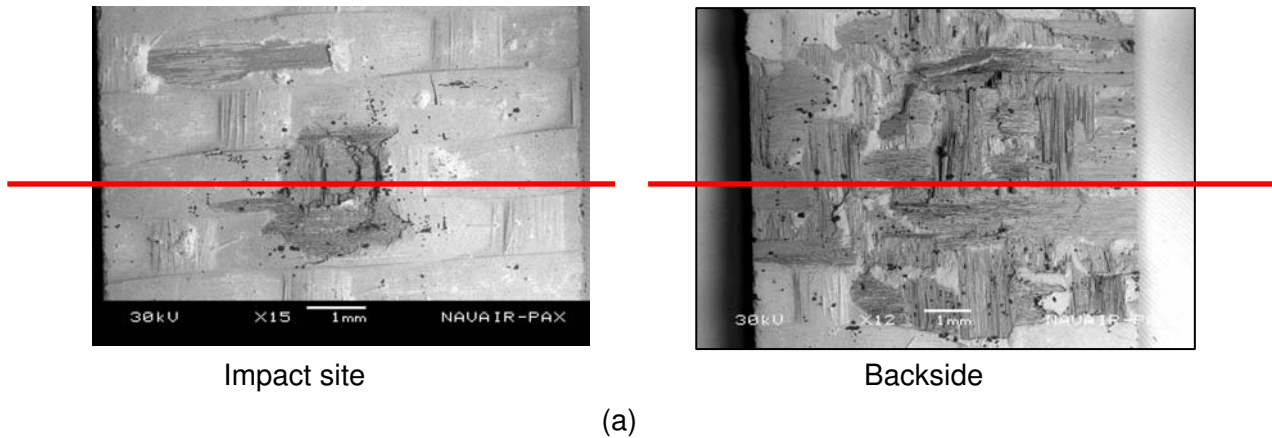
A cross-sectional view containing the impact site of a target specimen impacted at 400 m/sec in partial support at 25°C is shown in figure 11. Also included in the figure are the front and back sides of the target specimen prior to sectioning. A minor front but severe backside damages with some delamination are evident, showing even some material removal from the backside. Also important is the formation of cone cracks initiating from the impact site, making damage more significant at the backside than at the front impact site and letting the material beneath the impact site be displaced toward the backside. The angle of the cone cracks was about 120 deg. Generation of cone cracks by spherical projectiles has been observed in monolithic silicon nitrides (references 4, 9, 15, 16, 17, and 19) and is typified of many brittle solids including glass dynamically (references 1, 2, and 5) or statically (reference 8). One example such as in AS800 silicon nitride is shown in figure 12 (reference 16), where the contour of a well-developed cone crack is seen from the fracture surface, together with a *volcanic-island* like cone

Figure 11: (a) Front impact and backside damages and (b) cross-sectional view of the impact site of a SiC/SiC target specimen impacted at 400 m/sec by 1.59-mm steel ball projectile at ambient temperature. Lines in (a) indicate the related sectioning. Angle of cone cracks ≈ 120 deg.

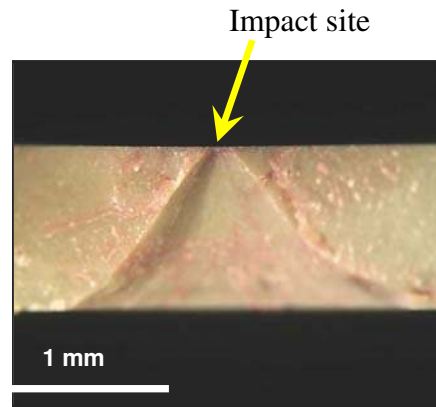
Figure 12: (a) Fracture surface and (b) a separated cone of an AS800 silicon nitride target specimen (disk) impacted at 400 m/sec by 1.59-mm steel ball projectile at ambient temperature. Angle of cone $\approx$ 80 deg.

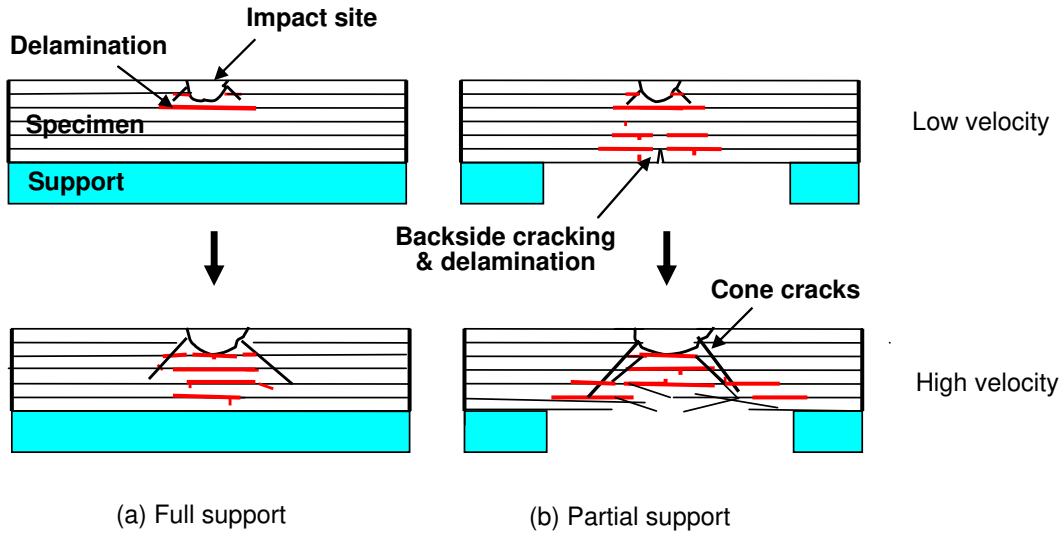
Figure 14: Schematics of damage progress from low (top) to high (bottom) impact velocities in: (a) full support and (b) partial support. The vertical arrows indicate a case of increase in impact velocity.

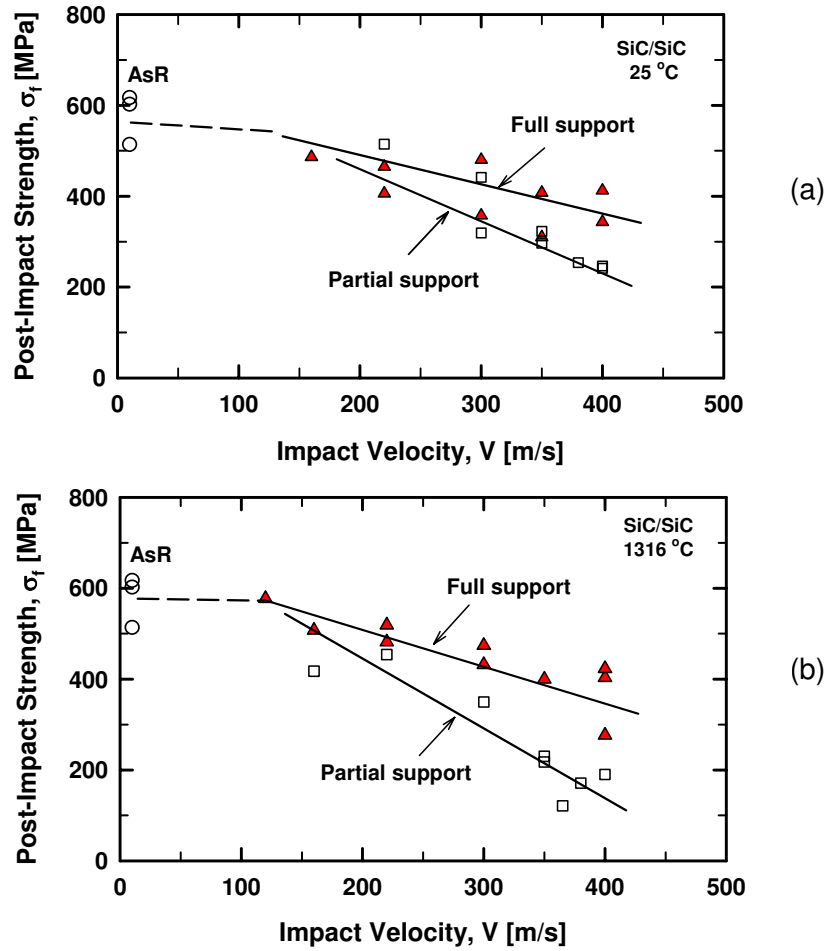
Results of strength testing for impacted target specimens are presented in figure 15, where post-impact flexure strength was presented as a function of impact velocity for both types of specimen support at each temperature. Included in figure 15 is the as-received (AsR) flexure strength (=578 ±56 MPa) determined at ambient temperature. Target specimens impacted failed from their impact sites (see, for example, figure 10). Exception to this was that one specimen at each temperature impacted at the lowest velocity (i.e., 160 m/sec at 25^{o}C and 115 m/sec at 1316^{o}C) did not fracture from impact site because of its negligible impact damage. The resulting strength of these specimens was close to the AsR strength. As seen in the figure, post-impact strength decreased with increasing impact velocity at both temperatures, regardless of the type of specimen support, due to impact damage increasing with impact velocity. It is also peculiar that the post-impact strength was almost a linear function of impact velocity. As expected, for a given impact velocity, strength degradation was greater for the partially supported specimens than for the fully supported counterparts, as mentioned in the Impact Damage Morphology section. Difference in strength degradation between 25^{o}C and 1316^{o}C was significant for the partially supported particularly at higher impact velocities ≥ 350 m/sec, while the difference appeared to be insignificant for the fully supported specimens.

Figure 15: Post-impact strength as a function of impact velocity for SiC/SiC CMC impacted by 1.59-mm diameter steel ball projectiles with two different types of specimen support at: (a) Ambient temperature (25°C) and (b) 1316°C. AsR = As-received strength determined at ambient temperature with no impact.

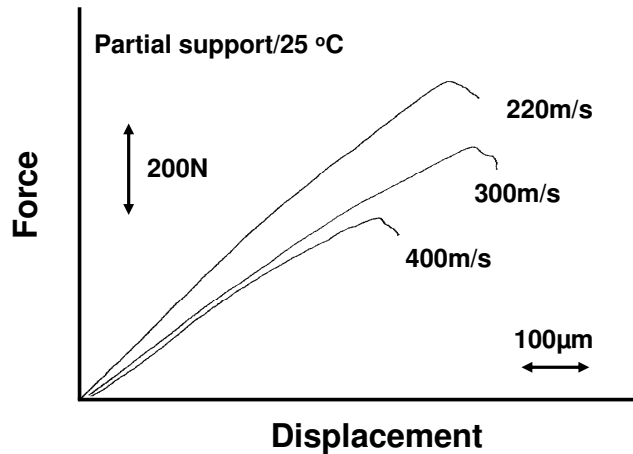
Figure 16 shows typical load-displacement curves determined in post-impact testing for partially supported specimens impacted at 25°C. Progressive decrease in both stiffness and strength is manifest with increasing impact velocity from 220 to 400 m/sec, again indicative of increasing severity of impact damage. A similar trend has also been observed for fully supported specimens (reference 18). However, the degree of change in stiffness was somewhat less noticeable for fully supported specimens, compared to partially supported counterparts, because of less impact damage associated with the fully supported.

Figure 16: Typical force-versus-displacement curves in flexure determined from SiC/SiC target specimens impacted at three different velocities by 1.59-mm steel ball projectiles in partial support at ambient temperature (25°C). The peak of each curve indicates a fracture force.

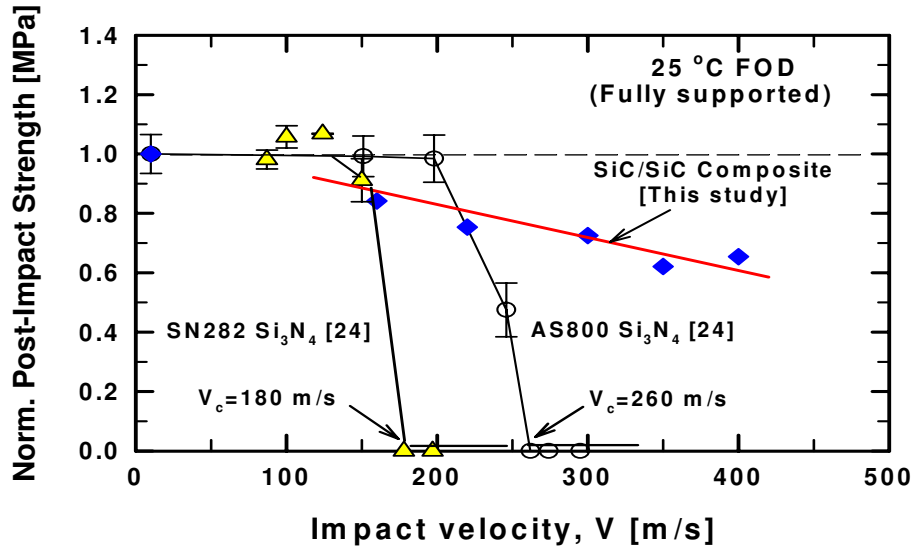
where m is the mass of steel ball projectile. Similar to the trend shown in figure 17, monotonic degradation in strength with increasing impact energy was typified for the SiC/SiC composite, while significant strength degradation was exemplified for AS800 and SN282 silicon nitrides at U_k>0.2J and U_k>0.3J, respectively. The critical kinetic impact energy (U_{kc}), where all target specimens failed upon impact, was U_{kc}=0.56J and 0.27J for AS800 and SN282 silicon nitrides,

The SiC/SiC composite showed somewhat reasonable agreement (0.15 versus 0.20) in slope with the Hertzian contact stress theory. However, this does not mean the material respond to projectile impact like a homogeneous, isotropic elastic body. The previous studies (references 15, 16, and 17), in fact, indicated that the data on both AS800 and SN282 exhibited a significant deviation from the contact stress theory, as also seen from the data in figure 18. A model to predict FOD and strength degradation in CMCs is thus a prerequisite.

Figure 18: Comparison of normalized post-impact strength as a function of impact kinetic energy between SiC/SiC composite and AS800 and SN282 silicon nitrides (2-mm thick) (reference 24) impacted in full support at ambient temperature (25°C). U_{kc} is a critical impact kinetic energy where target specimens fracture catastrophically upon impact.

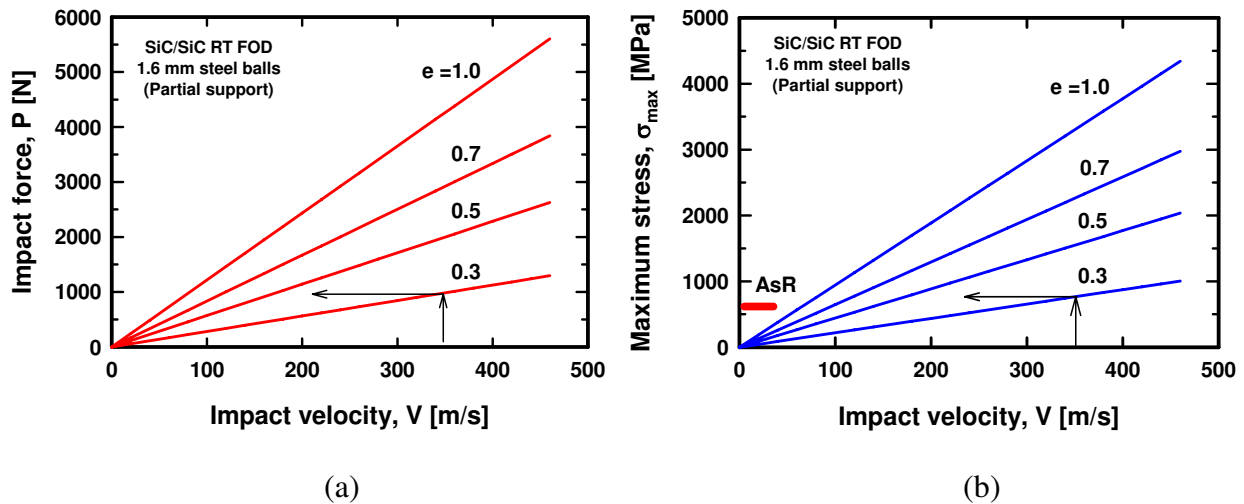
The results of the predicted impact force and maximum tensile stress as a function of the coefficient of restitution (e) are shown in figure 20. For a given impact velocity, both impact force and maximum backside stress are strongly dependent on the coefficient of restitution. The impact force and backside stress seem to be too large when $e \geq 0.5$, compared to the experimental observations. The value of $e=0.3$, which results in $P = 986$ N and $\sigma_{max} = 764$ MPa, appears to reasonable in view of the facts that the backside cracking/damage of the targets was observed significant at $V \geq 350$ m/sec and that the as-received flexure strength of the target was 580

±60 MPa. An example at V=350 m/sec for e=0.3 is presented in the figure. It should be noted that the case for e=0.3 is also indicative of significant decrease in bouncing-back velocity, V_f=105 m/sec. This could be understandable (at least quantitatively) considering the violent impact event at 350 m/sec, accompanying both the appreciable plastic deformation of the projectiles and the higher degree of impact damage generated on the targets, which results in significant loss in the kinetic energy (U_k).

Figure 20: Predicted impact force (a) and maximum backside tensile stress (b) as a function of the coefficient of restitution (e) in SiC/SiC target specimens under a partial support configuration, impact by 1.59-mm diameter steel ball projectiles. An example at V=350 m/sec was indicated with arrows. AsR=As-received strength of target specimens (580 ±60 MPa).
