Full-Scale Tests of Butt-Welded Splices in Heavy-Rolled Steel Sections Subjected to Primary Tensile Stresses

MICHEL BRUNEAU and STEPHEN A. MAHIN

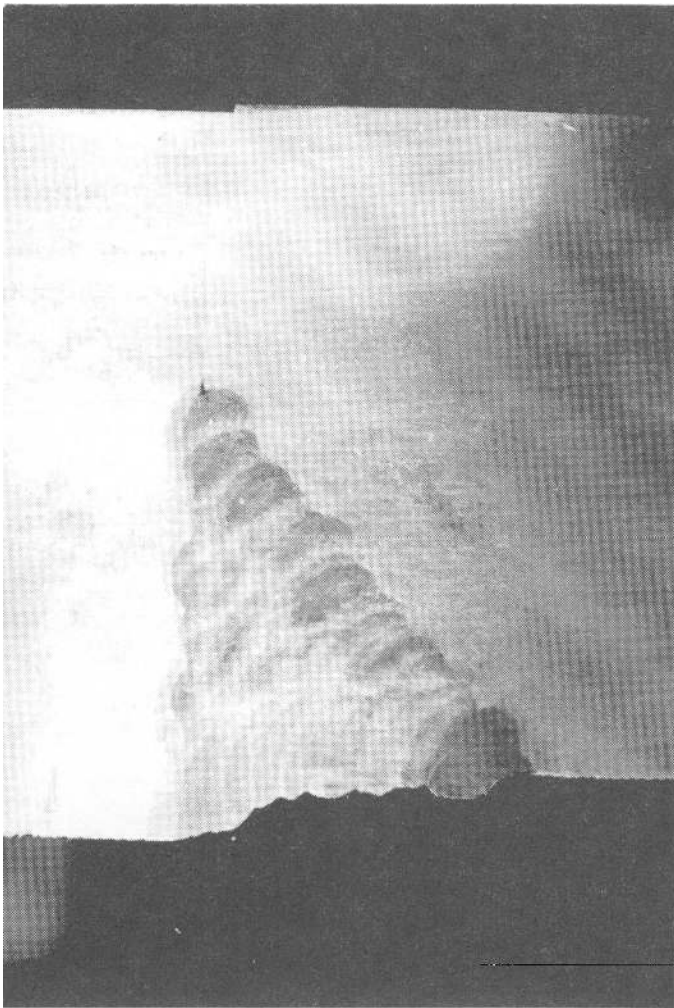
Fig. 7. Polished and etched half penetration weld on a thick flange.

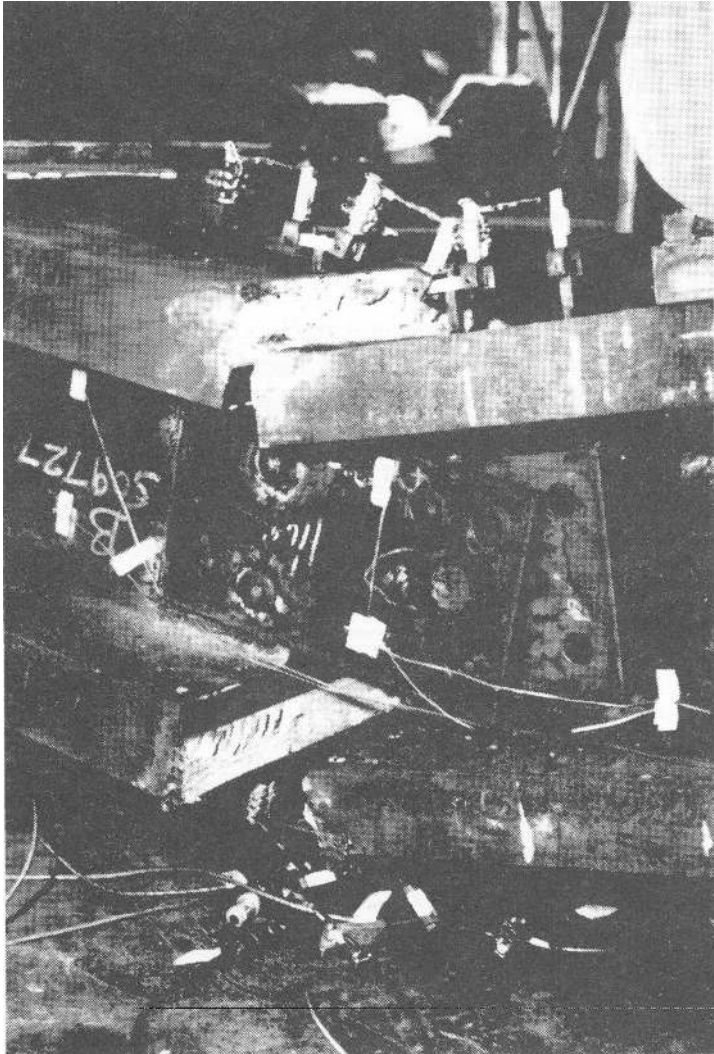
There was a 30-second pause at that point (which produced a negligible 13 kips loss of load) to make sure non-linearity of the splice had not started to occur. Visual inspection of the plotted splice moment-curvature record and of the other printed transducer measurements still showed no sign of significant yielding. It was consequently decided to continue the loading. The subsequent rate of loading was reduced to 1.6 kip/sec. The moment-curvature relationship was observed to remain practically linear up to approximately 1475 kips (the last digitized value was 1458 kips) when a sudden and brittle failure occurred through the weld. Failure was complete (Fig. 9) and very loud.

Once failure started in the tension (bottom) flange, the remaining unfailed part of the section was unable to accommodate the imposed displacement. The failure then quickly progressed through the whole section. The erection plate (Fig. 9) did not help restrain or stabilize the failure once it initiated. The erection bolts sheared suddenly and they were thrown with considerable energy away from the splice.

Fig. 9. Failure of partial penetration welded splice.

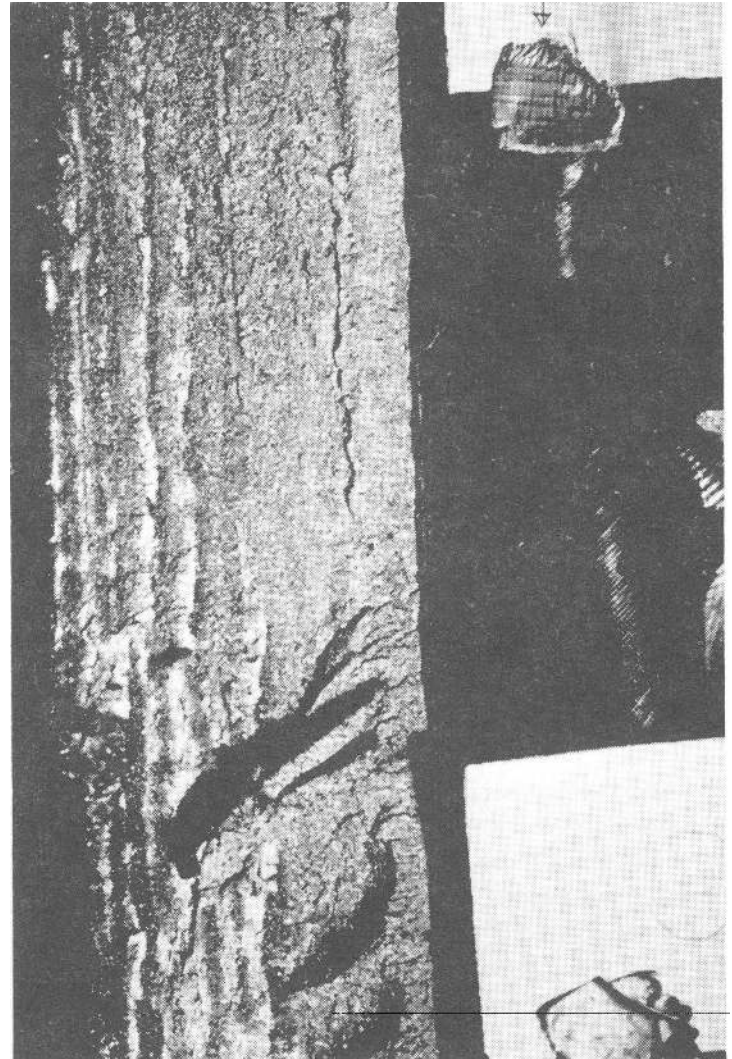
Since failure occurred through the weld (Fig. 10), the failure surface was carefully investigated. The failure surface was nearly planar and followed the juncture of the two sections. At this location the weld was thickest, extending from the mid-depth of the thinner flange to the top of the thicker flange. After inspecting the failure surface, a welding consultant[8] indicated the following:

- The welds were rated as poor welds because of lack of fusion between passes (individual passes were very pronounced and the passes in the surface of the welds had valleys between passes and most of the fracture surfaces were between passes), lack of penetration and fusion of root passes (as much as $\frac{1}{8}$ in. of the prepared 45° bevel being unfused in several places), and some other minor controversial metallurgical items (large columnar grain growth in some of the weld beads).
- The brittle mode of failure was virtually assured by the lateral restraint of the welds being welded to the

Fig. 10. Failure surface of partial penetration welded splice—center of bottom flange.

large jumbo sections, which restricted the reduction in area (necking down) of the welds; the "zero-gauge-length" effect, due to the very short length of the welds, which prevented the elongation of the welds in the longitudinal direction; the large stress concentration factors in the rupture section; and the placing of the splice welds in pure tension.

- Even with a very good weld, the splice weld would still fracture in a brittle mode, but the deposited weld metal, being stronger than the base metal, would tear out a nugget of the base metal, mainly because the reduction in area of the weld and the elongation of the weld are both restricted.

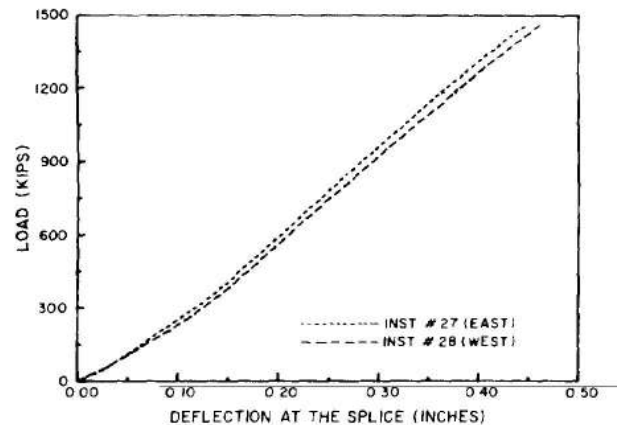
Fig. 11. Center span deflection for partial penetration specimen.

As expected, the load-deflection (P - δ) curve (Fig. 11) is not a good indicator of localizing yielding around the weld. The P - δ relationship is almost linear up to failure, but close inspection of the curve reveals a sudden change of stiffness at around 200 kips (the system becoming stiffer) and a very slight departure from a straight line at around 1200 kips (softening of the system). Table 1 compares the measured deflection with the ones calculated by linear elastic analyses under various assumptions. The best match of measured and calculated deflections is obtained when the proper respective moments of inertia are considered, the shear areas used are equal to the area of webs only (no participation from the flanges), and a short member (2 in. long) with a reduced moment of inertia equal to the splice stiffness (approximately $I/2$) is used to connect the two steel sections. Furthermore, in order to correct the effect of the initial "softness" of the setup, the experimental load-deflection curve has been shifted such that extrapolation of the elastic slope from 200 kips to 1200 kips defines a new origin at zero load. The computed deflections are still about 9% stiffer than the shifted experimental one, but it must be realized that the measured values include the deformation of the rollers, supports, and very likely some contribution from the testing machine (especially since the specimen was supported on the very corners of the base table).

The existence of an initially softer P - δ relationship is not entirely explained. A small gap could have been present between the two steel sections at the welds, and its closing on the compression flange side could have increased slightly the stiffness of the specimen. Also contributing to this may be the settling of the apparatus (rollers, plates, etc.), as the initial contact may not have been perfectly fit.

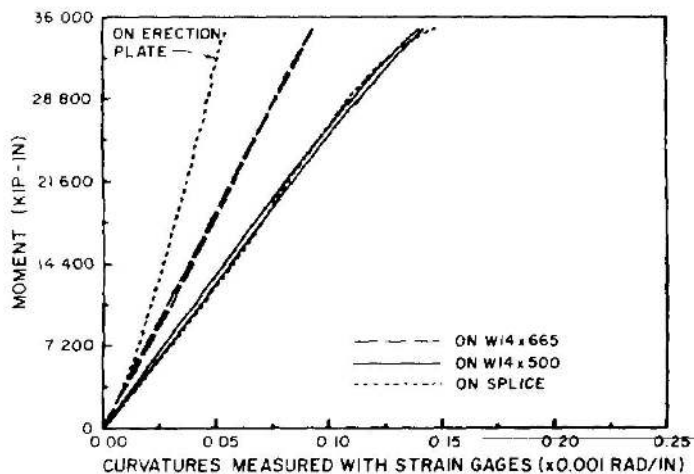
Fig. 12. Moment-curvature from strain gages on partial penetration specimen.

gages were placed on the erection plate). In the elastic range, moment-curvature relationships obtained from pairs of gages located on web (Fig. 12) are all equal to those predicted theoretically, within an acceptable accuracy. These relationships remained linear for most gaged sections except for the set on the W14×500's web near the splice which shows a slight softening near failure. This non-linearity recorded just before failure is an indicator of the initiation of yielding near the splice. The ratio of the maximum strain at this section to that further down the W14×500 (elastic) was only 1.05. This ratio can be an acceptable approximation of curvature ductility for small values of ductility. Nevertheless, the actual amount of yielding near the weld may have been larger than measured, as the gages were located 2¾ in. from the face of the splice.

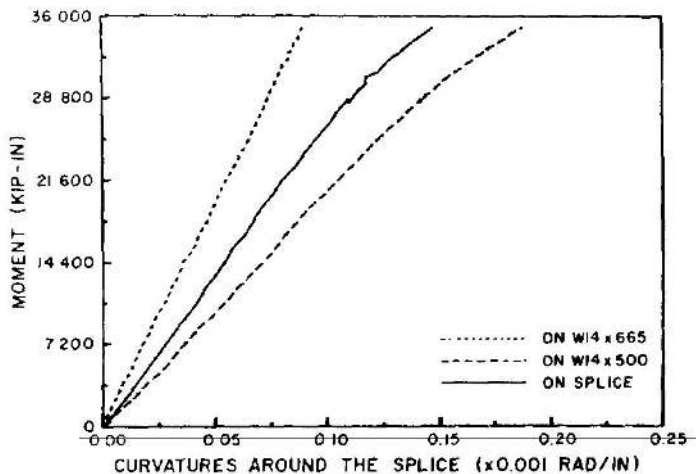
Fig. 15. Moment-curvature from clip gages on partial penetration specimen.

The most meaningful information was provided by three pairs of clip gages with gage lengths of approximately 6 in. (Fig. 15). All measured moment-curvature relationships in the elastic range are almost perfectly equal to their theoretically calculated ones, with the W14×665 shown to remain perfectly elastic until failure of the specimen. Also, as the loads get above the 1200 kips level (equivalent to the 28,800 kip-in. moment level), a slight softening of the moment-curvature relation can be observed on the W14×500

near the splice, which is a good indication of local yielding. At failure, the curvatures did not exceed the predicted elastic values by more than 10%.

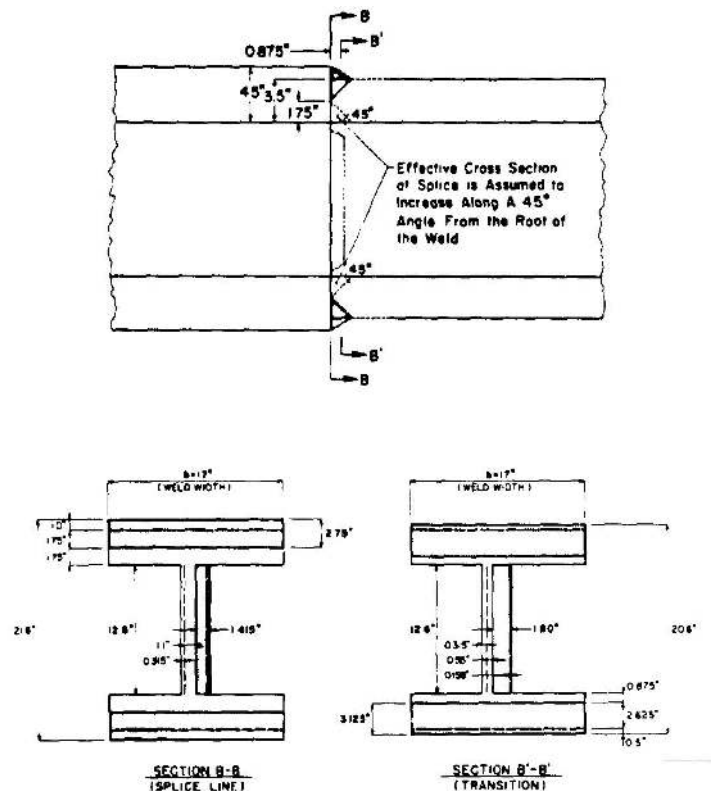
Fig. 16. Definition of various effective cross-sections at the splice for partial penetration specimen.

Attempts to deduct the magnitude of stresses at the critical section using simple traditional design methods can be deceiving. Using assumptions of linear elastic behavior, stresses at failure can be estimated at different cross-sections along the weld as shown on Fig. 16. Calculated maximum stress at the top of the cross sections would be 44.5 ksi at section B-B and 43 ksi at section B'-B'. This is assuming that the effective cross-section at the splice is increasing along a 45-degree angle from the root of the weld. Taking instead an average effective thickness of 2.25 in. on section B'-B' would produce a maximum stress of 51.5 ksi. These calculations indicate that these critical sections would have been elastic or, at worst, slightly starting to yield when failure occurred. The thickening of the section due to the transition welds provides one reason for the apparently higher than expected capacity of the splice. Further, the stresses calculated by these simplified methods would have been a lot higher if the edges of flanges had not been smoothly connected by welding material.

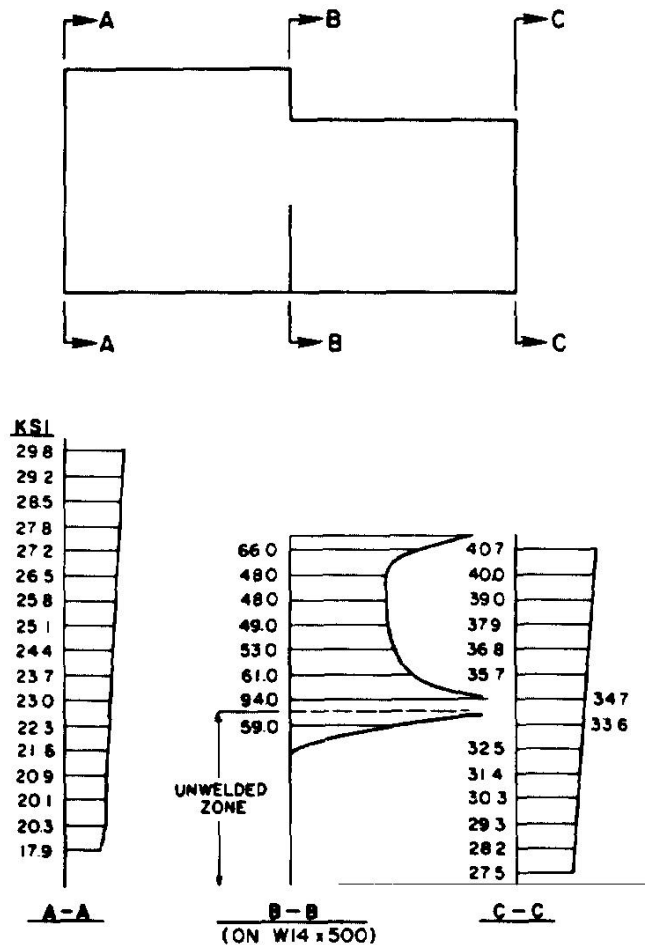
Fig. 18. σ_{11} *stress magnitudes and distribution profile for finite element analysis results along selected cross-sections for Model 1.*

Two different models of the flange were investigated and their respective behavior compared. Nodal loads approximating the states of stress in the flanges away from the splice at the time of failure were imposed to each model. In Model 1 (Fig. 17) the two steel sections are welded and left with the change of flange thicknesses unsmoothened. Less experienced welders have been observed leaving welds finished as in Model 1. A mesh of 576 regular elements was generated for this model. The distribution of principal stress σ_1 shown in Fig. 17 indicates a substantial stress concentration at the tip of the crack and at the discontinuous edge joining the two sections. Figure 18 re-emphasizes the fact that while uniformly varying stresses would be expected away from the weld, very high stresses would concentrate at the tip of the crack. Stresses much higher than yield are predicted, thereby violating the assumptions in the analyses.

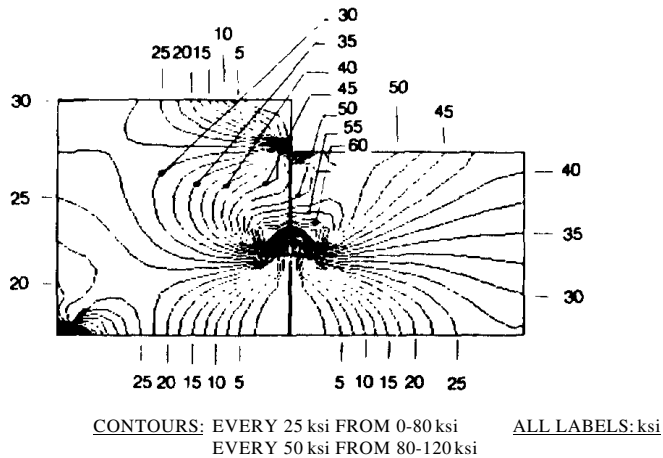
Fig. 19. σ_{11} stress contours for finite element analysis of Model 2.

In Model 2 (Fig. 19), the weld provides a progressive transition to the flange thicknesses, as would be expected in a properly executed weld. In this case, a mesh of 522 elements was used. Smoothening the weld does not change the basic nature of the results but helps to reduce the overall stresses and discontinuity effects, as seen in Fig. 20.

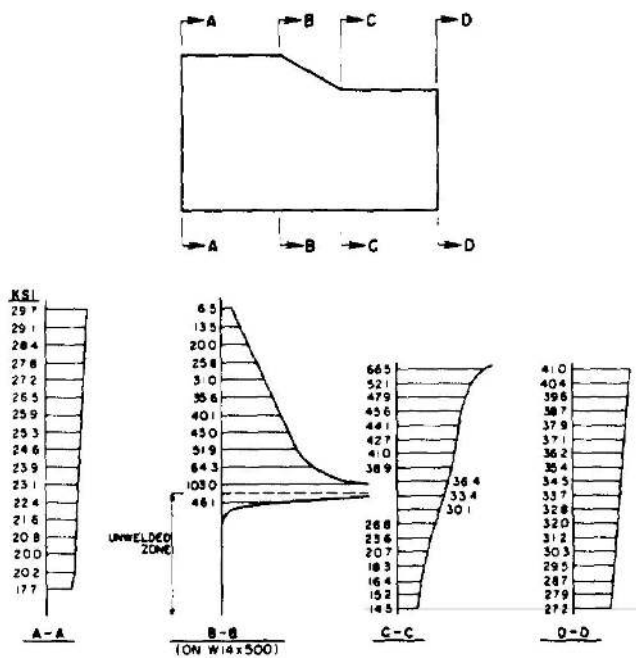
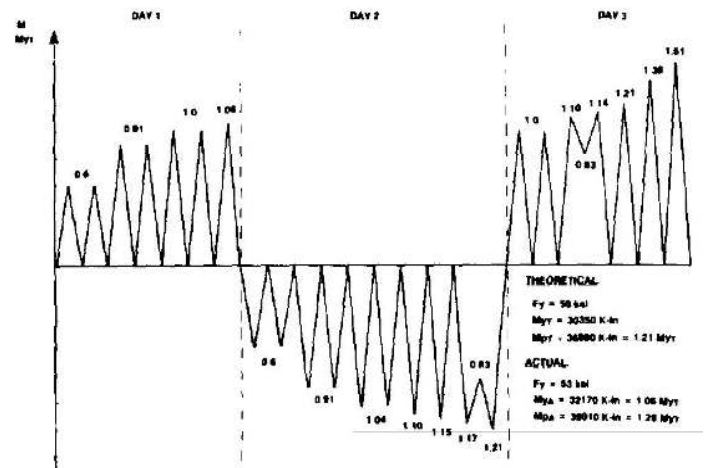
Fig. 21. History of loading applied to the full penetration specimen.

The loading sequence applied is schematically illustrated in Fig. 21. Rather than simply loading the specimen monotonically to a target displacement value as done for Specimen 1, numerous load excursions were employed in each direction before load reversal. By these successive loadings and unloadings to progressively larger force levels, the resiliency and deterioration of the specimen could be measured. In total more than 24 load excursions were applied during one complete cycle of deformation reversal.

As can be seen in Fig. 21, the specimen was first subjected to two load excursions at 60%, 91% and 100% of M_y (the nominal yield moment) of the smaller section, and then loaded in another excursion until an arbitrary small additional plastic curvature was measured. The specimen was coated with a very brittle white paint and, therefore, inelastic regions were easy to identify as yielding produced cracks in the paint. Some yield (Ludder's) lines were locally observed at midwidth on the outer face of the tension flange of the W14×370 near the weld as soon as the ($0.6M_y$) level was reached. More of those lines appeared as yielding progressed. No yield lines were observed on the compression flange in this first stage of the experiment. Large residual stresses were believed to be responsible for this early nonlinearity.

The specimen was then inverted and a similar loading history was applied. Curvatures were used to control the testing process once the nominal M_y level was exceeded. The curvatures obtained in the first part of testing were matched in this part of the test and then exceeded up to an arbitrarily larger value. The nominal value of M_p was also reached at this stage. Yield lines also became apparent during this loading at the web-flange intersection and all through the

tension flange, and compression yield lines (buckled paint) were visible on the inside of the compression flange.
