Hydraulic Performance Assessment of Mychew Small Scale Irrigation Scheme, North Ethiopia

Efriem Tariku Kassa[1*] and Mekonen Ayana[2]

Original Research Article

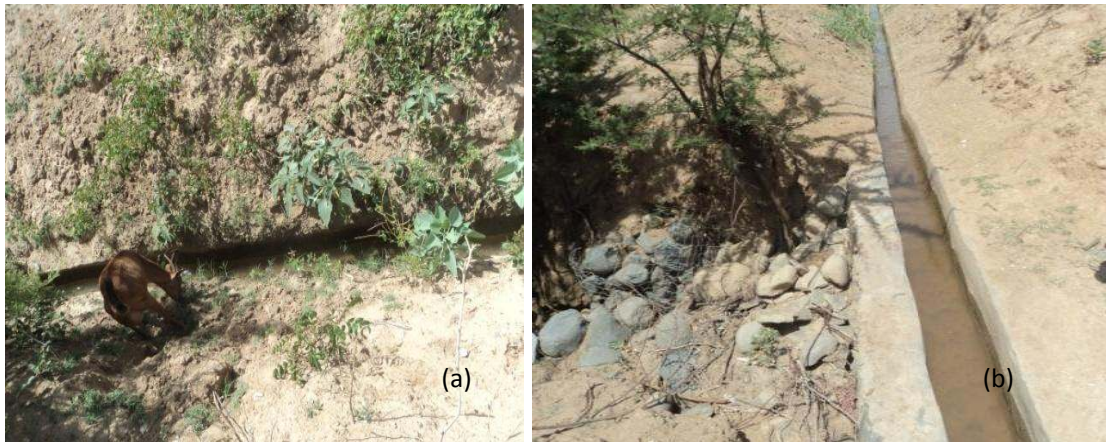
Fig. 2. Animal grazing on irrigation structures (a) and Mal-functioned (b)

In Mychew irrigation scheme the spill way sluice gates at the weir were not functional hence, are not effective yet. On the other hand, no failure was observed at main and branch canals. Based on the design document, the total number of structures was constructed on the main and branch canals were 93, however only 47 hydraulic structures are currently functional (Table 8). Therefore, the values of effectiveness of infrastructures were estimated to be 50.54%. These values suggest that maintenance activity of the systems were very poor. Based on [15] in Hare irrigation scheme, SNNPR, Ethiopia from 113 constructed irrigation structure only 18 structures were functional and its position was 15.9%.
