Title
Local-probe studies of degradation of composite LiNi0.8Co 0.15Al0.05O2 cathodes in high-power lithium-ion cells

Local-Probe Studies of Degradation of Composite $LiNi_{0.8}Co_{0.15}Al_{0.05}O_2$ Cathodes in High-Power Lithium-Ion Cells

Robert Kostecki[*z] and Frank McLarnon[**]

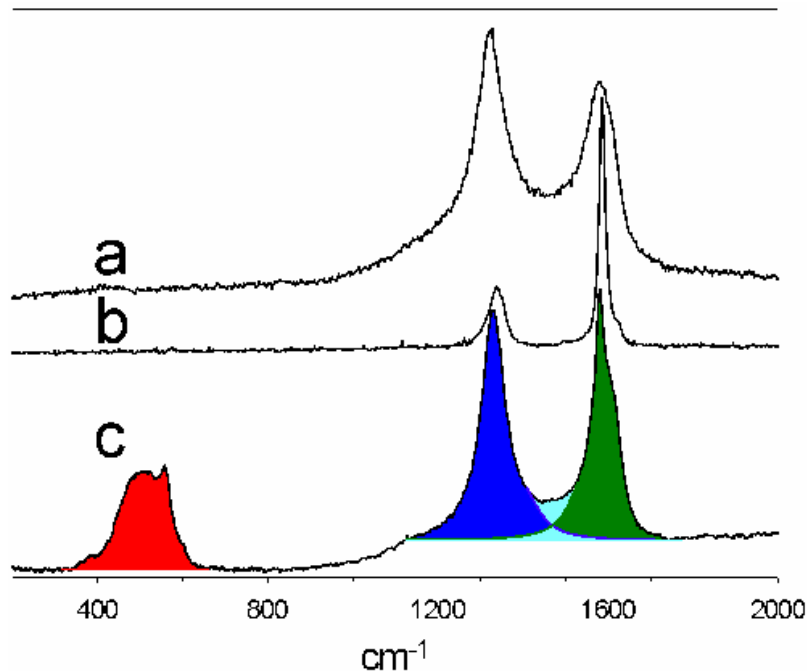
Figure 1 shows typical Raman microscopy spectra of a fresh composite $LiNi_{0.8}Co_{0.15}Al_{0.05}O_2$ cathode recorded at three different locations on the cathode surface. The Raman laser probe beam diameter was 1.2 µm, which is about one order of magnitude smaller that the size of an average $LiNi_{0.8}Co_{0.15}Al_{0.05}O_2$ particle (which is actually an agglomerate of smaller sub-micron crystallites). The Raman spectra of the fresh cathodes is dominated by two groups of bands: a broad maximum centered at ~510 cm^{-1}, characteristic for $LiNi_{0.8}Co_{0.15}Al_{0.05}O_2$ oxide, and two peaks at ~1350 and ~1600 cm^{-1}, which correspond to the D and G bands of elemental carbon, respectively. Recorded spectra of the fresh cathode vary as a function of location on the cathode surface, but carbon bands are predominant at almost all locations.

Figure 1. Typical Raman microscope spectra of the fresh composite $LiNi_{0.8}Co_{0.15}Al_{0.05}O_2$ cathode recorded at different surface locations. Spectra (a), (b), and (c) correspond to surface regions dominated by disordered carbon, graphitic carbon, and oxide, respectively. The color-coding analysis scheme is illustrated by spectrum (c).

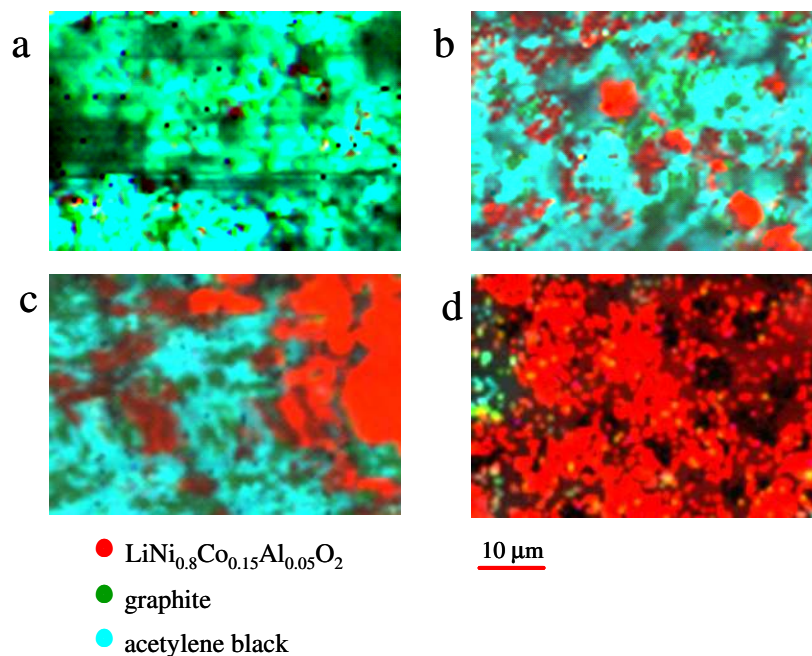
Representative micro-Raman surface composition image maps of a fresh cathode and the cathodes from high-power Li-ion cells that exhibited 10, 34, and 52% power loss are shown in Fig. 2. These unique composition maps clearly indicate that the fresh cathode surface is almost fully coated by acetylene black and graphite. Furthermore, the carbon coating is sufficiently thick to prevent detection of the underlying oxide active material. The cathode surface composition changed significantly in tested cells, which display much higher oxide/carbon surface concentration ratios. This composition change is particularly dramatic for the cathode from the cell with 52% power loss. This cathode surface consists almost entirely of bare oxide grains with only a few small regions of carbon additive. Although the color-coded maps represent a semi-quantitative comparison because of the different Raman scattering intensities of oxide and carbons, they clearly demonstrate dramatic changes in the electrode surface composition that accompanied cell tests. These data provide evidence for carbon retreat (or redistribution) from the cathode surface, a phenomenon that has escaped detection in prior diagnostic studies of Li-ion cells.

Figure 2. 52 x 75 μm Raman microscope images of the composite $LiNi_{0.8}Co_{0.15}Al_{0.05}O_2$ cathodes. The images consist of Raman spectra collected at 0.7 μm resolution. The intensity of red, blue and green color corresponds to the integrated bands intensity of $LiNi_{0.8}Co_{0.15}Al_{0.05}O_2$, and D, G carbon bands of each spectrum, respectively. (a) fresh cathode, (b), (c) and (d) cathodes from cells which lost 10, 34, and 52% of power, respectively.

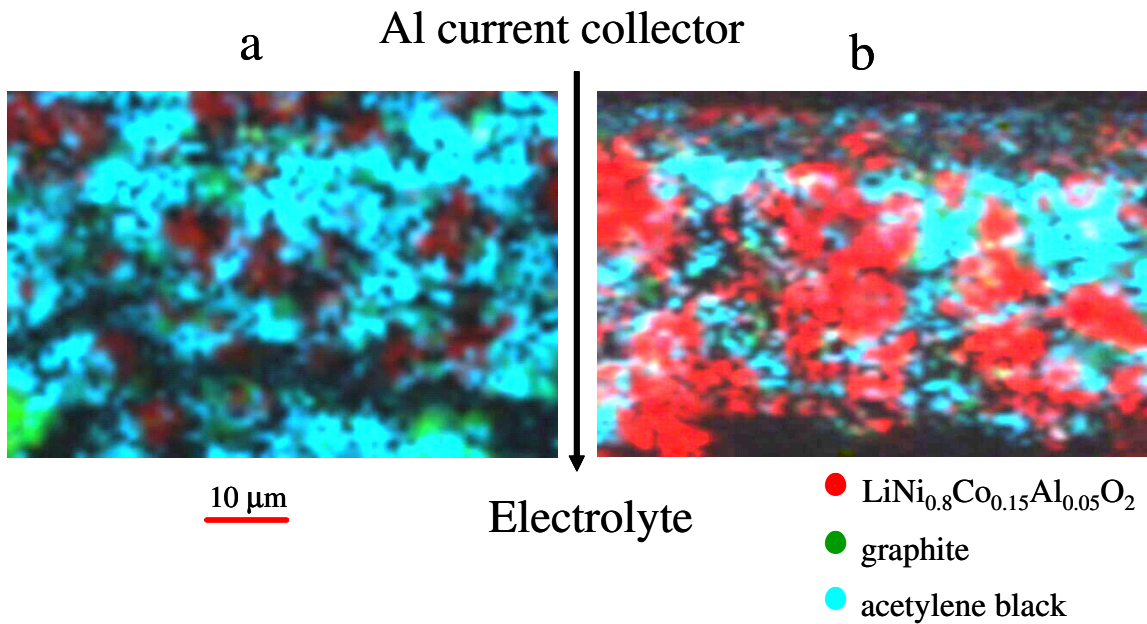
In order to determine if carbon redistribution or retreat also affects the bulk of the cathode, we carried out Raman micro-analysis of the cross-sections of $LiNi_{0.8}Co_{0.015}Al_{0.05}O_2$ cathode samples (Fig. 3). Samples of composite cathodes were prepared by folding the cathode until it cleaved and thereby exposed its cross-section.

Such a tool-less and non-invasive procedure allowed us **to reduce the risk of** sample contamination and possible structural damage. The results of the cross-section Raman microanalysis are consistent with our surface studies and clearly indicate that significant changes in the bulk (*i.e.*, sub-surface) $LiNi_{0.8}Co_{0.15}Al_{0.05}O_2$/elemental-carbon concentration ratio accompanied cell tests. We did not observe any clear carbon distribution pattern across the electrode thickness. **This absence of a distribution pattern may be a result of the sample preparation, which could possibly alter the distribution of the cathode components**. However, the extent of carbon retreat observed in the cathode bulk was somewhat smaller than that on the cathode surface.

Figure 3. 52 x 75 μm Raman microscope images of a cross-section of the composite $LiNi_{0.8}Co_{0.15}Al_{0.05}O_2$ cathodes. (a) fresh cathode, (b)cathode from the cells which lost 52% of power.

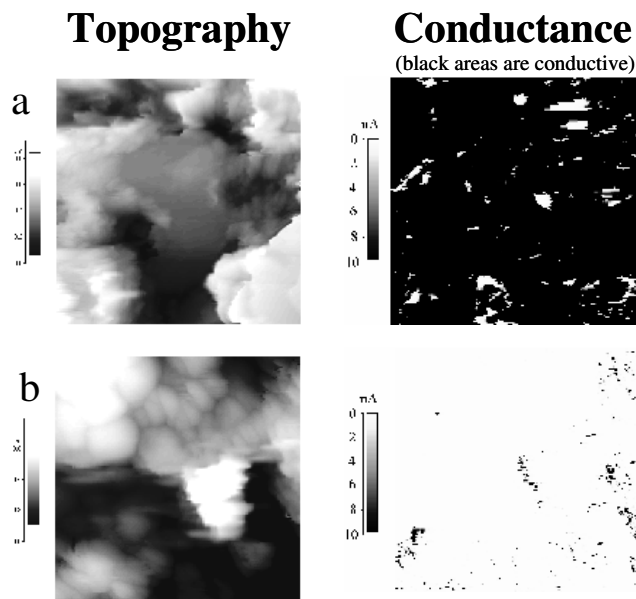
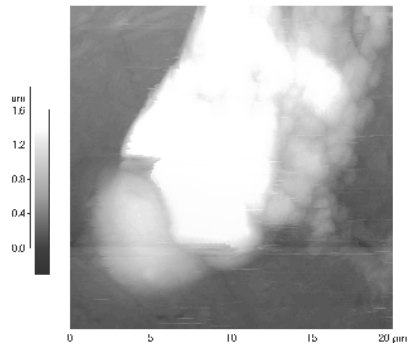
Figure 4 shows CSAFM images of surface conductance (right-hand panel) and topography (left-hand panel) of a representative 5 x 5 μm region of the composite $LiNi_{0.8}Co_{0.15}Al_{0.05}O_2$ cathode surface at 1.0 V tip-sample voltage difference from (A) a fresh cell; and (B) a cathode from the cell, which lost 34% of its power. The surface morphology images of both cathodes (left-hand panel) show large polycrystalline agglomerates and reveal no significant changes in the cathode surface topography in tested cells. This result is contrary to our earlier study of the $LiNi_{0.8}Co_{0.2}O_2$ cathodes, which showed that considerable amounts of nanocrystalline deposits accumulated in the cathode inter-granular spaces and across the crystal planes [2,3].

The conductance images in the right-hand panel of Fig. 4 show both dark and white regions, which correspond to local areas of high and low (or zero) electronic conductance, respectively. The surface conductance image of the cathode from a fresh cell exhibits areas of mostly high electronic conductance and only a few insulating regions. Highly conductive graphite and acetylene black additives, which are abundant in

The conductance images of cathodes tested at elevated temperatures show a dramatic increase of surface resistance. Most of the cathode surface became insulating except for a few locations, mainly in deep crevices and intergranular spaces, which remained conductive. Previous results for $LiNi_{0.8}Co_{0.2}O_2$ cathodes [2,3] also showed a complete lack of conductivity of the cathode surface, consistent with either loss of contact of particles at the electrode surface with the rest of the electrode, or the presence of a non-conductive film of polycarbonates, and LiF, Li_xPF_y-type and $Li_xPF_yO_z$-type compounds [13].

A reduction in conductance of portions of the cathode can easily explain the observed increase in cell impedance as well as loss of cathode capacity *via* isolation of oxide active material. Particle isolation is also in concert with our observations of carbon retreat or rearrangement in tested cathodes. These results represent the most clear and obvious difference (compared to other diagnostic studies) in cathode characteristics after prolonged cell tests at elevated temperatures. However, the intrinsic conductivity of the $LiNi_{0.8}Co_{0.15}Al_{0.05}O_2$ (10^{-2}-10^{-3} S cm^{-1}) should be sufficiently high to compensate for a partial carbon loss or carbon rearrangement within the thin (40 μm) cathode bulk. In other words, the potential drop across a 40 μm pure (*i.e.*, with no carbon additive) $LiNi_{0.8}Co_{0.15}Al_{0.05}O_2$ cathode cannot account for the observed cell power loss, not to mention the irreversible capacity loss that always accompanies the cathode impedance increase.

Figure 4. CSAFM images of surface conductance (right-hand panel) and topography (left-hand panel) of a 5 x 5 μm region of the composite $LiNi_{0.8}Co_{0.15}Al_{0.05}O_2$ cathode surface at 1.0 V tip-sample voltage difference: (A) virgin cell; (B) cathode from the cell which lost 34% of power.

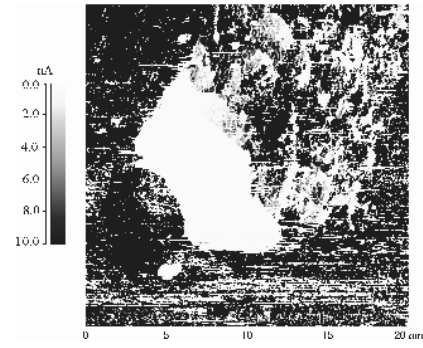
and then their local electronic properties were investigated *via* CSAFM. The surfaces of these embedded particles were scanned with a conductive AFM tip with a potential of 1V applied between the sample and the tip. The morphology image and the corresponding surface conductance map are shown in Fig. 5. Large agglomerates of $LiNi_{0.8}Co_{0.15}Al_{0.05}O_2$ consist of smaller (sub-micron to ~5 microns) crystallites fused tightly together. The conductance image revealed that the agglomerate crystallites were not uniformly conductive. Surprisingly, some crystallites displayed good electronic contact with the Au substrate (as expected) and some exhibited very high resistance, representing the lack of a facile electronic pathway to the Au substrate. We attribute this non-uniformity in electronic properties to poor inter-crystallite (*i.e.*, inter-granular) electronic contact. This poor contact inhibits electrons from reaching crystallites that are not in direct contact with the Au current collector. The presence of a nascent thin insulating surface region of Li_xNiO [1], a resistive film (Li_2CO_3) coating some of the $LiNi_{0.8}Co_{0.15}Al_{0.05}O_2$ crystallites, or poor mechanical contact between crystallites may be responsible for the observed effect.

Figure 5. 20 x 20 μm CSAFM images of surface conductance and topography of a single particle of $LiNi_{0.8}Co_{0.15}Al_{0.05}O_2$ embedded into a Au foil at 1.0 V tip-sample voltage difference.
