# OBSERVATION AND MODELLING OF ELECTROMIGRATION-INDUCED VOID GROWTH IN Al-BASED INTERCONNECTS

O. KRAFT, S. BADER, J.E. SANCHEZ JR.*, and E. ARZT
Max-Planck-Institut für Metallforschung, and Institut für Metallkunde, University of Stuttgart, D-7000 Stuttgart, Germany; * Advanced Micro Devices, Sunnyvale, CA 94088, USA

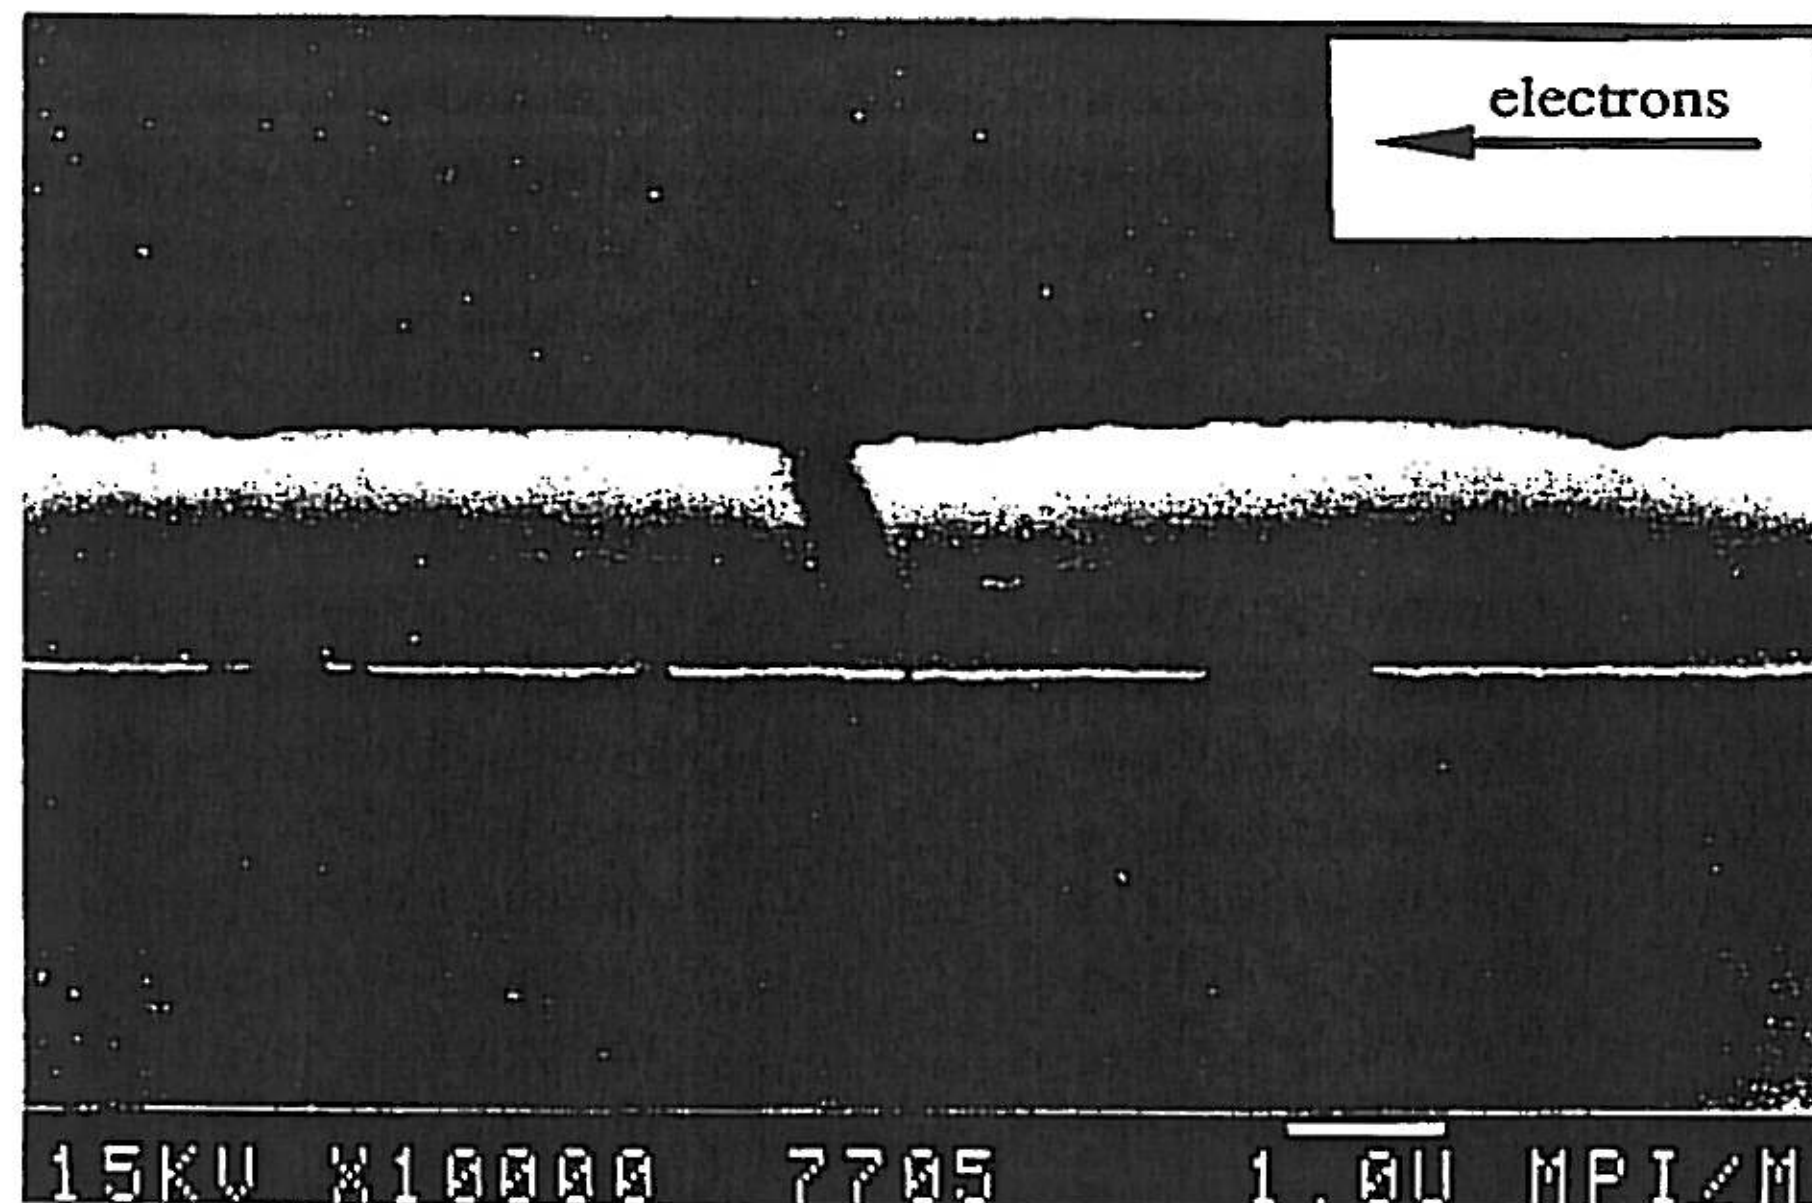
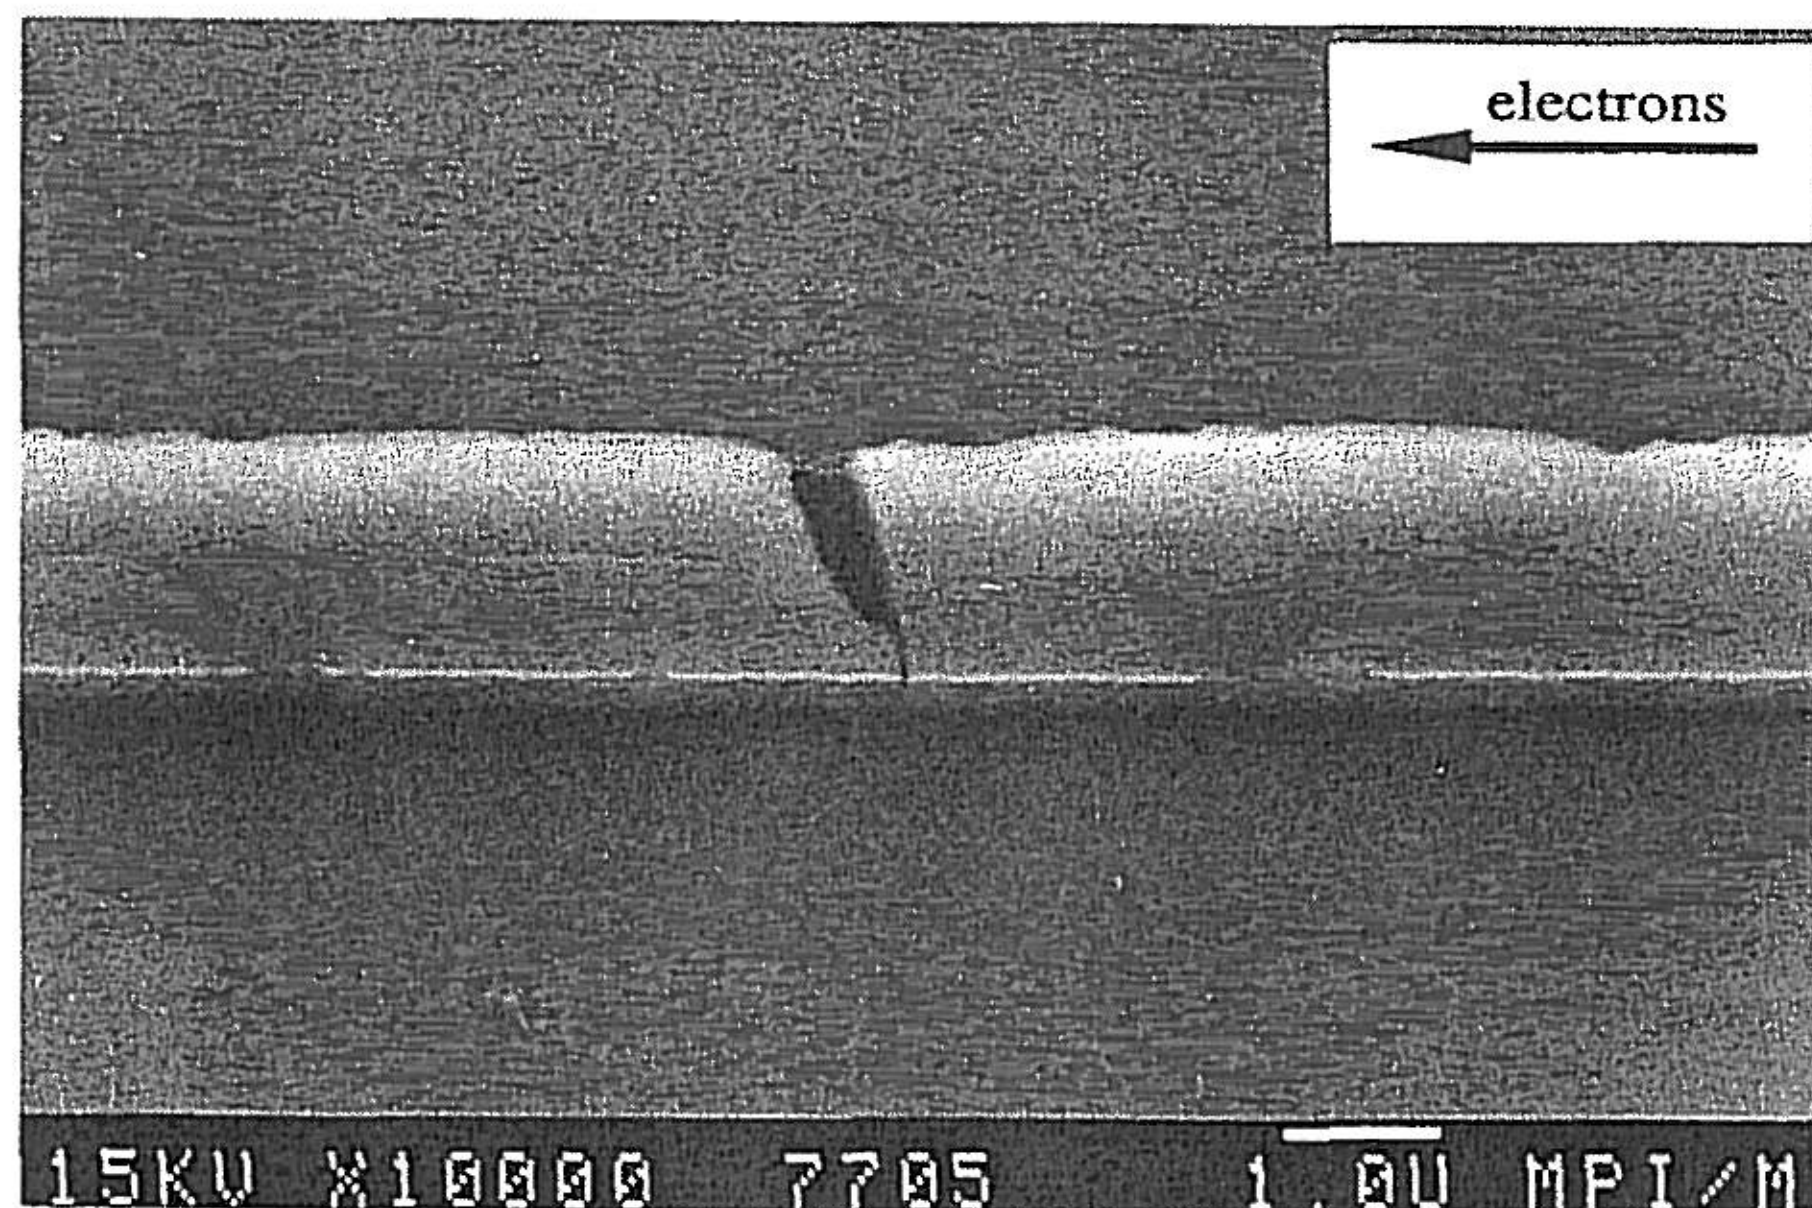
Fig. 1: SEM micrograph of a transgranular void producing an open circuit. The void shows the typical wedge shape, where the side turned against the direction of the electron flux (right side) is straight and almost perpendicular to the line. The angle between the other side and the line is smaller.

Fig. 1 shows an SEM micrograph of a typical open circuit produced by a transgranular void, which grew during an uninterrupted test. The direction of the electron flux in all figures is from right to left. About half of all opens were found to be transgranular under the test conditions used. Figs. 2a-c and Figs. 3a-c give two sequences of void motion, growth and ultimate failure obtained from an interrupted test. Fig. 2a shows, after a total testing time of 42.2 h, a small void which was not detected during a previous test interruption after 25.5 hours. The void was probably nucleated at the intersection of a grain boundary with the edge of the line. Then it moved along the edge through a small grain until it was pinned by a grain boundary (Fig. 2b). Note that for crystallographic reasons the void is facetted and these facets reorient as the void enters the adjacent bamboo grain, as suggested before [6]. The void does not move further into this grain, but now starts to grow in the transverse direction until it finally produces a transgranular open circuit (Fig. 2c). The sequence in Fig. 3 is similiar to the one in Fig. 2. Fig. 3a shows a void at the edge of the line in a bamboo grain; either the void was nucleated in

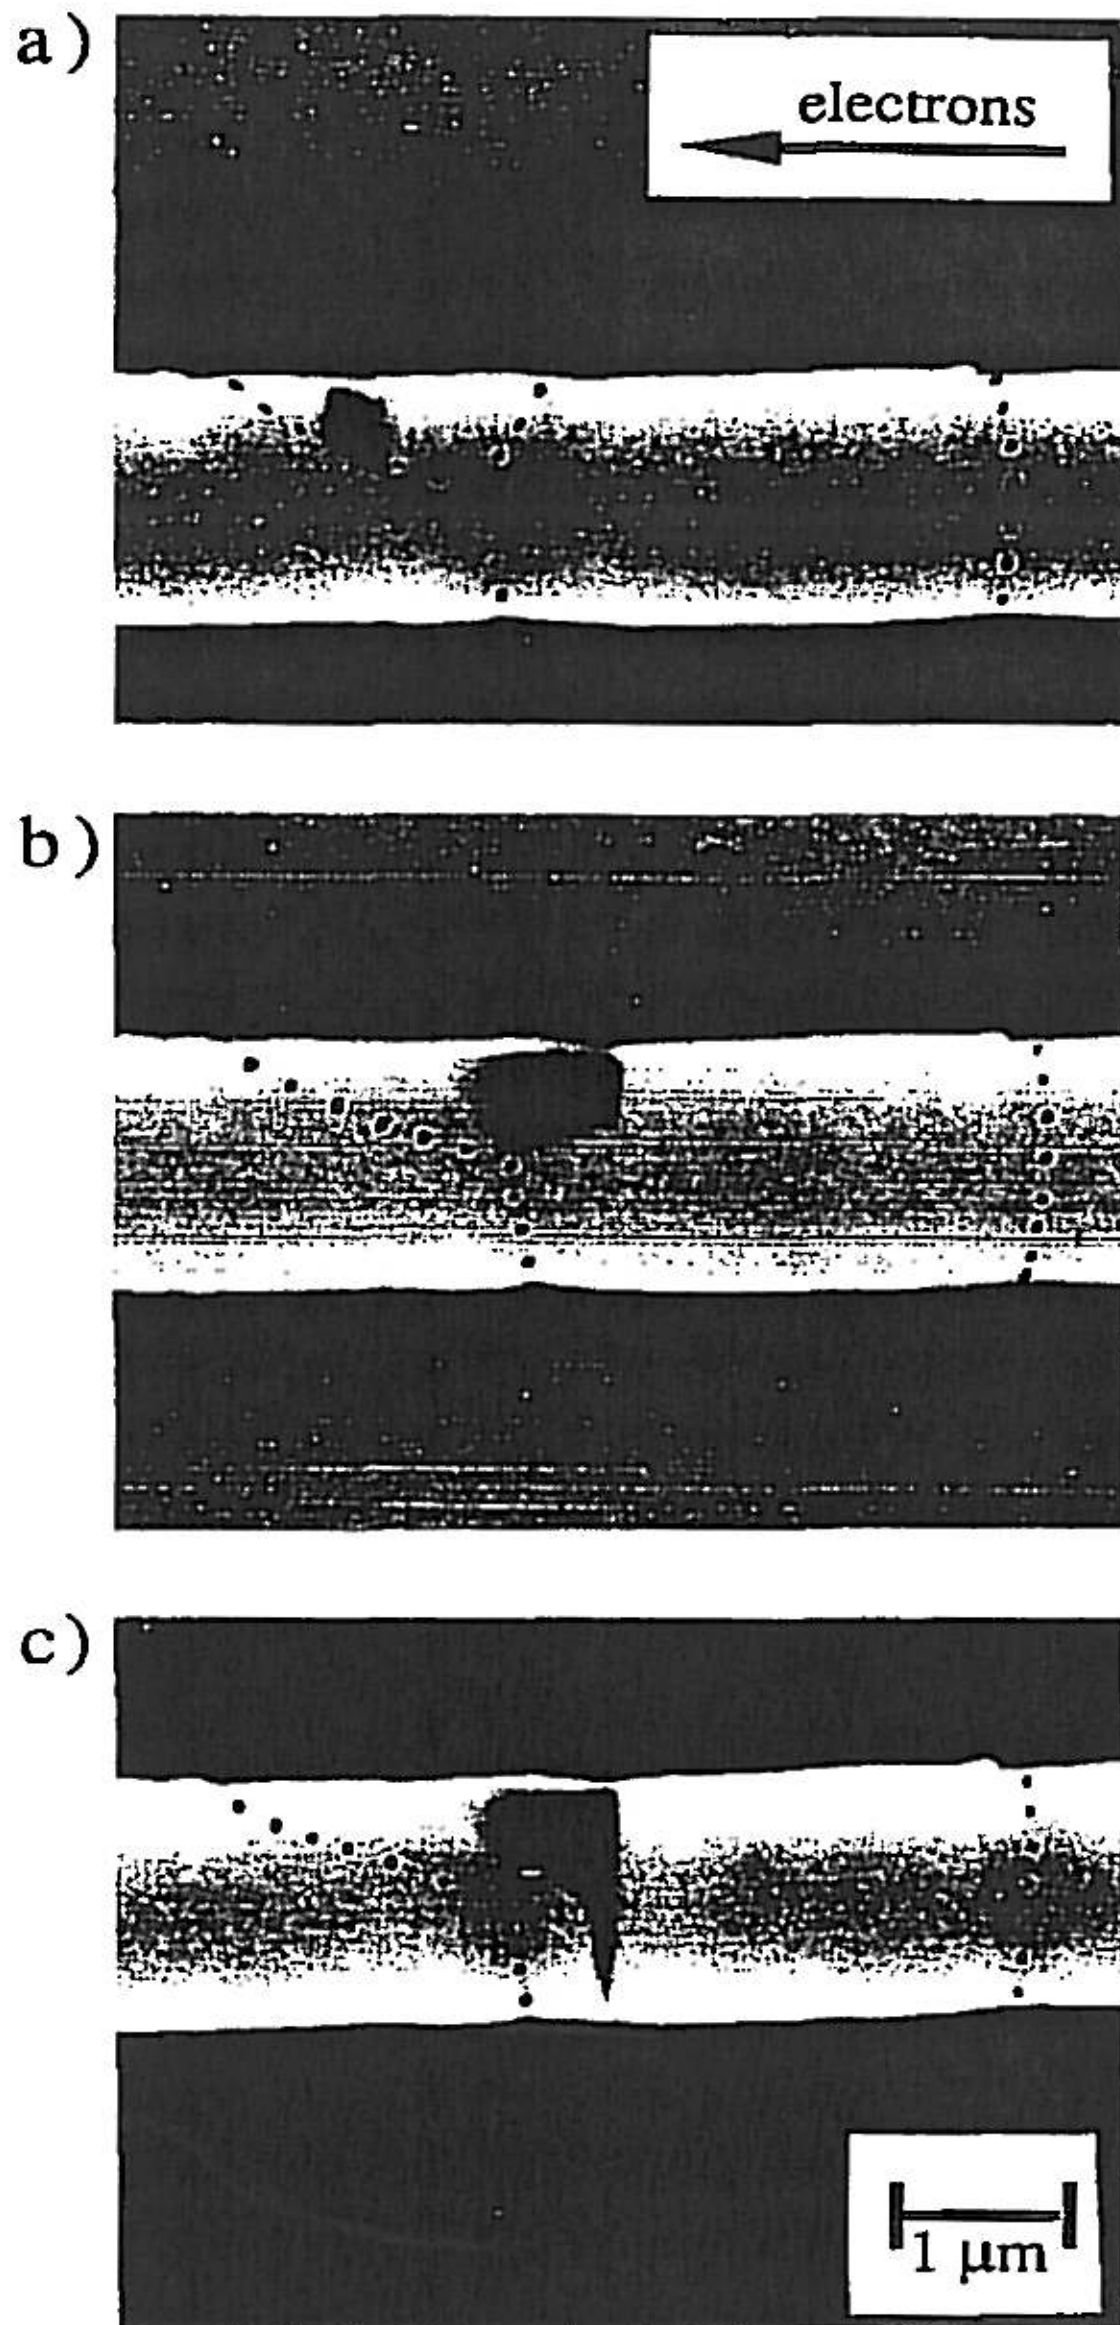
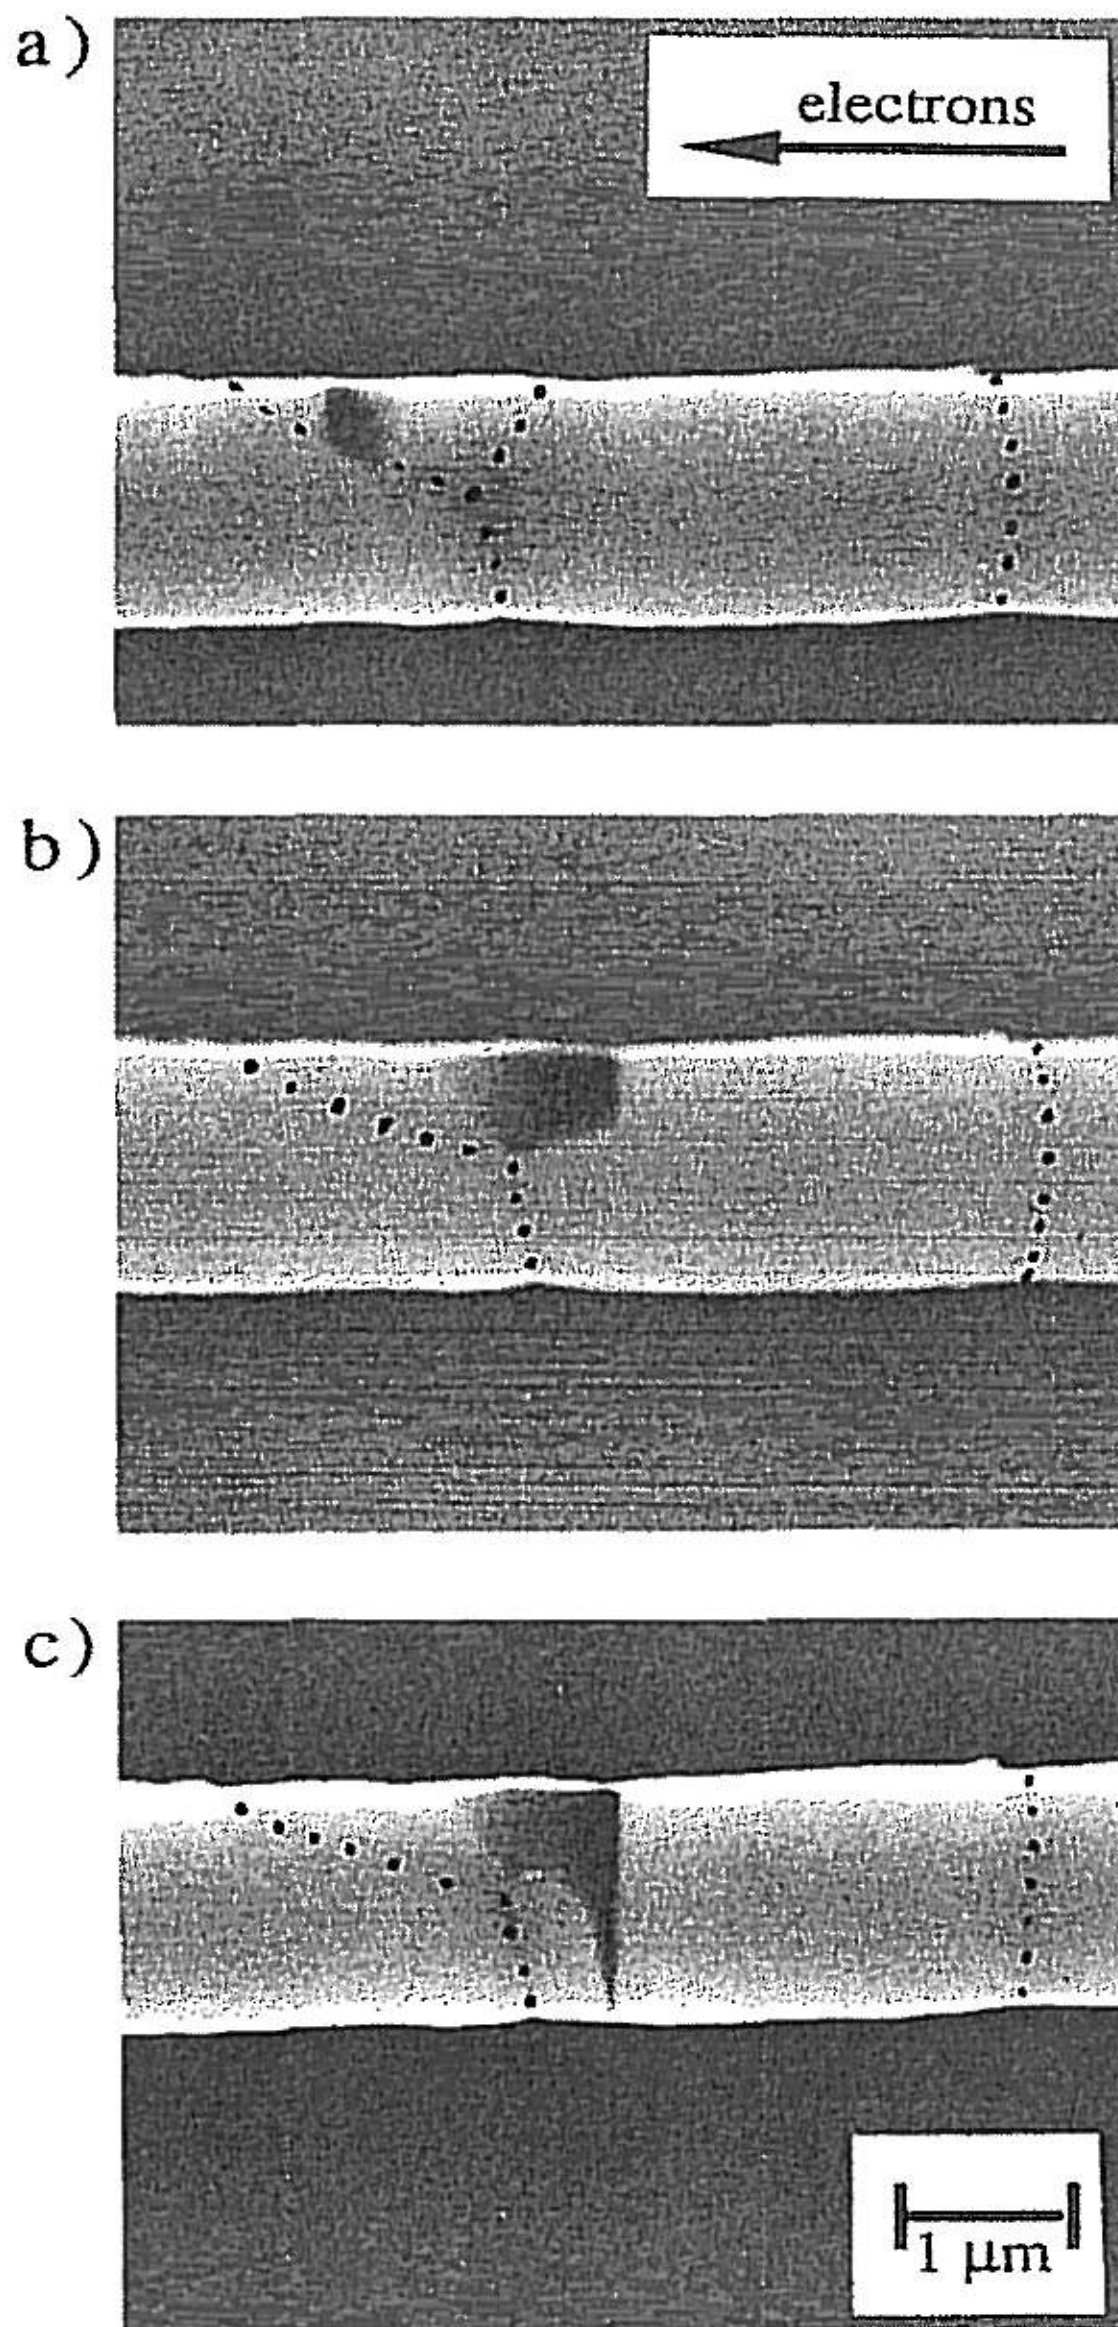
Fig. 2: SEM micrographs showing a time sequence of the same site on a conductor line after a) 42.2 h, b) 140.6 h, and c) 161.8 h total testing time. The void moved first along the edge of the line until it started to grow through a bamboo grain across the line. (Grain boundaries are artificially highlighted with dotted lines.)

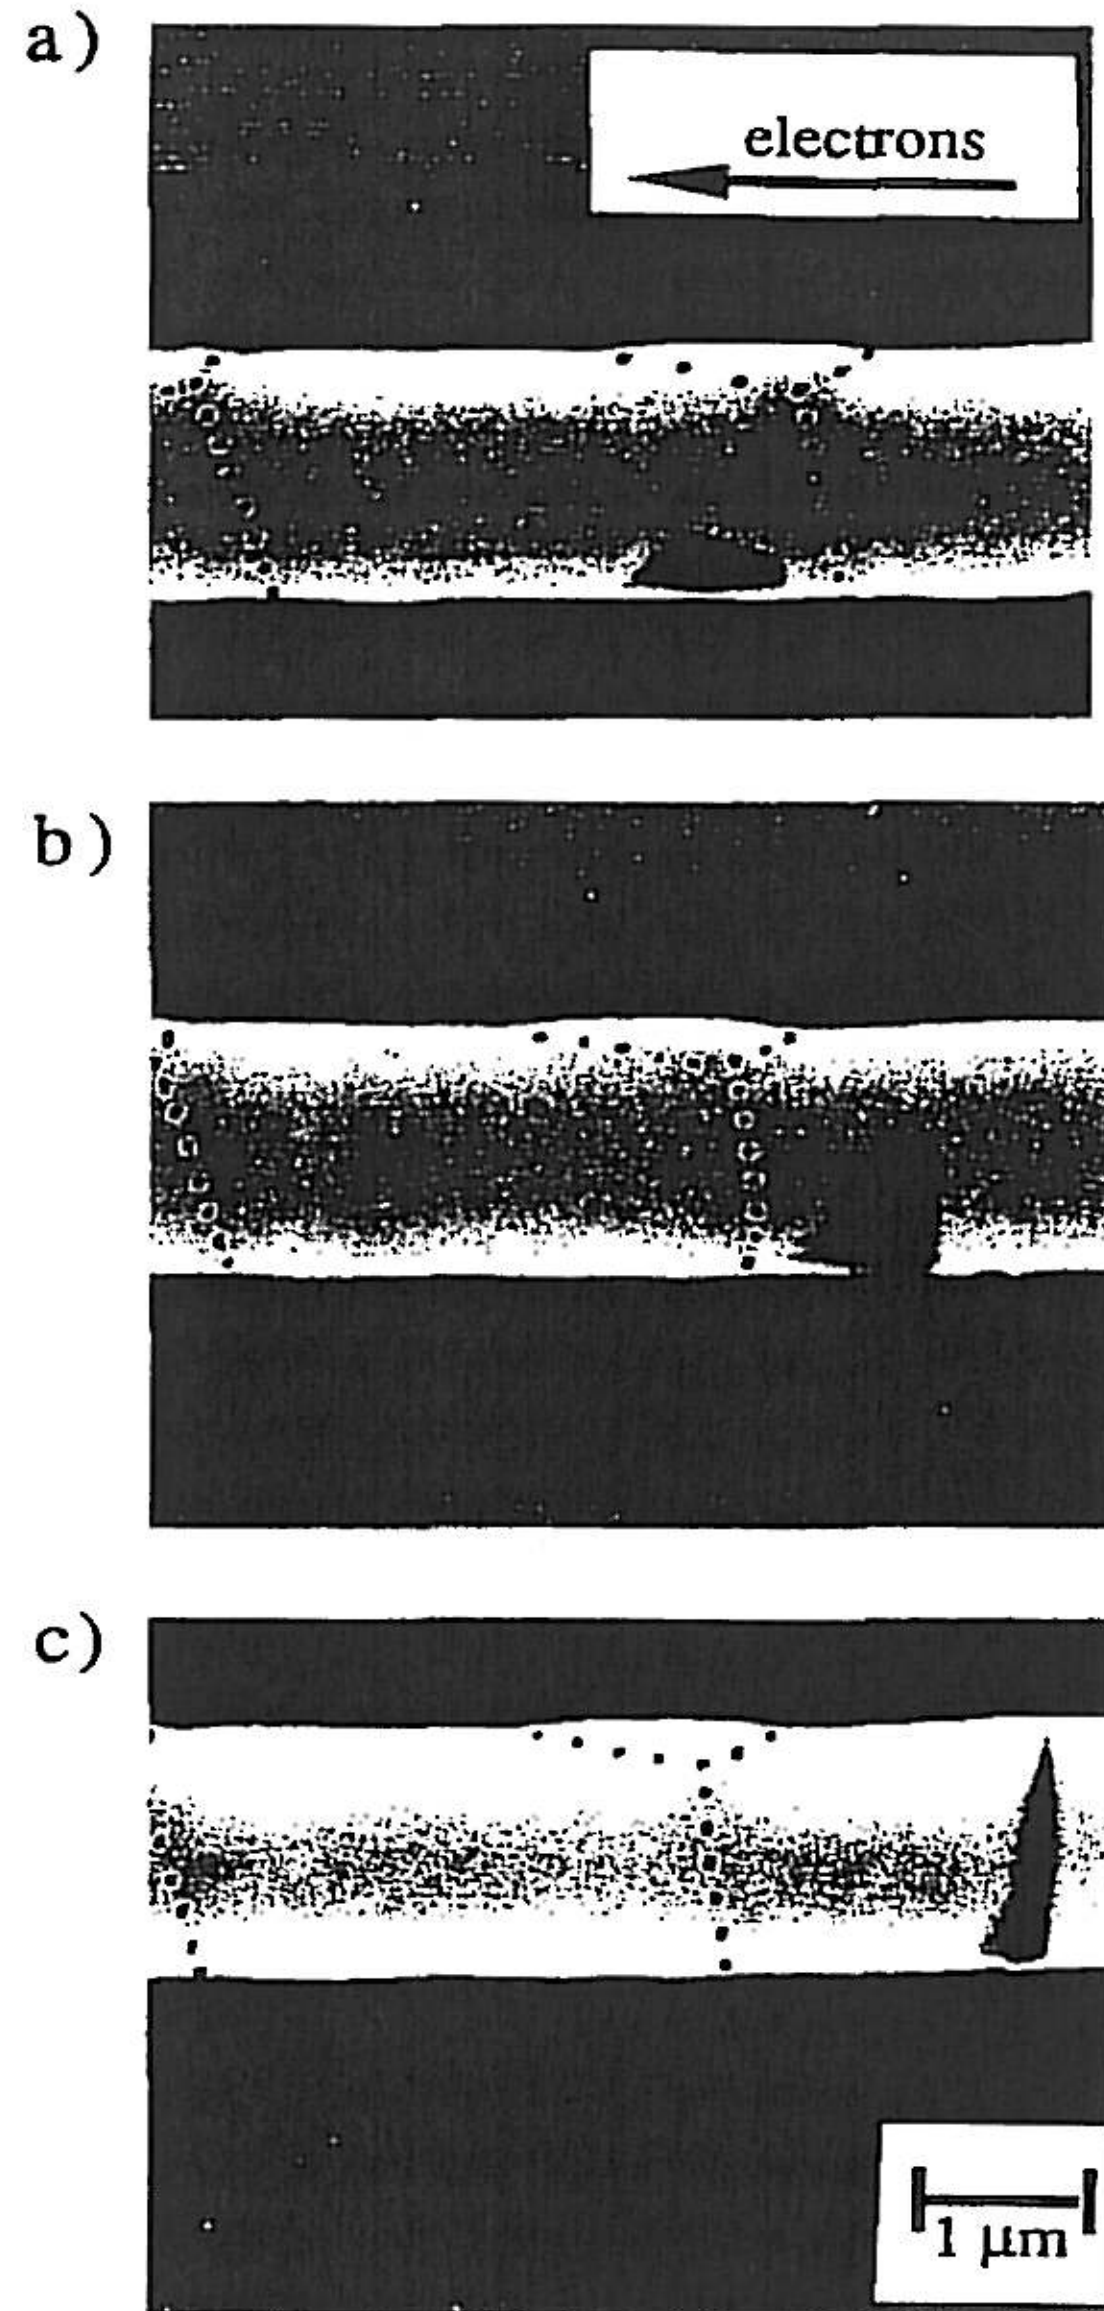
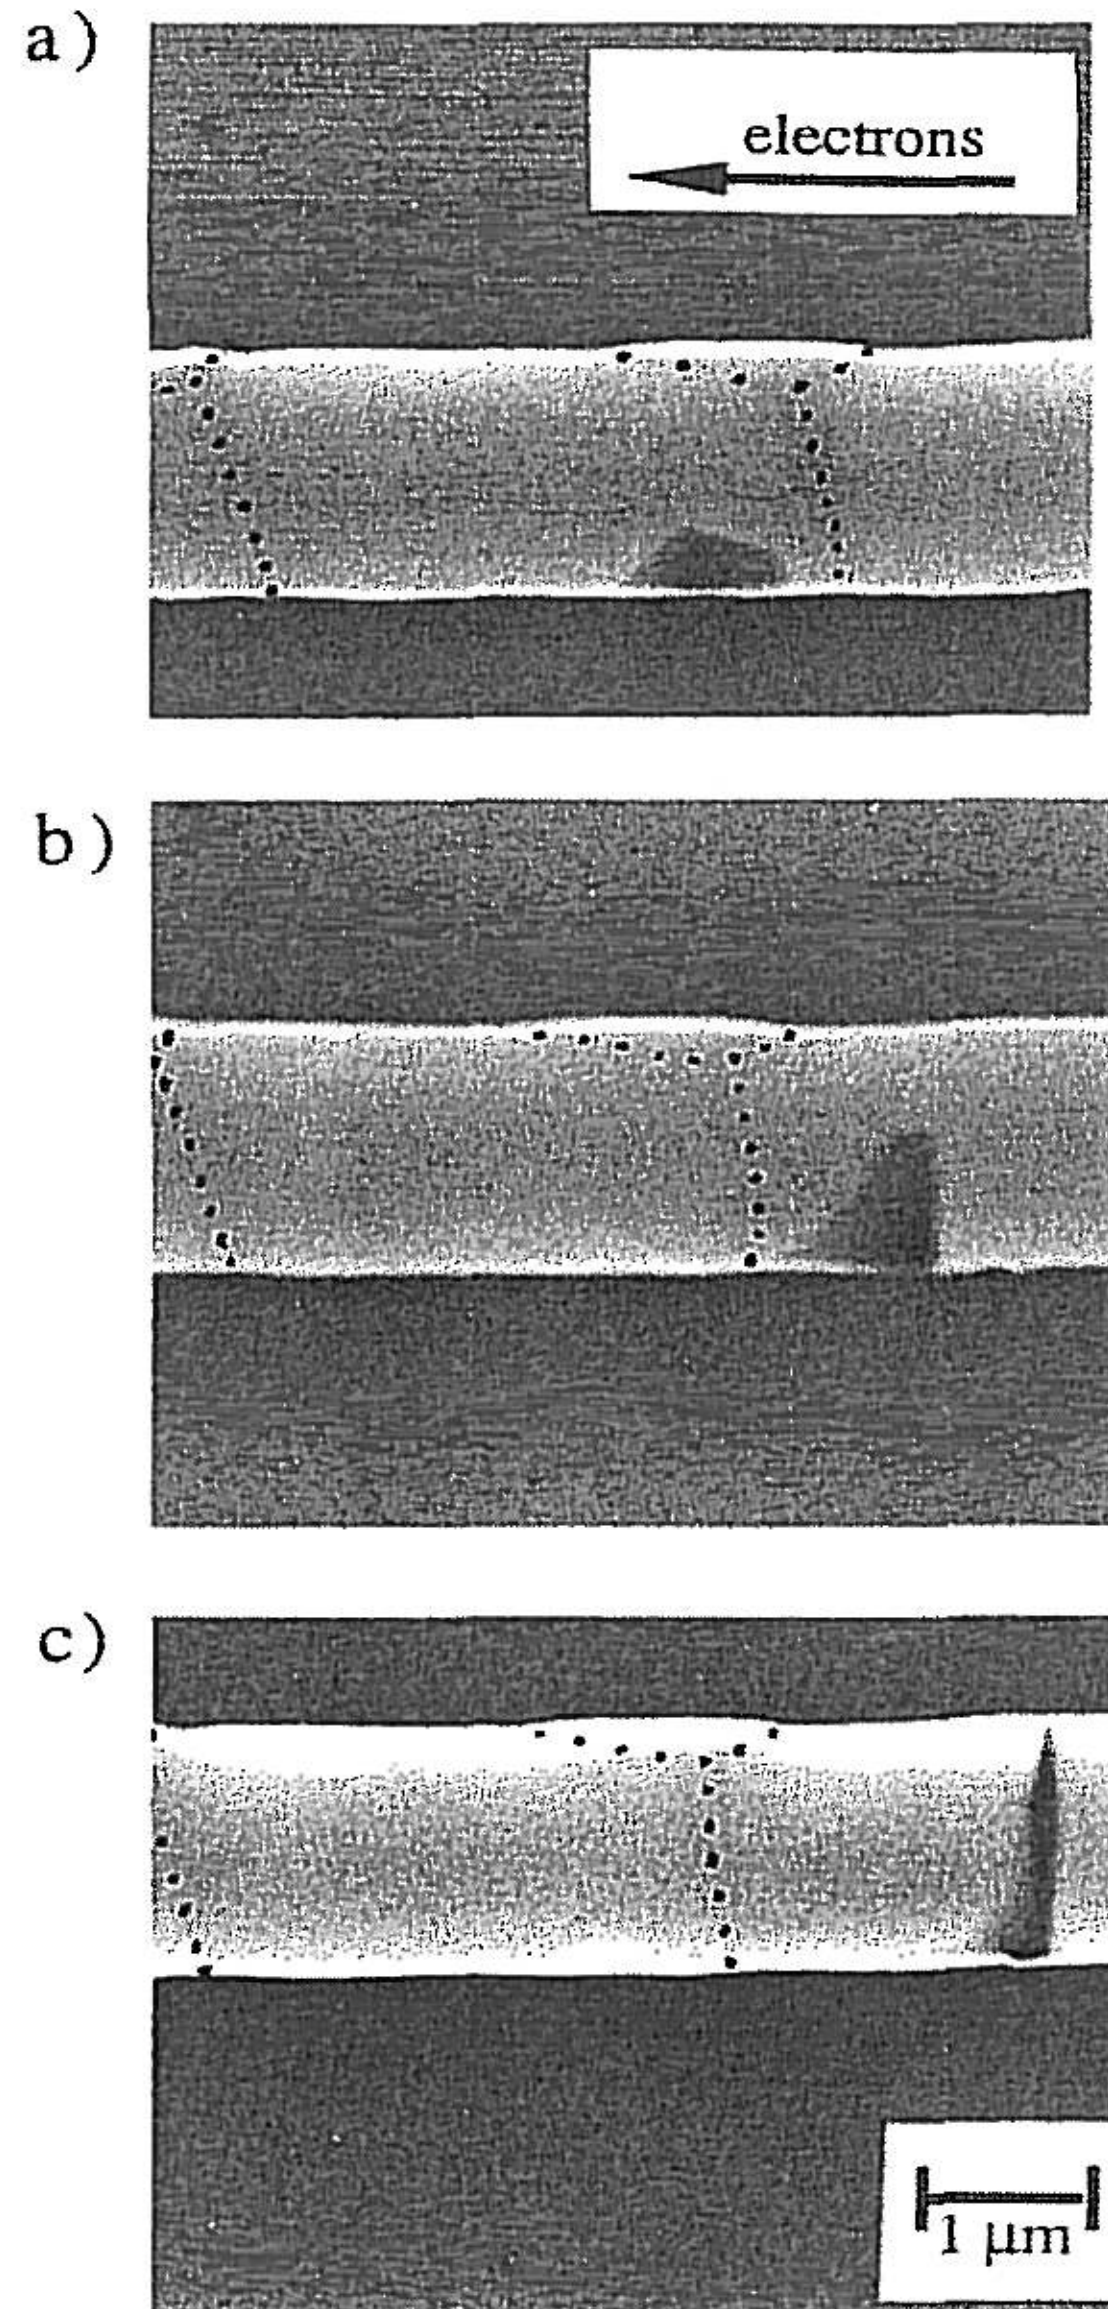
the grain or moved into the grain after nucleation at a grain boundary. Then the void penetrated the grain boundary to the next bamboo grain (Fig. 3b) and advanced into this grain. There it elongated producing a failure site (Fig. 3c).

Fig. 3: Sequence of SEM micrographs similar to Fig. 2 (testing time: a) 42.2 h, b) 140.6 h, c) 144.9 h). The void moved along the edge of the line, crossed a grain boundary, and started to grow across the line in the "second" bamboo grain.

meantime the void has developed, on its cathode end, a facet perpendicular to the line ("critical" shape), which starts to grow (in d). Finally this facet produces the opening of the line, showing the typical wedge shape (in e). Note that the void became critical only after a facet perpendicular to the line was established. From this moment the total void volume remained about constant, only the shape of the void was changed by surface diffusion in a manner as described above. A similiar shape change mechanism is visible in Figs. 3b-c.

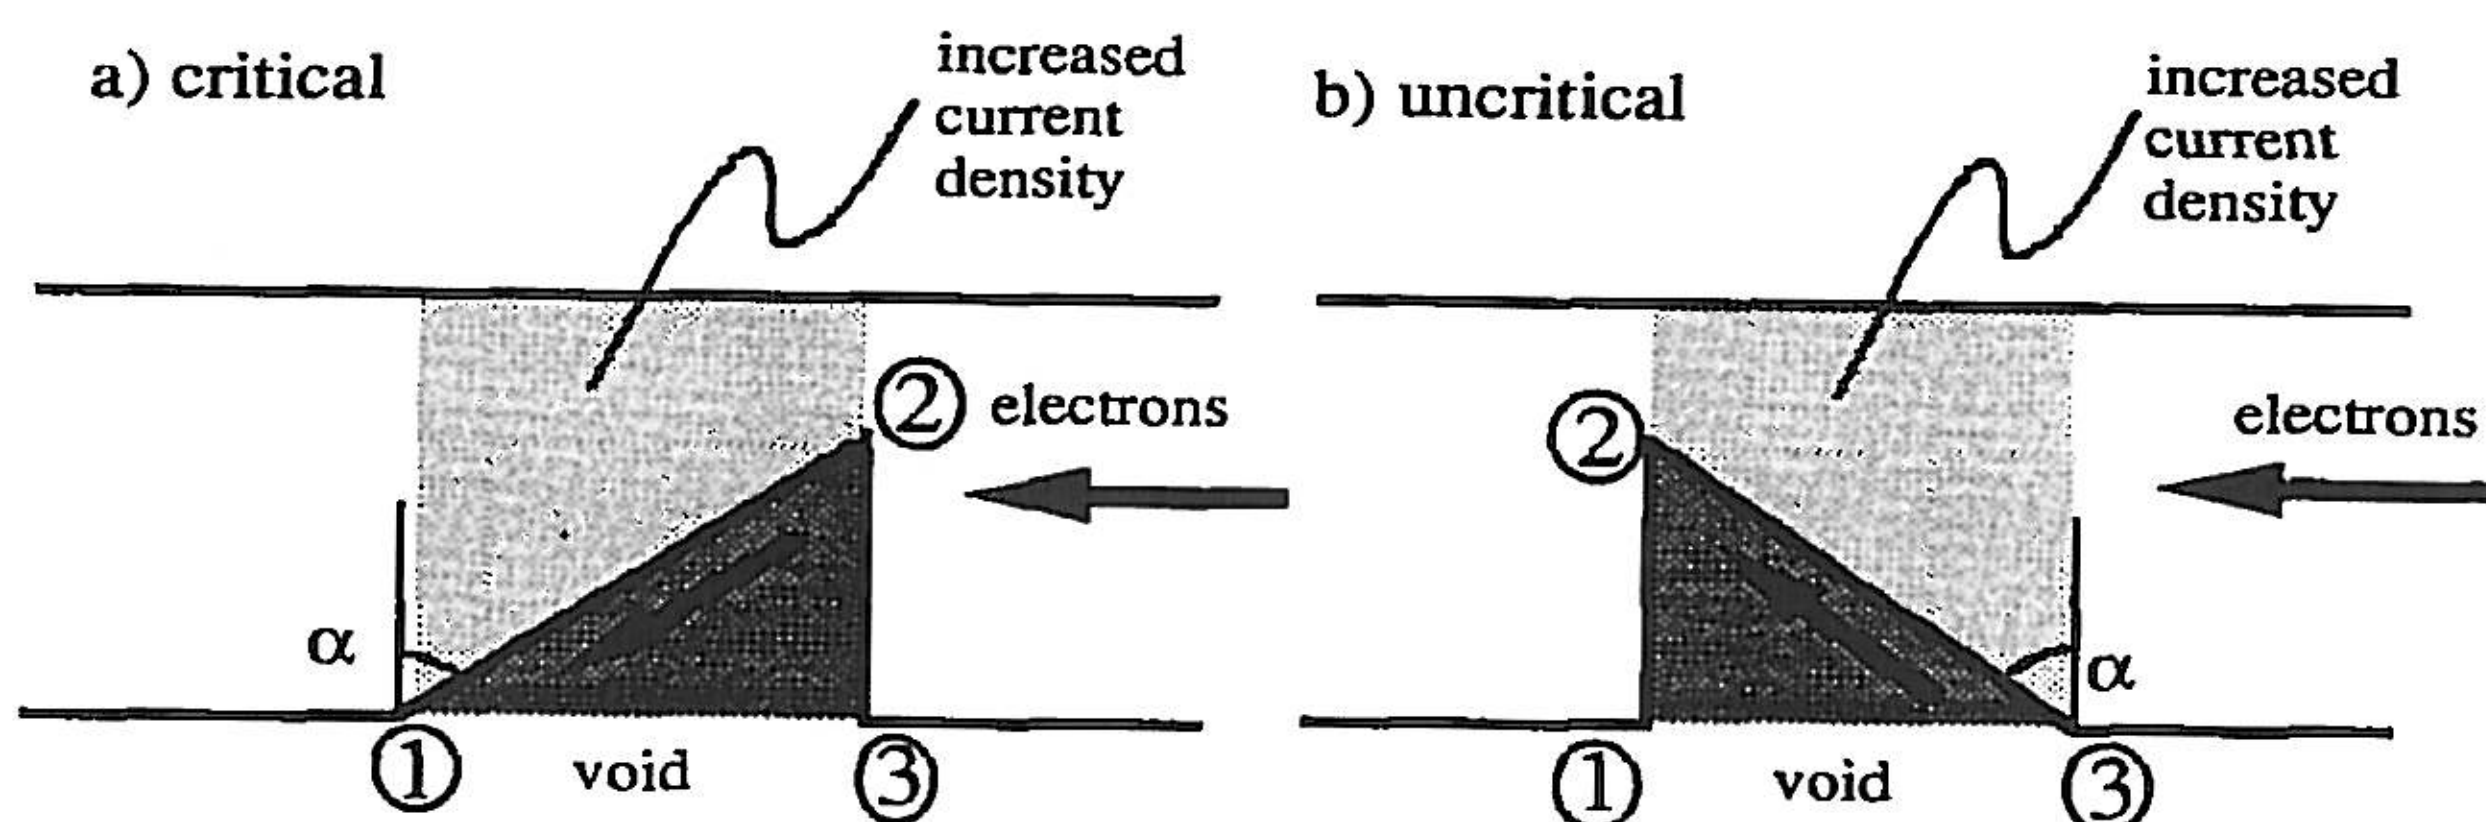
Because of this systematic asymmetry, void growth in our experiments cannot be driven by stresses alone (which are by definition symmetric). Rather, the electron wind is expected to interact with mechanical stress in a way suggested qualitatively in Fig. 4: A driving force for electromigration does not appear on a void surface perpendicular to the direction of the electron flux. However, on the tilted void surface, a mass flux is set up which depends on the angle to the line. Following this reasoning a void with a shape as shown in Fig. 4a becomes critical, because EM-induced mass flux occurs from 2 to 1, but not from 3 to 2. Consequently mass is removed at 2 and the void grows across the line and tends to become fatal. Additionally the void tip sharpens and may act as a location of stress concentration, if the line is under mechanical tension. The mass flux on the void surface from 2 to 1 increases for larger voids, caused by the

Fig. 4: Schematic illustration of the interconnection between void shape and electron wind:
a) no EM-induced mass flux on the void surface from 3 to 2, but from 2 to 1 (as a function of $\alpha$). As a result mass is removed at 2 and the void tends to become fatal ("critical" configuration).
b) no EM-induced mass flux from 2 to 1 but from 3 to 2, consequently the void grows along the line ("uncritical" configuration).

locally increased current density. Therefore the void growth accelerates with increasing void size. Contrary to this, a void with a shape as shown in Fig. 4b should be uncritical because EM-induced mass flux occurs only from 3 to 2, but not from 2 to 1. Hence mass is removed at 3 and added at 2: the void grows along the line and the void tip rounds off. Even a large void with this shape does not become critical because of the "self-healing" tendency which is further enhanced by the locally increased current density.
