# OBSERVATION AND MODELLING OF ELECTROMIGRATION-INDUCED VOID GROWTH IN Al-BASED INTERCONNECTS

O. KRAFT, S. BADER, J.E. SANCHEZ JR.*, and E. ARZT
Max-Planck-Institut für Metallforschung, and Institut für Metallkunde, University of Stuttgart, D-7000 Stuttgart, Germany; * Advanced Micro Devices, Sunnyvale, CA 94088, USA

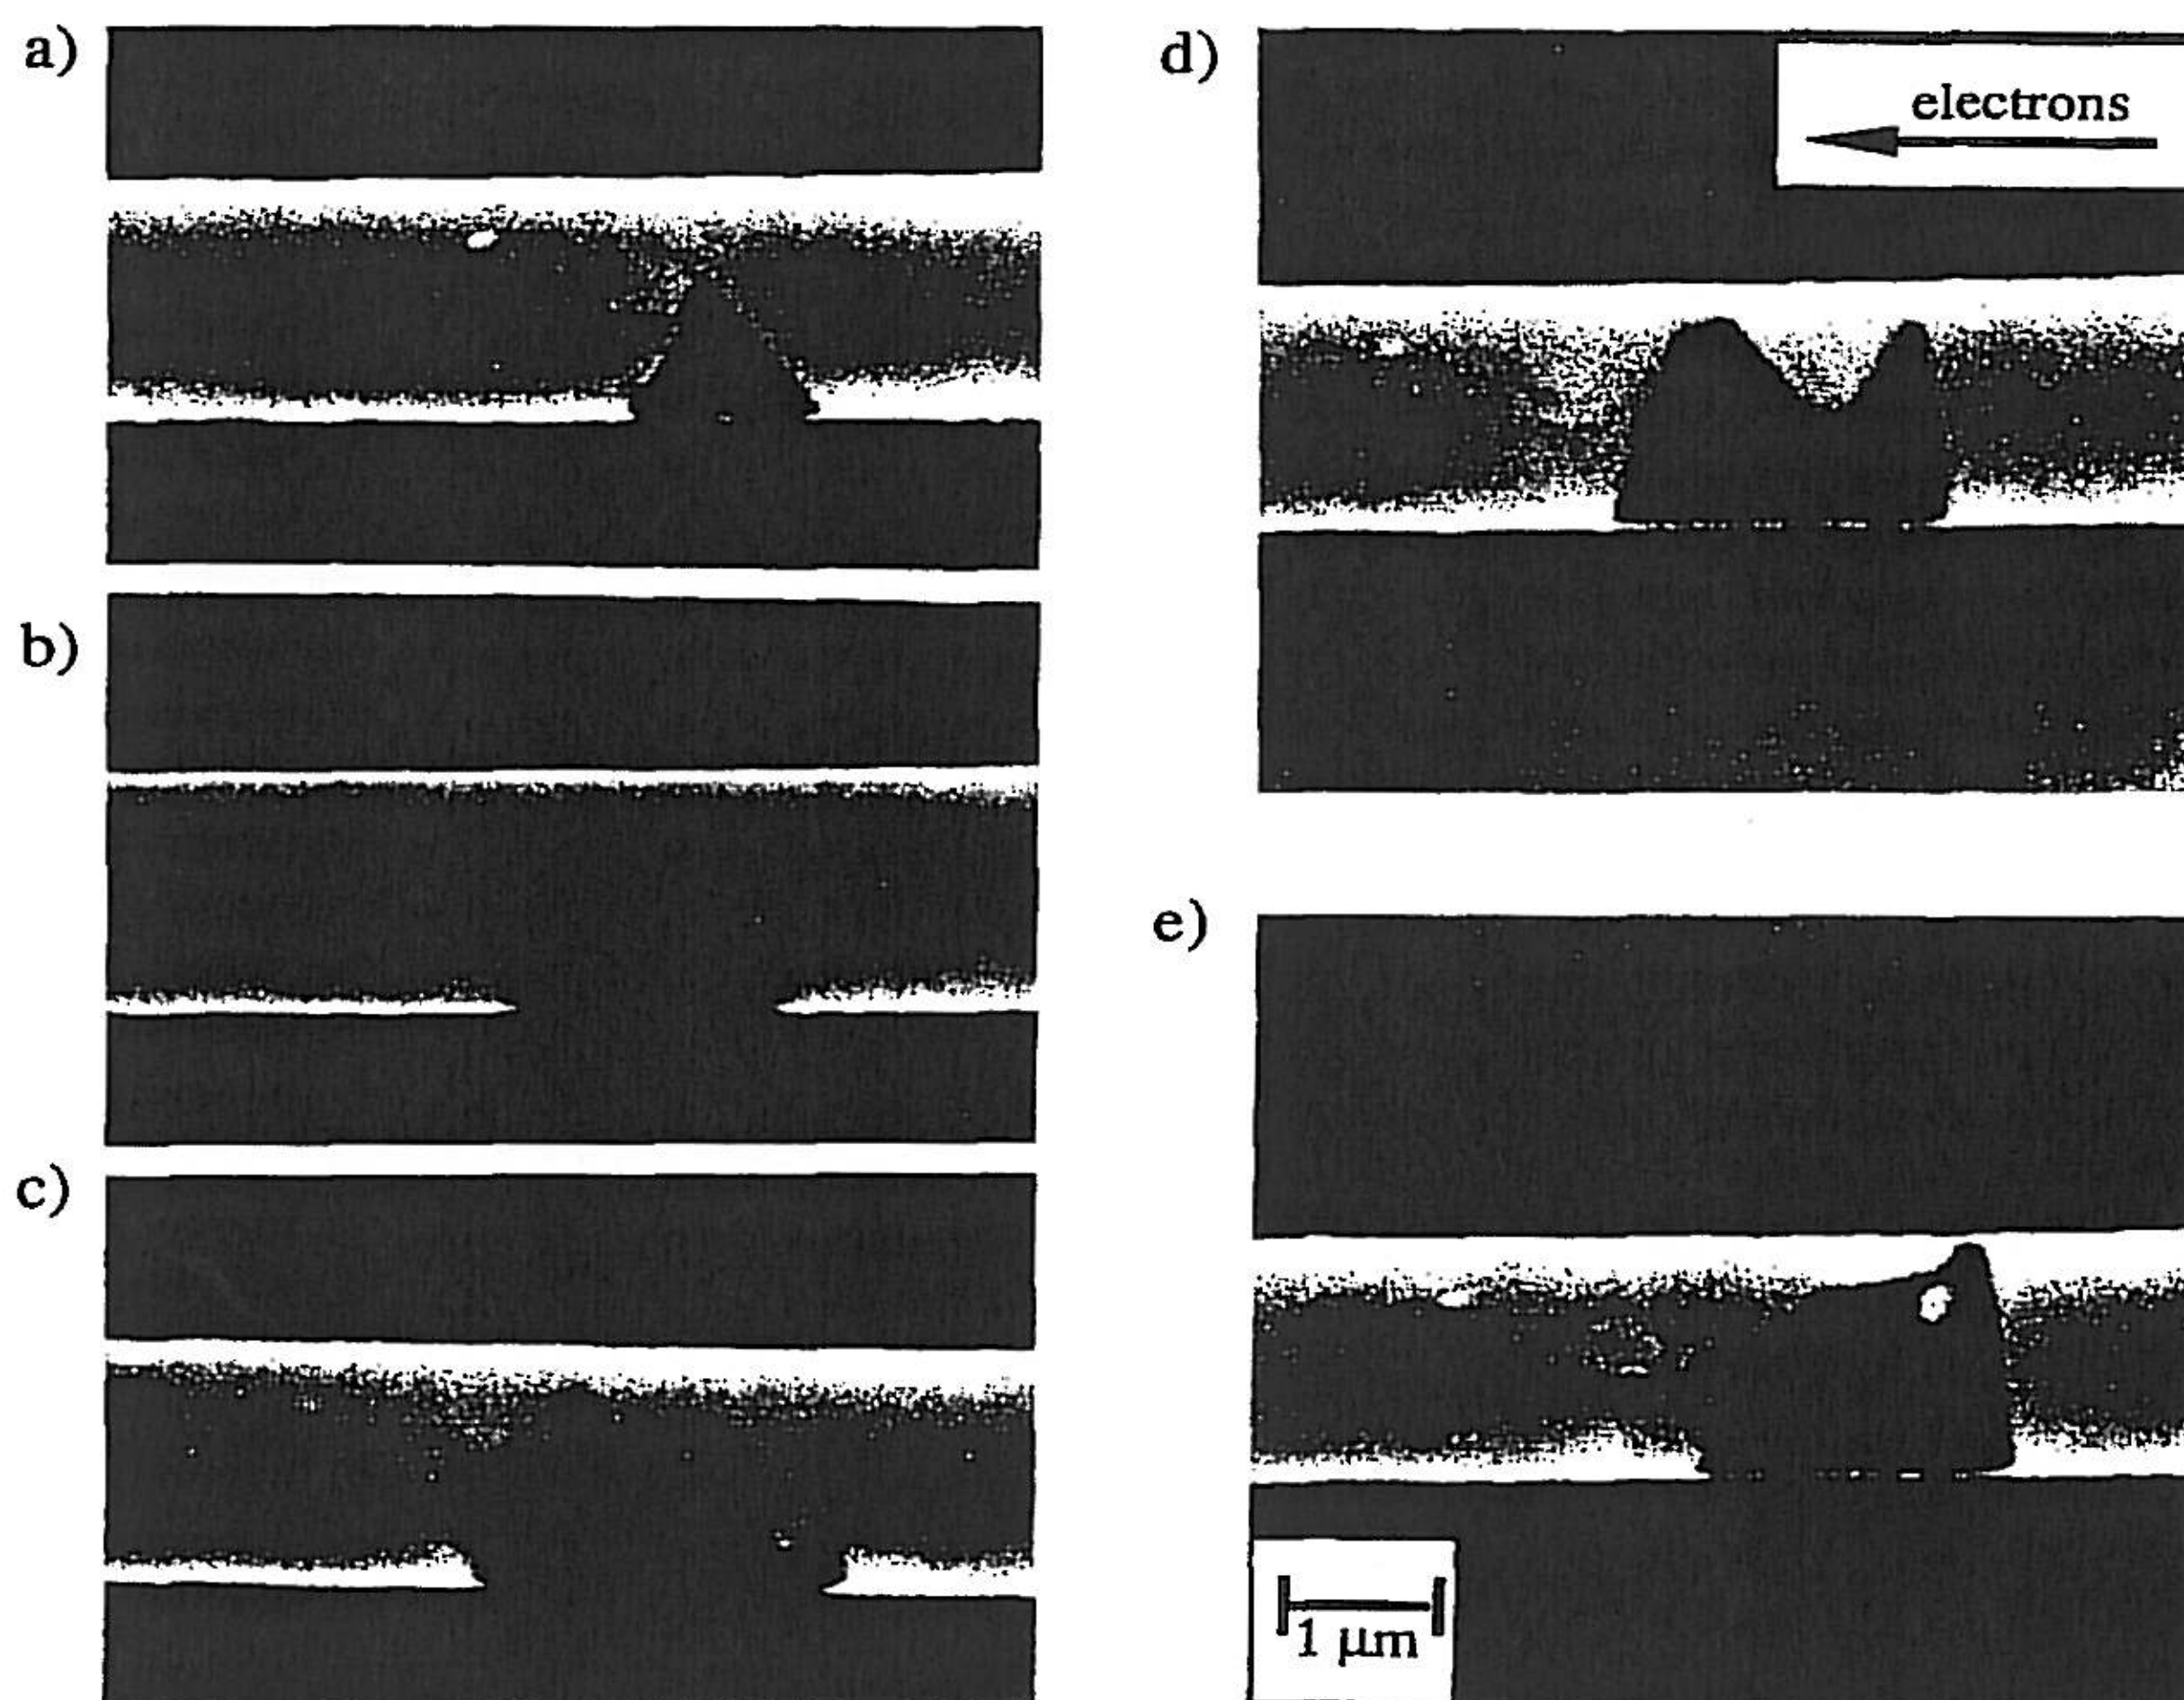
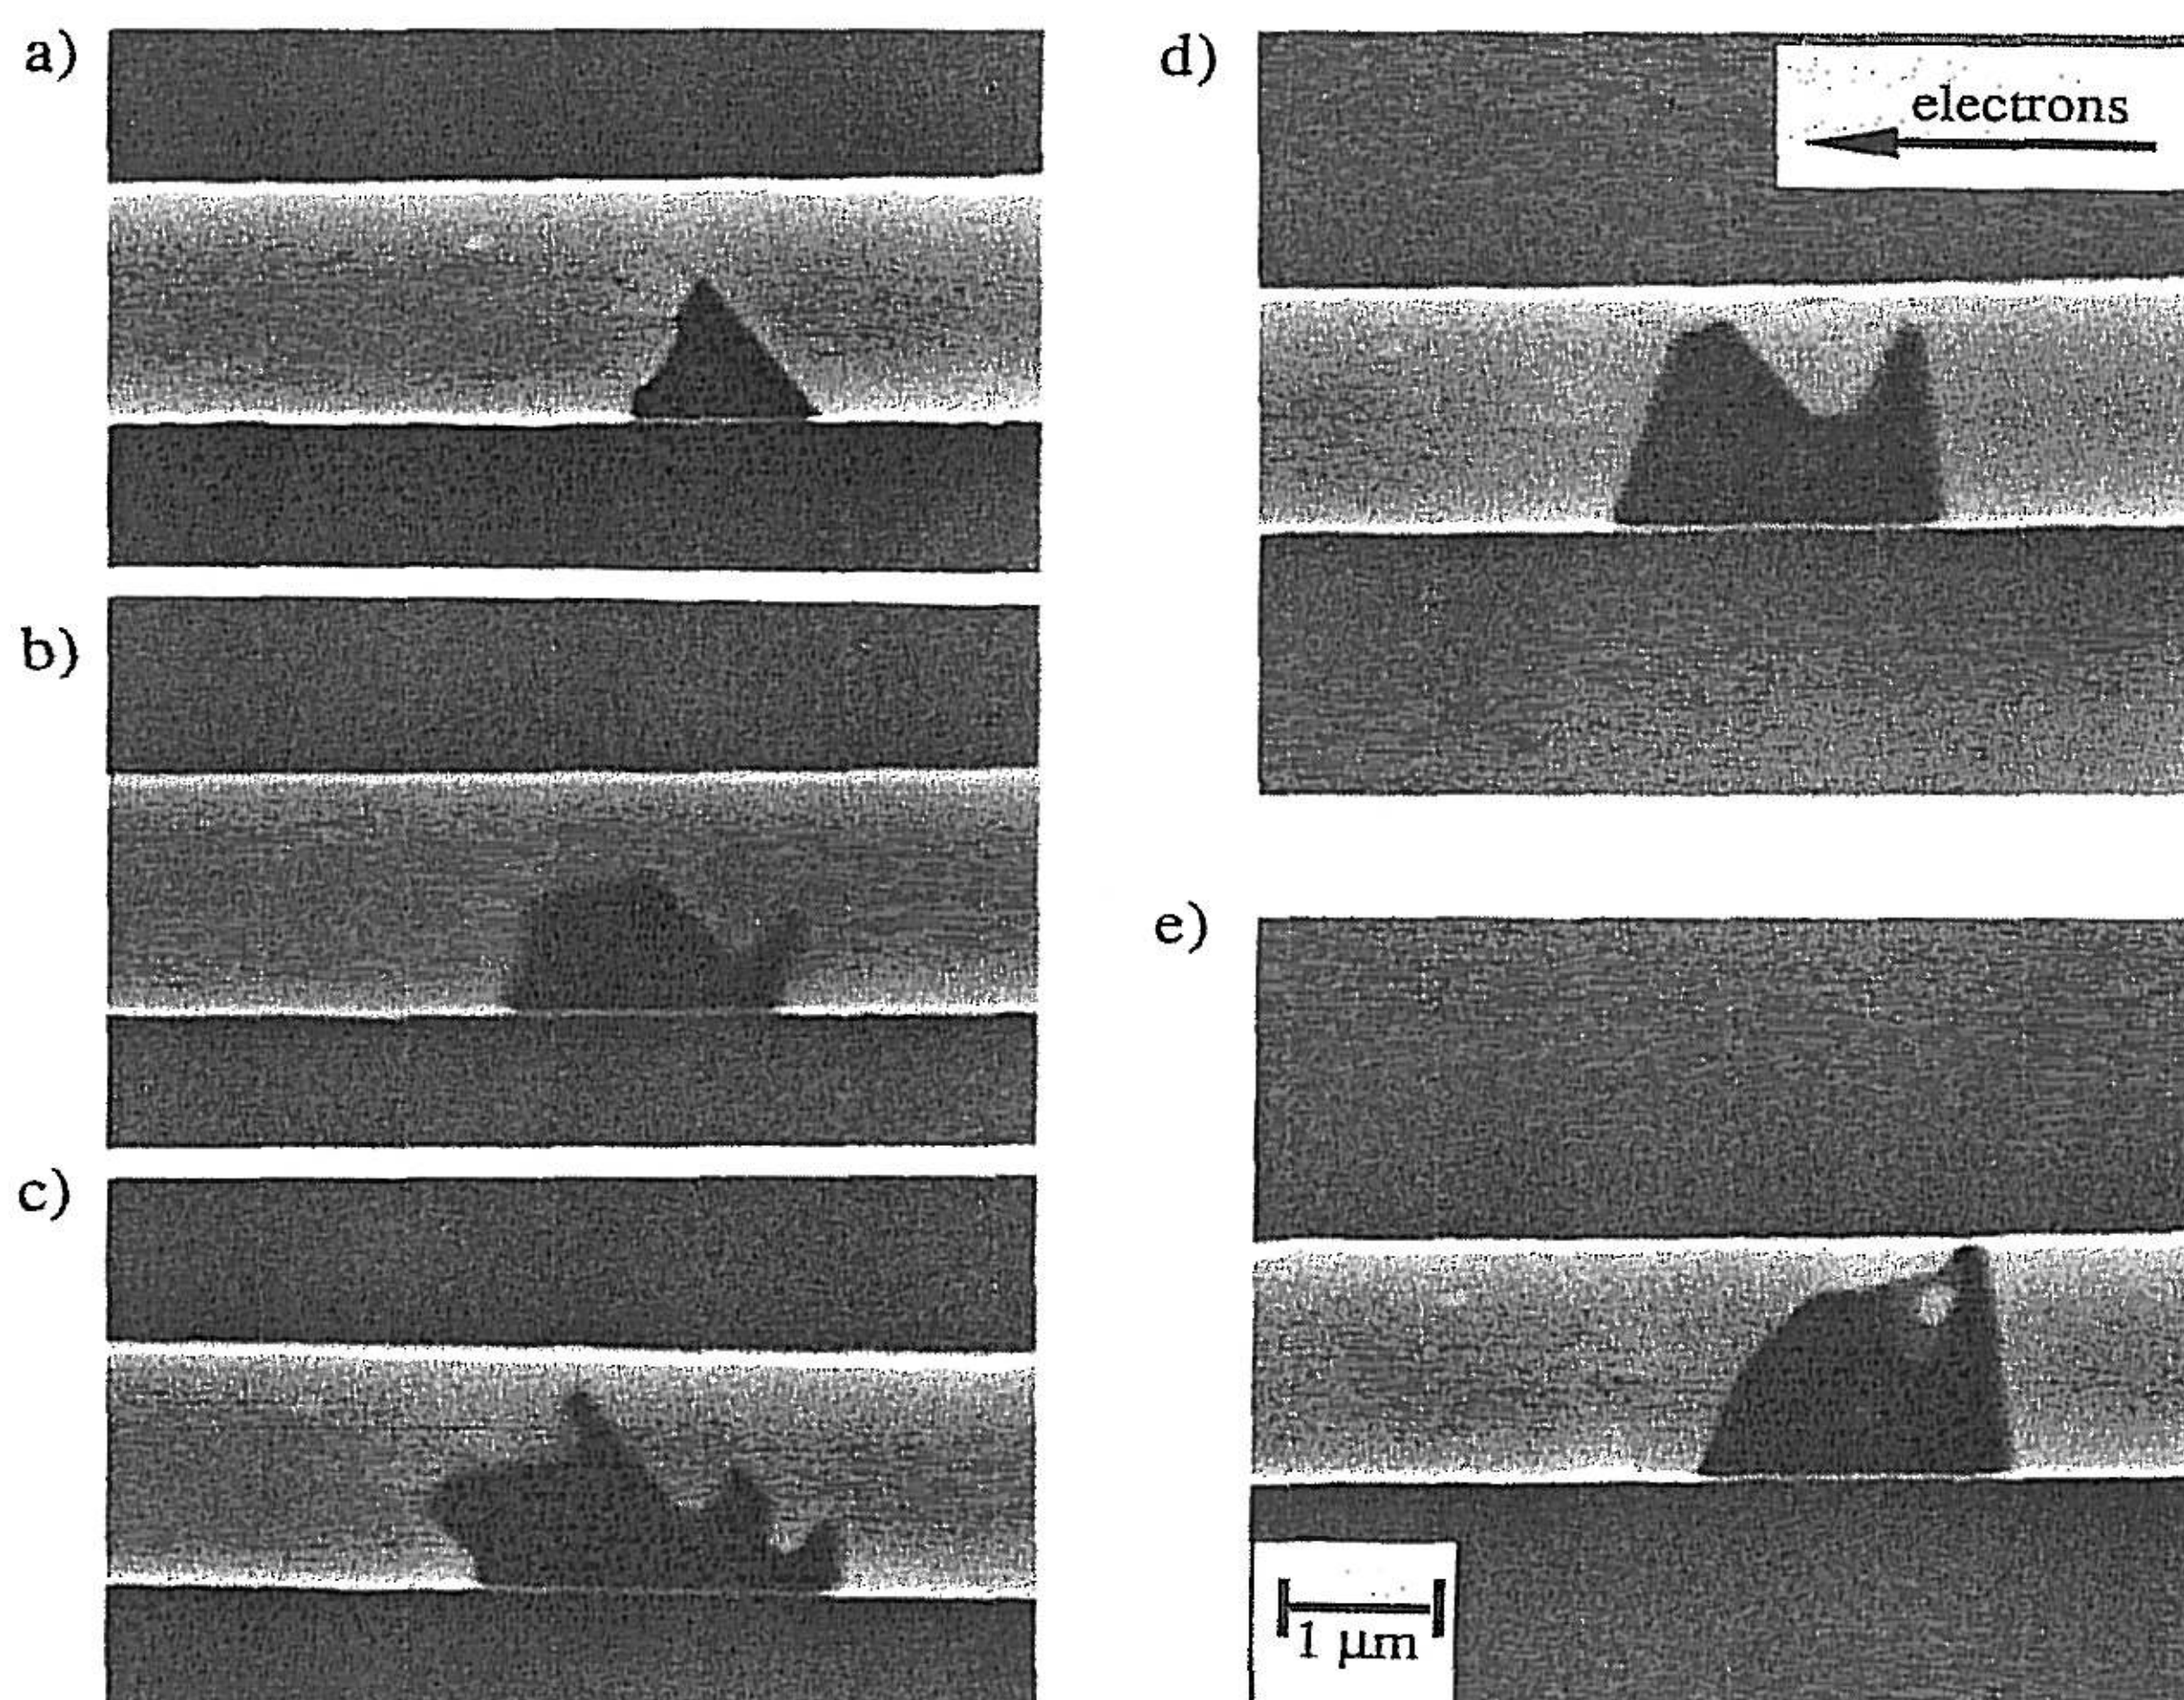
The time sequence of a growing void in Fig. 5a-e illustrates this simple model for microstructural failure. Fig. 5a shows a void whith an "uncritical" shape and as expected the void grows mainly along the line and less across the line (in b). Nevertheless after 172.2 h it seems that the void is almost fatal (in c), but even 50 h later the uncritical part of the void (on the left) has not grown further across the line, and the void tip has been rounded off. In the

Fig. 5: Time sequence of void growth: a) void at the edge of the line with an „uncritical" shape (65.8 h); b) void grows mainly along the line (131.8 h); c) void seems to be almost fatal (172.2 h); d) uncritical site: void growth stopped, critical site: void started to grow (224.3 h); e) fatal void where the cathode end of the void is perpendicular to the line (227.2 h). This Al film was not laser reflowed and therefore grain boundaries are not visible.

meantime the void has developed, on its cathode end, a facet perpendicular to the line ("critical" shape), which starts to grow (in d). Finally this facet produces the opening of the line, showing the typical wedge shape (in e). Note that the void became critical only after a facet perpendicular to the line was established. From this moment the total void volume remained about constant, only the shape of the void was changed by surface diffusion in a manner as described above. A similiar shape change mechanism is visible in Figs. 3b-c.
