Partial Discharge Investigation of Form-Wound Electric Machine Winding for Electric Aircraft Propulsion

Yalin Wang, *Member, IEEE*, Thanatheepan Balachandran, Yovahn Hoole, Yi Yin, *Member, IEEE*, and Kiruba Sivasubramaniam Haran, *Fellow, IEEE*

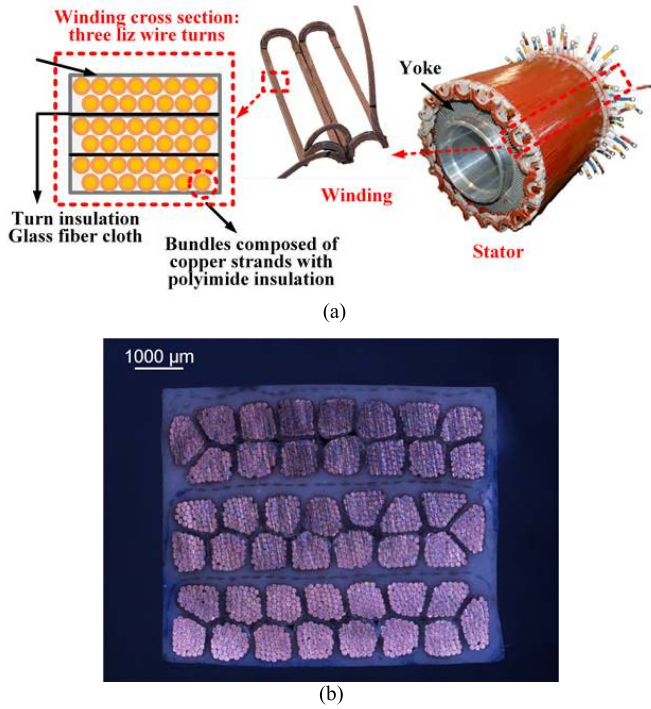
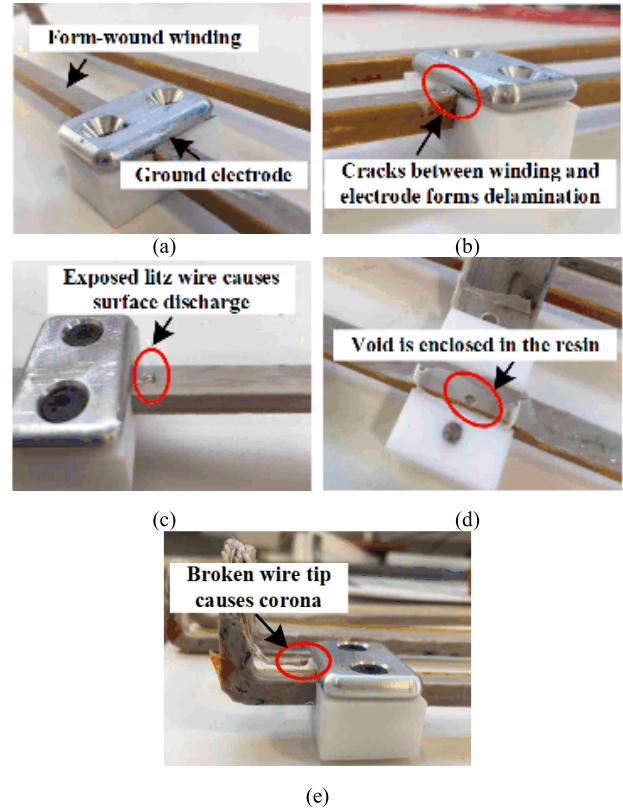
Fig. 3. Photographs of the defect samples and the normal winding. (a) Normal winding. (b) Delamination. (c) Surface defect. (d) Void defect. (e) Corona defect.

particular structure of our air-core form-wound windings, the normal winding and the windings with four kinds of defects (delamination, surface, void, and corona defect) were fabricated, as shown in Fig. 3(a)–(e). It should be noted that these four types of defects are not identical to those recommended in IEC standards due to the special structure of this motor. Therefore, PD patterns of these four defects are not the same to those in IEC standards, which means that combined patterns may appear, especially when the PD activity is dramatically enhanced at low air pressure.

are significant. Cracks can appear between the metal yoke and windings with long-term operation and temperature cycling. For the surface defect winding, the copper conductor of the uppermost turn was exposed with a 1-mm × 2-mm area in the middle, and the electrode was horizontally 2 mm from the exposed area edge. The void defect is made by injecting 1-mL air with a syringe into the resin between winding and ground electrode during the curing process. The major air bubbles are enclosed in the insulation, which agrees with the common void setup in the literature. Note that the bubbles may spread and be exposed to the outside air, which is the situation in real manufacturing. For the corona defect, a strand of litz wire in the end-winding area was broken and has a loose end pointing at the ground yoke 2 mm away. The electric field around the wire tip is concentrated to cause the corona. The structures of these defect samples were verified by the electrostatic field simulation to have electric field concentration around the defect position, so that the PD will occur at these positions rather than those with inherent defects in the winding.

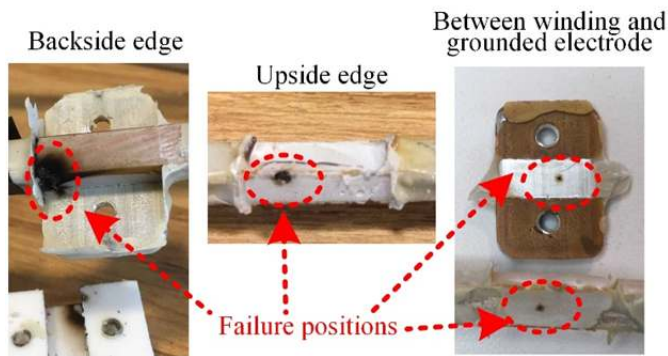
Fig. 10.   Failure positions of the windings aged at 0.2 atm.

During the aging experiment, it is found that the winding can fail in various positions, as shown in Fig. 10. According to electrostatic electric field simulations, the triple point of the copper conductor, the ground electrode, and the air is the position where the electric field is most concentrated. This region is usually covered with enhanced insulation to ensure reliability. However, the breakdown strength of air decreases under the low-pressure situation. Therefore, some locations, such as the backside edge of the winding, that do not cause PD under normal pressure may discharge at low air pressure and could lead to failure. This phenomenon shows that every exposed area or area with less electric field concentration is also dangerous at low air pressures and even the positions with long distance to the ground core iron are possible to cause failure. When designing the insulation structure, these positions can be covered with thermally conductive and high electrically resistive resin to simultaneously mitigate thermal and electrical stress.
