PV degradation curves: non-linearities and failure modes

EU PVSEC PAPER

Dirk C. Jordan*, Timothy J. Silverman, Bill Sekulic and Sarah R. Kurtz

National Renewable Energy Laboratory (NREL), 15013 Denver West Parkway, Golden, CO 80401, USA

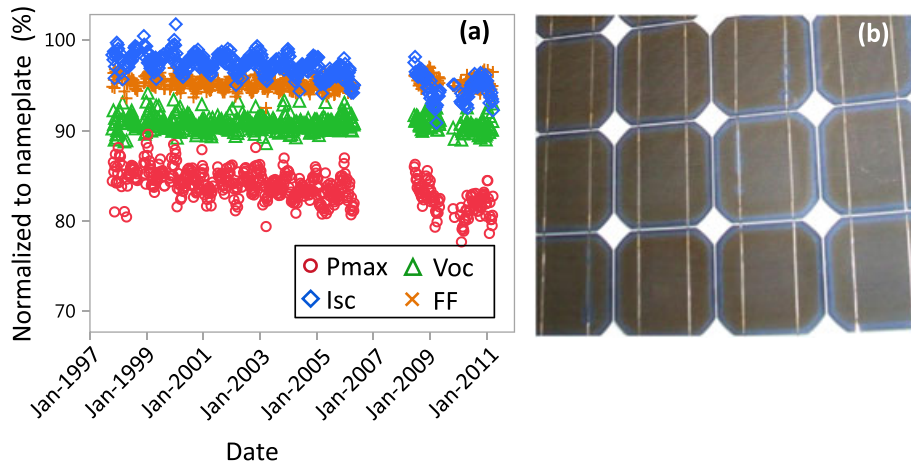
Figure 3. Mono-Si module I-V performance over 20 years of field exposure (a). The vertical axis shows the I-V parameter as a percentage of the nameplate rating. Discoloration in the center of the cells is shown (b) and some bleaching at the cell edges. Photo credit: Dirk Jordan, NREL PIX 36886. [Colour figure can be viewed at wileyonlinelibrary.com]

display relative stability: (0.01 ± 0.01)%/year and (0.02 ± 0.01)%/year, respectively, within the statistical uncertainty. The Pmax loss totals to less than 5% over the lifetime of the module; the transmission loss from the discoloration in the center of the cells is shown in Figure 3(b) with some bleaching at the cell edges corroborating the Isc dominated decline. The degradation appears to be approximately linear although a subtle non-linear trend that is masked by latent seasonality and measurement uncertainty cannot be completely excluded.

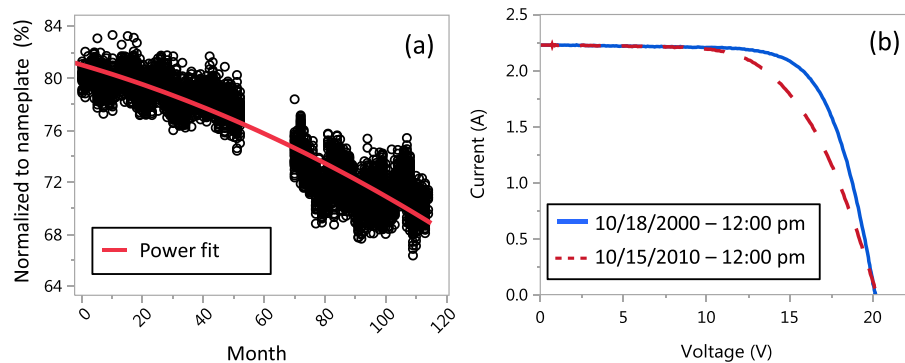
In contrast, the x-Si module of Figure 4 that was exposed next to the module of Figure 3 shows initially a fairly stable behavior that appears to be followed by a concave decline. Pmax data were corrected to $45\,°C$ module temperature, as it was a more typical value than $25\,°C$ during the lifetime of the module at this particular location. Data acquisition problems led to ~1 year gap during which the module was exposed outside and continued to

degrade. A second interruption starting at month 71 was caused when the module was stored inside while the data collection system was upgraded. During this time, no additional degradation was observed; for clarity, this section was removed from Figure 4. It is interesting to note that a power fit provides a better fit to the data than a linear fit. The I-V characteristics that are taken at the beginning and almost exactly after 10 years display clear signs of series resistance increase. Series resistance increase has been associated with thermal mechanical fatigue of solder joints, solder corrosion or ribbon fatigue [15,21–23].

Figure 4. Time series behavior for series resistance impacted x-Si module over 10 years (a). Initial and end-of-life I-V shows clear signs of series resistance increase (b). [Colour figure can be viewed at wileyonlinelibrary.com]

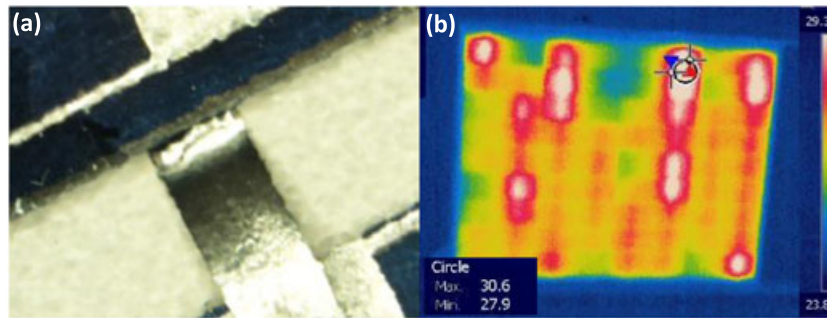
This module exhibited many cracks in the cell and string interconnect ribbons, an example of which is shown in Figure 5(a). The cracks appear to have not caused a complete failure; however, they affirm the increased series resistance and the hot spots in the infrared image that occur along the cell interconnect ribbons (Figure 5(b)). The interconnect connections could be improved by applying pressure to the front side of the module. The electroluminescence images of Figure 6 demonstrate the change in connection pointed out by the arrows.

Figure 5. Visual image of one of the cracks in the cell interconnect ribbon (a). Infrared image showing hot spots along interconnect ribbons (b). Photo credit: Dirk Jordan, NREL PIX 38042 and 38044. [Colour figure can be viewed at wileyonlinelibrary.com]

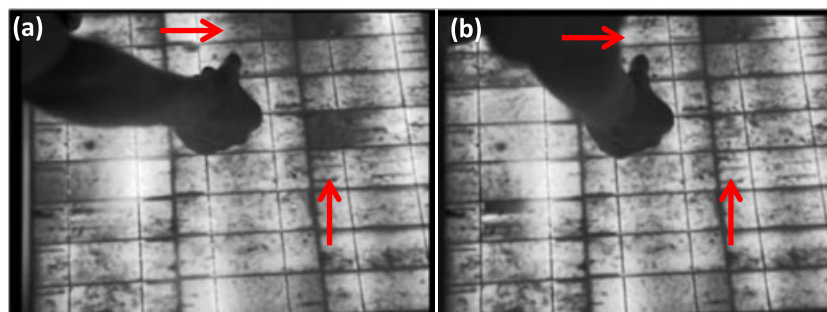
Figure 6. Electroluminescence images before (a) and while applying (b) pressure to the front side. The arrows point out changes in the luminescence because of improved conductivity through bridging of the gaps. Photo credit: Tim Silverman, NREL PIX 38045 and 38046. [Colour figure can be viewed at wileyonlinelibrary.com]

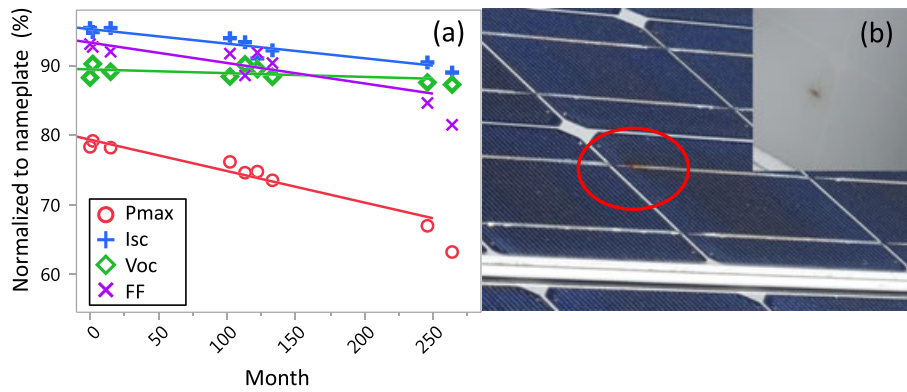
Thermal cycling can eventually lead to solder bond failures. Figure 7(a) shows I-V parameters of a single string over nearly 22 years of field exposure that was recently affected by a hot spot. The hot spot was caused by solder-bond failure between the ribbon and the cell busbar. A characteristic burn mark was observable on the front and the backsheet of the module (b). The hot spot was first detected in 2014 but the temperature was measured to be in the 50–60 °C range. After an additional 1½ years of field exposure, the hot spot had significantly increased in temperature to 110–130 °C. I-V parameter analysis of the affected string shows a fairly linear decline during 20 years that was correlated equally to FF and Isc losses. However, the more recent evaluation concluded that the power loss is now following a different path that is more significantly correlated to FF loss.

Figure 7. Solder bond failure-induced hot spot and its time series effect (a) and visual front and back-side images (b). This particular module was part of a 20-year-old system. The I-V traces may show increased degradation. Photo credit: Dirk Jordan, NREL PIX 36887. [Colour figure can be viewed at wileyonlinelibrary.com]

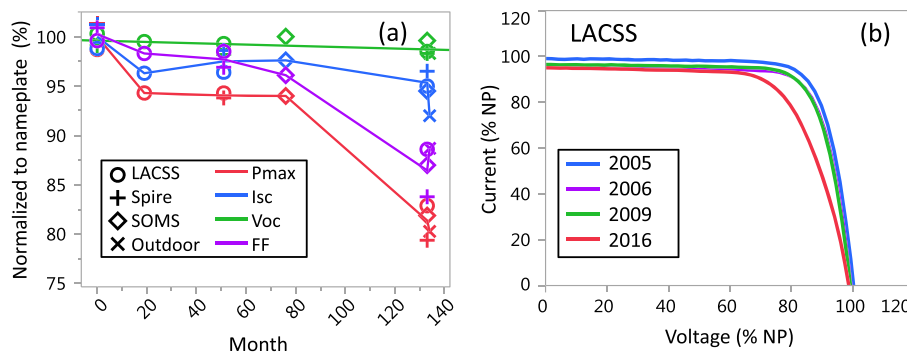
than 10 years of field exposure. The I-V parameters for this particular module are presented in Figure 8(a), which were measured by four different methods. Initially, a drop of several percent can be seen that appears to be dominated by current loss and could be associated with light-induced degradation. For the subsequent 5 years, very little change in all parameters can be discerned until the appearance of the crack-induced hot spot. The degradation slope changes and the power loss becomes FF-dominated. More frequent data points are needed to ascertain the exact functional form, as it could follow a two-step or possibly a more gradual power decline. The overlay from the large area continuous solar simulator (LACSS) shows the increased series resistance in the module, Figure 8(b).

Figure 8. I-V parameters of the hot-spot module for more than 10 years exposure, as measured by four different methods (a). Large area solar simulator measurements (b) show series resistance increase. [Colour figure can be viewed at wileyonlinelibrary.com]

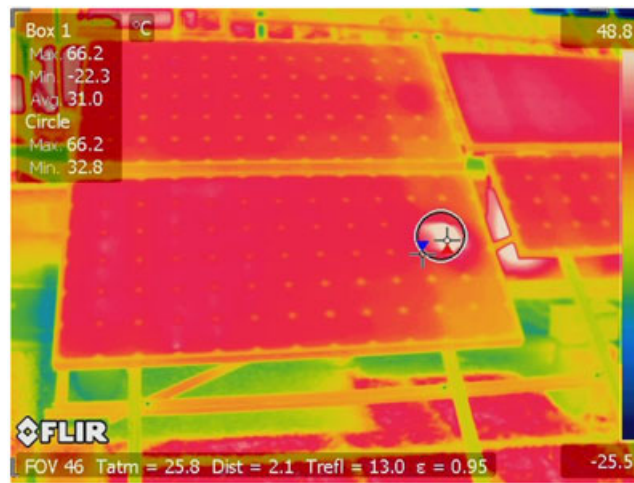
The infrared image indicates a moderate hot spot (ca. 60°C), Figure 9; electroluminescence image, not shown here, exhibited cracks in several cells, but only the crack in one cell resulted in a hot spot. The loss in power is related to the loss of current flow and is a complex function of the direction of the cracks as well as the integrity of the metallization (grid lines and busbars). It appears that some cracks have a more deleterious impact on the module power performance than others [26].

Figure 9. Infrared image of a mono-Si module that has been fielded for more than 10 years with a hot spot caused by a cell crack. Photo credit Dirk Jordan, NREL PIX 36888. [Colour figure can be viewed at wileyonlinelibrary.com]

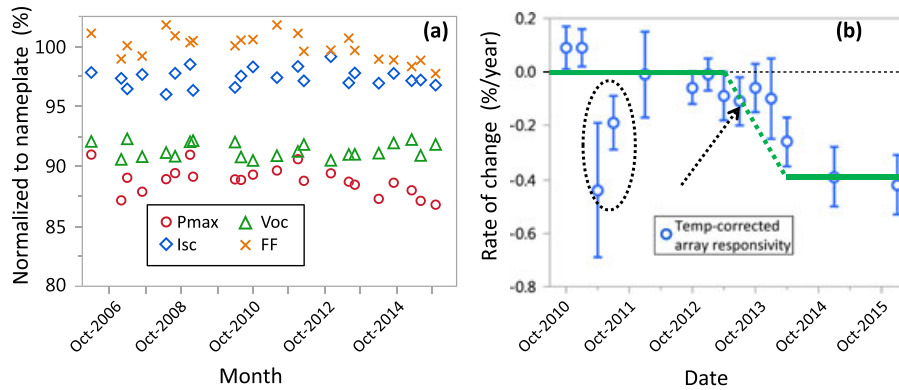
Figure 10 [27]. The measurements were made without washing the system and therefore display some noise. Despite this noise in the data, the curve for Pmax appears to consist of two distinct sections. In the first 6 years, the system appears without any significant degradation. In the 6th to 7th year, a downward trend begins to emerge that is mostly caused by FF losses. During that period, visible cracks in three modules were observed from the front (Figure 11). Isc and Voc appear to be stable over the entire 10 years field exposure.

Figure 10. Outdoor measured I-V parameters for a Shell CIS system for a 10-year period (a). Continuous data for the system analyzed the temperature-corrected array responsivity (blue circles). The dashed oval indicates the time period of a drifting current transducer and the dashed arrow identifies when cracks first were observed. [Colour figure can be viewed at wileyonlinelibrary.com]

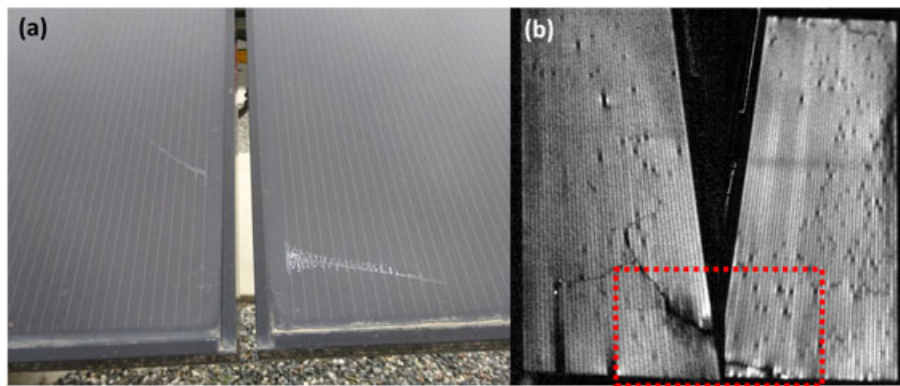
Figure 11. Two modules of a Shell E80 CIGS system after 10 years of field exposure. Visual image (a) is close up of the photoluminescence image (b) indicated by a red dashed rectangle. Photo credit Tim Silverman, NREL PIX 36890. [Colour figure can be viewed at wileyonlinelibrary.com]

The temperature-corrected array responsivity (blue circles) shows the two distinct degradation sections clearly; this technique provides reduced uncertainty relative to the more commonly used performance ratio [7]. Furthermore, a third section becomes clear with the temperature-corrected array responsivity that is indicated by a dashed oval. This time preceded our implementation of daily, automated data quality checks and was caused by a drifting current transducer. It was not reflective of the system performance but indicated data collection problems. After replacement of the transducer, the system returned to near zero degradation before the cracking of the modules. At first, the severity of the decline is surprising, as the cracks appear not very severe, yet the cracks are not located in the front glass but the active cell area. Photoluminescence corroborates the significant decline dominated by FF losses, as the cracks extended far more into the module than is visible to the naked eye.
