Journal of Materials Research and Technology

Seeing the Big Picture: Improving The Prosthetic Design Cycle Using 360° 3D Digital Image Correlation
--Manuscript Draft--

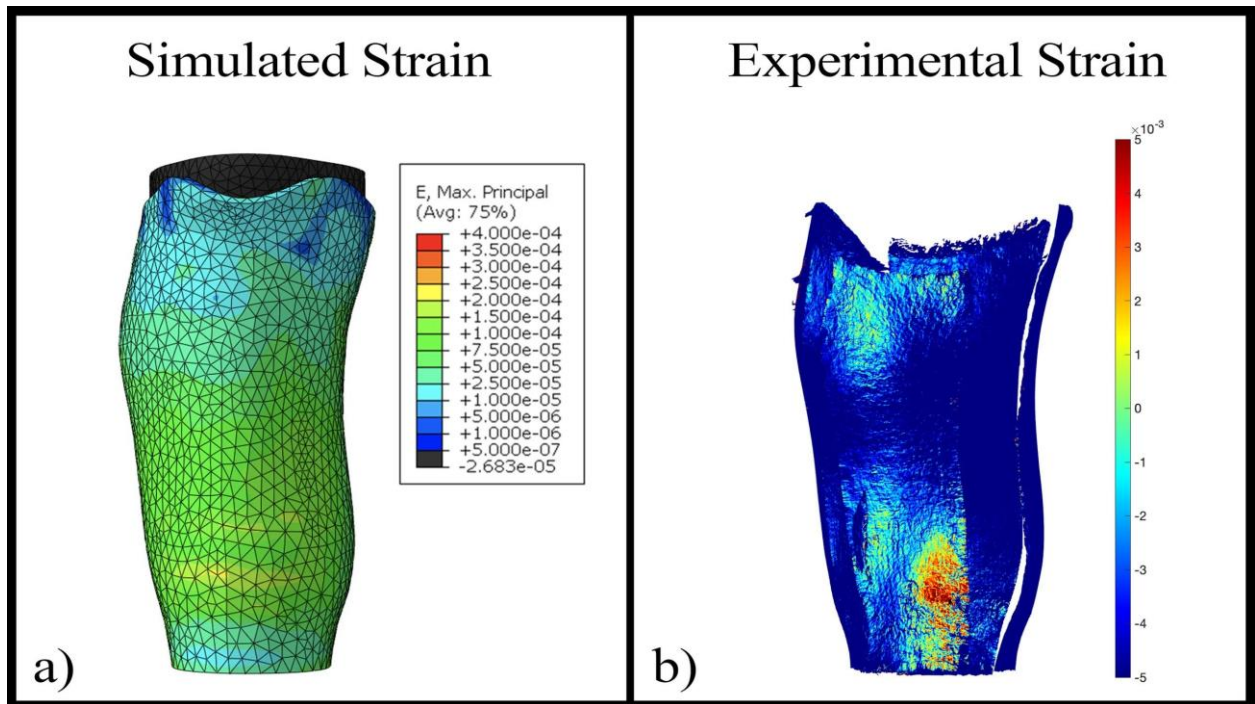
The simulated and experimental strain maps were plotted using ABAQUS CAE and the MultiDIC MATLAB toolbox. When compared, these two strain maps showed similar strain profiles (**Figure 6**). This agreement suggests that the multibody simulation model is able to accurately impose a loading condition similar to the real-world experiment. However, comparing the numerical data between the two profiles, the simulated strain is significantly smaller than the observed experimental strain (**Figure 6**) The maximum simulated strain was $2.5*10^{-4}$ while the maximum experimental strain was $5.7*10^{-3}$, one order of magnitude higher. This difference implies that the homogeneous isotropic material properties assumed by many previous researchers are not sufficient to accurately characterize the structural behavior of prosthetic sockets. Thus, one way to improve simulated models is to determine the anisotropic material properties of printed specimens and incorporate this data into simulations. Following this result, the mechanical properties of the PLA specimens were measured using ASTM D638 [19] and found to have a lower Young's modulus and tensile strength than expected from the bulk material (**Table 2**).

Figure 6: Image showing a comparison between experimentally generated strain maps and simulated strain maps. These two graphics show great agreement as to the strain distribution, but the simulated strain is much smaller than the experimental strain.

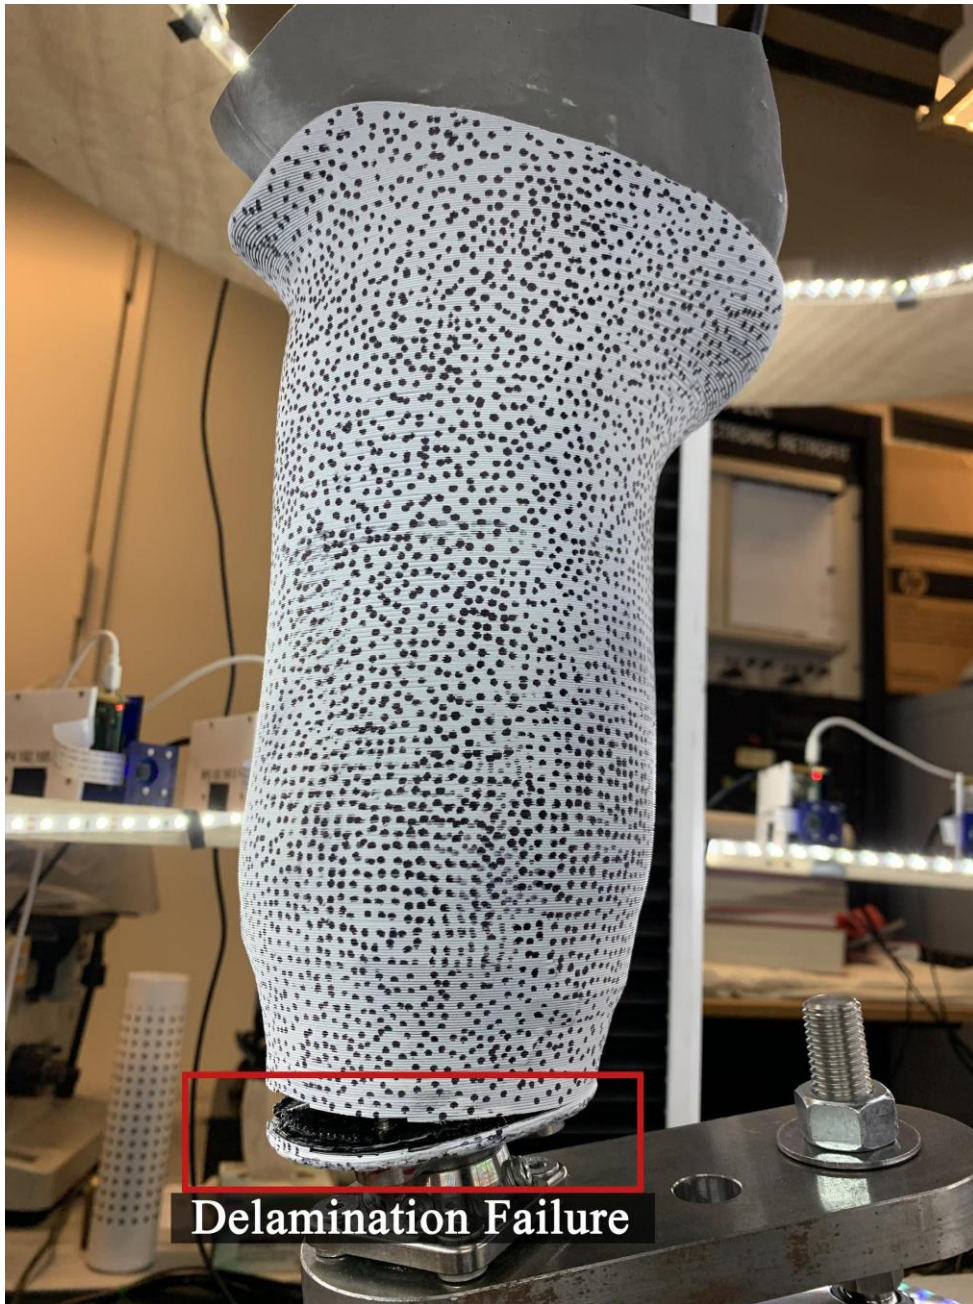
Interestingly, the ultimate failure and delamination of the socket occurred at the bottom of the distal end, even though the simulated model and the experimental model show the highest surface strain concentration in a different location (**Figures 6 & 7**). This discrepancy means that the true strain concentration that led to failure occurred on the inside of the socket. **Figure 8** shows several small breaks before the large delamination event. These breaks could potentially be from the attachment screws destroying individual printed layers on the inside of the socket. The prosthetic socket specimen failed at 694.4 N which is lower than the 2240 N proof strength required by ISO 10328. Since the prosthetic socket failed at a low force under quasistatic loading conditions, it would not be capable of surviving the 1330 N cyclic loading requirement. Based on this observation, a new boundary condition for the distal end attachment should be utilized to identify interior stress concentrations. Clearly, there are both structural and material deficiencies that need to be addressed in 3D printed prosthetic sockets.

Figure 7: Image showing the delamination failure at the distal end of the tested prosthetic socket. Although both the simulation and the experiment observed high strain in a different region, the socket delaminated completely at the distal end indicating there was an internal stress concentration due to the attachment mechanism.

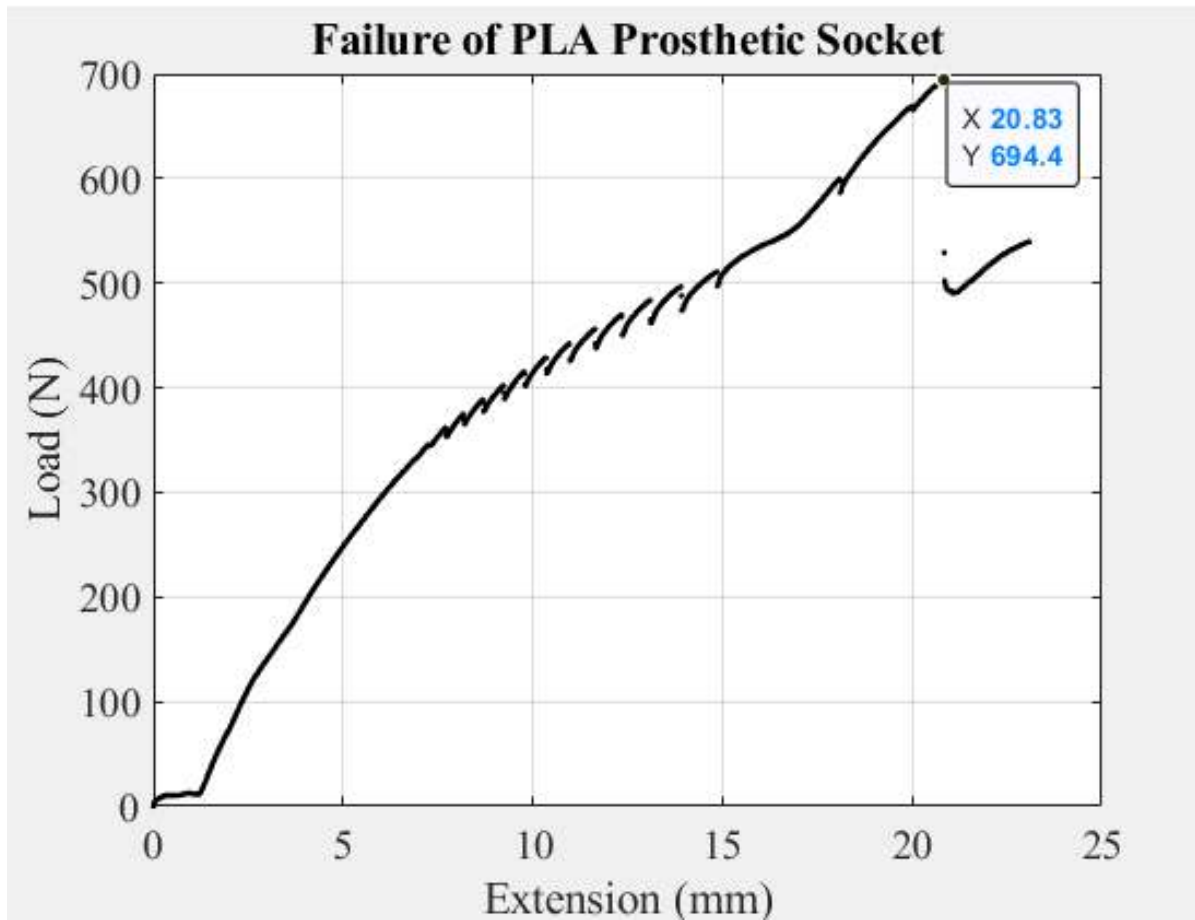
Figure 8: Graph displaying the load-displacement curve from the Instron. The prosthetic socket failed at 694.4 N which is much less than the 2240 N proof strength specified by ISO 10328.

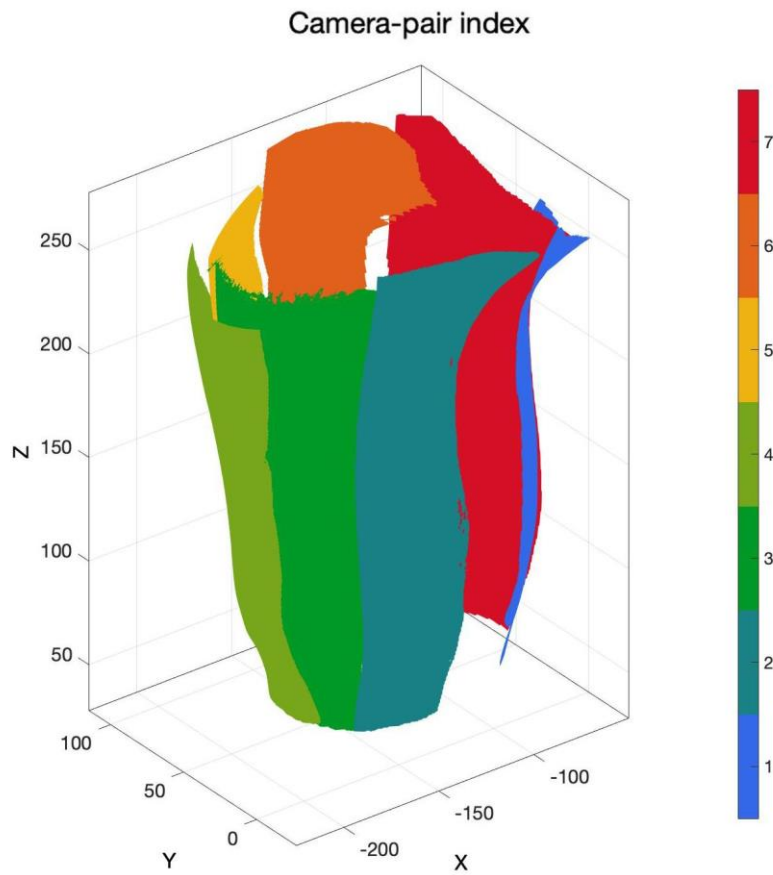
One limitation of the 360º 3D strain analysis is that the surfaces did not perfectly align during reconstruction (**Figure 9**). This could be due to the prosthetic socket being positioned off the central axis whereas the calibration object was positioned in the center of the camera array. The calibration object was slightly smaller than the prosthetic socket, but this should not have had any effect on calculating camera parameters because the calibration object was equally within the field of view of all cameras. It is important to note that while changing these factors can improve the quality of the visualization, the quantitative strain values will remain unchanged. Engineers can utilize this quantitative strain data to make design adjustments to improve the safety and mechanical performance of prosthetic sockets. Overall, 360° 3D DIC improves the testing phase of the prosthetic socket design cycle by precisely identifying

Figure 9: Image showing reconstructed 360° 3D geometry. While the surfaces do not perfectly align into the original shape, the numerical strain values are valid.

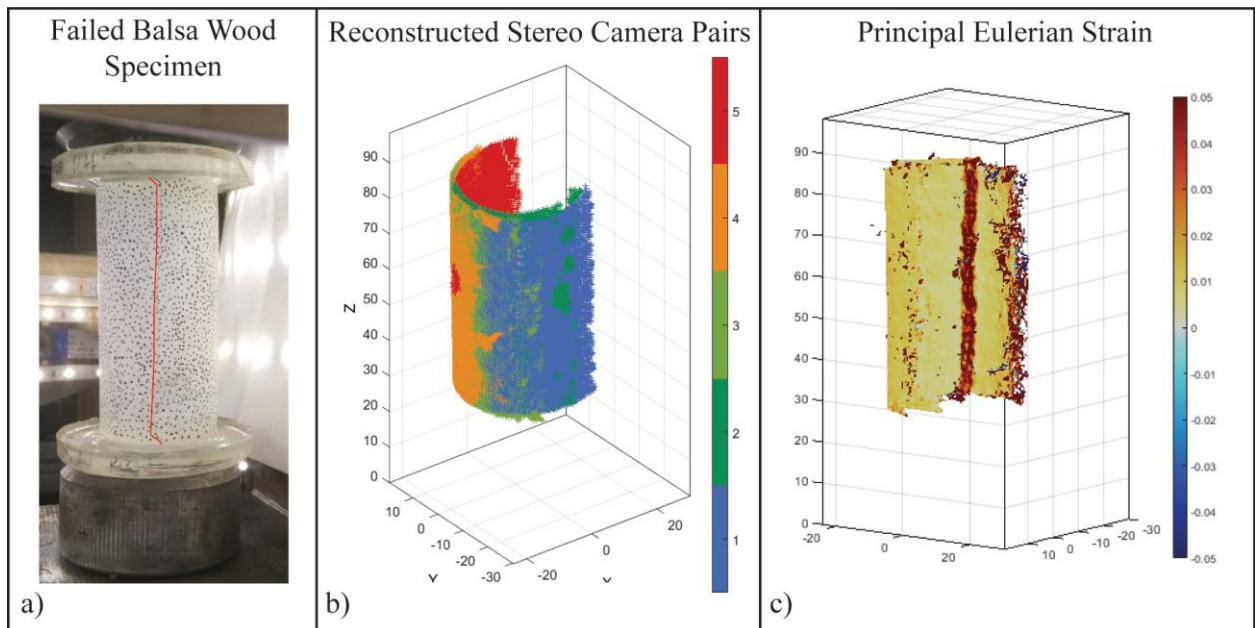
In **Figure A2,** we can clearly see that a crack propagated longitudinally across the sample. This behavior was entirely expected based off of the work by Chen et al. [37]. Looking at the principal strain map, we can observe that the MultiDIC system was able to keep track of the surface strain over the entire testing period. The system is able to show the strain concentration leading to the crack. This means that we were able to successfully observe strain concentrations in the sample even before they presented themselves as macroscopic cracks.

Figure A2: Image showing the (a) failed torsional specimen, (b) reconstructed 3D geometry, (c) successfully reconstructed 180° 3D strain map.
