Splitting Failures in Trapezoidal Steel Roof Cladding

By M. Mahendran[1] and D. Mahaarachchi[2]

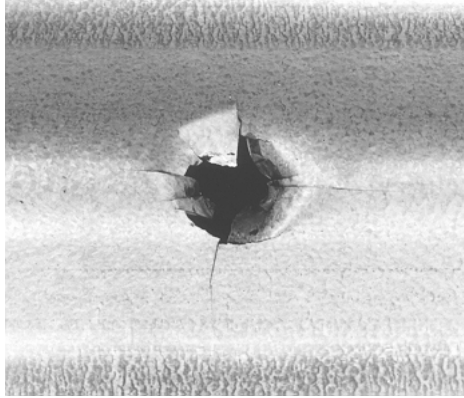
Figure 1. Fatigue Cracking of Steel Sheeting under Cyclic Wind Forces

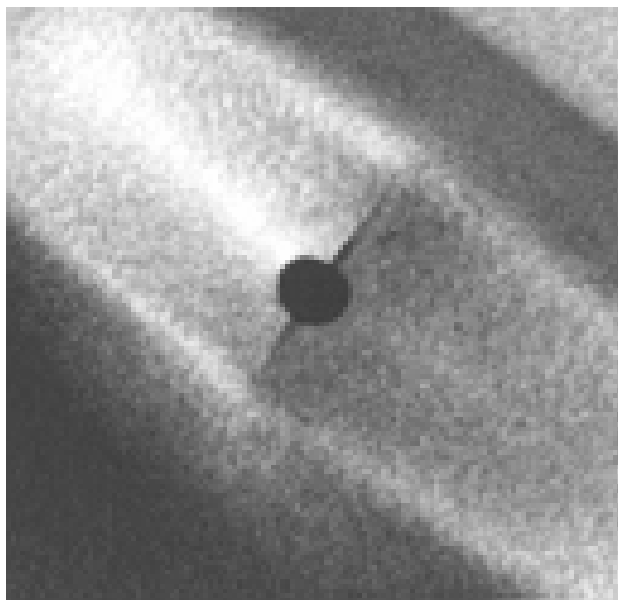
An inspection of steel roofs made of trapezoidal steel sheeting (Reardon and Mahendran, 1988) has shown that roofing has been split in the transverse direction under the screw heads due to the overtightening of screw fasteners either accidentally or by poor workmanship (see Figure 2). The transverse splitting was observed in more than ten locations on the roof, that is, at more than 50% of the locations inspected. The splitting mode was identical and included permanent dimpling of the crest within the rib and transverse splitting as shown in Figure 2. Once split, even slightly, the roofing can only survive a few cycles of uplift wind loading. Fatigue cracking will propagate rapidly around the fastener holes at lower wind uplift loads

The influence of overtightening of screw fasteners on the sheeting was very localised and extended only about 100 mm on either side of the fastener hole in the longitudinal direction (see Figure 2). Hence the length of roofing model beyond 200 mm did not affect the splitting load results. Considering all these observations, it was therefore decided to use a small scale roofing model shown in Figure 6 to investigate the splitting behaviour further. This model including a single trapezoidal rib was only 200 mm long as it has already been shown that dimpling is localised within 200 mm length and that there is no need to include longer sheets. A screw fastener was added to the model at points A and B to eliminate the slip at these points and thus to simulate the lateral continuity of the sheeting. The lateral continuity of the sheeting in practice allows some slip at points A and B, but the splitting load did not depend on the slip. It was essentially dependent on the local dimpling deflection (Δ, see Figure 5). The slip at points A and B was translated to simple elastic global deflections of the entire rib, and hence did not affect the splitting load. This small scale model shown in Figure 6 was therefore adopted and a number of tests were conducted to prove its adequacy (see Table 1).

Figure 2. Split Trapezoidal Roof Cladding

- When the commonly used trapezoidal steel roof claddings made of thin G550 steel are used, they must be installed by experienced builders to ensure no overtightening takes place. The initial crushing of neoprene washers can be used as an indicator in avoiding any overtightening of thin steel roof sheeting. The manufacturers' roofing manuals must include advisory statements regarding this potential problem.

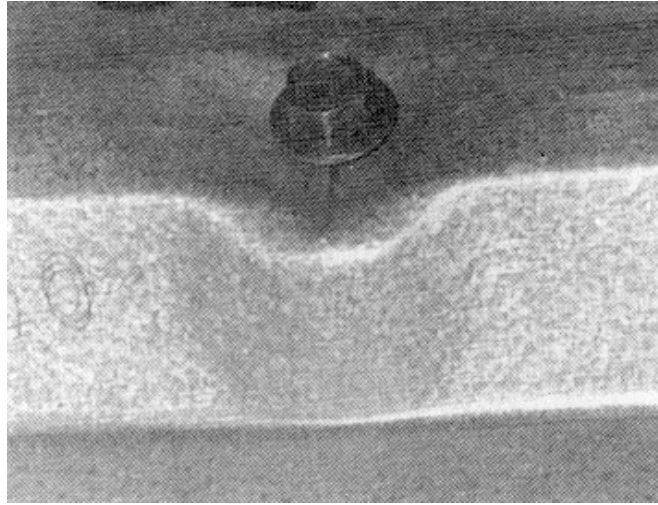
To validate the above explanation, a small scale trapezoidal roofing model was made of a more ductile steel that had a strain at failure of about 0.2. In this case, a greater failure load was achieved with no splitting. The sheeting underwent large dimpling type deformations, but did not undergo splitting as shown in Figure 11.

Figure 11. Local Dimpling Failure of Sheeting

- A more ductile steel with a strain at failure of at least 0.1 can be used to eliminate the transverse splitting failures in steel roof claddings.
