Title
Subsurface Characterization at Ground Failure Sites in Adapazari, Turkey

Journal
Journal of Geotechnical & Geoenvironmental Engineering, 130(7)

Authors
Bray, Jonathan D
Sancio, Rololfo B
Durgunoglu, Turan
et al.

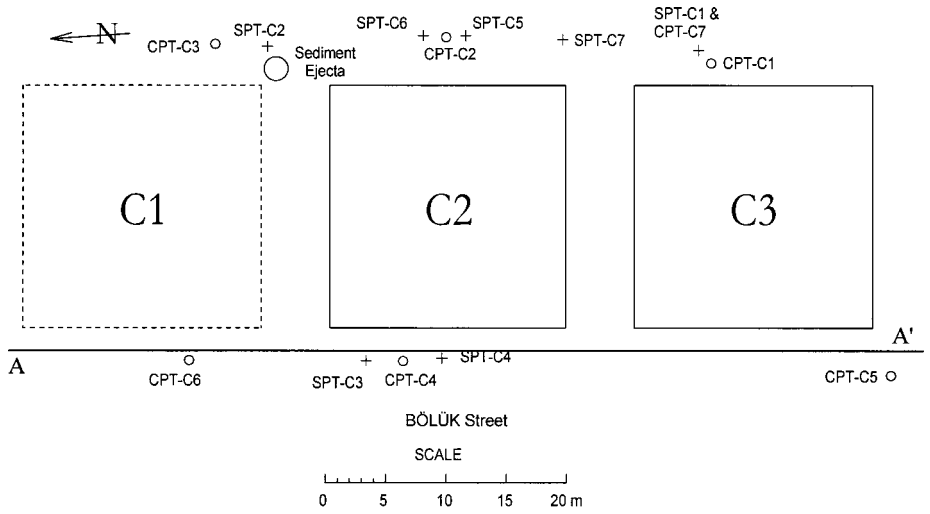
Fig. 4. Plan view of Site C and location of subsurface explorations

The middle building (designated C2 in Fig. 4) and the building to its north (designated C1) moved toward the street and down-

ward (Bray and Stewart 2000). For example, building C2 translated 57 cm towards the street (west), 34 cm towards building C1 (north), and the relative downward vertical movement between it and the pavement was about 35 cm. However, there was no evidence of distress to building C3, which is located directly south of building C2. Significant pavement distress and sediment ejecta were observed in the alley between buildings C1 and C2, but no ground failure was observed in the alley between buildings C2 and C3. The sediment ejecta is classified as a brown low plasticity sandy silt. Inspection of the structural components of buildings C2 and C3 showed no evidence of significant structural distress. Building C1 was demolished after the earthquake.

As shown in Fig. 4, six CPTs and seven exploratory borings were performed at Site C. The generalized subsurface conditions along the western side of the buildings are shown in Fig. 5. The subsurface conditions at this site appear to have significant variations in both the vertical and horizontal direction as a result of the fluvial nature of the depositional environment.

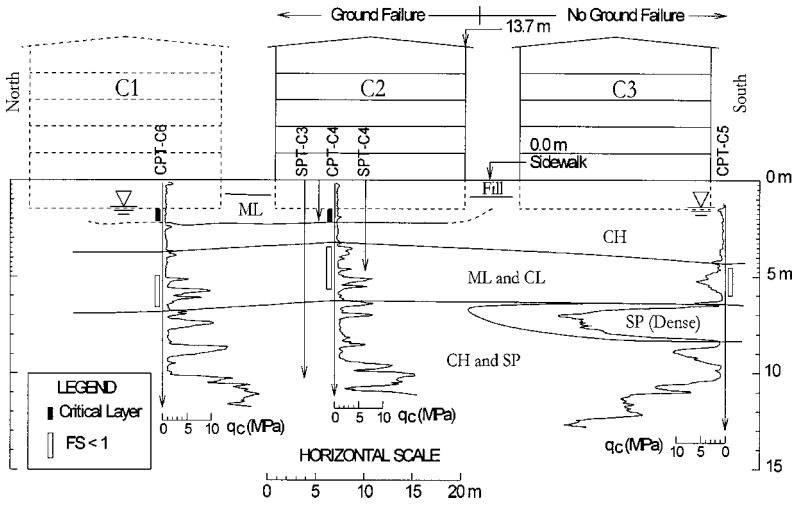
Fig. 5. North to south generalized soil profile of Site C (cross section A-A′ in Fig. 4)

Building C3's mat foundation is underlain by 2.5 m of tan brown plastic silty clay. Between approximately 4 and 5.5 m a red-brown to gray stratum of low plasticity medium dense sandy silts interspersed with more plastic clayey silts was identified. At approximately 6 m below the surface and down to about 8 m, a dense gray sand ($q_{c1N}>160$) with some fine gravel was found. Interbedded clayey silts and medium dense silty sands continue below this layer down to the extent of the exploration ($\sim$13 m).

Different than at building C3, the soil directly beneath the foundation of building C2 is a meter-thick deposit of loose, tan brown, low plasticity silt, with a water content consistently greater than 0.9 LL. Below this deposit down to a depth of about 8 m, the soils are interbedded loose to medium dense silts and sandy silts, with no dense clean sand with fine gravel layer as was present under building C3. Beyond a depth of 8 m and up to the

Reexamining Fig. 5, which also identifies layers with FS_l<1 and the critical layer with respect to liquefaction, there are two significant differences in the soil conditions below building C2, which underwent severe ground failure, and the "undamaged" building C3, which did not. Most importantly, loose, liquefiable, low plasticity sandy silts lie directly beneath building C2, but are absent directly under building C3. The liquefaction of these soils directly below building C2's mat foundation most likely led to the observed horizontal translation of the building on the order of 66

cm. Additionally, at a depth of 6–8 m, a layer of dense sand with fine gravel that should not have liquefied under building C3 is in sharp contrast to the alternating layers of liquefiable silty sands and low plasticity silts in the soil deposit underlying building C2 over a similar depth, and this may have also contributed to ground failure being observed at building C2, but not at building C3.

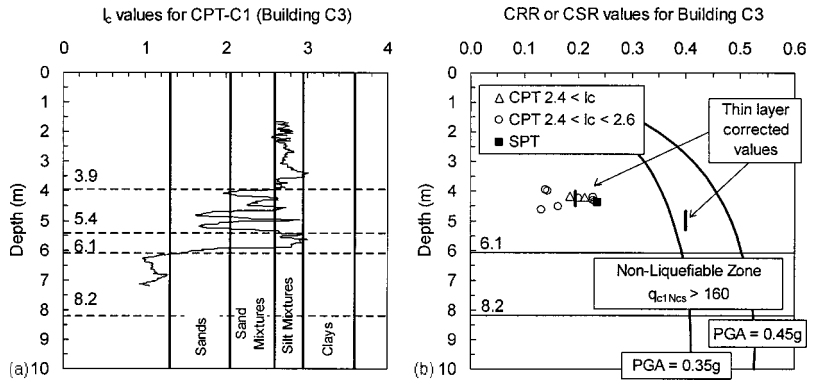
Fig. 6. (a) Soil behavior index (I_c) values for CPT-C1 (Building C3), and (b) cyclic stress ratio (CSR) induced by the earthquake versus depth for free-field acceleration of 0.35*g* and 0.45*g* compared with the cyclic resistance ratio (CRR) of the soil for Building C3

Some limited portions of the stratum of sandy silt found between depths of 3.9 and 5.4 m under building C3 are possibly liquefiable [I_c<2.6 as shown in Fig. 6(a)]. Samples retrieved from these soils have LL=26–36, with water contents near the LL, and clay contents (%<5 μm) close to, but generally exceeding, 15%. Due to the low liquid limits and high water contents, these thin silt layers are considered potentially liquefiable, although these soils would not be liquefiable if the Chinese criteria are strictly applied. The free-field CSR for PGA values of 0.35 and 0.45*g* are greater than the cyclic resistance of these soils [Fig. 6(b)]. The SPT data from a nearby boring corroborates this finding. The dense sand stratum (6.1–8.2 m), the clean to silty sand layer (8.5–9.3 m), and the medium dense to dense gray low plasticity silt to silty sand (10–13 m) are susceptible to liquefaction based on soil type, but only the layer between 8.5 and 9.3 m has $(q_{c1N})_{cs}$ values lower than 160, which is the asymptote of the Robertson and Wride (1998) clean sand liquefaction-triggering curve. Hence liquefaction of these dense sands is not likely even at the high CSRs experienced in Adapazari.

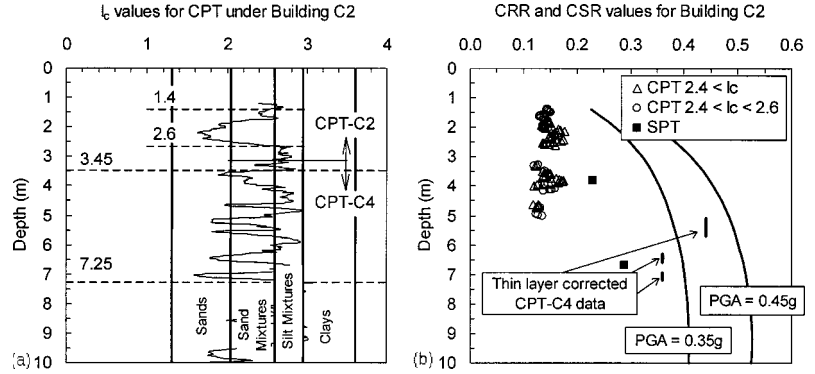
Fig. 7. (a) Soil behavior index (I_c) values for CPT-C4 (Building C2), and (b) cyclic stress ratio (CSR) induced by the earthquake versus depth for free-field acceleration of 0.35*g* and 0.45*g* compared with the cyclic resistance ratio (CRR) of the soil for Building C2

The loose, low plasticity silt at a depth from 1.4 to 2.6 m, which is directly below the mat foundation of building C2, is judged to have liquefied based on the low I_c values (<2) and estimated CRR values of about 0.15 (Fig. 7). Over this depth interval, soil samples indicate FC=66–87, LL=23–33, w_n/LL =1–1.3, and clay content (%<5 μm) between 14 and 28%. The characteristics of the sediment ejecta found between buildings C2 and C1 are consistent with those of the shallow low plasticity silt. This further indicates that the shallow loose silt deposit liquefied. At greater depths, numerous loose to medium dense layers of silt to silty sand found between 3.45 and 7.25 m have I_c values lower than 2.6. These silts have LL<31 and w_n/LL~1, but clay contents >23%. Again, these soils are considered potentially liquefiable for this study. As can be seen in Fig. 7(b), the values of the soil's CRR obtained from the analysis of CPT-C4 and neighboring SPTs in the range of depth of 3.45–7.25 m is lower than the free-field CSR for PGA=0.35*g*, and hence these strata most likely liquefied. Below a depth of 8 m, the soil liquefaction evaluation for building C2 is consistent with that previously presented for soils below building C3.

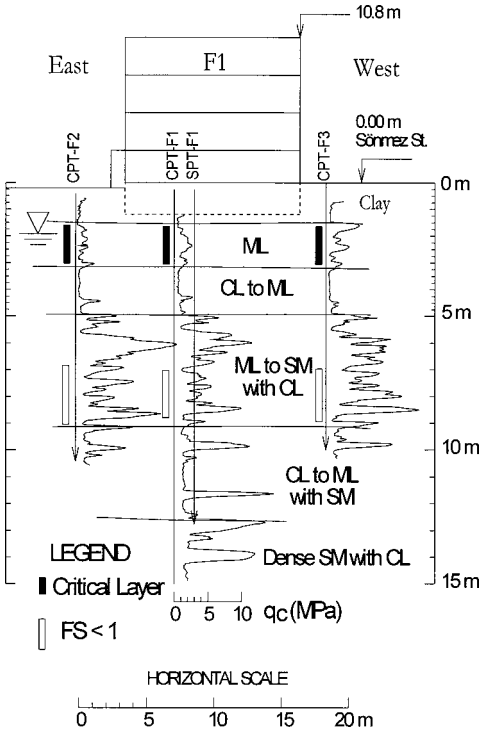
Fig. 9. East to west generalized subsurface soil profile of Site F

Fig. 8. Four-story building at Site F that underwent significant vertical and lateral displacement. Note gap between street and building that a felled tree was thrown in after the earthquake.

The 4-story, reinforced concrete apartment building shown in Fig. 8 is located in the Yenigün District (N40.77148° E30.40795°). The foundation of this structure consists of a 40-cm-thick reinforced concrete mat strengthened with 120-cm-high grade beams. The dimensions of the building are 13 m (E-W) by 7.7 m (N-S), with a height of 10.8 m, and a height-to-width ratio of 1.4. This building experienced 90 cm of downward movement relative to the surrounding pavement. Additionally, it translated approximately 25 cm towards the west (away from the street) and 30–40 cm to the north (away from photographer in Fig. 8). No significant foundation distress was observed, and the structural frame was essentially undamaged, indicating that the foundation underwent essentially rigid-body displacement.

At Site F, three CPT profiles and one boring with SPT were performed to characterize the foundation soils. The depth of the water table was about 1.9 m. The generalized subsurface profile below the building is shown in Fig. 9. Although the soils were explored to a depth of 27 m, only the upper 15 m are shown, as only the soils to this depth are judged to have had a significant effect on the observed ground failure.

The surficial soils consist of 1.5 m of clayey fill, underlain by 1.7 m of loose $[(N_1)_{60}=7]$, low plasticity (LL$<$30), and high water content (w_c/LL$>$0.9) brown to reddish brown silt to sandy silt. Zones with higher clay content were identified to have a pronounced reddish coloring, perhaps due to oxidation of ferric minerals. From 3.2 m to approximately 5 m lies a stratum of brown silty clay to clayey silt with some fine sand. At approximately 5 m, the soil color changes from brown to gray and the soil changes to medium dense gray nonplastic sandy silt and silty fine sand (35%$<$FC$<$77%) interspersed with thin silty clay strata. These sequences extend to a depth of approximately 9 m. The normalized SPT penetration resistance ranges between 14 and 22. However, given the high stratification in this depth range, these values may be influenced by the lower penetration resistance of the softer interbedded thin silty clay strata, as seldom do the thicker, stiffer silt deposits have a thickness greater than 50 cm. A 3.5-m-thick stratum of gray silty clay to clayey silt interbedded with occasional thin, medium dense to dense silty sand was found underlying the upper deposits of sandy silt.

The liquefaction triggering analysis has shown that it is probable that the observed downward movement and translation experienced by the building was primarily due to liquefaction of the upper brown silty soils (as delineated in Fig. 9). The intense stratification of the gray silty sandy soils in the depth range of 5–9 m (Zone B) makes it difficult to apply the SPT and/or CPT based simplified procedures for determining liquefaction potential, as weaker nonliquefiable clayey strata decrease the soil's penetration resistance. However, once appropriate thin layer corrections are applied, much of these sandy silt strata are judged to have not liquefied, except for a few thin layers at depths of around 6.5–8 m.

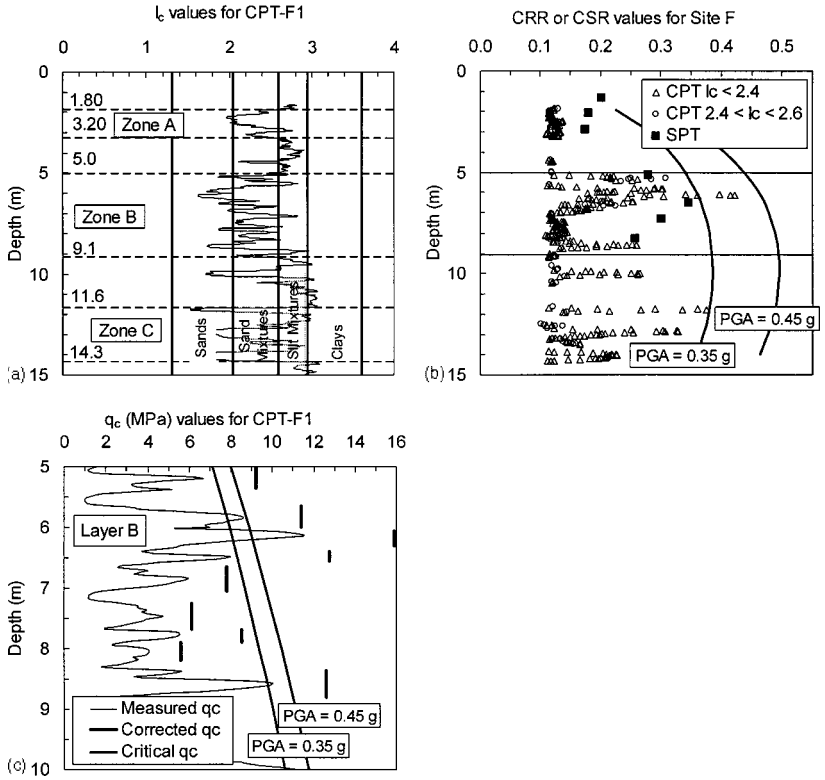
Fig. 10(a) shows where the soils had values of $I_c<2.6$ in a representative CPT profile. Comparisons between the free-field CSR induced by the earthquake and CRR of the soils susceptible to liquefaction are shown in Fig. 10(b). The CSR induced by the earthquake is significantly greater than the CRR of the soil in Zone A; thus the shallow, loose silt is judged to have liquefied.

The large fluctuations of the cone tip penetration resistance in Zone B indicate significant soil stratification as shown in Fig. 10(c). In this zone, the stiffer layers are seldom greater than 40

cm; therefore the full penetration resistance is not sensed by the 10 cm^2 cone tip used in these studies. These layers would need to be thicker than 75 cm for the tip resistance to reach its maximum value (Lunne et al. 1997). A correction factor as recommended by Youd et al. (2001) has been applied to the stiffer silt layers, which are susceptible to liquefaction, as shown in Fig. 10(c). Thin-layer corrections indicate that much of the Zone B soil did not liquefy for PGA$<$0.45g (i.e., all but four thin layers at depths of around 6.5–8 m). Consistent with the CPT results, the equivalent clean sand normalized SPT value, $(N_1)_{60\text{-}cs}$, exceeded 30 for some of the silt lenses indicating that much of the Zone B soils did not liquefy. Once thin layer corrections are made to the susceptible soil layers in Zone C, they are found to have not liquefied.

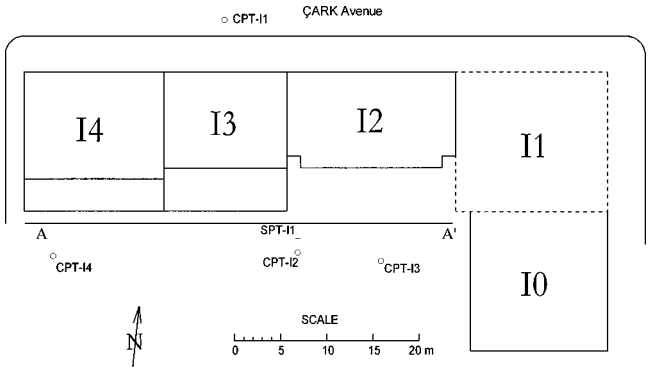
Fig. 11. Plan view of Site I and location of subsurface exploration points

The group of buildings shown in Fig. 11 corresponds to a block located along Çark Avenue (Line 1) in the Semerciler District, Adapazari (N40.77681° E30.39223°). Consistent with most foundation systems in Adapazari, building I3 is founded on a 35-cm-thick mat foundation, reinforced with 1.2-m-deep tie-beams. The height-to-width ratio for these buildings is between 1.1 and 1.3. The first building of the group from east to west, designated I1, experienced total failure of the columns of its first

story. The other four buildings suffered light to moderate structural damage. Buildings I3 and I4 have 6 stories each and displaced vertically relative to the surrounding ground 17 and 12 cm, respectively. Building I2 has only 4 stories, but it moved downward 30–35 cm. Brown soil ejecta were found about 25 m south of building I1.

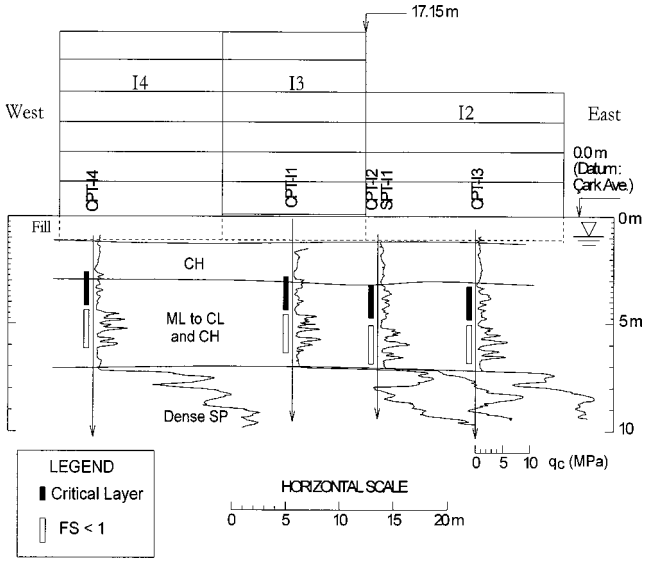
Fig. 12. West to east generalized soil profile of Site I (cross section A-A′ in Fig. 11)

As indicated in Fig. 11, four CPT profiles and one exploratory boring with SPT were performed at this site. The water table was found to be at a depth of about 0.8 m. The site's generalized subsurface profile is shown in Fig. 12. Directly below the foundation level and to a depth of approximately 3 m lies a stratum of stiff high plasticity gray silty clay. A sequence of highly stratified brown low plasticity sandy silt, clayey silt, and high plasticity silty clay was found from 3 to 7 m. The color of the soil in this deposit transitions to gray at about 4 m. The normalized SPT penetration resistance $[(N_1)_{60}]$ of the soils between 3 and 5 m is about 7, and about 14 for the soils between 5 and 7 m. Below 7 m and up to the maximum depth explored ($\sim$10 m) lies a dense $[q_{c1N}>160$ and $(N_1)_{60}>30]$ stratum of poorly graded gray sand with some silt (FC$<$10%).

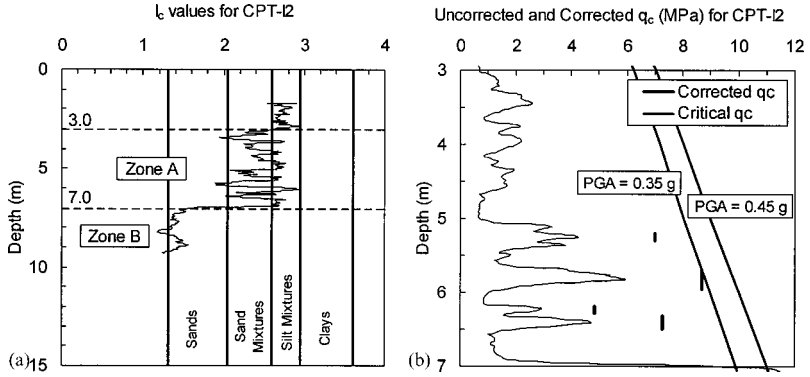
Fig. 13. (a) Soil behavior index (I_c) values for CPT-I2, and (b) thin layer corrected q_c and critical q_c for free-field acceleration of 0.35 and 0.45g versus depth for CPT-I2

The stratified silts and clays between 3 and 7 m [Zone A in Fig. 13(a)] were found to be the only part of the subsurface profile below Site I that met both CPT conditions that render a soil liquefiable according to Youd et al. (2001) [i.e., $I_c<2.6$ and $(q_{c1N})_{cs}<160$]. Soil samples show that some lenses have LL <35 and $w_c/\mathrm{LL}>0.9$, but in general the soils have $30<$LL <40. Fig. 13(b) indicates that over the depth of 3–7 m the tip resistance corresponding to the threshold of liquefaction for free-field PGAs of 0.35 and 0.45g is generally greater than the measured tip resistances, even after correcting for thin layers. Therefore those layers in Zone A that have values of $I_c<2.6$ with LL <35 and $w_c/\mathrm{LL}>0.9$ that also have low penetration resistances most likely liquefied during the Kocaeli earthquake. The soils between depths of 3 and 4.6 m had the lowest factor of safety against liquefaction and are therefore judged to be the critical layer (see Fig. 12). Conversely, the stratum of gray poorly graded sand [Zone B in Fig. 13(a)] has a penetration resistance characterized by $q_{c1N}>160$ and $(N_1)_{60\text{-cs}}>30$ and should not have liquefied.

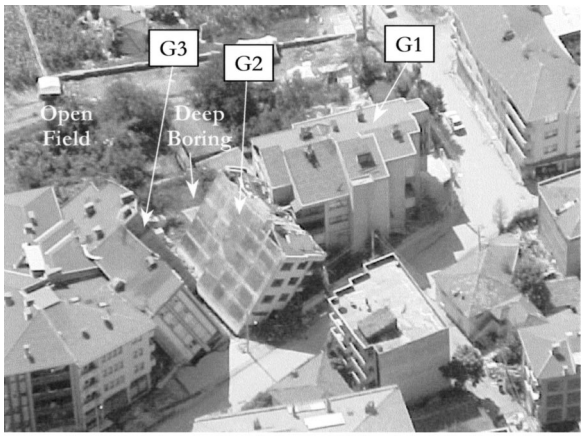
Fig. 14. Aerial view of Site G 13 days after the Kocaeli earthquake

The group of Site G buildings shown in Fig. 14 is located in Yenigün District, Adapazari (N40.77450° E30.40896°), which is only 350 m north of Site F. The irregularly shaped building G1 has a length (E-W) of 22.2 m, a width (N-S) of 14.1 m, and a height of 11.2 m, with a height-to-width ratio of 0.8. This building experienced vertical movement of approximately 10 cm with no significant tilting and suffered light damage aside from that caused by the impact of building G2. The adjacent 4 and 5 story buildings (designated G2 and G3, respectively) experienced bearing capacity type failures with excessive tilt. These buildings have been demolished. According to building drawings, building G3 was 21.7 m long with its width varying between 8.6 and 6.2 m. The structure was 14 m high, so its maximum height-to-width ratio was 2.3. The mat foundation of these buildings consists of 25- to 30-cm-thick reinforced concrete slabs with 1–1.2-m-deep tie-beams. The ground immediately surrounding these buildings was littered with brown sediment ejecta, which were classified as low plasticity (LL~30) silty sand (SM). Sand boils were not observed away from the buildings, i.e., in the open field to their rear (see Fig. 14).

Although all buildings seem to have a similar subsurface soil profile, foundation type, and embedment depth, the shape of the structure appears to have had a significant effect on their individual performance. Low aspect ratio building G1 settled only slightly, which allowed the apartment owners to reinhabit it after repairing the damage caused by the adjacent overturned building G2. High aspect ratio buildings G2 and G3 experienced bearing failure, and were later demolished.

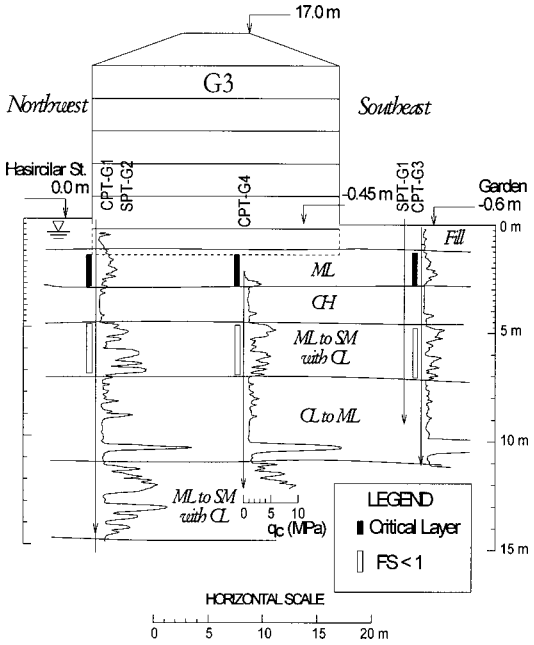
Fig. 15. Northwest to southeast generalized subsurface profile of Site G

A total of four CPT profiles, two borings with SPT, and one very deep boring were performed at this site. The upper 15 m of the generalized subsurface profile of this site is depicted in Fig. 15. The first 1.5 m below the sidewalk level consist of clayey soil followed by approximately 1.5 m of loose $[(N_1)_{60}<10]$ to medium dense reddish brown sandy clayey silt. The soil samples of this deposit generally exhibit LL<35 and $w_c/\mathrm{LL}>0.9$. The brown sediment ejecta identified during the postearthquake reconnaissance appear to have originated in this stratum based on color and LL similarity. The depth to the water table was found to fluctuate between 0.4 and 0.6 m below the sidewalk level.

From approximately 3–5 m the soil transitions from brown clayey silt to gray high plasticity silty clay. Between approxi-

mately 5 and 7.4 m lies a medium dense gray low plasticity silt grading to silty sand interbedded with thin strata of clayey silt. The fines content of the soils in this deposit varies ($22\% < FC < 100\%$) and most samples have $LL < 35$. A thick deposit of gray silty clay to clayey silt with $36 < LL < 58$, but predominantly $LL > 50$, lying approximately between 7.4 and 11.3 m, was found overlying sequences of medium dense to dense silt and sand mixtures interbedded with silty clay and clayey silts down to 25 m.

The brown silty soils located in the upper 3 m (Zone A) was judged to be primarily responsible for the bearing failure experienced by buildings G2 and G3. At a number of sites where the potentially liquefiable soils at depths of about 5–7.5 m (Zone B) at Site G were replaced with a dense coarse sand that was nonliquefiable (e.g., Site B; profile shown in Fig. 17), bearing capacity failures occurred. Thus softening of the lower Zone B soils is not required to produce a bearing capacity failure for a tall slender

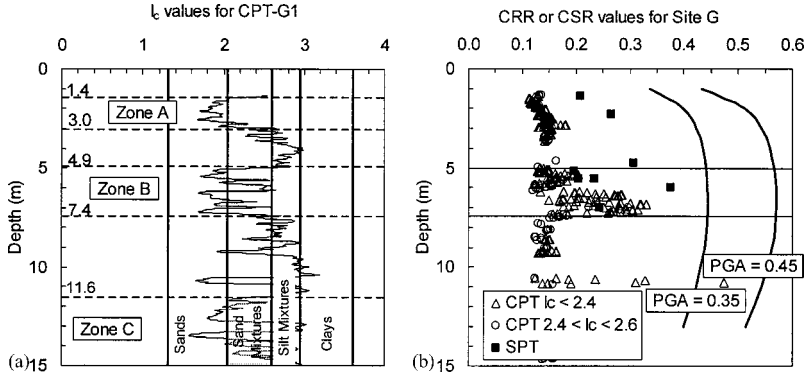
Fig. 16. Representative soil data for Site G: (a) Soil behavior index (I_c) values for CPT-G1, and (b) cyclic stress ratio (CSR) induced by earthquake versus depth for peak ground acceleration (PGA)=0.35*g* and 0.45*g* compared with the cyclic resistance ratio (CRR) of the soil

Fig. 16 shows values of I_c in a representative sounding CPT-G1, as well as a comparison of CRR and CSR values for Site G. As can be observed, the subsurface conditions beneath this site are remarkably similar to the conditions under Site F (see Fig. 10). The liquefaction evaluation of the soils at Site G is similar to that at Site F and is not discussed further for brevity. However, the liquefaction evaluation is summarized in Fig. 15 by showing layers with $FS_l < 1$ and the critical layer.

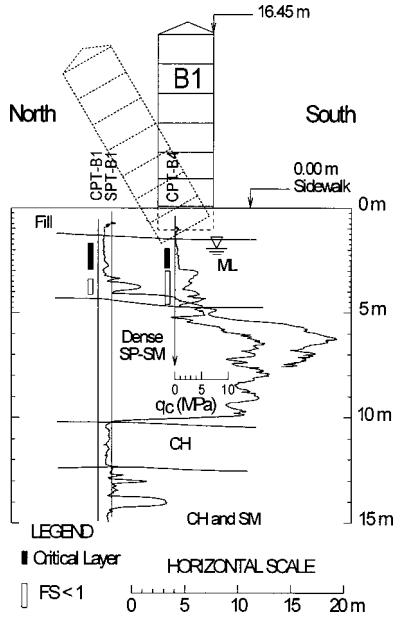
Fig. 17. Soil profile at Site B where a tall slender building failed in bearing

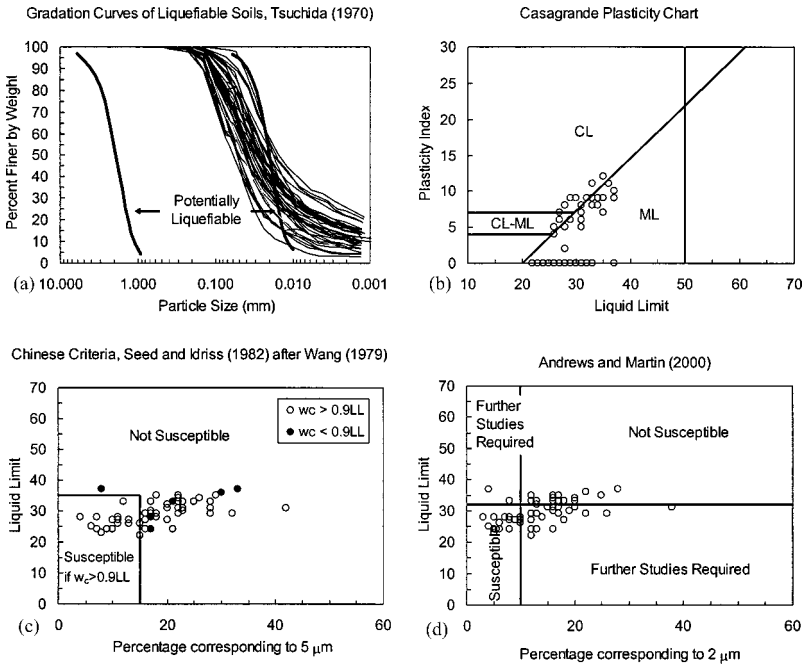
Fig. 18. Characteristics of liquefiable soils in Adapazari: (a) grain size distributions; (b) plasticity chart; (c) Chinese criteria for liquefaction of clayey soils after Seed and Idriss (1982) (after Wang 1979); and (d) liquefaction criteria for silty soils after Andrews and Martin (2000)

In Table 2, the characteristics of the critical soil layers in terms of liquefaction triggering at the 12 building sites investigated in Adapazari are summarized. The data points for these critical soil layers are shown on the CSR versus $(N_1)_{60}$ plot in Fig. 3, which was presented previously. The soil characteristics data that forms the basis for the critical soil layers described in Table 2 are plotted in Fig. 18. Soils that liquefied in Adapazari often contain grain size distributions outside of that commonly believed to be susceptible to liquefaction [Fig. 18(a)]. The Adapazari soils contain a significant amount of clay-size particles, yet they liquefied. Moreover, many of these soils have significant plasticity [Fig. 18(b)]. The soil index data for these soils that liquefied are also plotted in Fig. 18(c) to allow evaluation of the robustness of the Chinese criteria. Only a few of the soils tested satisfy all conditions of the Chinese criteria. For the silts of Adapazari, low liquid limits ($\leqslant$35 or so) and high water contents ($w_c \geqslant 0.9$ LL or so) are good indicators of liquefaction or significant strength loss due to shaking, as shown in Fig. 18(c) and Table 2. The percent clay fraction criterion is not a reliable screening tool, because many cases of ground failure occurred in soils that had more than 15% clay-size (5 μm) particles. An examination of the Andrews and Martin (2000) liquefaction criteria for silty soils [Fig. 18(d)] also indicates that the percent clay-size (<2 μm) criterion is not a reliable indicator of liquefaction susceptibility, and that soils with LL >32 can liquefy.
