US Efforts in Support of Examinations at Fukushima Daiichi – 2016 Evaluations

ANL/LWRS-16/02

Light Water Reactor Sustainability Program

August 2016

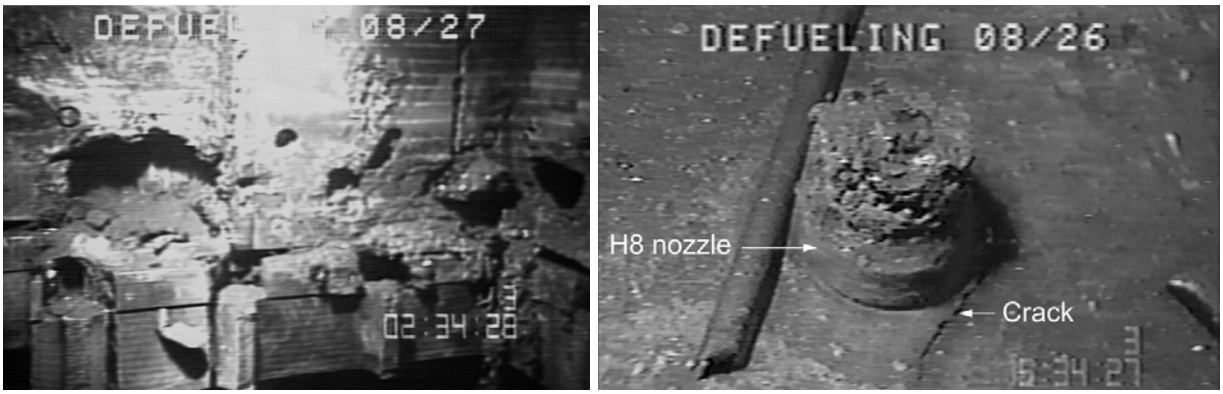
Figure 2. TMI-2 video examinations revealed locations where damage to core barrel and nozzles was more severe. (Courtesy of FirstEnergy)

A systematic investigation of the costs and benefits of TMI-2 inspection information is not available. It is clear that visual inspection information from within the TMI-2 vessel and the containment offered important insights at a lower cost than insights gained from post-accident examinations of radioactive samples. Nevertheless, important insights about the potential for vessel failure were also gained from examinations of vessel steel and nozzles.

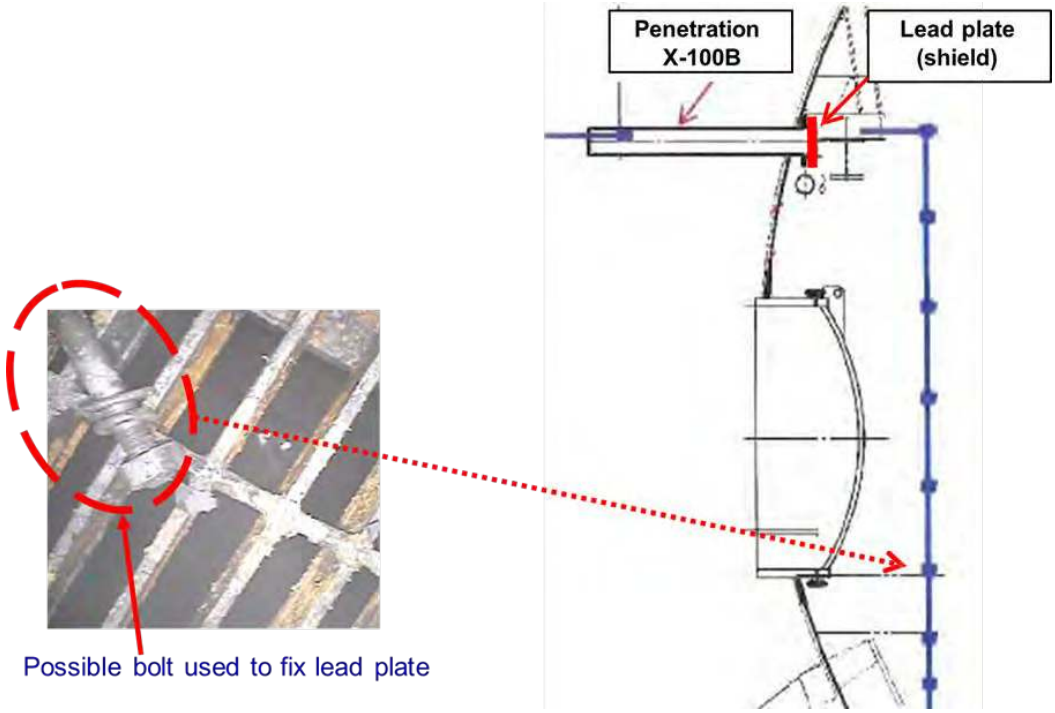
For 1F1, pressure data [8] indicate that peak PCV pressures were as high as 0.84 MPa/122 psia on March 12, 2011. Temperature data were not available until March 21, 2011. Calculated saturation temperatures for this measured peak pressure, assuming a pure steam environment and neglecting localized hot spots, indicate values as high as 172°C /342°F. However, as shown in Figure 9, examinations within 1F1 revealed that a lead shield plate was missing. It is currently unknown whether the plate relocated due to melting or creep. In order for this lead plate to have melted, gas temperatures inside the drywell exceeded 328 °C/ 622 °F, the melting point for lead.

Figure 9. Visual examinations within X-100B penetrations in 1F1 PCV. (Courtesy of TEPCO [10])

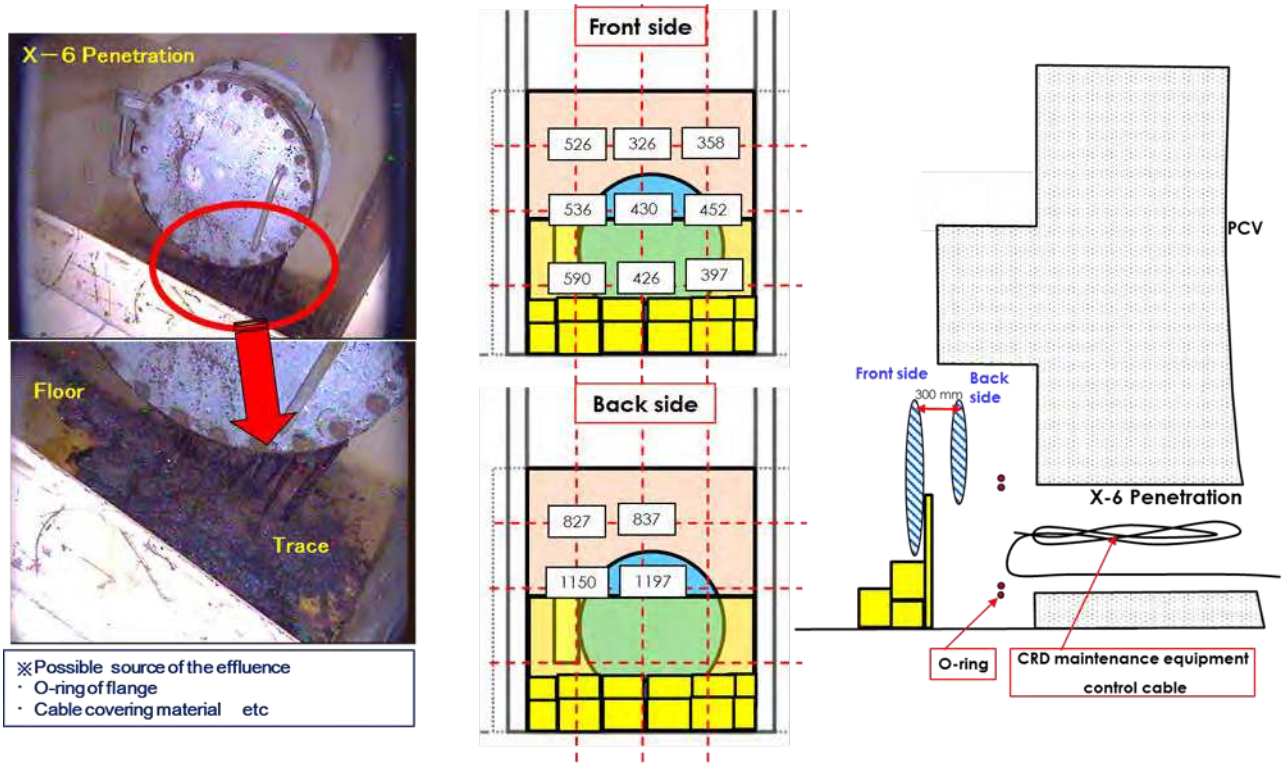
For 1F2, insights related to peak temperatures within the PCV are available from visual examinations, radiation survey information, and temperature and pressure data. As shown in Figure 10, visual examinations of material from the X-6 penetration suggest that either the chloroprene cable cover or silicon flange seal material melted and dribbled out of this penetration. In their review, US experts concluded this evidence indicates peak temperatures at this location exceeded 300 °C/572°F and the dribbling pattern suggests that relocation occurred at low pressure (rather than a high pressure ejection of material). Plant data [8] indicate that 1F2 peak pressures were as high as 0.75 MPa/109 psia on March 15, 2011. Temperature data were not available until March 21, 2011. Calculated saturation temperatures for the measured peak pressure, assuming a pure steam environment and neglecting localized hot spots, indicate values as high as 168 °C/334 °F.

Figure 10. Photographs and radiation surveys (in mSv/hr) near 1F2 X-6 penetration (values measured in 13 locations). (Courtesy of TEPCO [91, 92])

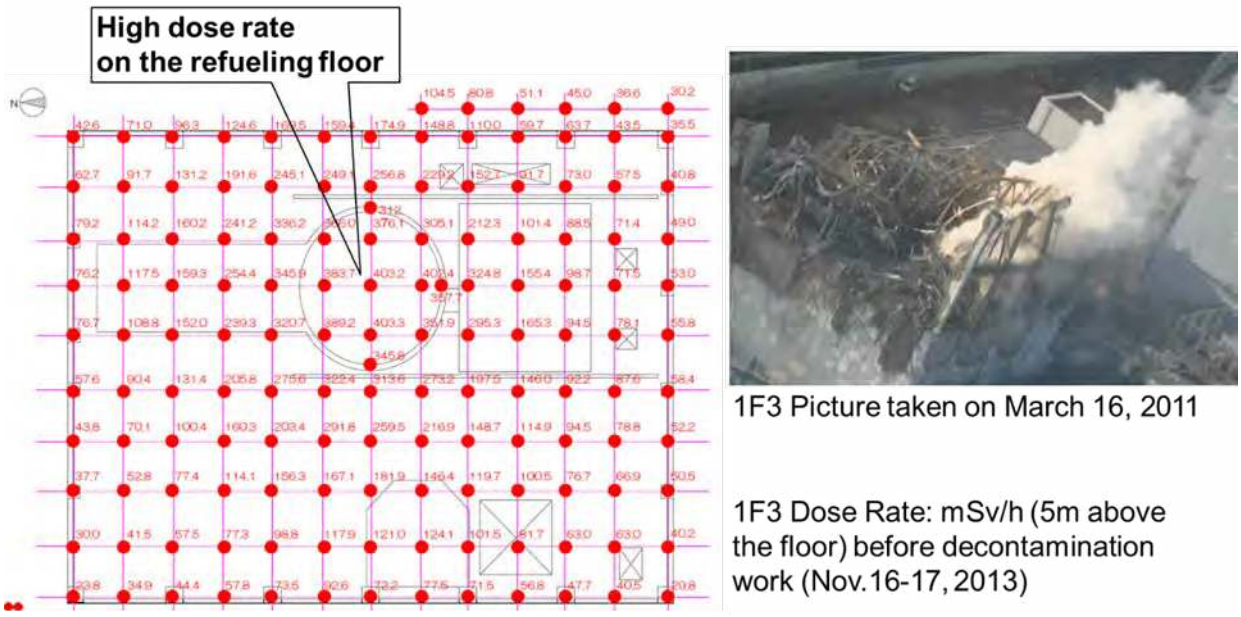
For 1F3, insights about leakage come from photos and data obtained in March 2011 and dose rates obtained in November 2013. As shown in Figure 11, steam appears to be escaping at locations near the drywell head, and higher dose rates were measured near the drywell head. Both of these observations are consistent with a failure of the drywell head, perhaps due to drywell bolt expansion or strain or due to seal degradation from high temperatures and pressures within the PCV. Plant data [8] indicate that 1F3 pressures were as high as 0.75 MPa/109 psia on March 13, 2011. Temperature data were not available until March 20, 2011. Calculated saturation temperatures for the measured peak pressure, assuming a pure steam environment and neglecting localized hot spots, indicate values as high as 168 °C /334 °F. The combined pressure and temperature challenges are postulated to have stretched the drywell head bolts and allowed leakage through that pathway. However, the degree of damage to the head gasket is not known at this time. Photos showing leakage from MSIV expansion joints and radiological surveys from the equipment hatch penetration indicate that 1F3 experienced multiple leakage locations.

Figure 11. 1F3 radiation survey (value in mSv/hr measured on November 16-17, 2013 at 5 m above the floor at points shown on red grid) and photograph taken on March 16, 2011 (Courtesy of TEPCO [10,12])

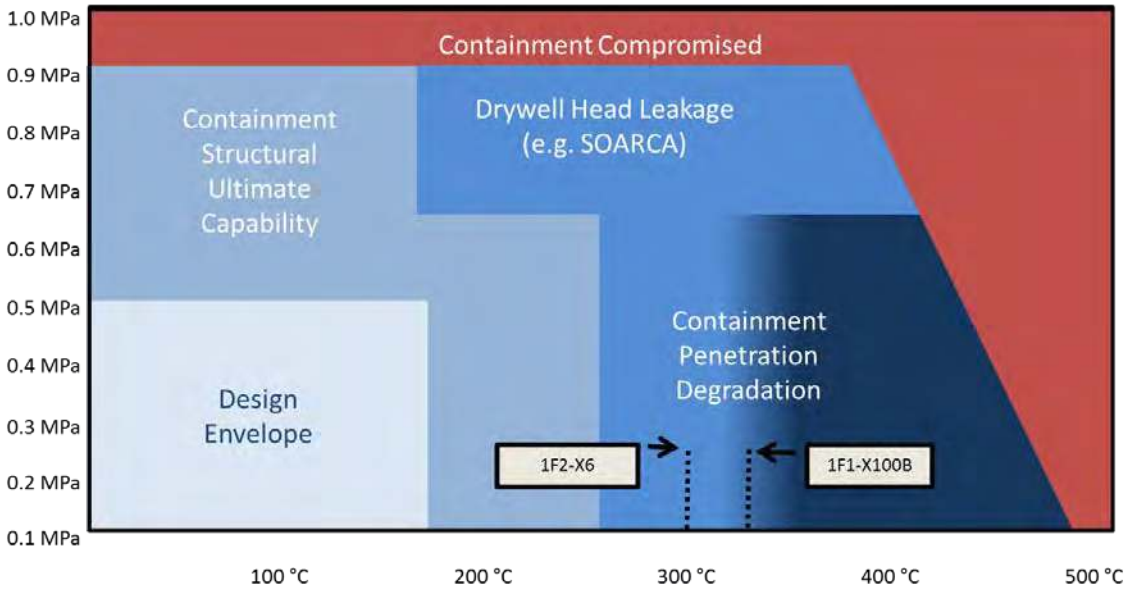
Figure 12 shows available peak temperature information on a figure developed from information in the NEI 13-02 industry guidance for venting. The DW vent is assumed to have a design temperature of 285°C/ 545 °F, and containment penetration degradation temperatures in the figure are based on engineering evaluations and testing information available in the literature. Black temperature lines in Figure 12 correspond to 1F1 and 1F2, and peak temperature information available from examinations at Daiichi. These values are consistent with the range of values assumed to cause degradation in NEI 13-02; thus, available information from Daiichi support NEI 13-02 guidance recommending that operators maintain containments at low pressure.

Figure 12. Containment pressure/temperature curve with available 1F1, 1F2, and 1F3 information. (Graphic courtesy of Nuclear Energy Institute [62] as modified by Jensen Hughes)

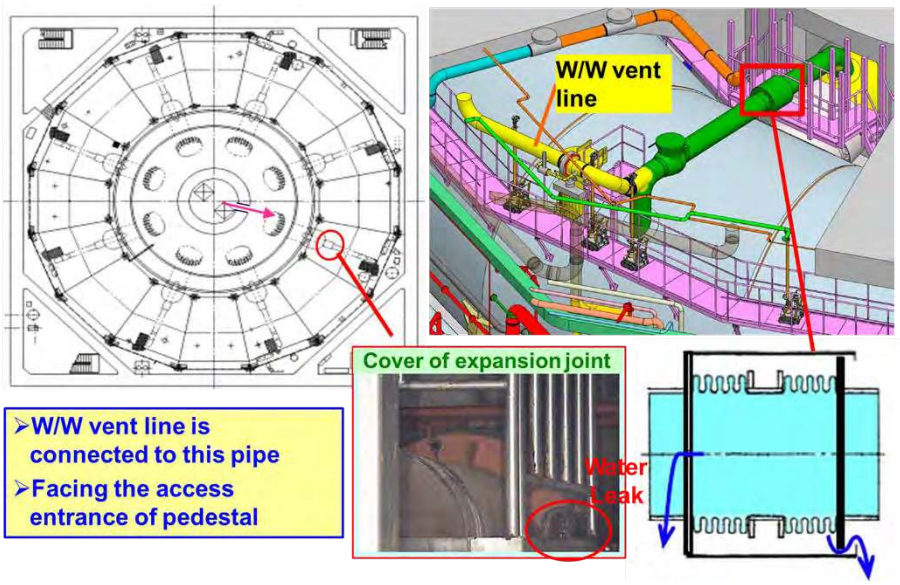
Figure 14. Impairment of 1F1 vacuum breaker line expansion joint. (Courtesy of TEPCO [117])

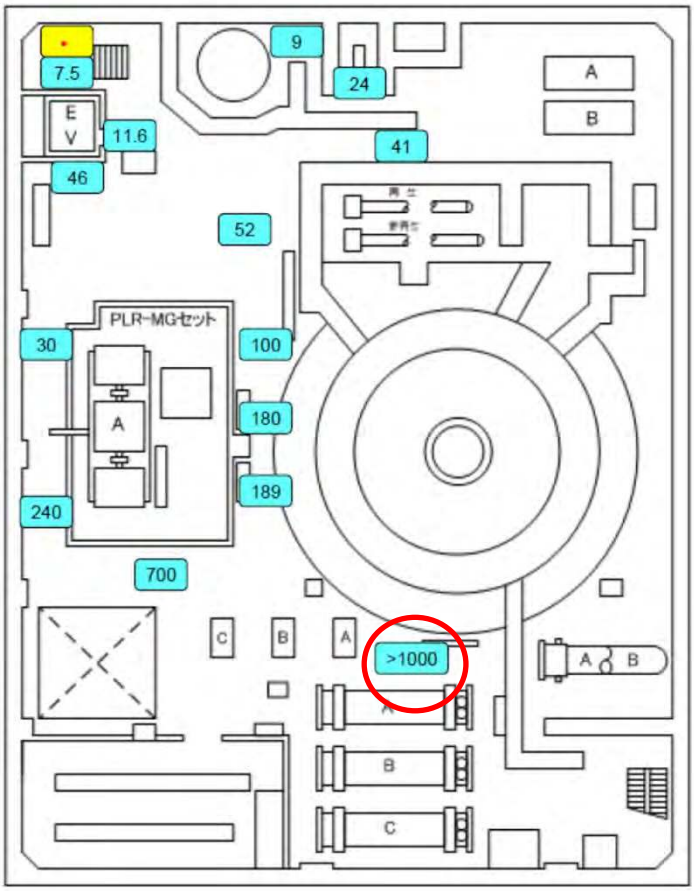
Figure 15. 1F1 reactor building first floor dose rate measurements (in mSv/hr; taken above floor elevation) illustrating elevated radiological contamination of RCW system (circled area). (Courtesy of TEPCO [118])

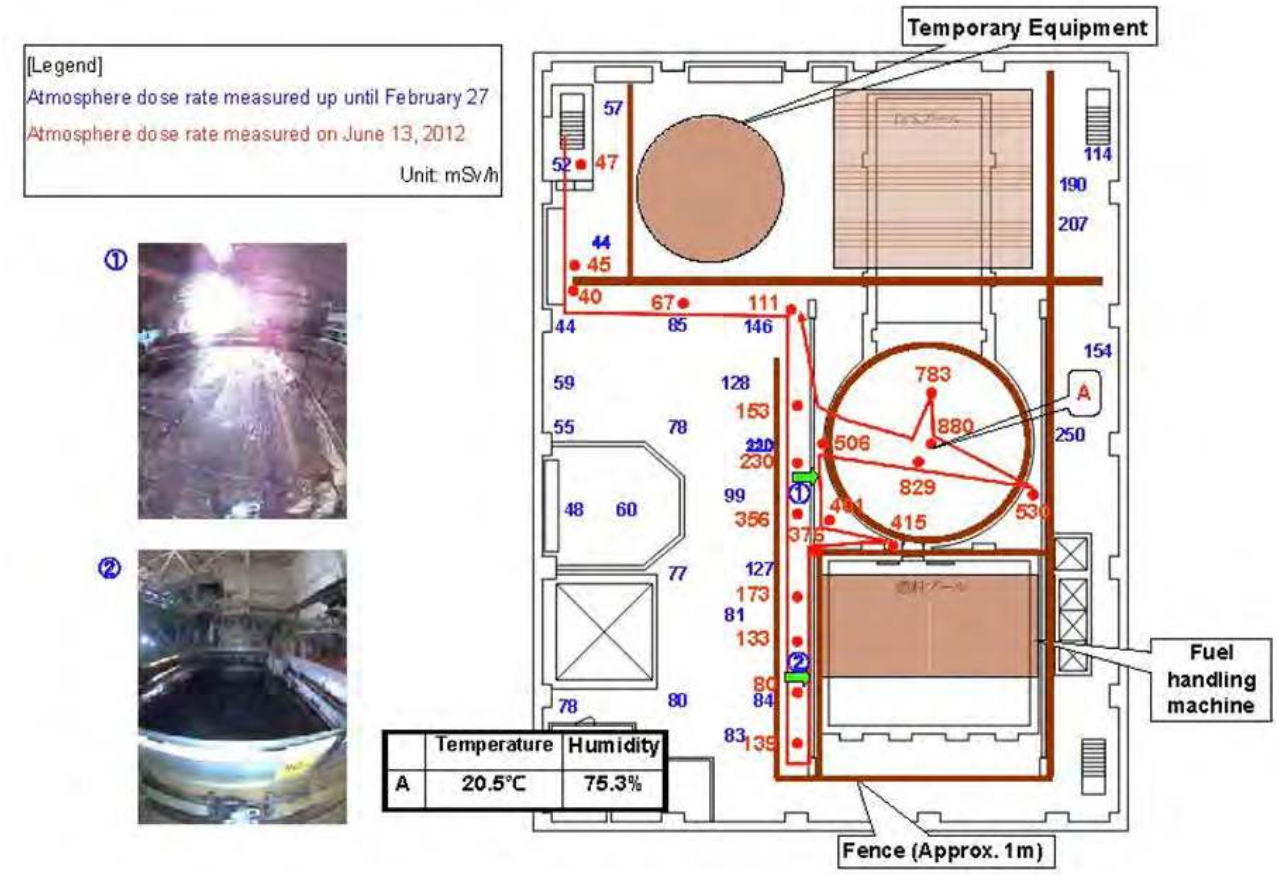
Shield plugs above the drywell head, covering the refueling cavity, have measured dose rates of ~800 mSv/h (Figure 17).

Figure 17. 1F2 reactor building refueling floor visual and dose rate information. (Courtesy of TEPCO [120])

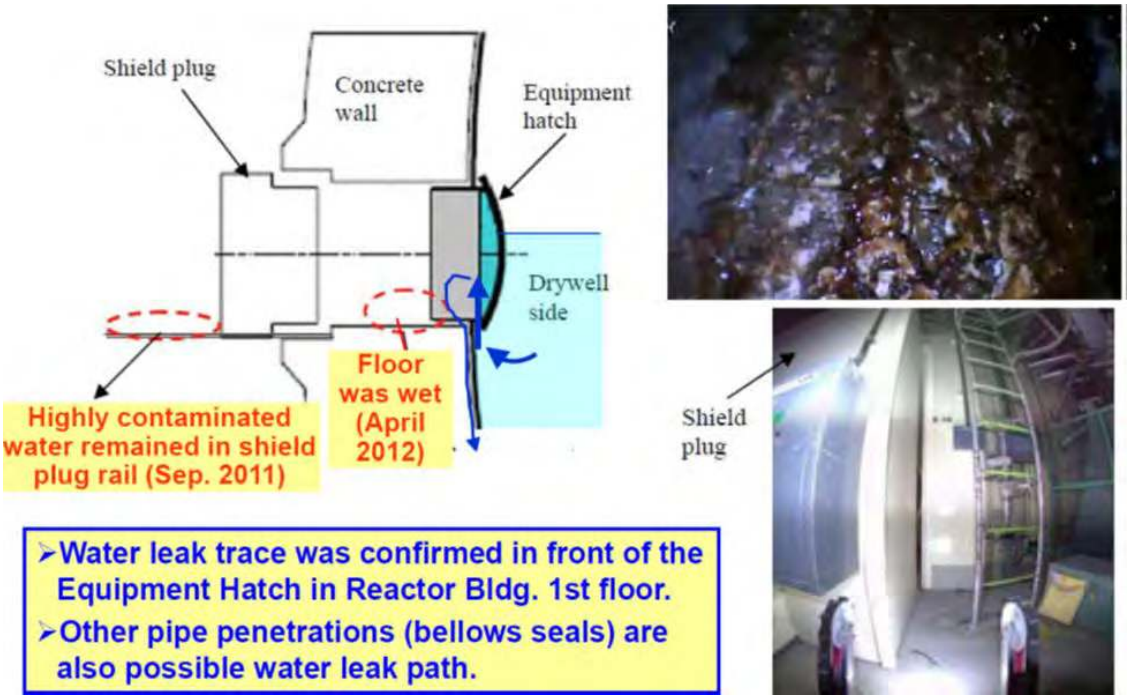
Figure 18. Liquid-phase leakage from 1F3 equipment hatch. (Courtesy of TEPCO [117])

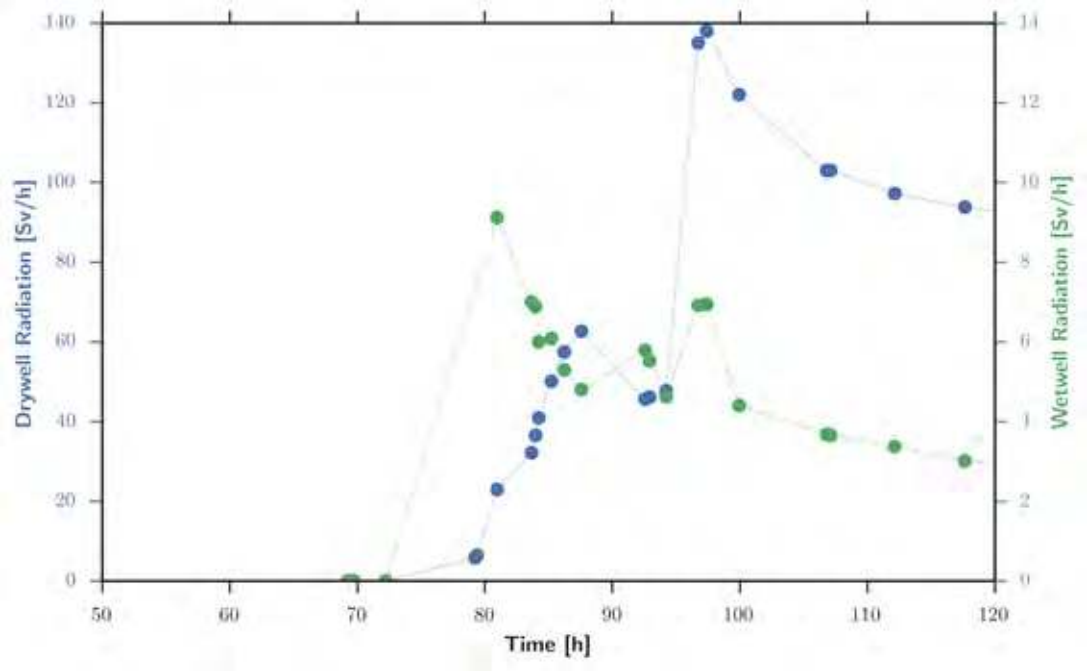
evolving core damage and potential failure of the reactor pressure boundary. Figure 19 shows radiation measurements obtained from the drywell and wetwell during a period of significant core damage progression at 1F2.

Figure 19. 1F2 drywell and wetwell CAMS readings. (Courtesy of Jensen Hughes based on information in [72])

As shown in Figure 19, drywell radiation readings increased just prior to 80 hours into the event (e.g., drywell radiation measurements increased significantly over a few hours around this time). This increase in drywell radiation readings also corresponds to the measured rapid increase in drywell pressure at around 80 hours into the event.

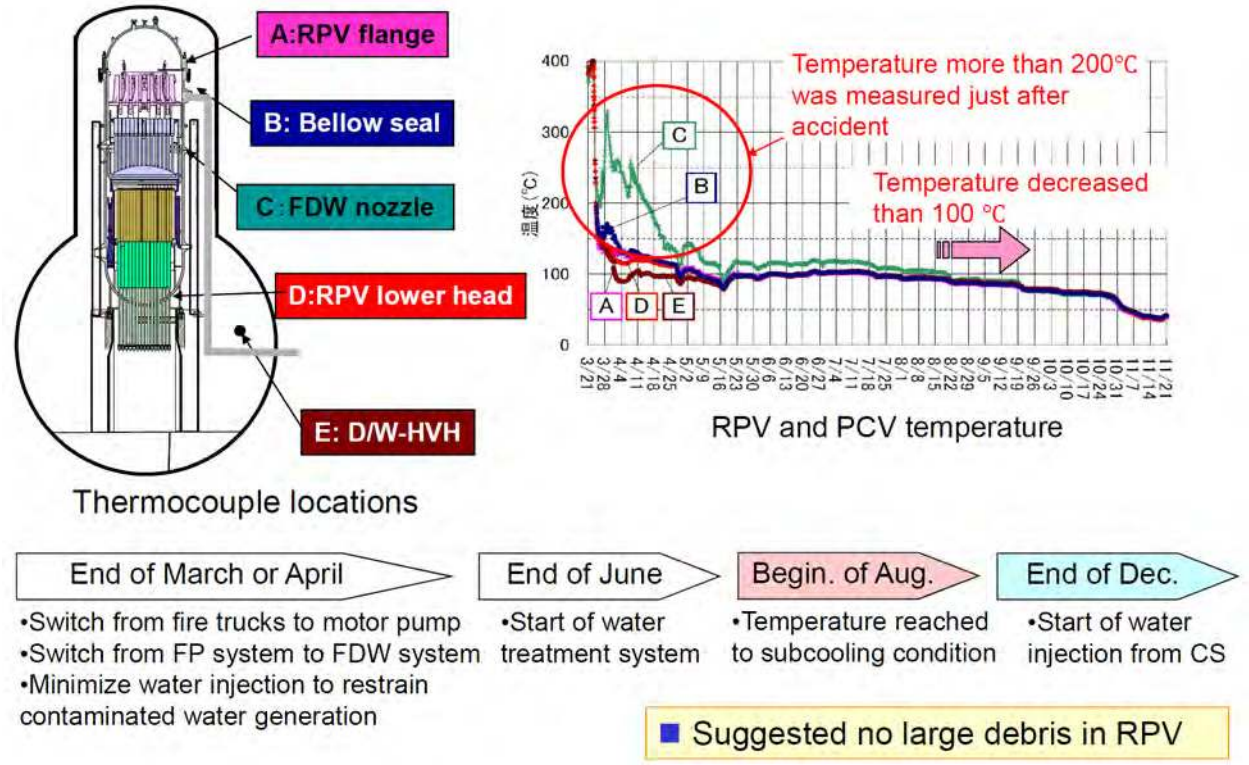
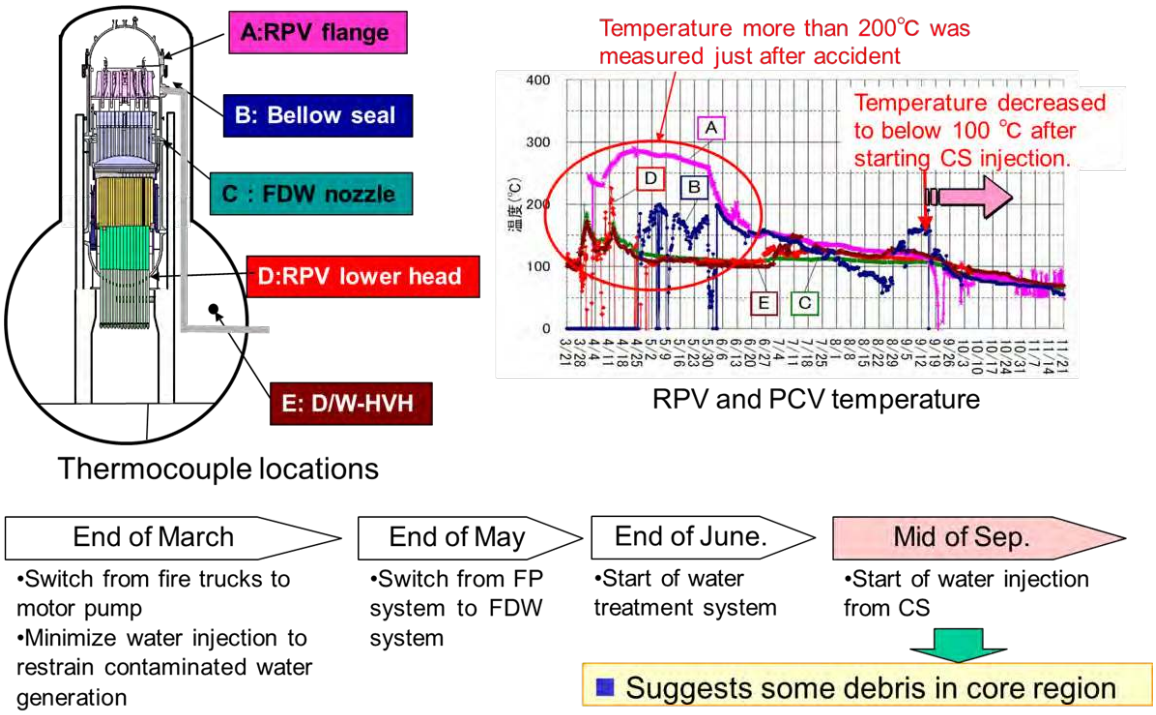
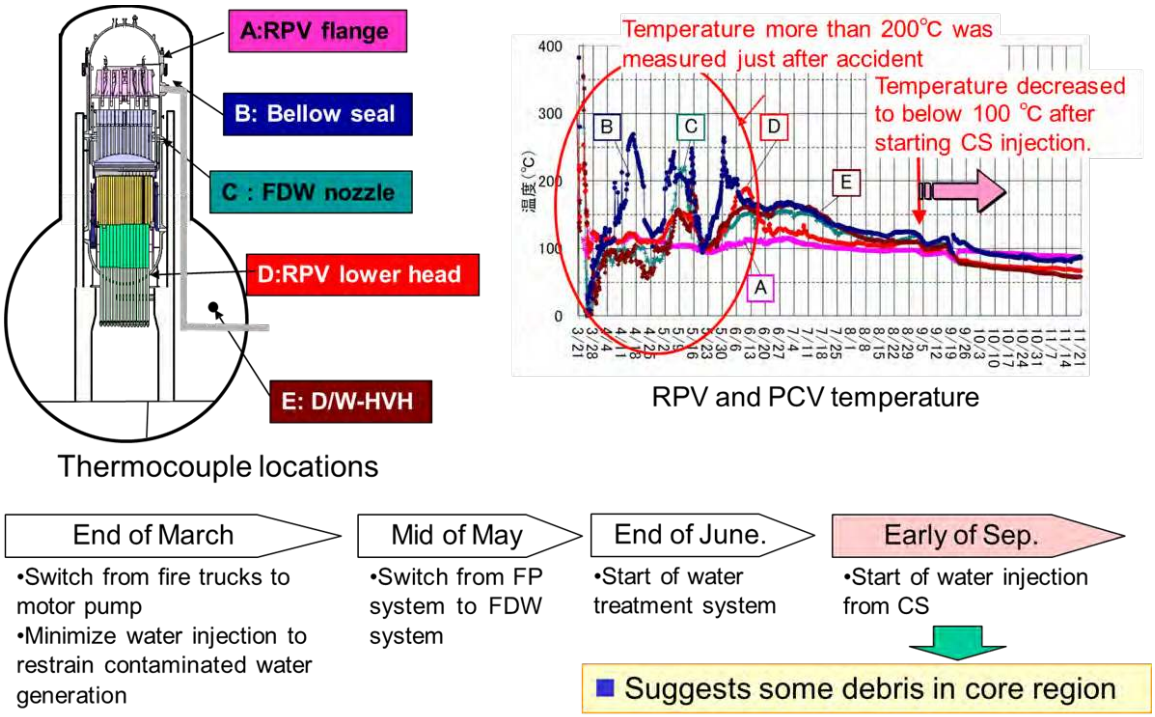
Figures 20 through 22 provide thermocouple measurements [10] obtained from 1F1, 1F2, and 1F3, respectively, for a time period spanning several months following the accident. These measurements provided the first indication of where core debris likely resides, and equally important, where it is not. In particular, water injection was shifted from the fire protection (FP) to feedwater (FDW) injection systems for the three units in the April-May timeframe. However, RPV thermocouple (TC) measurements indicated temperatures well above the coolant saturation temperature after this switch was made, particularly for 1F2 and 1F3. This provided an early indication that all core debris may not have been cooled using the FDW injection pathway. As a reminder, the feedwater for a BWR is introduced near the top of the RPV (see Figures 20 through 22) and then flows down along the exterior surface of the core barrel to the core inlet. This led TEPCO and the technical support community to conclude that there may be significant leakage path(s) in the bottom region of the reactor vessel for all three units (e.g., BWR recirculation pumps are known to leak under severe accident conditions [123]). In such cases, some fraction of the coolant was able to bypass the core debris; and the material was not fully cooled.

Figure 20. RPV temperature measurements for 1F1 following the accident. (Courtesy of TEPCO [10])

Figure 21. RPV temperature measurements for 1F2 following the accident. (Courtesy of TEPCO [10])

Figure 22. RPV temperature measurements for 1F3 following the accident. (Courtesy of TEPCO [10])

On this basis, TEPCO changed the water injection from the FDW system to the core spray (CS) system in the September 2011 timeframe for 1F2 and 1F3, while this change was made in late December 2011 for 1F1. This injection method directly introduces a water spray from above the core. As shown in Figures 21 and 22, this changed injection point caused the RPV temperatures for 1F2 and 1F3 to be reduced to coolant saturation temperature, which is the expected condition when core debris is covered with water. However, this change had little if any impact for 1F1, for which the RPV temperatures had already fallen below saturation. This, along with indications from water level instrumentation not increasing, led TEPCO and many in the technical support community to conclude that some fraction of fuel remained in the RPV for 1F2 and 1F3, but most of the core debris was likely ex-vessel for 1F1. Note that this information does not rule out the possibility of ex-vessel core debris for 1F2 and 1F3; however, there is likely some fraction of core debris in-vessel that caused elevated temperatures to occur when water was introduced via the FDW system.

This information is consistent with early US [27,28] as well as international [124] code predictions of likely debris locations for the three units based on modeling conducted relatively soon after the accident. Since that time, further refinements of these analyses have not changed these same basic conclusions. The picture is clearest for 1F1 which was essentially a hands-off station blackout until ~15 hours into the accident sequence [e.g., an event in which all onsite and offsite alternating current (ac) power is lost and in which no successful mitigating actions are taken]. At this point, operators were able to reflood the core with seawater. However, the predictions are less consistent for 1F2 and 1F3 where operators were able to maintain some degree of core cooling by various means for the first several days of the accident. The uncertainties arise as to the effectiveness of water injection (due to elevated PCV pressure), and the effectiveness and extent of backup cooling system operation under severe accident conditions; this situation was compounded by a general lack of functioning instrumentation (as well as the fact that surviving instrumentation had in many cases been pushed well outside the normal operating envelope; this statement is true for the TC measurements shown in Figures 20 through 22) that would allow the actual plant conditions to be ascertained.

Aside from these general observations, it is noteworthy that the TC data in Figures 20 through 22 may provide valuable information that could be used to further evaluate likely core debris end-state locations using system-level codes. In particular, these codes have the ability to calculate heatup of the RPV, and through appropriate nodalization, it may be possible to calculate temperatures on structures that correspond to locations where the measurements were obtained in Figures 20 through 22. The core debris distribution calculated by the codes would influence the temperature responses at these locations, and the extent that the codes are able to reproduce the signatures shown in Figures 20 through 22 may provide further insights on likely debris distributions. This type of analysis is relevant to the ongoing MAAP-MELCOR cross-walk activity [29]; i.e., these two codes predict quite different in-vessel core melt behavior and, as a result, RCS failure modes. These modeling differences may be reflected in long-term RPV temperature predictions that could, by comparison with the data, provide an indication of likely relocation mode(s), which is one of the key questions being addressed as part of the crosswalk activity.

As alluded to in Section 5.2, refine the MAAP and MELCOR RPV nodalization schemes for the RPVs of Units 1 through 3 with the aim of predicting the measured temperatures shown in Figures 20 through 22. The post-accident debris locations predicted inside the RPV, coupled with changes in water addition rate and location, may provide a means for assessing the accuracy of the debris end-state predictions. This comparison may also provide insights into appropriate modeling of in-core melt progression that has been identified as a key uncertainty in the MAAP-MELCOR crosswalk exercise [29].

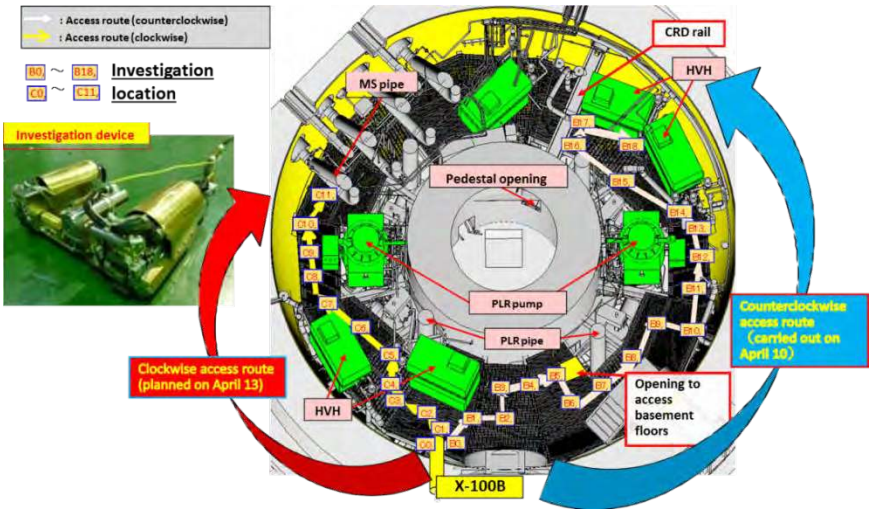
TEPCO has also obtained other valuable information from within the 1F1 PCV using robotics examinations through a containment penetration, i.e., the 'X-100B' penetration (see Figure 23).[125] Prior to the accident, this penetration was shielded on the interior of the PCV to reduce the radiation level in the reactor building. The first piece of information gathered when this penetration was opened was that the lead shielding appears to have melted during the accident (see Section 3.2.1). Lead melts at 328 ºC; temperatures this high in the PCV are hard to rationalize unless one postulates vessel failure and core debris discharge into the PCV.

Figure 23. Location of X-100B in 1F1 PCV and pathways of robotic examinations completed on April 10, 2015 (Courtesy of TEPCO [125]).

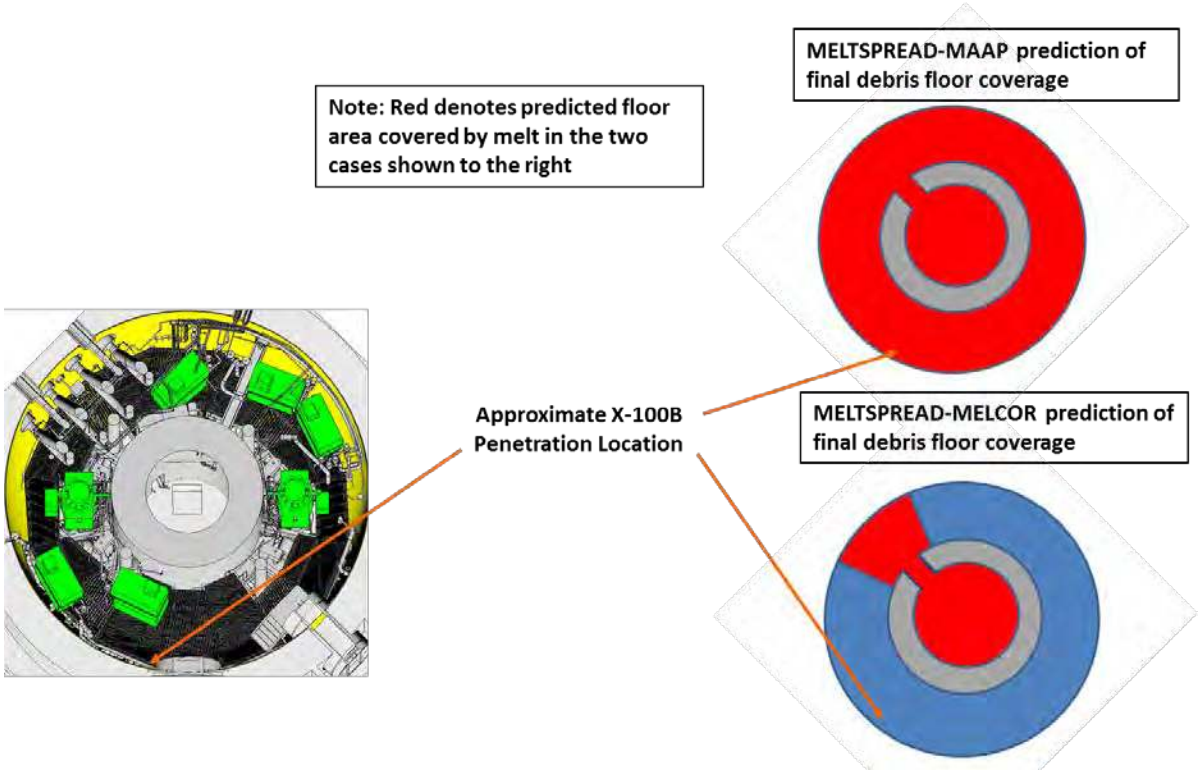
Upon gaining access through this penetration, TEPCO initially lowered a video camera through the catwalk to the drywell floor to measure water level, temperatures, and radiation levels inside the PCV. These inspections showed that there was no core debris on the drywell floor at this location, which is ~ 130 degrees from the pedestal doorway (Figure 23). This finding was important as it provided a data point for assessing predictions of ex-vessel core melt spreading based on MAAP and MELCOR pour scenarios as calculated with MELTSPREAD [30]. As is evident from Figure 24, the measurement indicates that the MELTSPREAD prediction of spreading distance based on MAAP pour conditions over-predicts the actual spreading distance. Conversely, this single data point is insufficient to gauge the accuracy of the MELTSPREAD-MELCOR prediction as the spreading prediction for that case is limited to the vicinity of the pedestal doorway. Nonetheless, this initial observation through this penetration has been useful in reducing the range of possibilities regarding the extent of melt spreading in 1F1.

Figure 24. Approximate location of X-100B penetration relative to predictions of core debris spreading in 1F1 (Courtesy of TEPCO and ORNL [30,125].

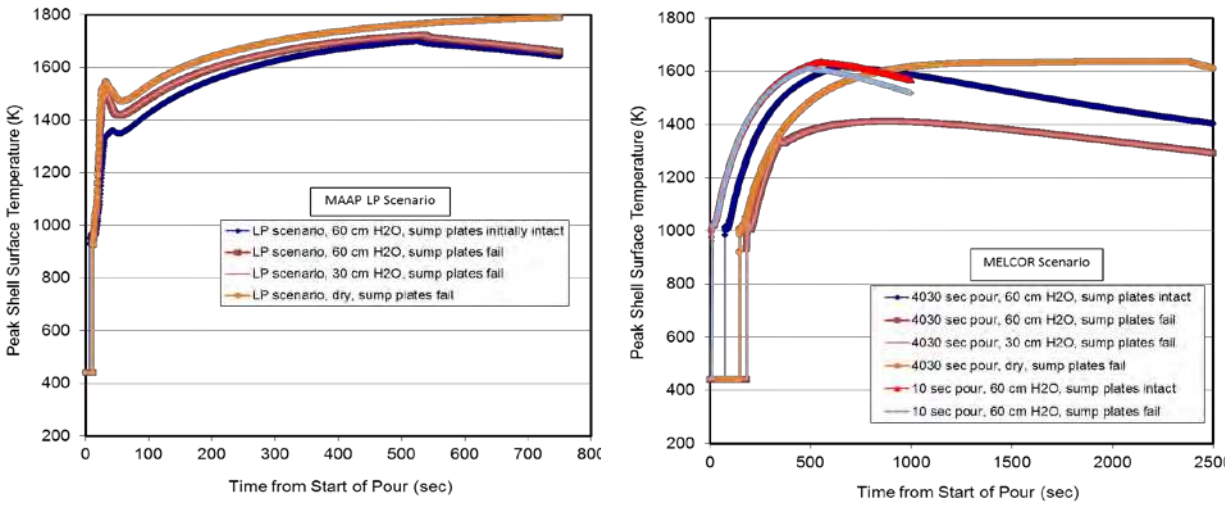
Another important finding regarding ex-vessel behavior is the discovery by TEPCO that the sand cushion drain line is leaking in 1F1.[102] This indicates that there is a leak through the PCV liner. Examinations did not detect water leakage from the bellows on the downcomer, but observations were limited. The MELTSPREAD analyses of liner heatup (Figure 25) indicate that the liner would not have been ablated through based on either the MAAP low pressure (LP) or MELCOR pour scenarios [27,28,30]; however, the liner would have been heated significantly, resulting in a vulnerability to failure by creep rupture due to the elevated containment pressures (~ twice the design pressure) at the time of the accidents. Hence, liner failure is consistent with code predictions and measured radiation levels in the 1F1 reactor building.

Figure 25. MELTSPREAD predictions of liner heatup due to heat transfer from impinging melt for 1F1 based on a MAAP low pressure (LP) scenario [28] (left) and MELCOR[27] (right) melt pour conditions. (Courtesy of ORNL, [30])

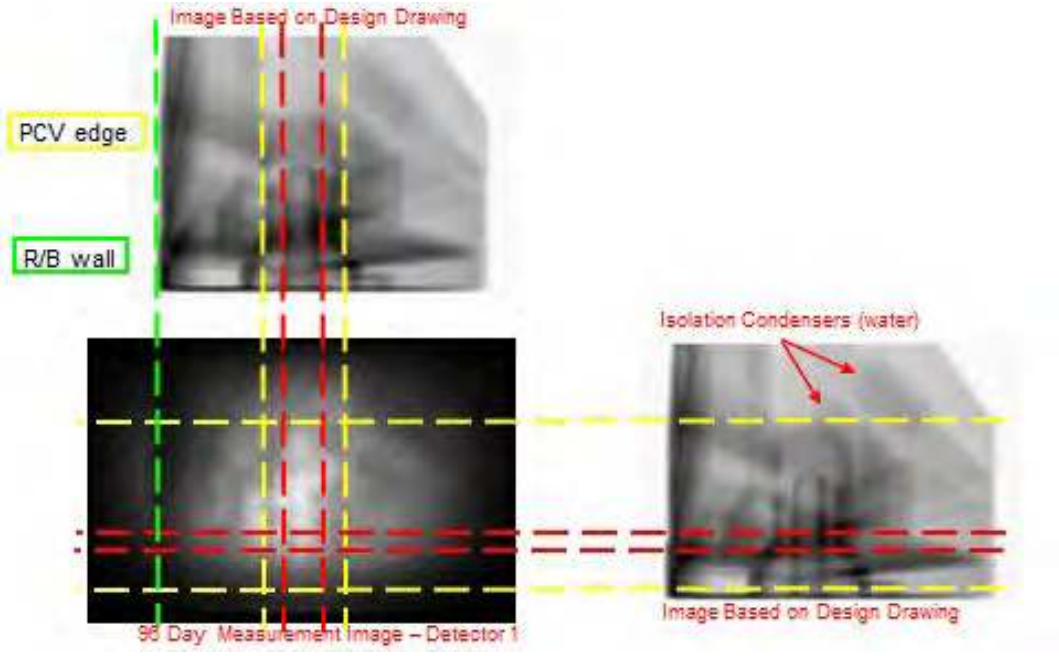
Muon tomography measurements using scintillation detectors are another information source that has been extremely valuable for evaluating debris end-state conditions for 1F1 (see Figure 26) [14]. Using this approach, high density fuel should show up as dark regions in captured images due to muon attenuation. As shown in Figure 26, the core region appears to be essentially devoid of core material. The findings for 1F1 are consistent with previously described system-level code analyses. [27,28]

Figure 26. Images of 1F1 obtained using muon tomography with scintillation detectors (The lower left image is measured; the other two images were calculated. Dashed lines are provided to show location of identified geometrical features). (Courtesy of TEPCO [14])

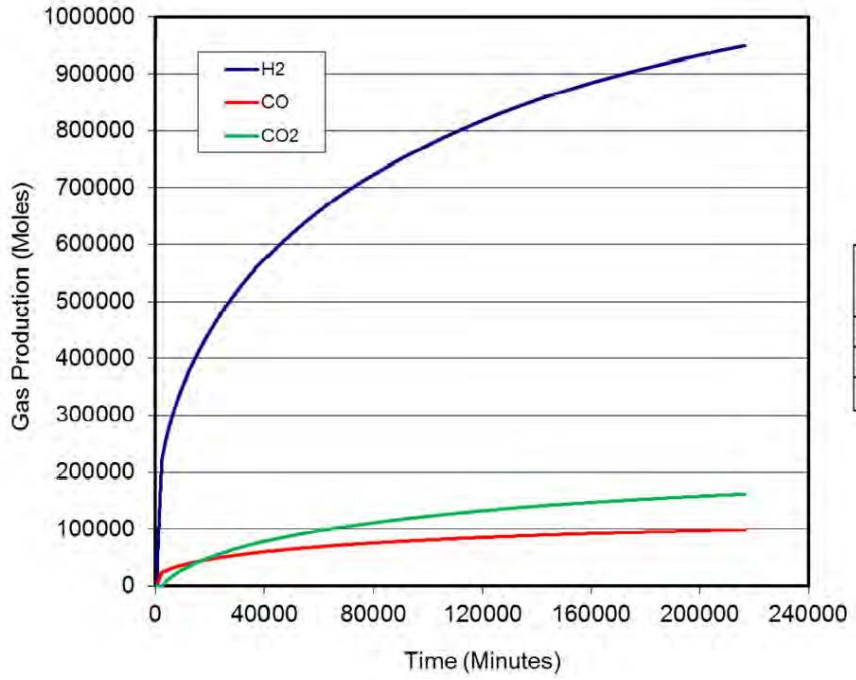
The results (Figure 27) indicate that if the MCCI had not been stabilized, then ~1.8 Sm^3/hr of noncondensable-combustible gases would still be generated through parasitic, long-term core-concrete interaction at the time the gas samples were drawn. Although cladding and core structural steel initially present in the melt would be oxidized in the first few hours of the accident, long-term production of combustible gases H_2 and CO could occur due to oxidation of iron that is present as rebar in the concrete; reinforcement was assumed to be present at a level of 6 wt %.

Figure 27. Expected long-term noncondensable-combustible gas production from ablation within the 1F1 sump if debris had not been quenched and stabilized. (Courtesy of ANL, [19])

Given the data in Figure 27, the expected levels of noncondensable-combustible gases from MCCI in the containment atmosphere for 1F1 at the time the samples were taken are summarized in Table 18. These levels reflect the fact that a N_2 purge into containment has been maintained at a rate of 10-30 Sm^3/hr. The results indicate that if the core debris had not been quenched and stabilized, then the expected gas production would have been easily detectable by gas mass spectroscopy. Thus, if the vessel did fail in 1F1 and MCCI occurred, then the indications are that the ex-vessel core debris was quenched and stabilized. This is a *significant finding for reactor safety*. Ex-vessel debris coolability is one of the key technical issues raised in the wake of the TMI-2 accident. The fact that the debris was stabilized was one of the factors that allowed TEPCO to declare that cold shutdown conditions had been achieved and the accident effectively terminated.

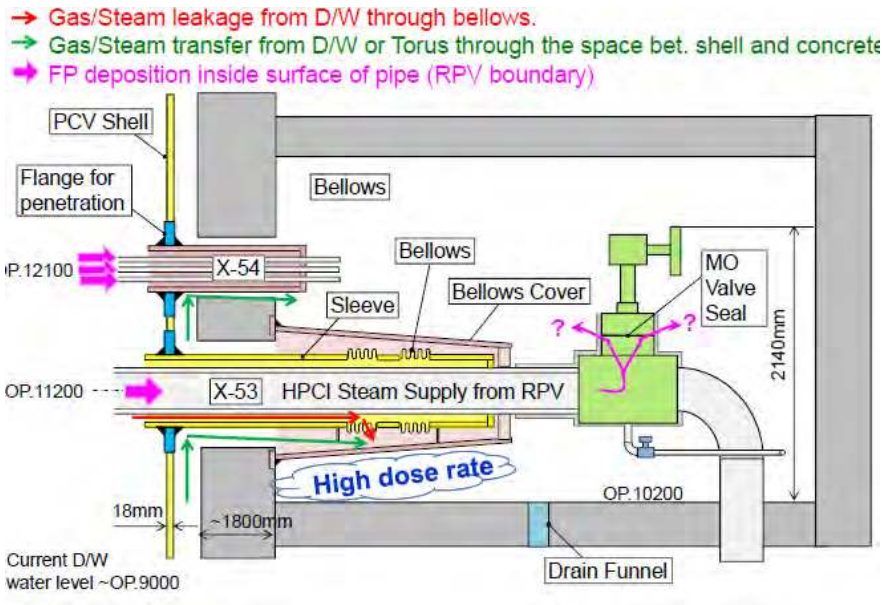
As a part of characterizing high dose rate locations within the 1F1 reactor building,[15] TEPCO has discovered a high dose rate deposit that could provide additional insight regarding the accident progression, particularly as it relates to debris location. Namely, TEPCO found white sediment that was deposited by leakage within the HPCI PCV wall penetration; see Figures 15 and 16.

Figure 28. Depiction of HPCI pump steam supply penetration showing location of deposit with high dose rate. (Courtesy of TEPCO [15])

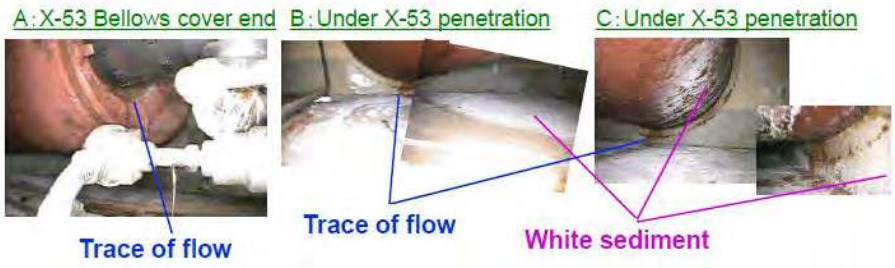
Figure 29. Photographs of leakage location and sediment. (Courtesy of TEPCO [15])

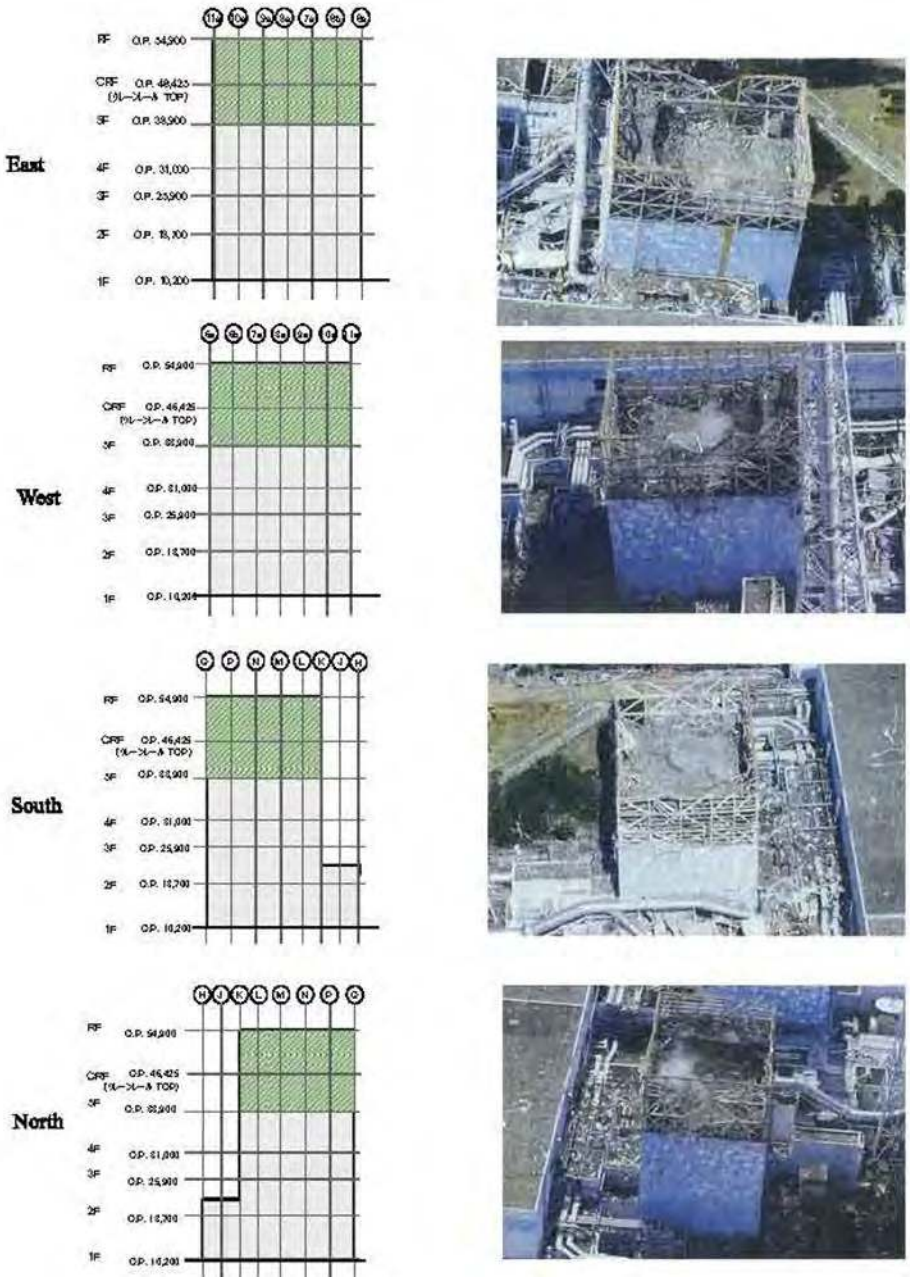
Figure 30. 1F1 reactor building damage following explosion. (Courtesy of TEPCO, [128])

The upper part of the 1F1 reactor building above the operating floor (the 5th floor) experienced an apparent hydrogen explosion on March 12, 2011 at 3:36 pm, approximately 25 hours after the seismic event. [130] It is believed that this hydrogen was primarily due to reactions between steam and the fuel zircaloy cladding. As discussed in Sections 3 and 4, the exact pathway through which the hydrogen flowed is unknown, but available information on the explosion damage suggests that it leaked into the building through degraded seals on the head of the PCV and accumulated in the refueling floor (5th floor) to a significantly high level (see Figure 35).

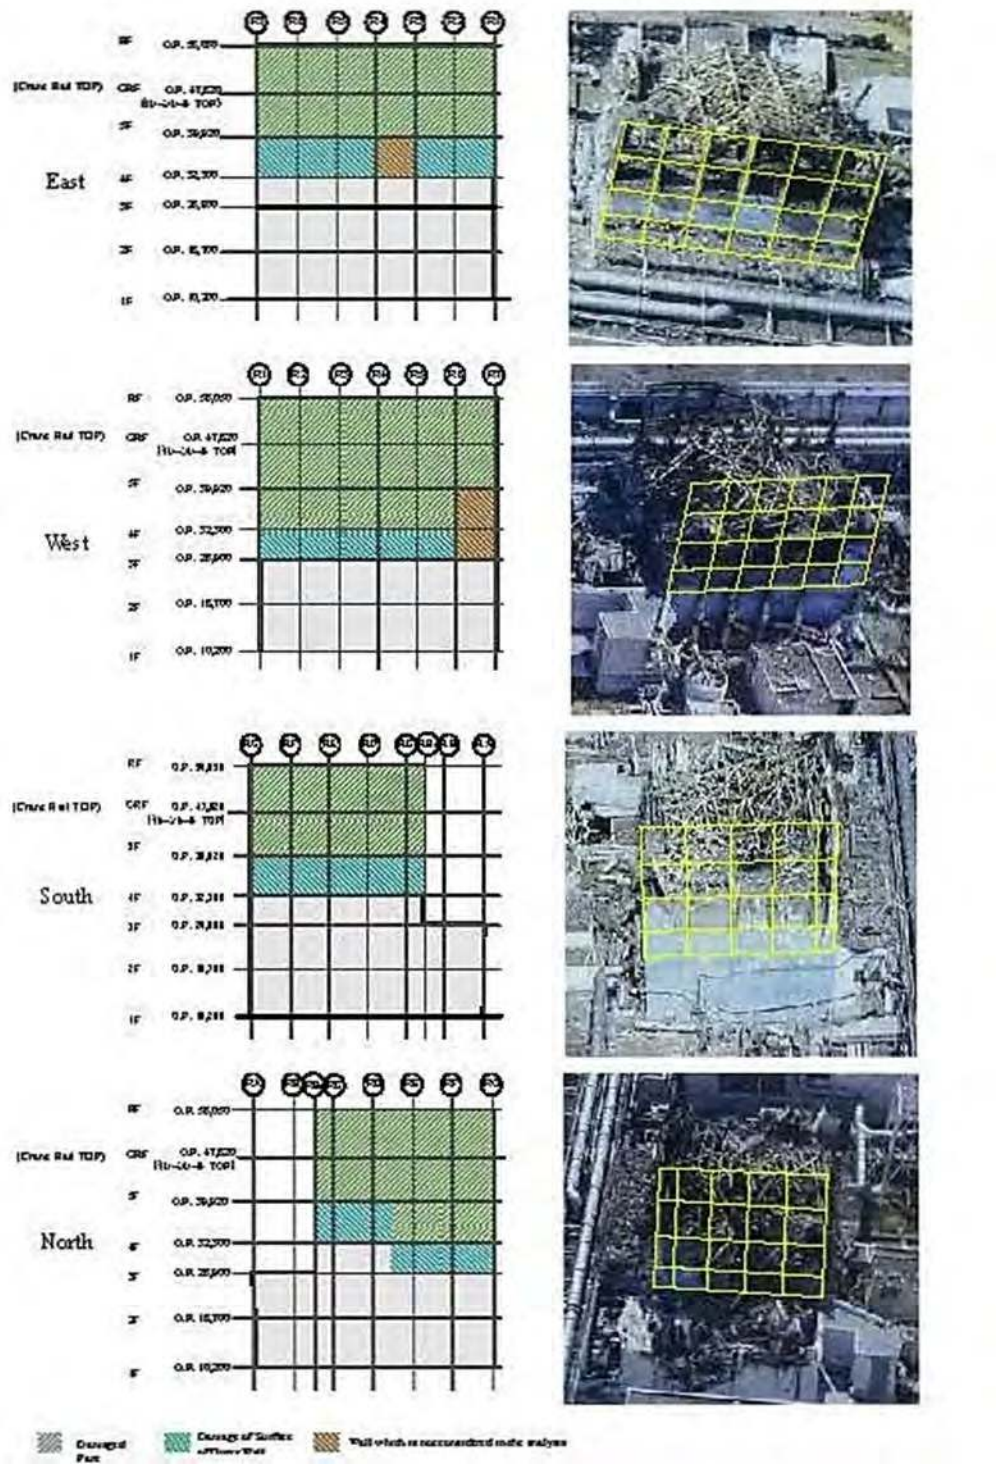
Figure 31. 1F3 reactor building damage following explosion. (Courtesy of TEPCO, [129])
