US Efforts in Support of Examinations at Fukushima Daiichi – 2016 Evaluations

ANL/LWRS-16/02

Light Water Reactor Sustainability Program

August 2016

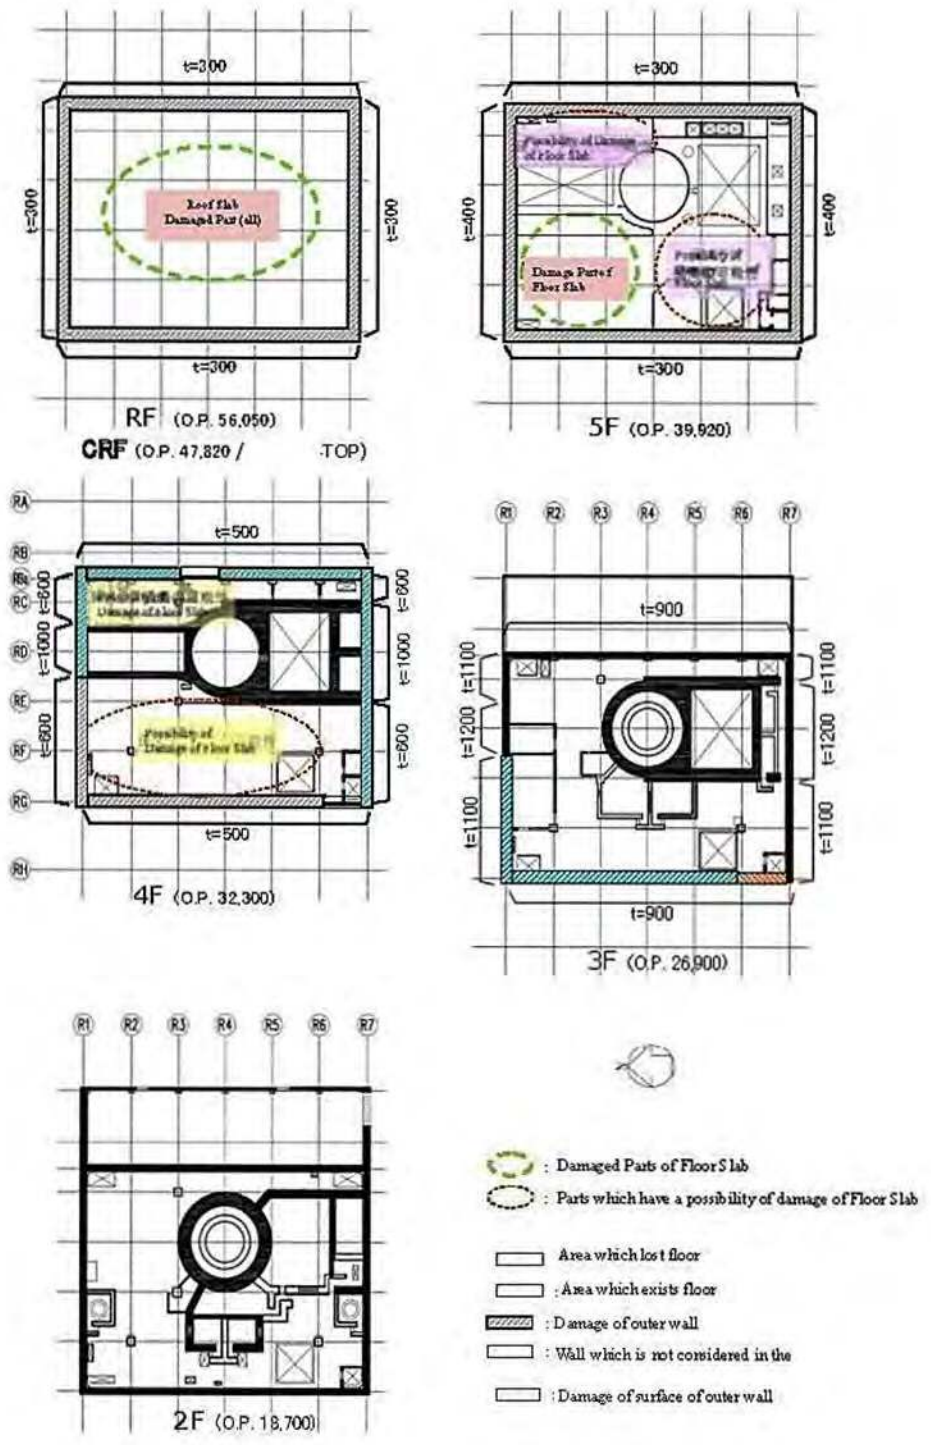
Figure 32. Damaged areas on 1F3 reactor building floor plan. (Courtesy of TEPCO, [129])

Figure 33. Damaged areas on 1F3 reactor building floor plan. (Courtesy of TEPCO, [15])

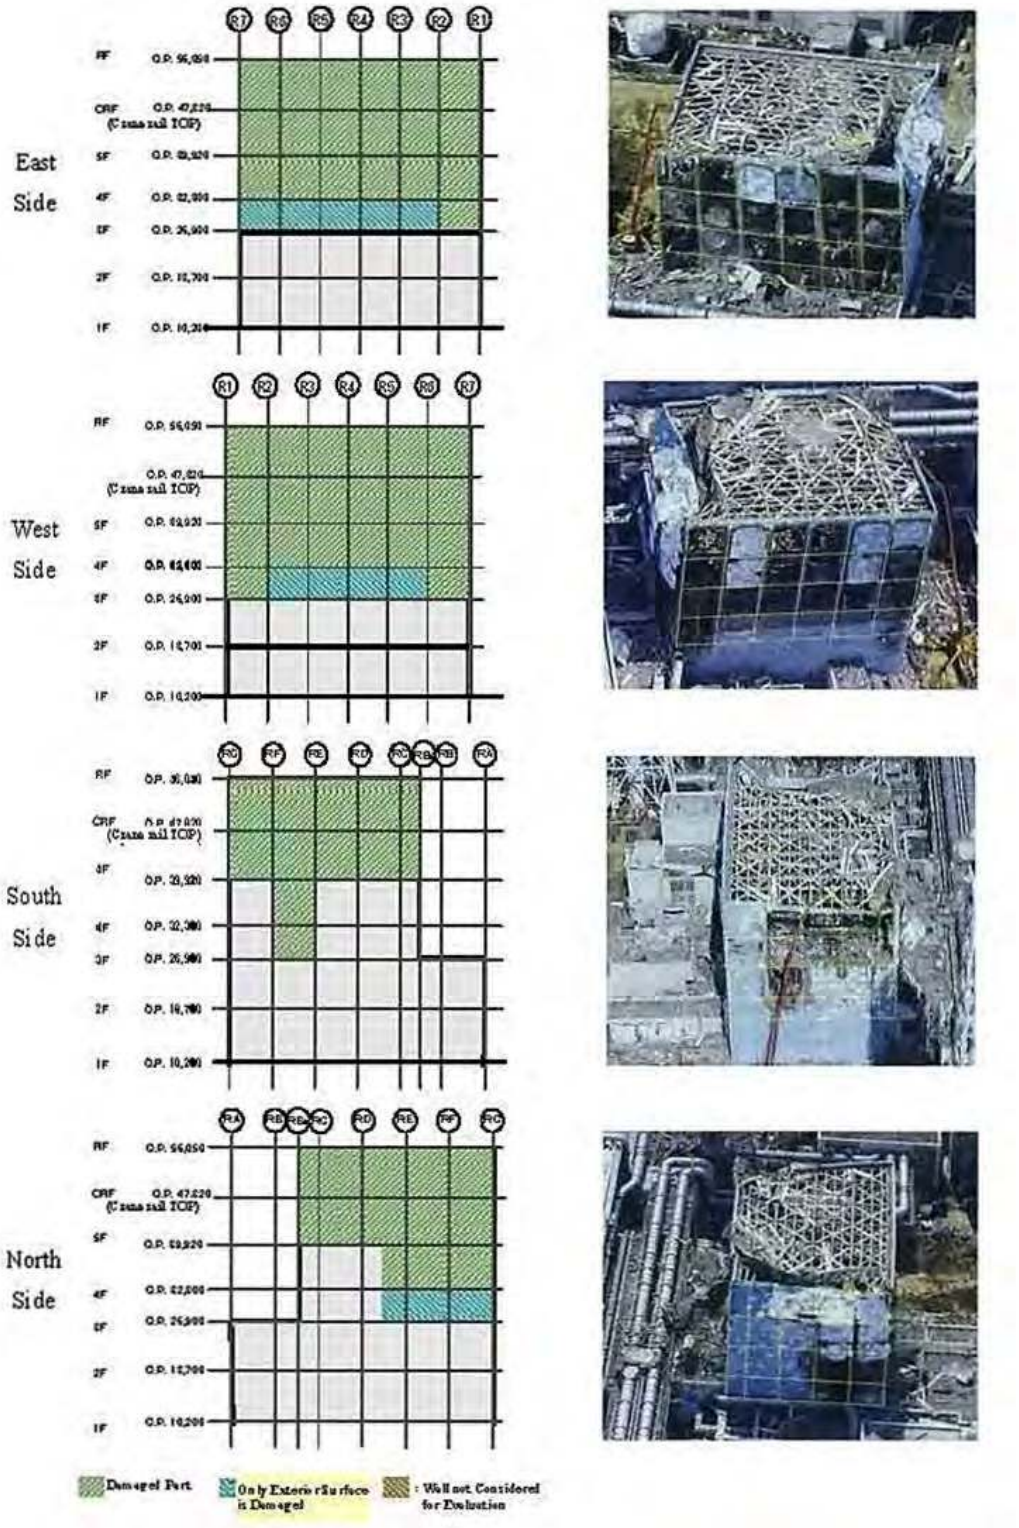
Figure 34. 1F4 reactor building damage following explosion. (Courtesy of TEPCO, [128])

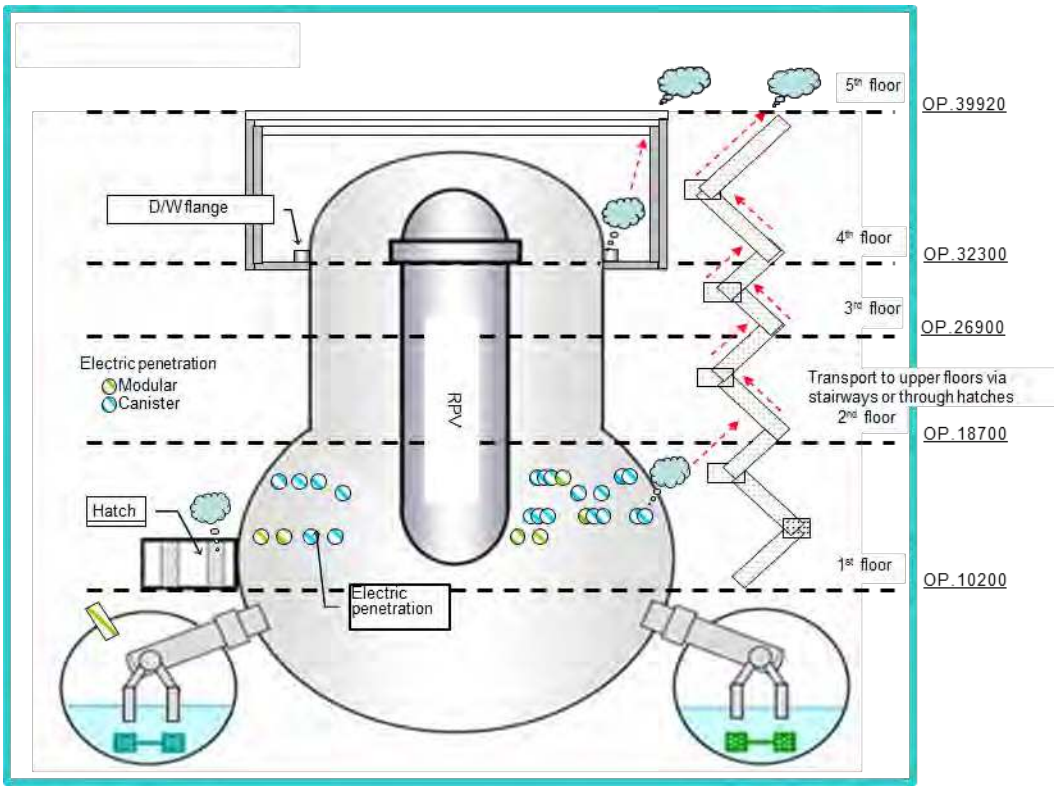
Figure 35. Inferred leakage paths; flow paths differ from 1F1 and 1F3 due to system configuration. (Courtesy of TEPCO, [131])

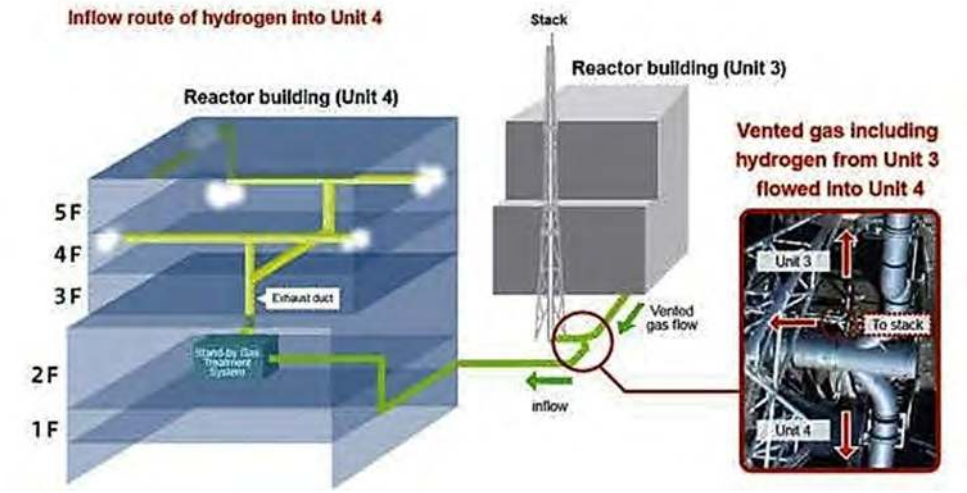
These findings are consistent with the hypothesis that the wetwell vent flow from 1F3 travelled into the 2nd floor of 1F4 and then into other areas of the 1F4 reactor building via pipes and the SGTS ducts.[gg]

Figure 36. Hydrogen transport path from 1F3 to 1F4. (Courtesy of TEPCO, [130])

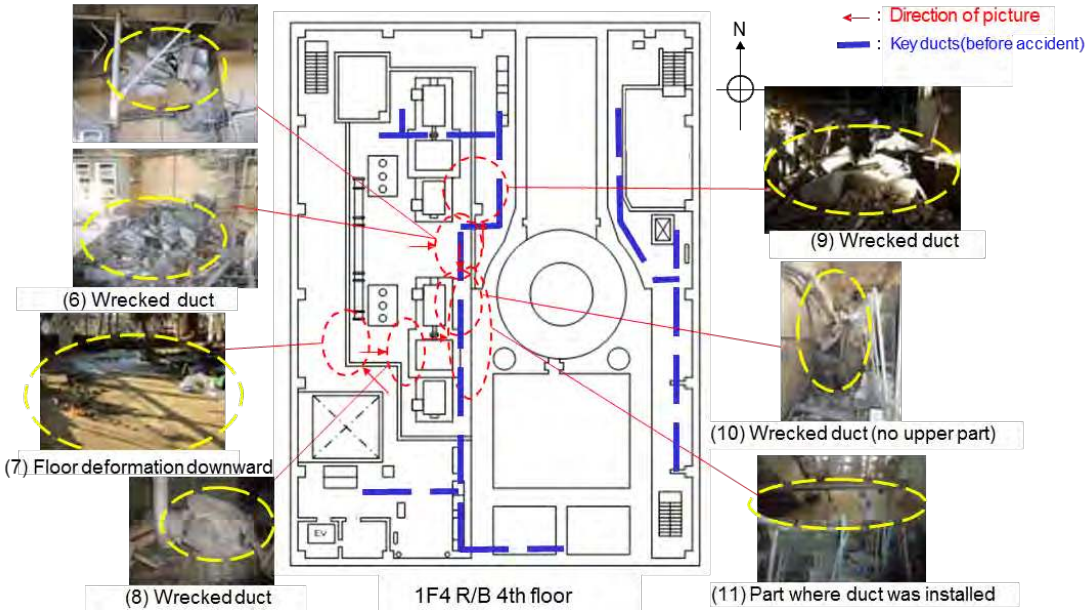
Figure 38. Field investigation of the 1F4 4th floor (Courtesy of TEPCO, [130])

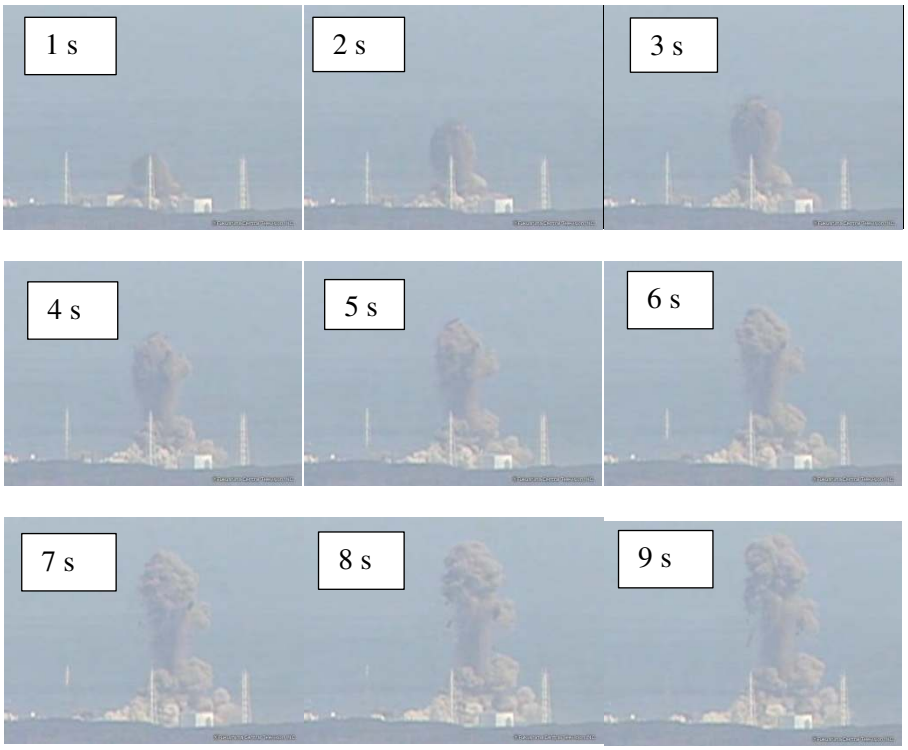
Figure 39. Images of 1F3 explosions at 1-second intervals. (Courtesy of FCT, [133])

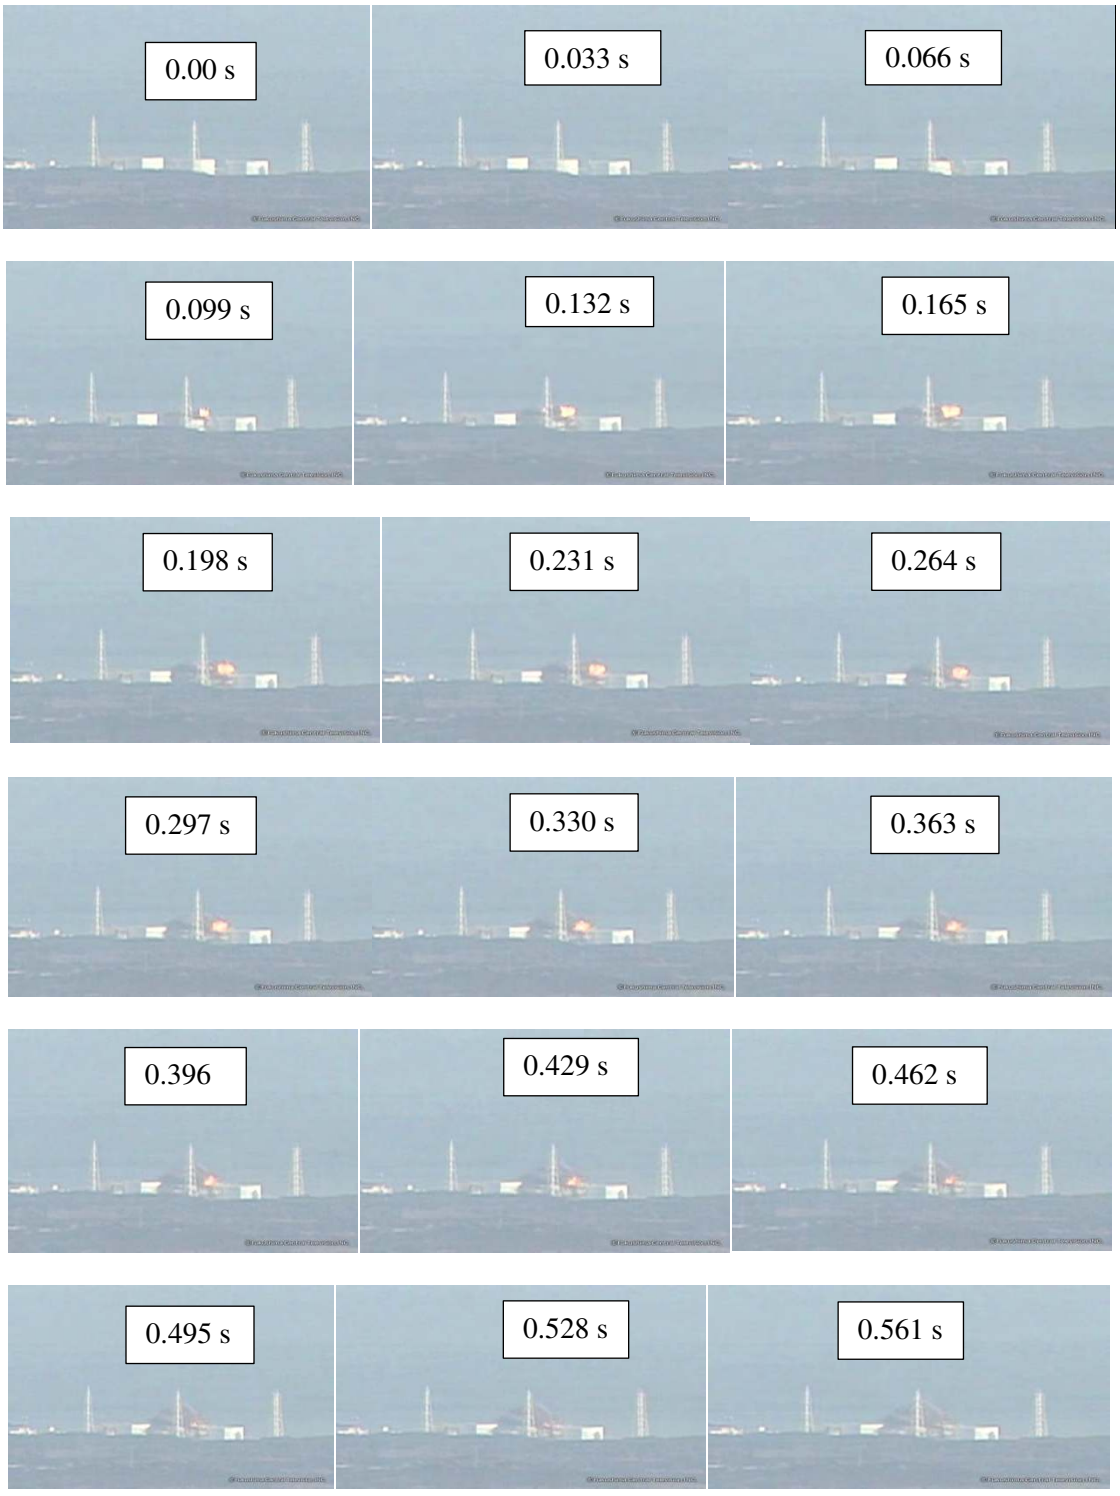
Figure 40. Images of 1F3 Explosions during an appearance of a flash fire (Courtesy of FCT [133])

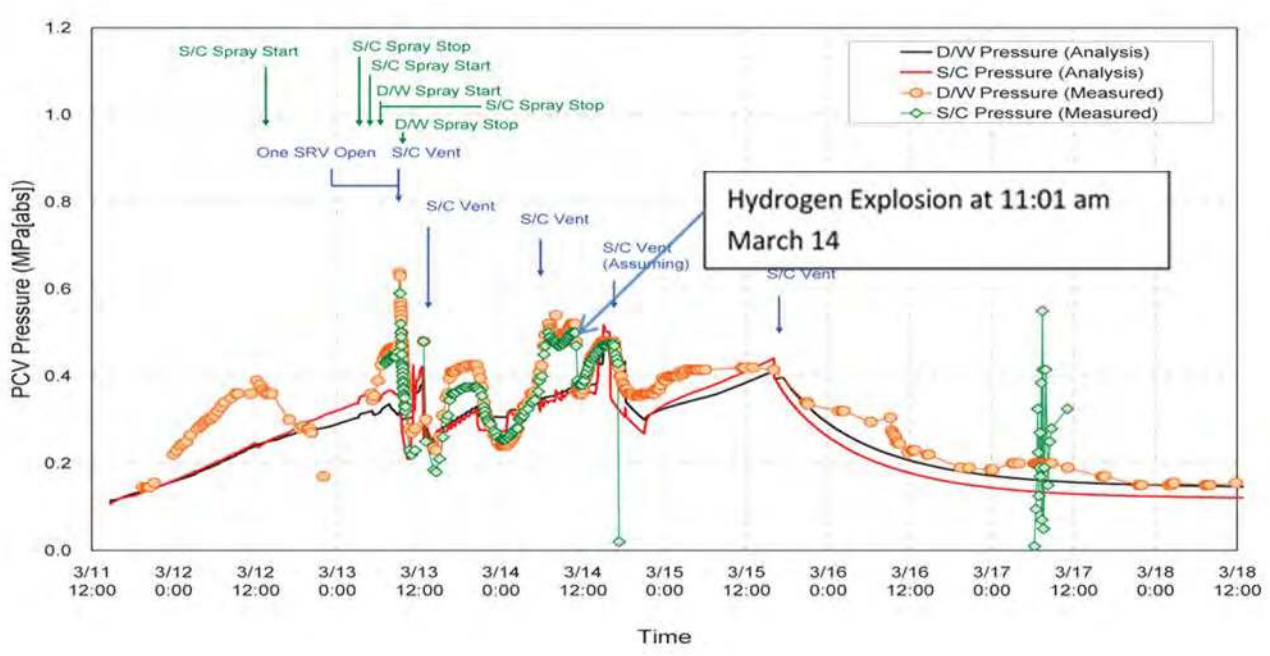
The time of the 1F3 explosion, 11:01 am, March 14, 2011, was about the same time when the 1F3 PCV pressure instantaneously dropped from about 0.53 to about 0.36 MPa (Figure 42). The instantaneous drop in pressure is believed to correspond to drywell upper head seal failure. This PCV failure would release a hot hydrogen-steam gaseous mixture into the 5th floor of the reactor building around the drywell plug lifted by pressure buildup below it. It was possible that these hot vented gases (among other random ignition sources) could have ignited hydrogen gas, which leaked earlier and accumulated on the 5th floor (and 4th floor) of the reactor building. Ignition of this hydrogen resulted in the first explosion whose burning mechanism (i.e., deflagration) was the same as the 1F1 explosion. Then, a catastrophic failure of the 1F3 drywell upper head seal would have provided a large, continual supply of hydrogen gas from inside the drywell through the failed head seal. (It is noted that it would require only about 4 psig/0.03 MPa differential pressure (Δp) to lift the drywell shield plug where $\Delta p = \rho g H$, and for the purpose of

approximation, ρ= shield plug density ~2330 kg/m^3, g=9.8 m/s^2, and H=shield plug thickness ~ 1.2 m. This magnitude of Δp was achievable with the prevailing DW pressure at the time of the explosion.) This combustible gas jet entrained surrounding air as it moved upward and burned in the form of unconfined "gas cloud explosion" as a large fireball emanating from the reactor building into the sky. The first appearance of combustible gas jet was in a form of the flash fire [visible from the video snapshot at the very beginning (less than 0.5 s) of the 1F3 explosion transient shown in Figure 40]. At the beginning, the combustible gas jet just started to form. The gas cloud was then initially burned as a flash fire. The flash fire anchored at the same location for about 0.4 seconds. When more combustible gas jet came out, the flash fire disappeared and the energetic second explosion began its process as shown in Figure 39. The observed combustion phenomena were the consequence of the PCV blowdown that supplied combustible gas to the second explosion, which was initially visible as a flash fire. The amount of blowdown gases (nitrogen, steam, hydrogen and possibly, carbon monoxide) could be as much as the amount of gases released from the PCV, which experienced a 1.7 bar decrease in pressure at the prevaling temperature, decreasing from 0.53 to about 0.36 MPa in about 9 seconds (as seen from the video snapshot in Figure 39). There is a clear linkage between the PCV blowdown, the second explosion smoke shape and duration, the observed flash fire, and the PCV failure (fast pressure drop).

Figure 42. 1F3 PCV pressure - Rapid drop in PCV pressure coincides well with the timing of 1F3 explosion at 11:01 am March 14, 2011 (Courtesy of TEPCO, [137])

- ***The 1F3 explosion was not a stand-alone randomly occurring event.*** The 1F3 explosion was most likely initiated by failure of the drywell upper head seal when it was at high PCV pressure

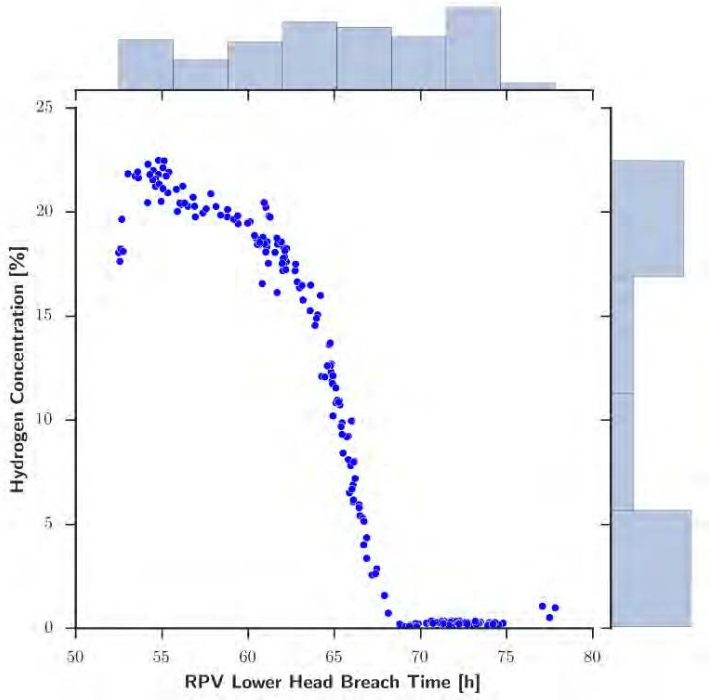
Results from recent studies comparing MAAP5 and MELCOR calculations [29] have identified how limited knowledge regarding in-core damage progression can lead to significant differences in code predictions for hydrogen production. Differences between code predictions stem from a lack of experimental data that would clarify appropriate modeling assumptions regarding in-core melt progression behavior. As a result, the two codes predict different amounts of in-core hydrogen generation, with MAAP5 typically predicting lesser amounts of in-core hydrogen generation relative to MELCOR [29]. Evaluations with MAAP5 tend to find that this has important consequences for the development of flammable conditions in the 1F1 and 1F3 reactor buildings. Figures 43 and 44 compare results from a MAAP5 uncertainty evaluation of the 1F3 accident [32]. These figures show the predicted hydrogen concentrations on the refueling and fourth floors of the 1F3 reactor building, respectively, at the time of the actual 1F3 explosion (68.7 hours after the earthquake), versus the timing of RPV lower head breach.

These results illustrate that for simulations predicting RPV lower head breach occurs after ~ 65 hours, there is limited potential for flammable conditions to develop on either the 1F3 refueling or 4th floors. That is, MAAP5 simulations of scenarios with in-vessel retention, at least up to the point of the actual 1F3 explosion, do not support the necessary conditions for combustion. This is due to relatively low amounts of in-core hydrogen generation being predicted. By contrast, MELCOR simulations can evolve enough hydrogen to support conditions for flammable gas combustion in the reactor building.[72]

Figure 43. MAAP 1F3 modeling uncertainty evaluation: refueling floor hydrogen build-up at time of 1F3 reactor building explosion. (Courtesy of EPRI [32])

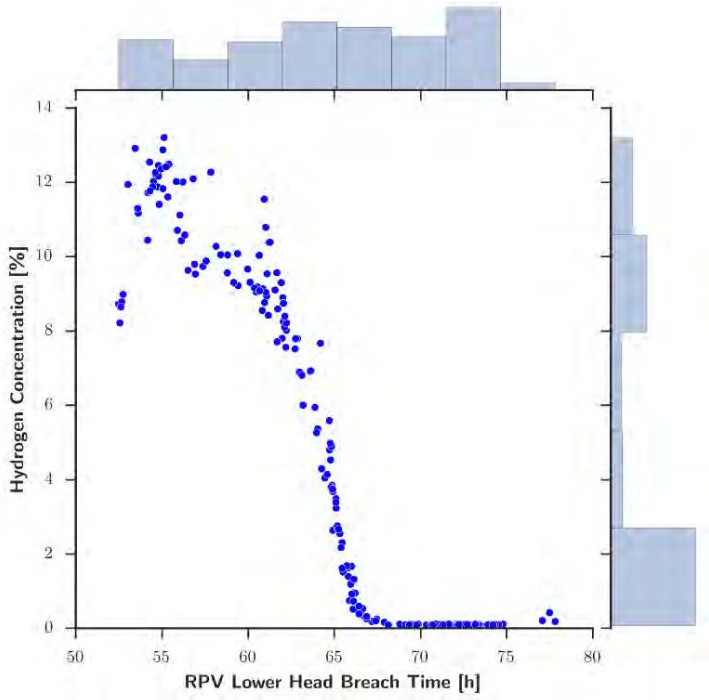
Figure 44. MAAP 1F3 modeling uncertainty evaluation: fourth floor hydrogen build-up at time of 1F3 reactor building explosion (Courtesy of EPRI [32])
