6 FEBRUARY 2023 KAHRAMANMARAŞ – TÜRKİYE EARTHQUAKES: A GENERAL OVERVIEW

C. Gokceoglu¹

¹ Dept. of Geological Engineering, Hacettepe University, 06800 Beytepe Ankara, Turkey - cgokce@hacettepe.edu.tr

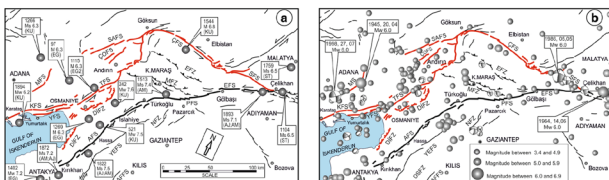
Figure 1. Fig. 2 Distribution of both historical (a) and instrumental (b) earthquakes along the southern segments of the EAFZ (taken from Duman et al., 2020)

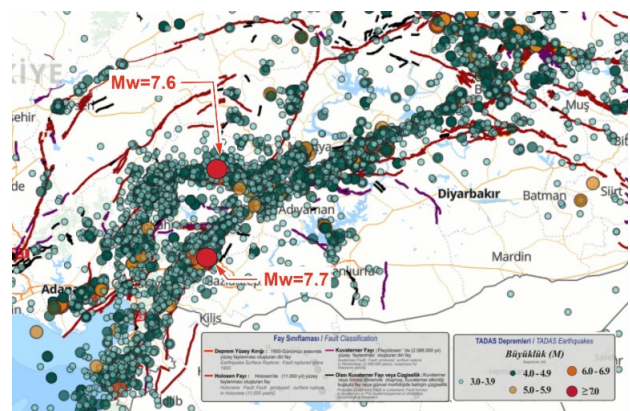
Figure 2. Epicenters of the 6 February 2023 Türkiye Earthquakes (AFAD, 2023)

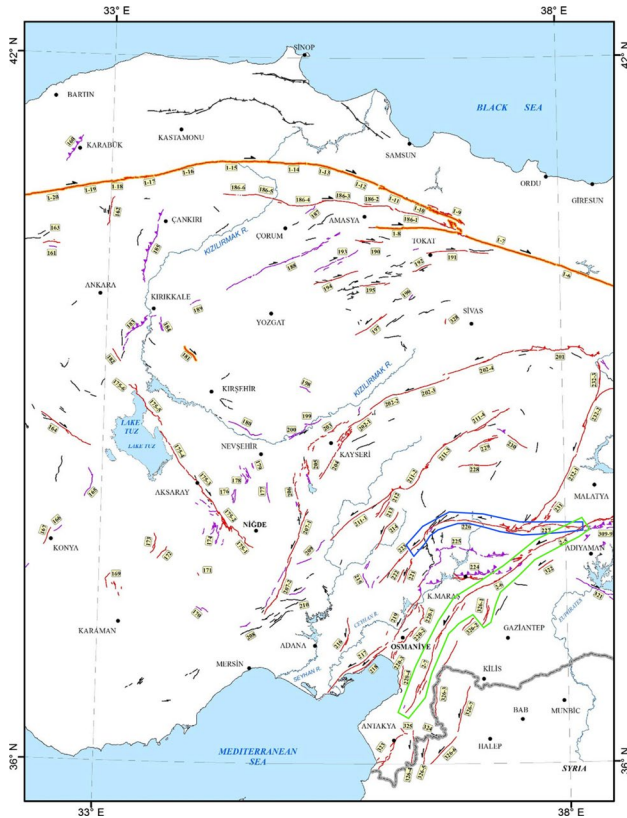
The Pazarcık earthquake was initiated on a smaller Narlı fault (326-1 in Figure 3) in the south, jumped to the north, and

ruptured the Pazarcık (2-6 in Figure 3) and Erkenek (2-5 in Figure 3) segments of EAFZ towards NE and the Amanos segment (2-7 in Figure 3) towards SW. This earthquake produced left-lateral surface ruptures and the displacements reached to 4 m (Figure 4).

Figure 3. The ruptured segments of DAFZ (yellow frame shows the Pazarcık Earthquake while blue frame shows the Elbistan Earthquake) (modified after Emre et al., 2018).

During the Elbistan earthquake, the Çardak segment (226 in Figure 3) and the Sürgü segment (227 in Figure 3) ruptured. These segments also produced surface ruptures and the maximum displacement was measured as 6.7 m by Taylan Sancar (Figure 11).

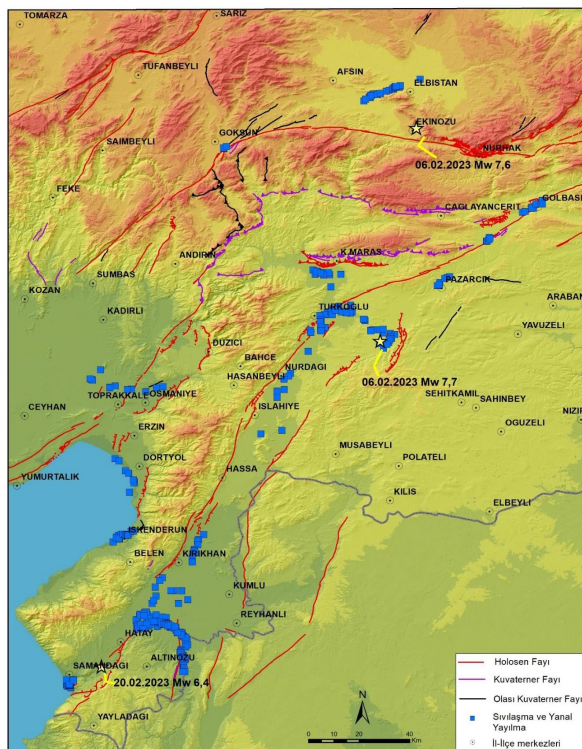
During the 6 February 2023 Earthquakes, the liquefactions occurred commonly. A liquefaction and lateral spreading map was prepared by Üstün et al. (2023) (Figure 21). As can be seen from Figure 20, severe liquefactions were observed in Elbistan, Gölbaşı, Türkoğlu, Antakya, Samandağı and İskenderun.

Figure 21. The liquefaction and lateral spreading map of the Earthquake region (Üstün et al., 2023).
