# A Soil-Structure Interaction Analysis of a Damaged Building

R.F. Wilson-Fahmy

**SYNOPSIS:** A twenty years old reinforced concrete building suffered from fracture of one of its ground floor corner columns. The extent of damage resulting from fracture of the column is examined. Plane frame structural analysis is used in the interpretation of the signs of damage of the building. Soil compressibility is incorporated in the analysis by assuming the footings to rest on Winkler type subgrade. The theoretical analysis is assessed by comparing the results with the actual behaviour of the structure.

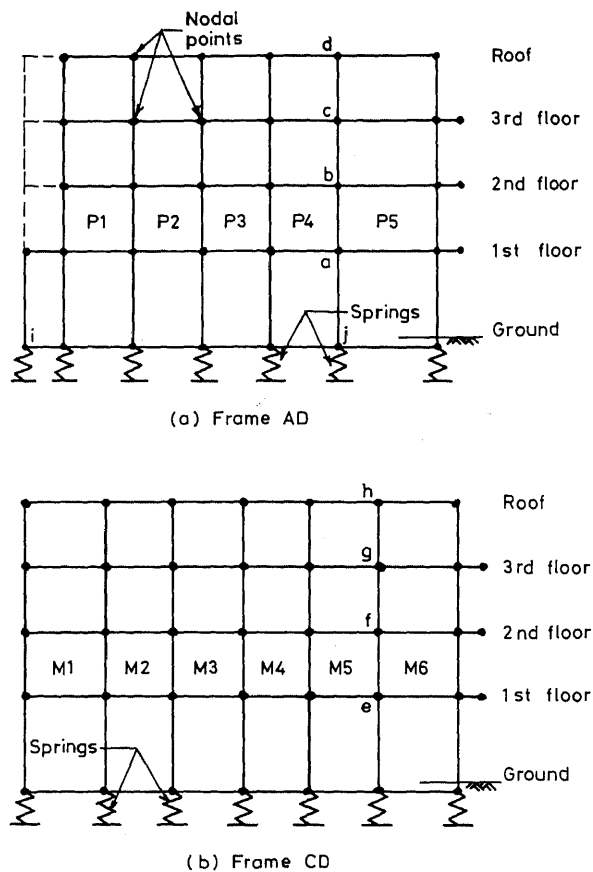
Fig.3 Idealisation of Frames AD and CD in Frame Analysis

The plane frame analysis was applied to the two exterior frames AD and CD intersecting at right angle at the fractured column, Fig. 1. The idealized representation of the two frames in the analysis are given in Fig. 3. The effective flange widths of T-beams and L-beams and the loads transmitted from the slabs to the beams were determined according to the Egyptian Code of Practice. The moment and shear just to the right of the nodal points marked a, b, c, d, e, f, g and h in Fig. 3a and b after column fracture were calculated in an approximate manner by treating the slab with the two beams originally supported by the column (Fig. 1) as a plate supported on two sides. The tables compiled by El-Behairy (1974) for plates under different support conditions were used in the calculations.

The predicted relationships between the shear strain and the modulus of subgrade reaction  $k$  for the first floor wall panels of frame CD (marked M1, M2, M3, M4 and M5 in Fig. 3b) and those of frame AD (marked P1, P2, P3 and P4 in Fig. 3a) are given in Fig. 6a and Fig. 6b respectively. The predicted horizontal and vertical displacements of the nodal points at the corners of each wall panel are used in determining the shear strains. As already mentioned, the beams to the right of nodes  $a$  and  $e$  in Fig. 3 were treated in a simplified manner in the frame analysis. The shear strains for the wall panels above these beams could not, therefore, be determined. The relationships between  $k$  and the shear strains for the wall panels above the second and third floors are found to follow the same trend as those for the first floor wall panels.

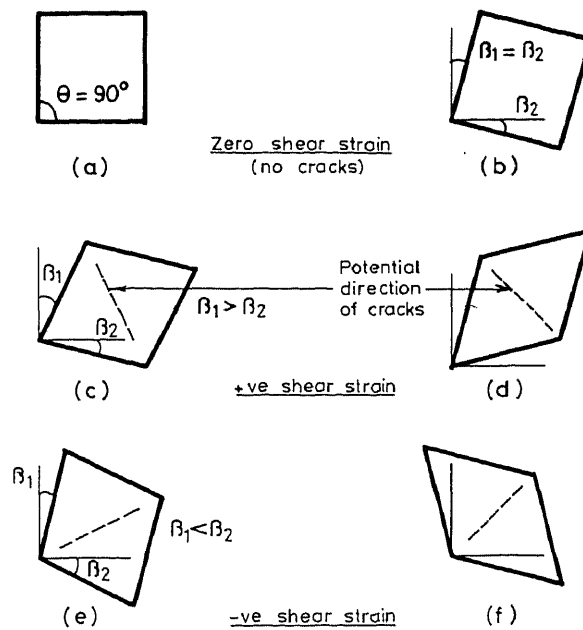
Fig.5 Wall Distortion and Potential Direction of Cracks

In order to overcome the difficulties involved in relating cracks solely to foundation settlements, the method shown in Fig. 5 is used. Each wall panel is considered as an element undergoing shear strain. The potential direction of cracks in the wall will depend on whether the angle  $\theta$ , Fig. 5a, increases or decreases with reference to its initial value (90°). The increase or decrease of  $\theta$  is assumed equal to the shear strain experienced by the wall element. Various modes of deformations and tilt are shown in Fig. 5 together with the corresponding potential directions of cracks and the sign convention adopted.

that the direction of the cracks in these panels would have been at right angle to those observed if related only to the deflection of the supporting beams which are acting more as cantilever beams after column fracture. This shows that the walls are probably subjected to the deformation mode shown in Fig. 5c as a result of the horizontal sway suffered by the building.
