# Application of FRP composites for underwater piles repair

Rajan Sen \*, Gray Mullins

*Department of Civil and Environmental Engineering, University of South Florida Tampa, FL 33620, USA*

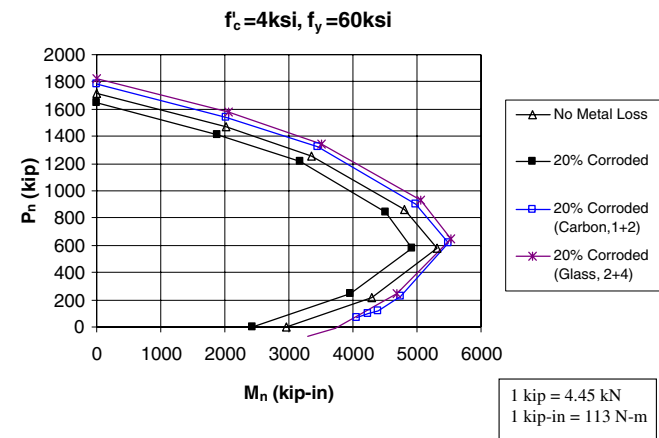
Fig. 3. Interaction diagram for corrosion repair of piles.

Fig. 3 shows a typical interaction diagram for the design of the wrap used for underwater corrosion repair. In the applications, capacity loss was estimated to be 20%. It

was found that this could be restored by using two transverse and one longitudinal carbon layer for the material properties outlined in Table 2. For the weaker glass, two longitudinal and four transverse layers were required to restore full capacity [6].
