**BEHAVIOR OF COMPRESSION-LOADED COMPOSITE PANELS
WITH STRINGER TERMINATIONS AND IMPACT DAMAGE**

Dawn C. Jegley
NASA Langley Research Center
Hampton, VA

AIAA Paper No. 98-1785-CP
Long Beach, California

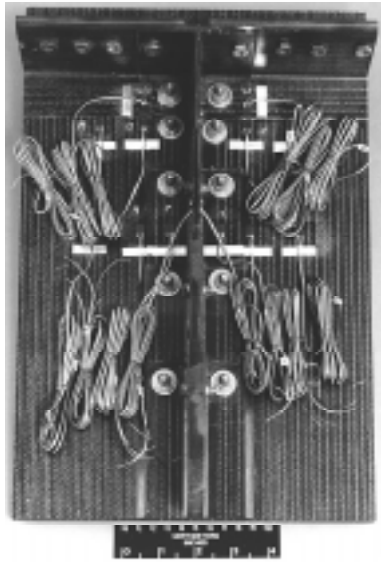
Figure 1. Photograph of single-stringer panel U-1 prior to testing.

Single-stringer panels with centrally located stringers were cut from the upper cover panel of the wing box and are designated as panels U-1 and U-2 herein. Panel U-1 is shown in figure 1. Multi-stringer panels were cut from the lower cover panel of the wing box and are designated as L-1, L-2 and L-3 herein. Panel L-2 is shown in figure 2.

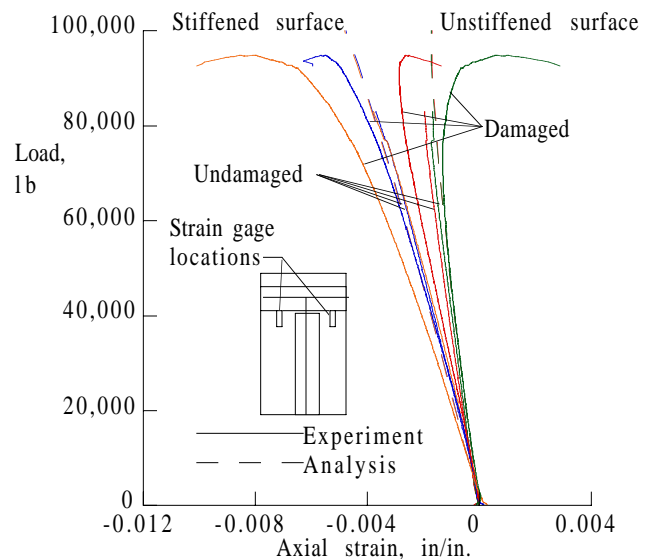
Figure 12. Axial strains near the intercostal flange in panel U-2.

After being subjected to impact damage, the panel was loaded to failure. The impact damage had little effect on the far-field behavior or on the global behavior of the panel. The local effect of the impact damage can be seen in figure 12, in which results are shown for strain gages within one inch of the impact sites. Surface damage closer than one inch from the impact site was too severe to allow strain measurements.

The allowable midplane strain for damaged structure is .0053 in/in. The analysis predicts a strain at the impact site of .0053 in/in. for a load of 147,000 lb. Failure through the impact site would not be expected for loads less than 147,000 lb. Since the failure load is significantly less than 147,000 lb, the midplane strain at the impact site cannot be used to predict failure of this panel.
