**BEHAVIOR OF COMPRESSION-LOADED COMPOSITE PANELS
WITH STRINGER TERMINATIONS AND IMPACT DAMAGE**

Dawn C. Jegley
NASA Langley Research Center
Hampton, VA

AIAA Paper No. 98-1785-CP
Long Beach, California

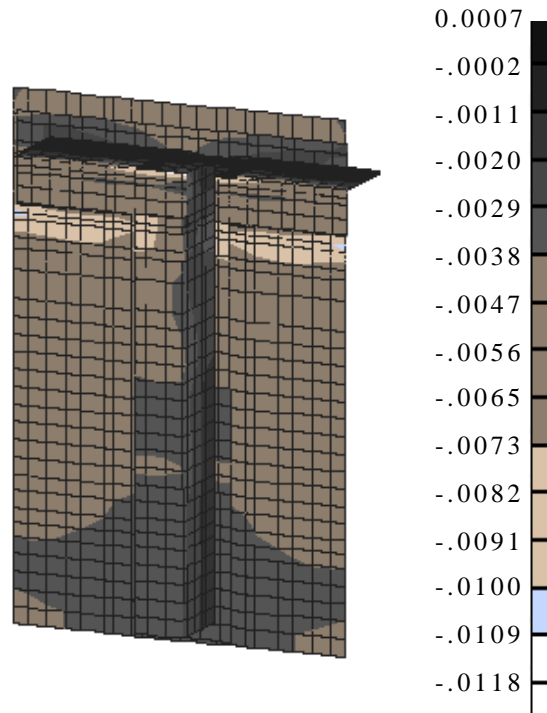
Analytically determined axial surface strains for a load of 100,000 lb are shown in figure 9. The maximum compressive axial surface strain occurs in the intercostal flange near the intercostal, but the maximum axial strain at the laminate midplane occurs in the stringer flange near the intercostal. Based on an allowable axial strain value at the laminate midplane for undamaged structure of .0093 in/in., failure should not occur due to axial strain for a load less than 108,500 lb. Lateral strains were small enough to have little effect on failure. However, the shear strain in the intercostal flange is predicted to exceed the shear strain allowable of .0126 in/in. for loads greater than 91,200 lb. Shear strain in the intercostal flange causes or contributes to failure of the panel since the panel failed at 98,200 lb.

Figure 9. Axial surface strain for a load of 100,000 lb for panel U-1.

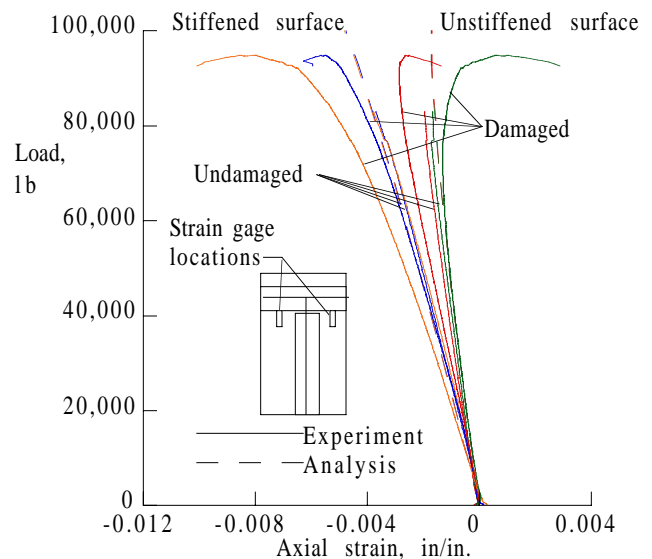
After being subjected to impact damage, the panel was loaded to failure. The impact damage had little effect on the far-field behavior or on the global behavior of the panel. The local effect of the impact damage can be seen in figure 12, in which results are shown for strain gages within one inch of the impact sites. Surface damage closer than one inch from the impact site was too severe to allow strain measurements.

Figure 12. Axial strains near the intercostal flange in panel U-2.

The allowable midplane strain for damaged structure is .0053 in/in. The analysis predicts a strain at the impact site of .0053 in/in. for a load of 147,000 lb. Failure through the impact site would not be expected for loads less than 147,000 lb. Since the failure load is significantly less than 147,000 lb, the midplane strain at the impact site cannot be used to predict failure of this panel.

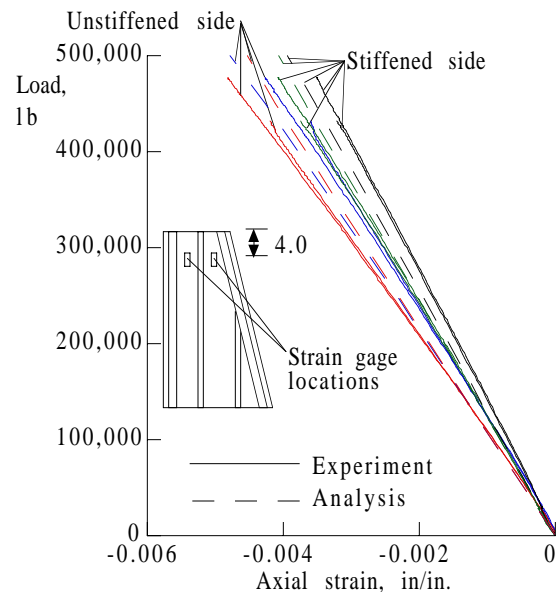
Panel L-1 was initially loaded to approximately 485,000 lb. No damage was found that was caused by the initial loading. Axial surface strains predicted by finite element analysis and measured during the preliminary and final loading are shown in figures 13 and 14. Impact damage had little effect on the far field strains, but had a significant effect on strain gage results 0.5 inches away from the impact site.

Figure 13. Axial strains in the skin away from the impact site of panel L-1.

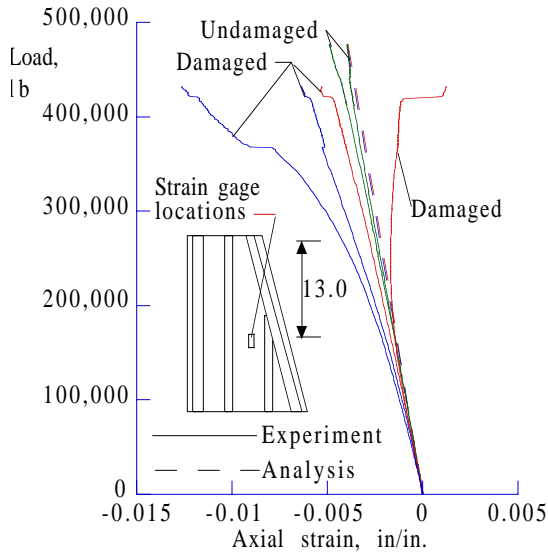
Panel L-1 was subjected to severe impact damage resulting in an indentation with a depth of 0.16 inches. The criterion of allowable strain at the reference surface of .0053 in/in. and the criterion described in reference 4

assume an indentation depth of approximately 0.1 inches. Damage to the panel is significantly more severe than appropriate for either of these methods. However, the predicted strain at the impact site exceeds the allowable axial strain for damaged structure with loads greater than 650,000 lb. By using the method described in reference 4, panel L-1 would be expected to fail at a load of 640,000 lb. The two methods produce similar results since there is little bending behavior near the impact site.

Figure 14. Axial strains in the skin at the impact site of panel L-1.

Panel L-1 failed through the impact site and the point of maximum strain in an undamaged skin with a load of 435,000 lb, and with damage 1.6 times as severe as required by the criterion. The panel failed with a stress at the impact site of 35.2 ksi, which is approximately 89 percent of the design stress. An undamaged panel would have had a strain of approximately .0037 in/in. at the impact site for the load at which the damaged panel failed. The maximum midplane strain (based on the measured surface strains) near the impact site was equal to .0052 in/in. The predicted maximum strain in the panel away from the impact site is equal to .0043 in/in., which is significantly less than the allowable strain in undamaged structure. These results indicate that failure was caused by the strain in the region of the impact site. A photograph of panel L-1 after failure is shown in figure 15.

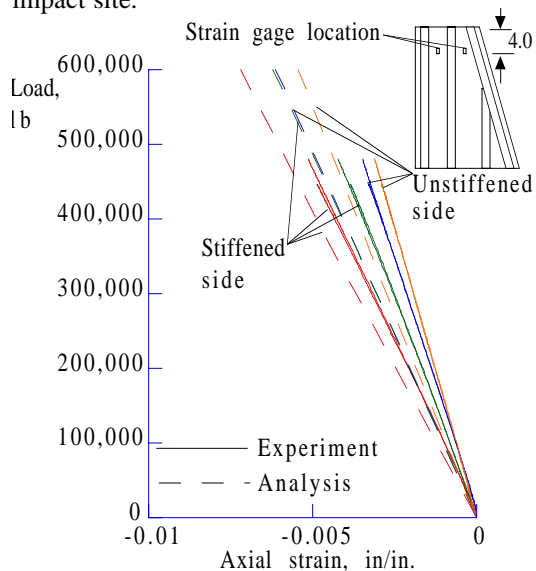
Panel L-2 was initially loaded to 447,000 lb. The panel was not damaged during the initial loading. Axial surface strains predicted by finite element analysis and measured during the preliminary and final loading are shown in figures 16 and 17. Strains located midbay and four inches from the top of the panel (away from the tapered stringer and impact site) are shown in figure 16. Strains near the impact site are shown in figure 17. These strain results are for the loading prior to inflicting damage, for the damaged panel and for the analysis. Analysis accurately predicts far field strains and strains at the impact site. Impact damage has a significant effect on the strain within one inch of the impact site, but has no effect away from the impact site.

Figure 16. Axial surface strains in the skin away from the impact site of panel L-2.

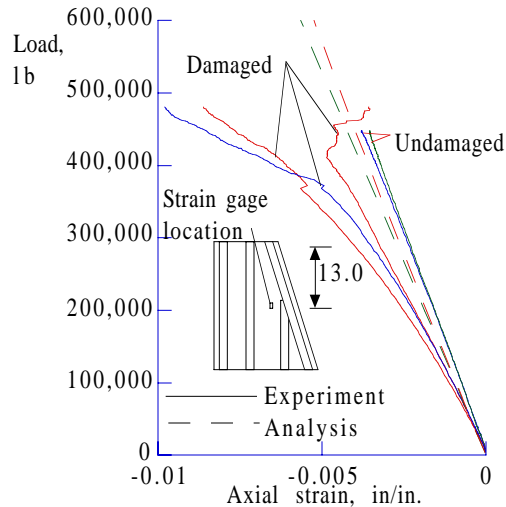
Figure 17. Axial surface strains in the skin at the impact site of panel L-2.

The panel was subjected to impact damage resulting in an indentation with a depth of 0.11 inches. The allowable strain of .0053 in/in. at the impact site is exceeded for loads greater than 580,000 lb. Applying the method of reference 4 results in a predicted failure load of 570,000 lb. The panel failed through the impact site for a load that is approximately 85 percent of that predicted by analysis. The panel failed with a stress at the impact site of 44.6 ksi, which is 113 percent of the design stress.

Test data indicate that the load at which the maximum midplane strain (based on the surface strain gages) near the impact site reached .0053 in/in. was 397,000 lb. The panel failed at a load of 484,000 lb. The maximum midplane strain in the region of the impact site was .0062 in/in., which is 1.16 times the allowable strain value. The predicted maximum strain in the panel away from the impact site is .0058 in/in., which is significantly less than the allowable strain value in undamaged structure, so failure was caused by the strain in the region of the impact.

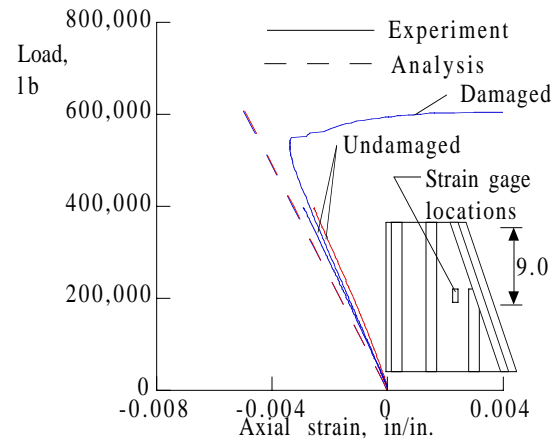
skin next to the tapered stiffener, but on the unstiffened side of the panel. Axial strains predicted by finite element analysis and measured during the preliminary and final loading are shown in figure 18 for strains at the impact site. Impact damage has little effect on strain at the impact site or far from the impact site. The relatively mild impact of 100 ft-lb did not disable the strain gage on the stiffened side of the panel at the impact site. Analysis accurately predicts the far field strains and strains at the impact site.

Figure 18. Axial surface strains in the skin at the impact site of panel L-3.

Analytically, a damage allowable strain value of .0053 in/in. at the reference surface of the skin at the impact site corresponds to a load of 648,000 lb. Applying the method described in reference 4 results in a predicted failure of 640,000 lb. The actual failure occurred through the impact site at 611,000 lb. Damage to the resin layer on the surface prevented strain from being measured at the impact site. The reference surface strain near the impact site was approximately .005 in/in. The panel failed at a strain that is slightly less than the allowable strain at the impact site. Failure prediction based on the damage allowable strain value and the analysis indicates that the panel failed at 95 percent of the prediction based on the method of reference 4 for impact damaged structure. However, that prediction is based on the assumption of a 0.1-inch-deep dent, rather than a dent depth of less than .01 inches that was applied to panel L-3. The predicted maximum strain in the panel away from the impact site is equal to .0067 in/in., which is significantly less than the allowable strain value in undamaged structure, so failure was caused by the strain in the region of the impact. The panel failed with a stress of 50.0 ksi at the impact site, which is 115 percent of the design stress.
