BUILDING DAMAGE FROM EXPANSIVE STEEL SLAG BACKFILL

BUILDING DAMAGE FROM EXPANSIVE STEEL SLAG BACKFILL^a

By Carl B. Crawford,¹ M. ASCE, and Kenneth N. Burn²

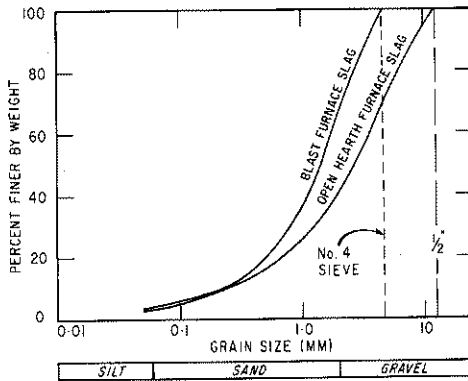
FIG. 6.—GRAIN SIZE OF SLAGS TESTED

Samples of iron blast furnace (BF) and open hearth steel furnace (OHF) slags were obtained from the local steel mill. The BF slag was greenish-brown and made up of angular particles, all passing the No. 4 sieve. The OHF slag was grey to black, with an occasional white particle; all particles

passed the 1/2-in. sieve, but 30% was retained on the No. 4 sieve. Grain-size curves are shown in Fig. 6.
