Cause Analysis of Pier Inclination of An Expressway Interchange Bridge: Case Study

Longxi interchange ramp bridge of Guangzhou–Zhongshan–Jiangmen Expressway, which connects the North Jiangzhu Extension Expressway and Zhongjiang Expressway, with a total length of 1452.236 m, as shown in Figure 1.

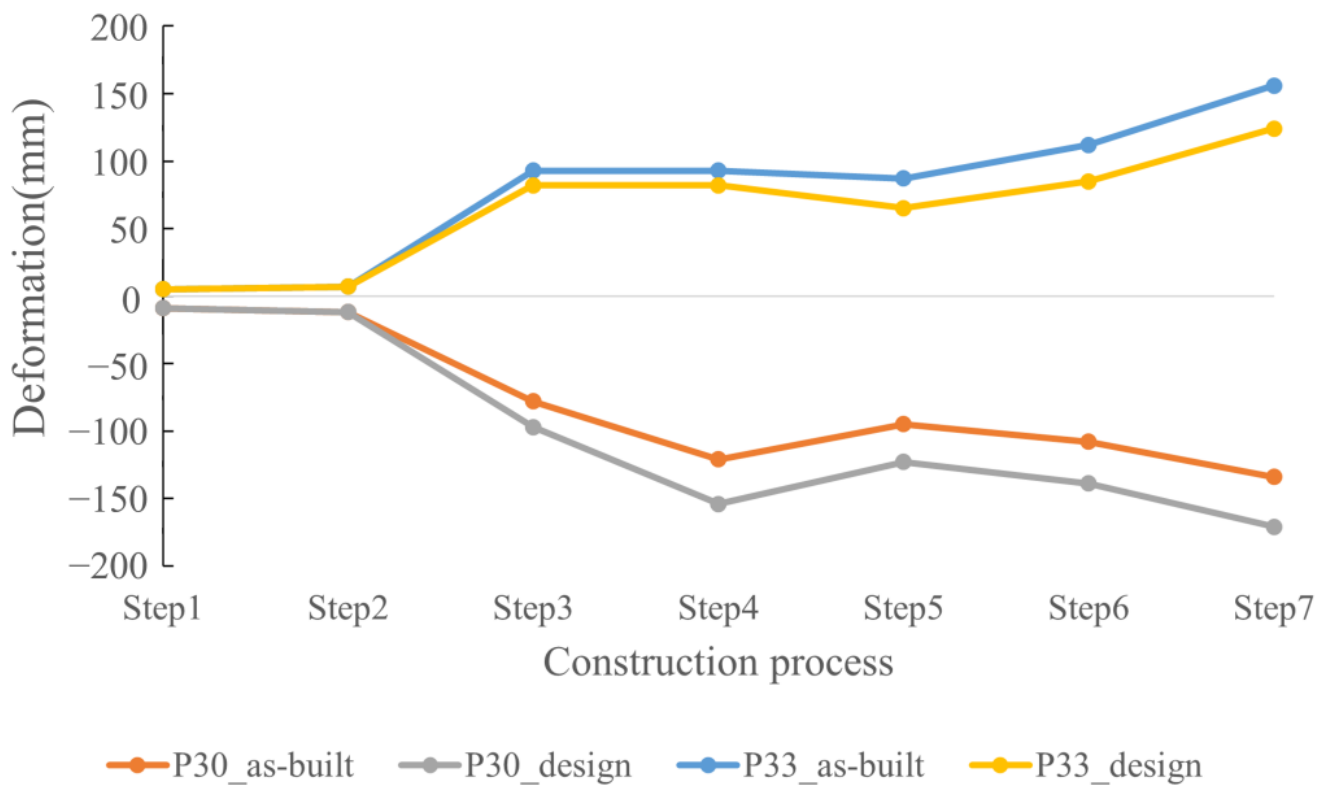
Figure 13. Pier inclination in the design model and as-built model.

There is a difference between the measured and design values of the support eccentricities for Piers P30 and P33 (see in Figure 9). Two models were established in the numerical analysis, the design model, considering the design values of support eccentricities, and the as-built model, considering the measured values. The analysis results show that Piers P30 and P33 are obviously inclined in both the design and as-built models (see in Figure 13).

The original design was changed; a steel box girder was adopted between Piers P30 and P33, resulting in the reaction force of the concrete side being much greater than that of the steel girder side on Piers P30 and P33. However, the design values of support eccentricities on Piers P30 and P33 are not reasonable, leading to a large eccentric compression occurring on the piers during construction and operation. Significantly, due to the difference between the measured and design values of support eccentricities, in the as-built model, the effect of the eccentricities of Pier P30 decreases and the same effect of Pier P33 increases, different to the design model.

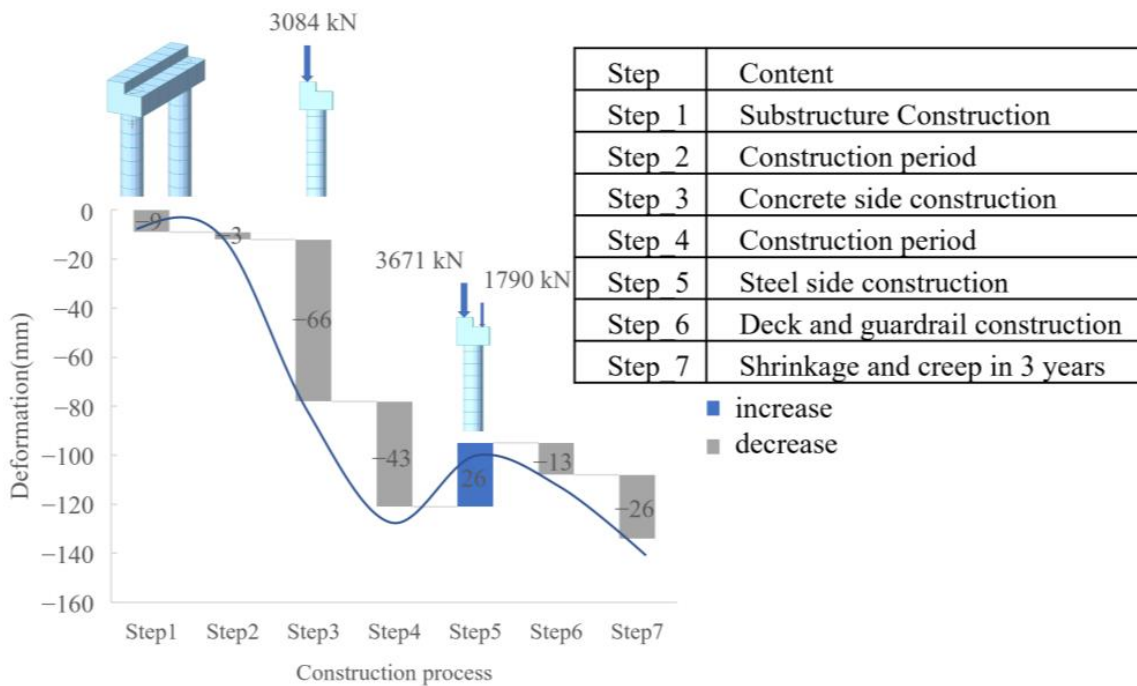
Figure 14. Waterfall plot of the longitudinal inclination on Pier P30.

Using Pier P30 as an example, the longitudinal inclination change during construction is shown in Figure 14, and the deformation process is described as follows:

1. Step 1: After the substructure was completed, there was a small longitudinal inclination of -9 mm since the cap is equivalent to the eccentricity of the pier.
2. Step 2: The displacement increased to -12 mm due to concrete shrinkage and creep in one year.
3. Step 3: After the superstructure between Piers P27 and P30 was constructed, the displacement increased abruptly to -78 mm since only the concrete bridge was erected on the pier.
4. Step 4: Over half a year, the displacement reached -121 mm.
5. Step 5: After the erection of the steel box girder between Piers P30 and P33, the displacement decreases to -95 mm since the eccentricity on the pier reduces.
6. Step 6: When the bridge construction was completed, the displacement was -108 mm.
7. Step 7: After 3 years of shrinkage and creep, the displacement reached -134 mm.

It is shown that after the design change, the reaction force of the concrete side is much greater than that of the steel girder side on Piers P30 and P33, as is the eccentricities of the support, and the concrete and steel girder were constructed asynchronously. All of the above data show that a large eccentric compression occurs on the piers during construction and operation, resulting in a larger inclined deformation of Piers P30 and P33.

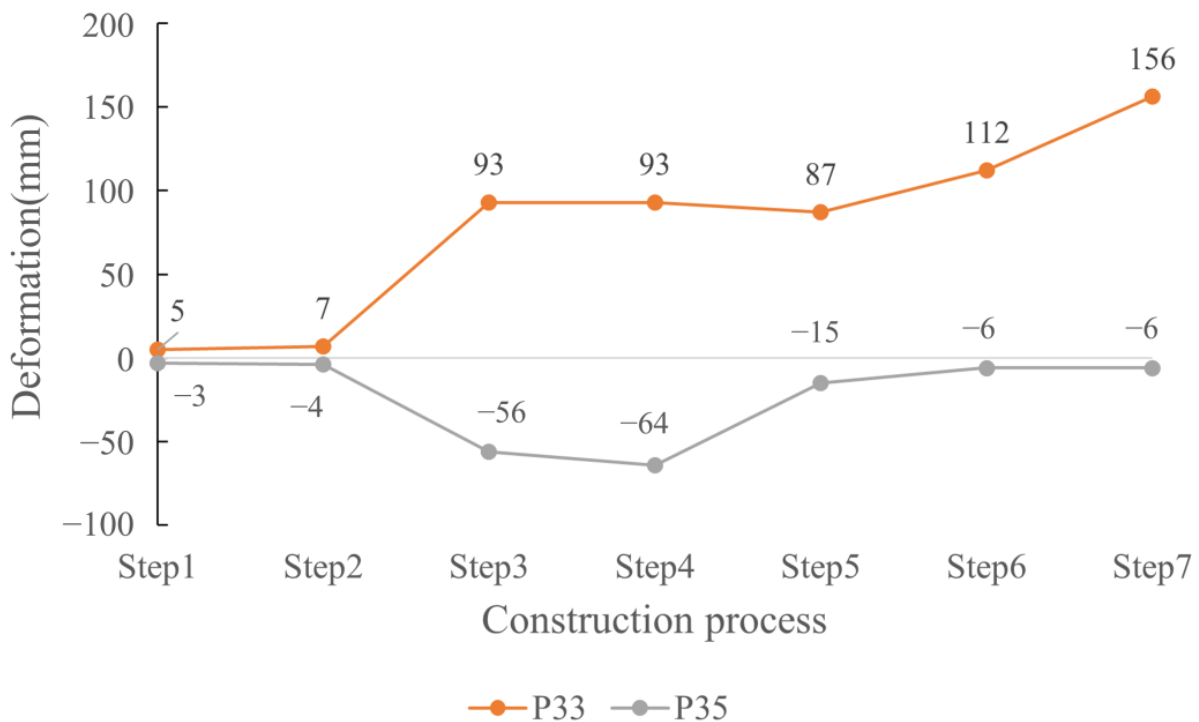
Figure 15. The longitudinal inclination of the pier.

The longitudinal inclination processes of Piers P33 and P35 are shown in Figure 15.

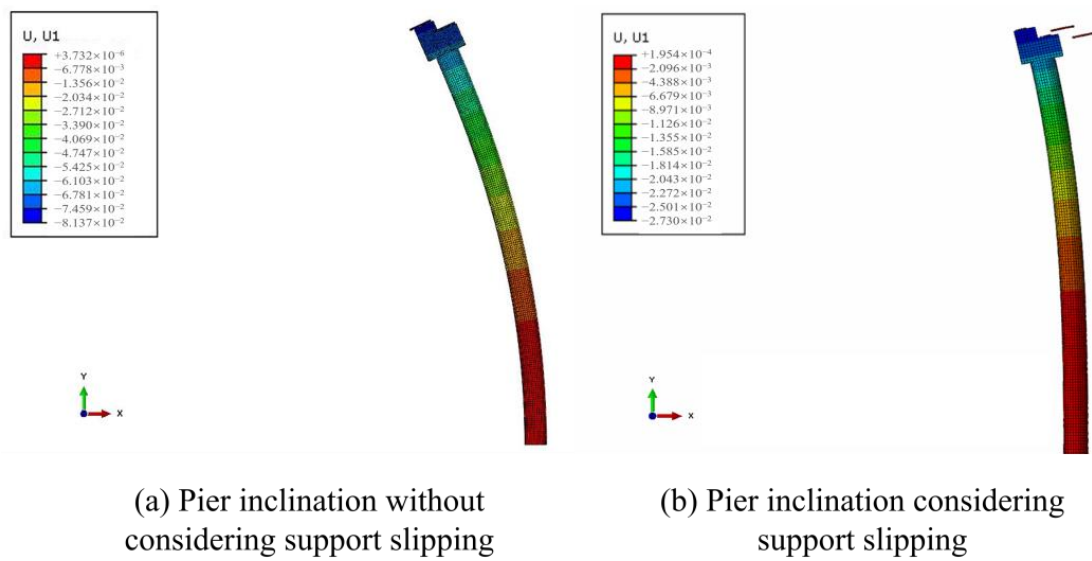
Figure 17. Deformation of Pier P30.

In the situation that the concrete girder is constructed on one side of a pier while the steel girder is not, under the conditions of the dead load on Pier P30, the longitudinal inclination at the top of the pier is -28 mm considering support friction resistance, while the displacement is -70 mm without considering this, as shown in Figure 17. Therefore, the deformation of Pier P30 caused by support friction resistance is 42 mm, in the direction opposite to pier deformation. It is worth noting that the deformation caused by support friction in the subsequent stages is stable. Similarly, the deformation values caused by the support friction resistance of Piers P33 and P35 are 41 mm and 20 mm, respectively. Therefore, the influence of support friction on pier inclination is not negligible when the support slips obviously, especially in high piers.

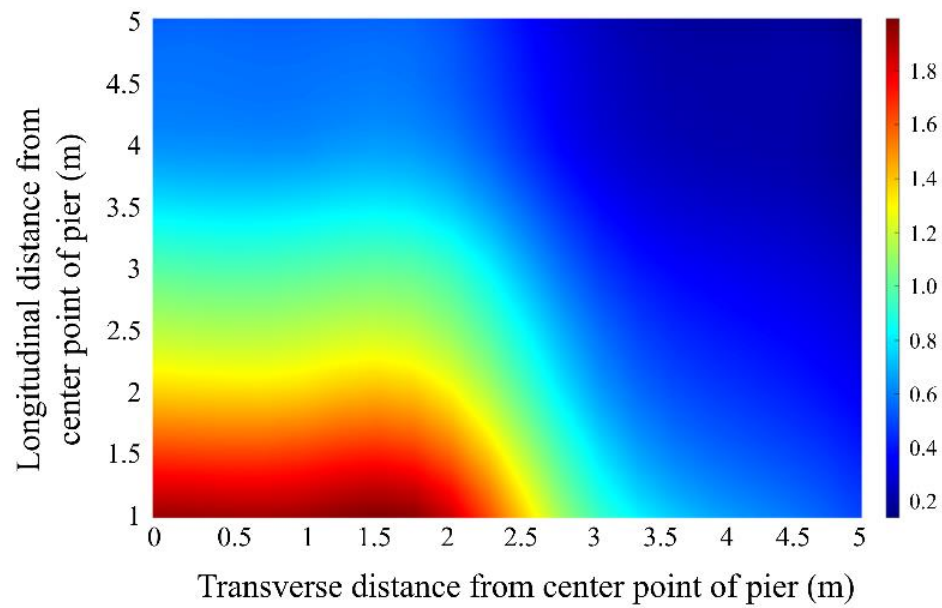
Figure 20. Pier deformation under temporary load at different positions (cm).

As shown in Figure 20, in the situation that a temporary load of 490 kN stowed within 3 m from the center point of the pier, the longitudinal deformation at the top of the pier is larger than 1 cm. The maximum deformation can reach 1.95 cm. This is due to the translation and rotation of the pile top caused by foundation deformation, which then leads to the rigid body deformation of the pier.

In conclusion, when pier construction is completed but the superstructure is not, soft foundation deformation caused by related construction equipment and temporary load on-site results in the deformation of piles, and then leads to the rigid body deformation of pier. The displacement value cannot be neglected and related to the position and magnitude of the temporary load.

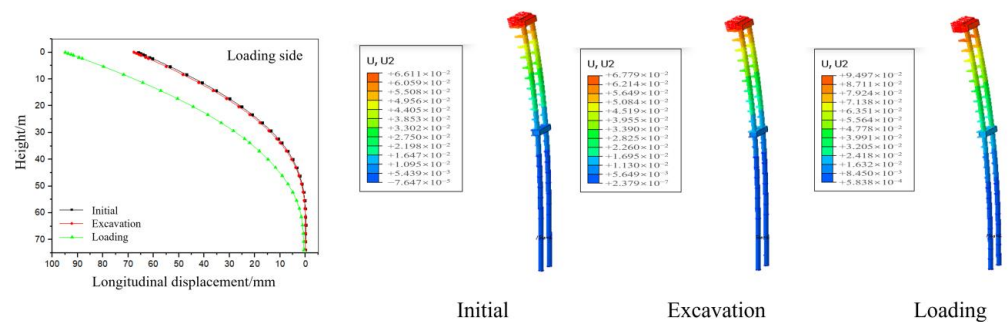
Figure 21. Displacement of Pier P30 under asymmetric filling soil load (m).

As shown in Figure 10, there is an asymmetric filling soil load at the bottom of Pier P30 during operation. The numerical results are shown in Figure 21 (note that the length of arrows indicates the magnitude of the displacement).

During the operation of the bridge, the silt around Pier P30 was excavated at a depth of 2 m at the river side and dumped at the other side. When the filling depth difference is 4 m in the numerical model, the longitudinal inclination of Pier P30 is $-(94.97 - 66.11) = -28.9$ mm, which is one of the main factors resulting in the inclination of Pier P30.

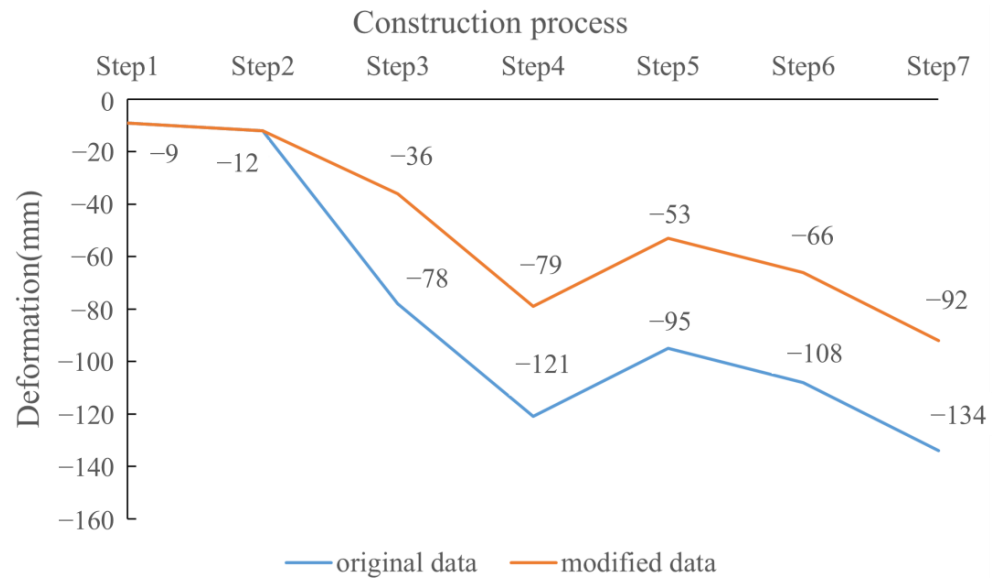
Figure 22. Modified deformation of Pier P30 considering support friction.

The inclination of pier under dead load is modified considering support slipping, as shown in Figure 22.

1. The superstructure between Piers P27 and P30 does not move, since during the forensic investigation of the critical region P27 (as shown in Figure 22), the distance between the girder end is 7 cm, and the expansion joint is a normal width, and the supports on the pier show no obvious slip or shear deformation.
2. The superstructure between Piers P30 and P33 does not move since the supports on Piers P31 and P32 showed no obvious slip during forensic investigation.

The forensic engineering investigation shows that the inclination of the top of Pier P30 is $-12.0/-11.2$ cm, while the superstructure does not move. It was concluded that the inclination of Pier P30 occurred after the superstructure was constructed. In the critical region of P30 (as shown in Figure 22), the girder end of the superstructure is $-8.0/-9.0$ cm away from the centerline of the cap, and the L30-30 support slipping is $15.0/14.0$ cm, allowing us to deduce that the girder end is about $7.0/5.0$ cm away from the centerline of the cap before the support slipped, which is within a reasonable error compared with the design value of 4 cm. Therefore, Pier P30 deformed after the superstructure was constructed.

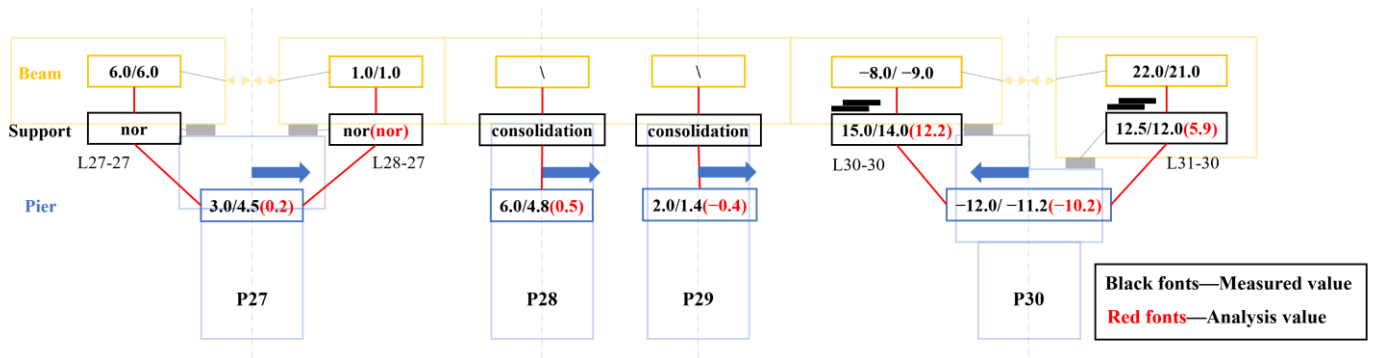
Figure 23. Numerical results and field investigation data between Piers P27 and P30 (cm).

In general, the numerical results of pier inclination and support slipping are consistent with the forensic field investigation data, which indicates that the numerical analysis results closely mirror the actual disease situation. According to the numerical analysis, improper reaction force and the eccentricities of the support on the piers, due to the design change and the asynchronous construction of the concrete and steel girder, cause a large, eccentric compression on Piers P30 and P33 during construction and operation. The asymmetric foundation settlement at the bottom of Pier P30 caused by the filling soil load during operation results in a larger pier inclination and excessive support slipping. On the other hand, the rigid body deformation of the pier occurs due to the soft soil foundation deformation caused by construction equipment and temporary loads on-site when the pier construction is completed but the superstructure is not.

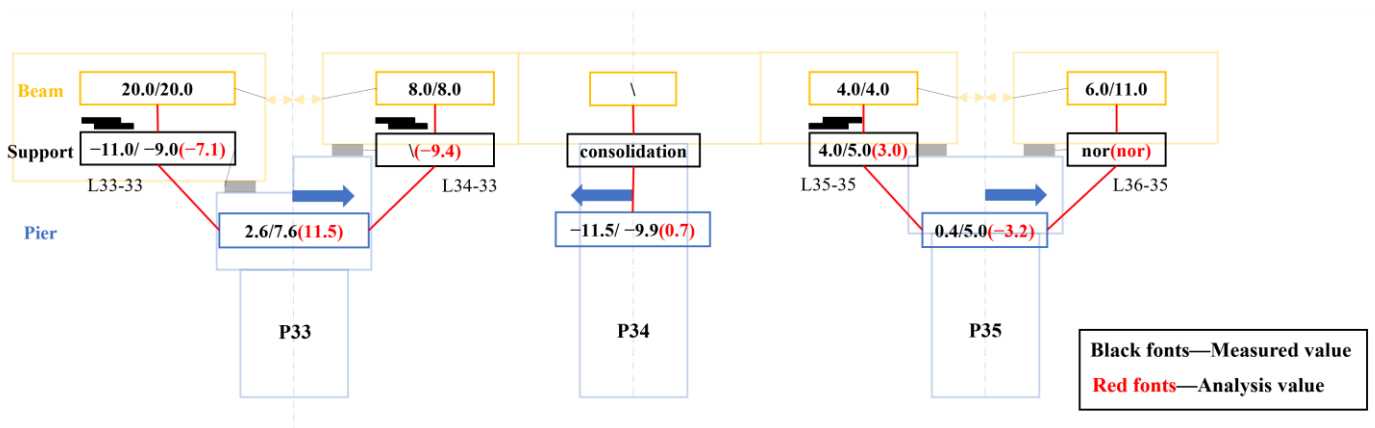
Figure 25. Numerical results and field investigation data between Piers P33 and P35 (cm).

4. Pier P34: In the forensic field investigation, the inclination of the top of Pier P34 is $-11.5/-9.9$ cm. Firstly, if the pier inclination occurs after the consolidation of the pier and superstructure, the deformation of the consolidated pier would drive the superstructure along the direction of the pier number decreasing, resulting in a narrower expansion joint on Pier P33 and a wider one on Pier P35. However, the expansion joint on Pier P33 is actually wider. Then, no concrete cracking was found on the surface of Pier P34 during the field inspection. Thus, the pier inclination occurred before the consolidation of the pier and superstructure.

Based on cause analysis, the appropriate treatment measures are proposed to repair the piers and supports that deformed severely. The inclination of Pier P34 is mainly rigid body deformation, and rectifying the consolidated pier would bring the risk of the girder falling. Thus, no rectification was carried out for Pier P34. The inclinations of Piers P30 and P33 are mainly due to the eccentric compression on the piers during construction and operation; meanwhile, the asymmetric foundation settlement caused by filling soil load during operation contributes to the status of Pier P30.
