PNNL-20365

# Characterization of Fish Passage Conditions through a Francis Turbine, Spillway, and Regulating Outlet at Detroit Dam, Oregon, Using Sensor Fish, 2009

## Final Report

JP Duncan  
TJ Carlson

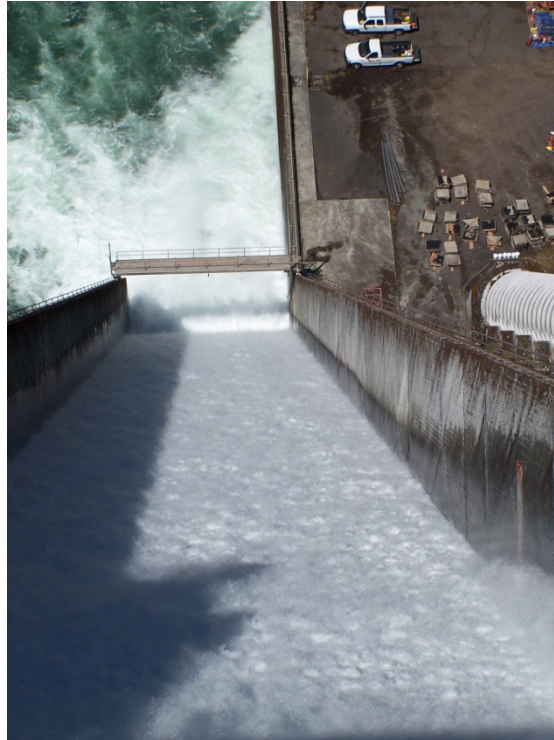
Spillbay 3 and Spillbay 6 were evaluated at two spillgate openings. The height and slope of the spillway chute contribute to deleterious exposure conditions observed during the study. Detroit Dam, completed in 1953, is slowly deteriorating due to age. The concrete surface of the spillway is rough from weathering (Figure 4.1), and the descending flow is irregular (Figure 4.2)—conditions that probably incrementally worsened spillway passage conditions.

In Spillbay 3, the unconfined spillway discharge spread rapidly once past the structure supporting the tainter gate hinge assemblies (Figure 4.3). In contrast, Spillbay 6 was confined from the tainter gate through stilling basin entry (Figure 4.2). Spillway flow velocities were estimated to exceed 150 fps before plunging into the stilling basin. Sensor Fish were often carried to depths of over 30 ft with spillway discharge, at times striking rocks or other unidentified objects as they were carried in turbulent flow through the stilling basin.

**Figure 4.2.** Spillbay 6, 3.5-ft gate opening (3090 cfs), showing walls confining the turbulent flow created on the rough spillway chute.

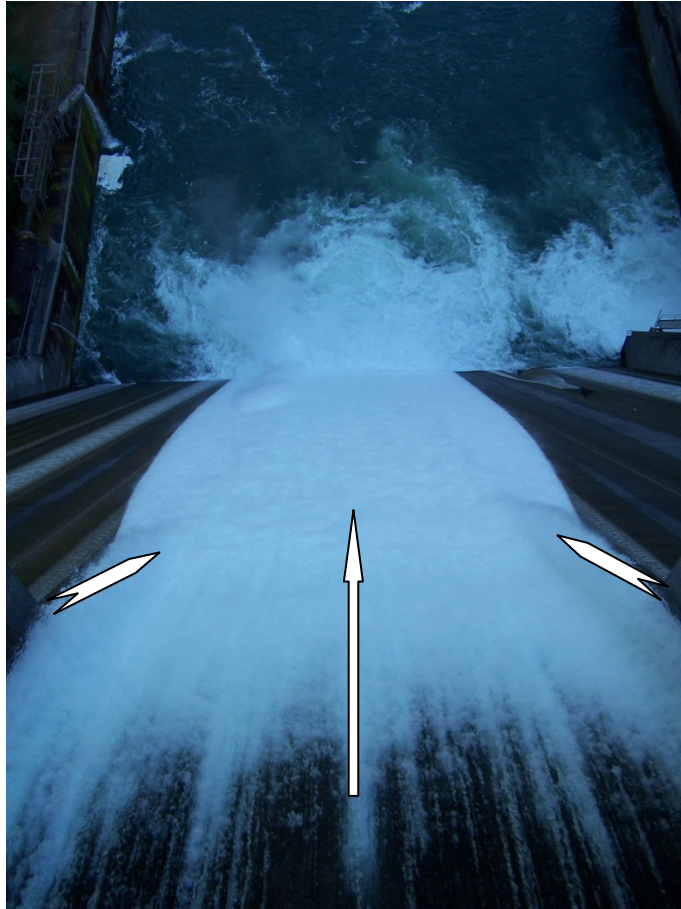
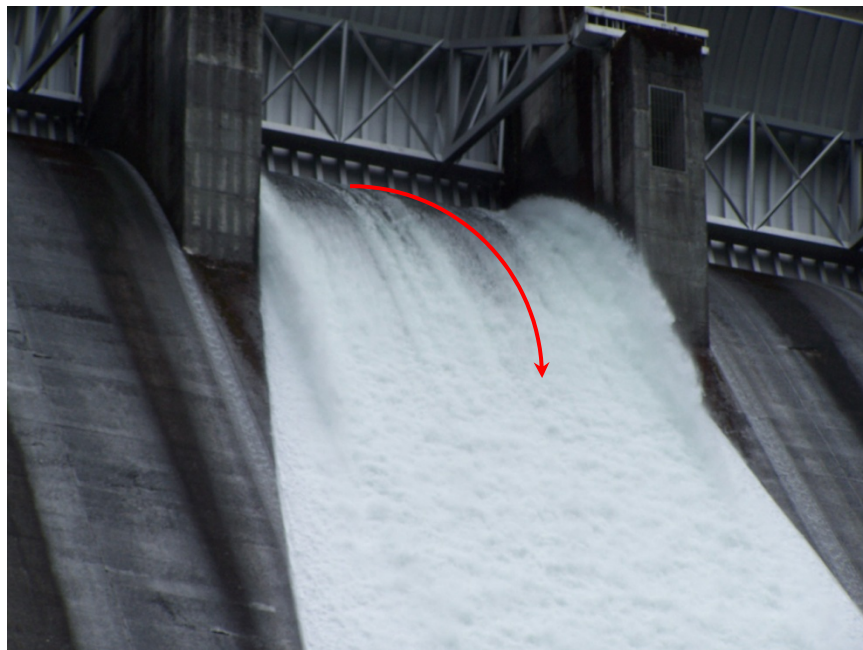
Almost all Sensor Fish experienced a collision on the spillway chute shortly after passage under the spillway tainter gate. Probably because of much less submergence and greater velocity during gate passage, the momentum of the Sensor Fish carried it a farther distance down the spillway chute prior to collision when the tainter gate opening was 1.5 ft (Figure 4.4). At the higher discharge when the tainter gate opening was 3.5 ft, it appears the Sensor Fish were traveling at a lower velocity and deeply enough entrained in discharge flow to be carried to a point of initial contact with the spillway surface upstream of that typical at the lesser discharge.

**Figure 4.4.** A hydraulic jump carries the Sensor Fish down the spillway chute as flow passes under the tainter gate in Spillbay 3 with the gate open 1.5 ft (1560 cfs discharge).

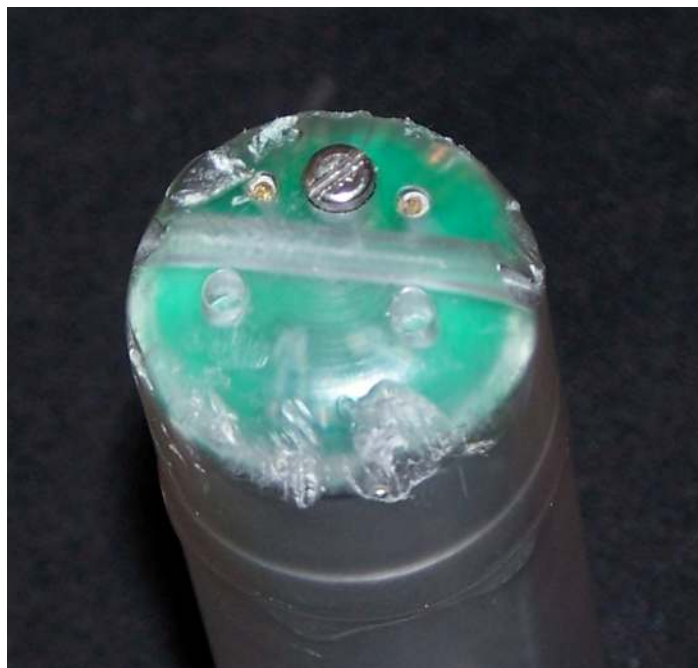
Several Sensor Fish recovered following passage through the spillway were noticeably damaged, with deep scratches and portions of the polycarbonate shell chipped away (Figure 4.5). Extreme forces are needed to fragment polycarbonate, a highly impact-resistant, low-scratch durable polymeric plastic. Although the Sensor Fish have been scratched and scraped during previous studies on the Columbia and Snake rivers, the damage observed on the casing following passage in spill at Detroit Dam was much worse.

**Figure 4.5.** Chips and scratches visible on the polycarbonate Sensor Fish casing.

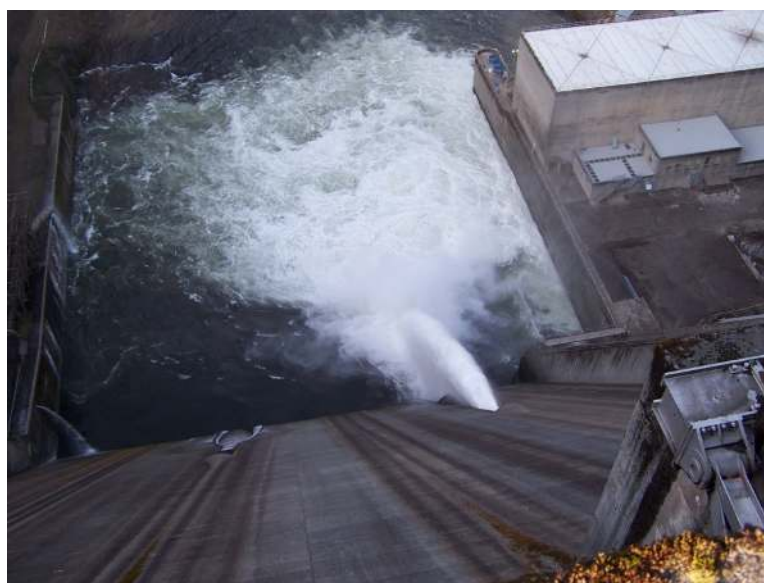
Passage conditions for fish through the upper north-side RO was evaluated at two gate openings, 1 ft and 5 ft (Figure 4.8 and Figure 4.9, respectively). The RO discharges into the spillway stilling basin from an opening in the face of the dam at a centerline elevation of 1315 ft MSL in the face of Spillbay 4–5. The velocity of the discharge jet at entry into the stilling basin was estimated to be approximately 90 fps. The RO discharge jet is rapidly entrained in the stilling basin, creating conditions that expose the Sensor Fish and live fish to shear. Overall, approximately 70% of Sensor Fish experienced a significant shear event at entry into the stilling basin. Approximately 82% of Sensor Fish releases showed a significant shear event when the control gate was open 1 ft and 58% when the control gate was open 5 ft.

**Figure 4.9.** Regulating outlet discharge at Detroit Dam when the control gate was open 5 ft.

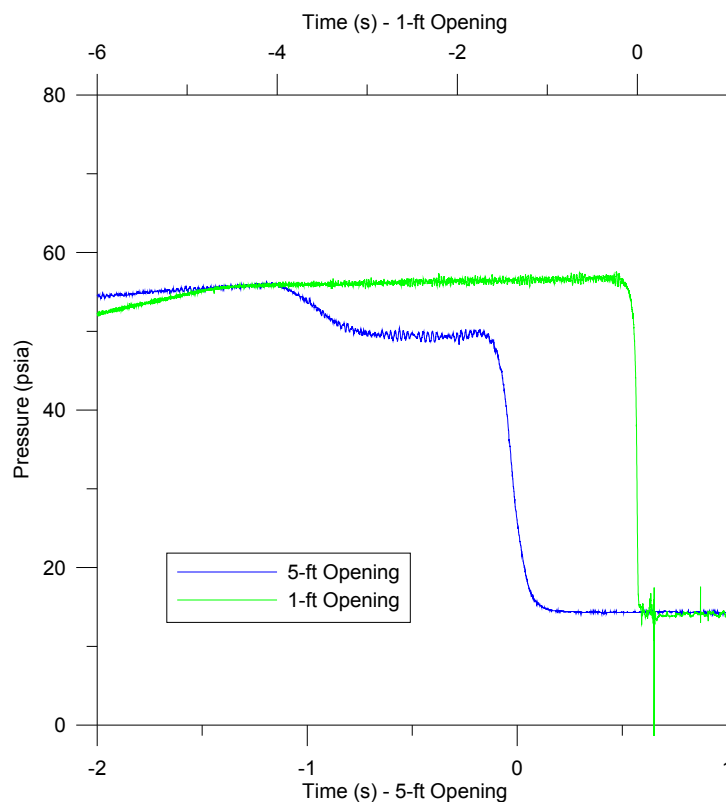
injection, Sensor Fish data showed a slight drop in pressure immediately following passage into RO flow, most likely the effect of slip velocity on the Sensor Fish pressure transducer. The pressure decrease was minor and also an artifact of the Sensor Fish measurement process and not a physical factor that would be a risk to fish health. Figure 4.11 Sensor Fish release pressure time histories for passage through the RO when the control gate was open 1 ft and 5 ft. The velocity of water through the RO conduit upstream of the control gate for the two gate settings and consequent discharges (approximately 30 fps with a discharge of 1900 cfs and 8 fps with a discharge of 500 cfs for the 5-ft and 1-ft openings, respectively) are evident in Sensor Fish travel times from injection to control gate passage, a distance of approximately 40 ft. These travel times were approximately 1.2 and 4.5 s for the 5-ft and 1-ft control gate openings, respectively.

**Figure 4.11.** Sensor Fish pressure time histories for passage through the RO from injection through passage under the RO control gate for control gate settings of 1 ft and 5 ft.
