Damage patterns in the town of Amatrice after August 24th 2016 Central Italy earthquakes

Gabriele Fiorentino¹

Received: 26 June 2017 / Accepted: 26 October 2017 / Published online: 9 November 2017
© The Author(s) 2017. This article is an open access publication

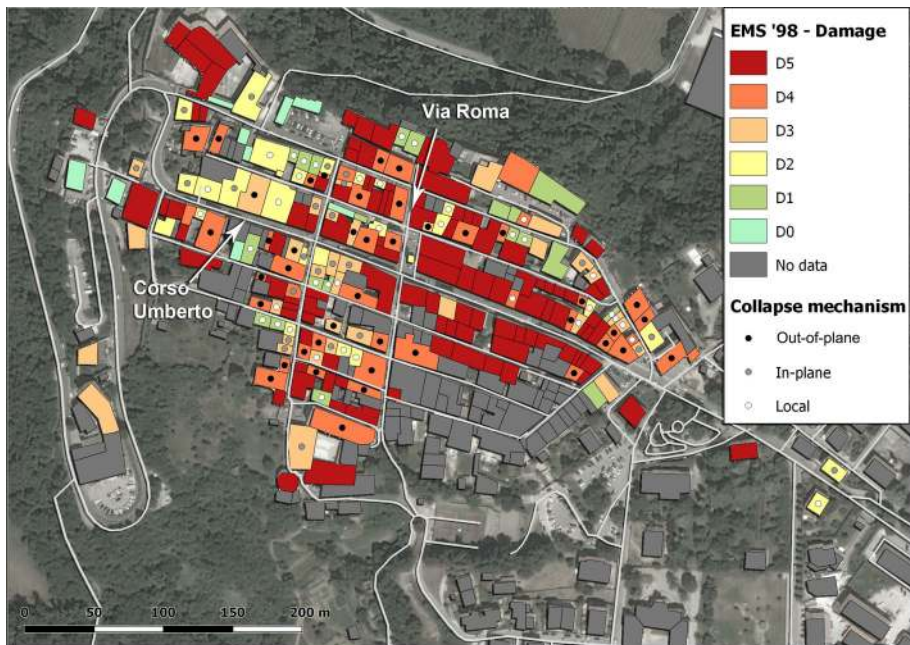
- the damage is assigned to single buildings, identified on the basis of the visual inspection;
- the field survey allowed to assign a damage level taking into account the whole situation of the single building and not only the condition of the roof;
- the map refers to the most probable damage mechanism only; a grey-scale-colored circle represents the type of mechanism: black circle for out-of-plane, grey circle for in-plane and white circle for local mechanism.
- in case of total collapse (D5) it was impossible to assign a mechanism.

The observation of the map allows to make the following considerations: many of the buildings which suffered major damage or collapsed lied along Corso Umberto, where the majority of the historical buildings are located (32 collapses out of a total of 105); the majority of the collapses in Corso Umberto happened east of Via Roma, while in the west part of the town the damage seems to be more scattered (see Fig. 11).

**Fig. 10** Map of damage in Amatrice according to EMS-98 damage classification: The main mechanisms identified for each building are reported

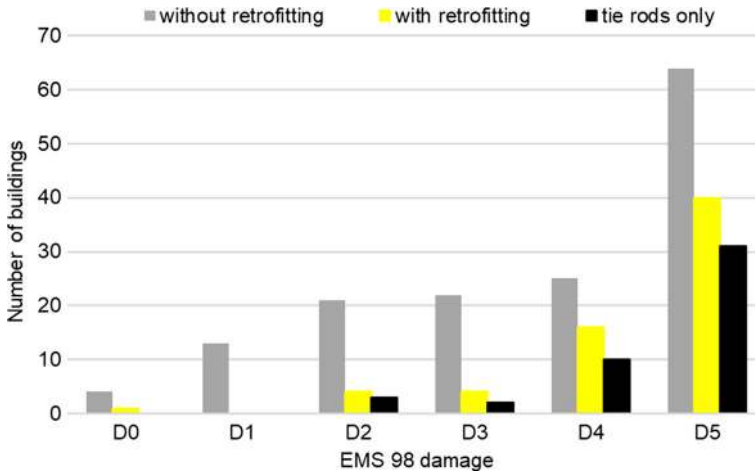
Fig. 13 Damage level of masonry buildings with and without tie rods

Many of the buildings inspected in Amatrice were provided with retrofitting systems, in particularly tie rods which constitute about 80% of the retrofitting interventions. Figure 13 shows the damage levels of masonry buildings without tie rods (grey bars), with any type of retrofitting system (yellow bars) and those who had only tie rods (black bars). The information was obtained by comparing the pictures of our survey with the images taken from Google Streetview©, dating to July and December 2011. It can be noted that many buildings which had tie rods suffered heavy damage and collapse, probably because in many cases the retrofitting had been made by means of inappropriate interventions, as depicted in Fig. 14. In fact, 31 out of 95 (32%) of the buildings which had a damage level

D5 had been retrofitted with tie rods. For damage level D4 there are similar results: 10 out of 35 (29%) had tie rods.

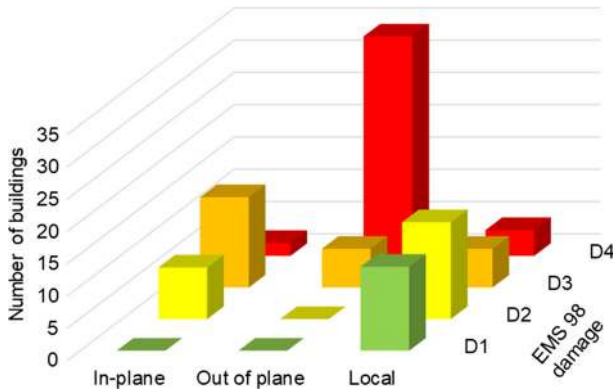
Fig. 15 Damage mechanisms for masonry buildings and D1–D4 damage levels

The most probable damage mechanism arises focusing on the 102 masonry buildings which have a damage level from D1 to D4 (from Table 1: 105 buildings—3 bell towers). In Fig. 15, for each damage level the number of buildings which had in-plane, out-of-plane and local collapse mechanisms is reported. For damage level D4 there were mainly out-of-plane mechanisms. In-plane mechanisms were identified mostly for damage levels D2 and D3, while local mechanisms are related mostly with levels D1–D2.

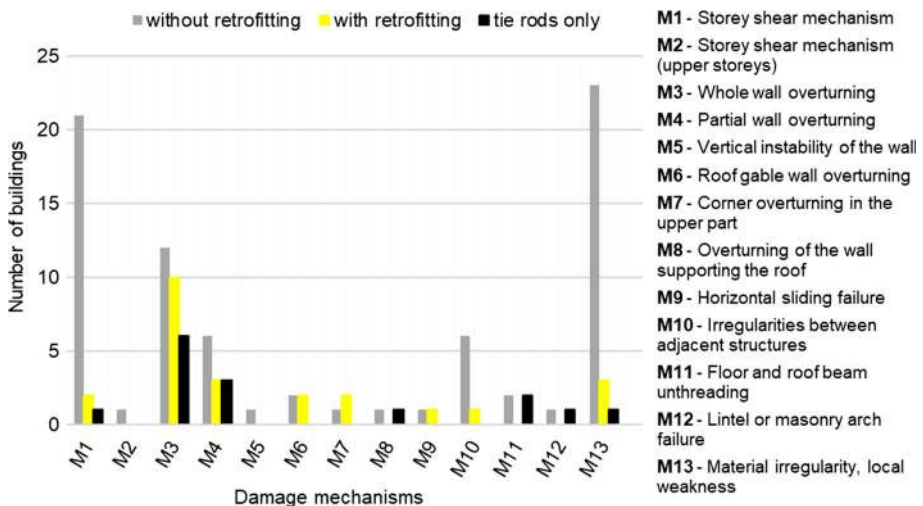
Figure 16 compares the different damage mechanisms identifying the buildings with retrofitting and tie rods. Differently to what expected in a retrofitted building, it must be observed that, among the buildings which suffered damage mechanisms M3 and M4 (total or partial wall overturning), 9 out of 18 buildings had tie rods, thus allowing to state that the presence of tie rods did not prevent the activation of out-of-plane mechanisms,

Fig. 16 Comparison between damage mechanisms and presence of tie rods for D1–D4 damage levels (see Table 3)

probably because of the poor masonry quality which did not allow an efficient force transfer system to the masonry.

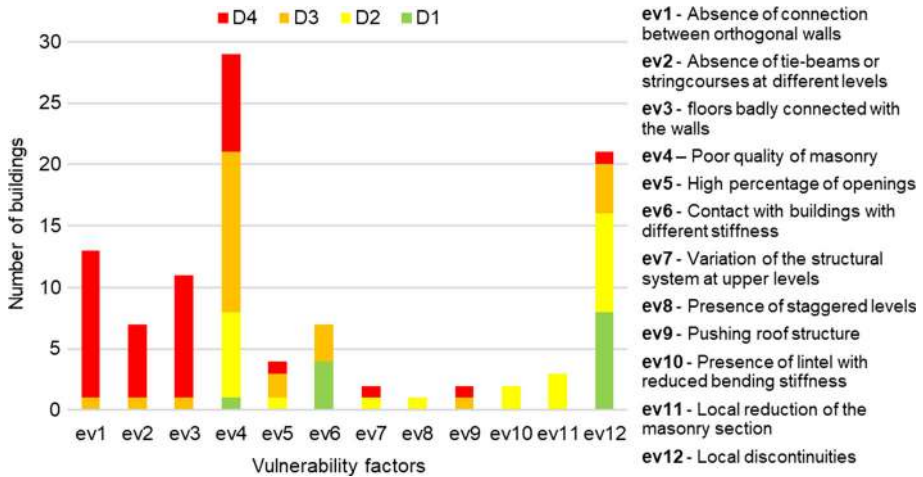
Fig. 17 Vulnerability factors identified for 102 masonry buildings and EMS 98 damage level

Figure 17 reports the vulnerability factors identified for 102 masonry buildings with damage level ranging from D1 to D4. The most relevant factors (more than 10 buildings affected) are:

Examples of the first two vulnerability factors are reported in Figs. 18 and 19. The above listed factors represent almost 75% of the buildings with Damage level D1–D4. It is possible to notice that D4 is mainly connected with vulnerability factors ev1 (absence of walls connection), ev2 (absence of stringcourses), ev3 (floor/walls bad connection), ev4 (poor quality masonry) and only in few cases with ev5 (high percentage of openings), ev7 (variations at upper levels), ev9 (pushing roof structure), ev12 (local discontinuities).

The vulnerability factors connected with the out-of-plane overturning of a wall (i.e. ev1, ev2, and ev3) are those related to the highest level of damage D3 and D4. The poor quality masonry (ev4) and local discontinuities (ev12) characterize all the damage scale.

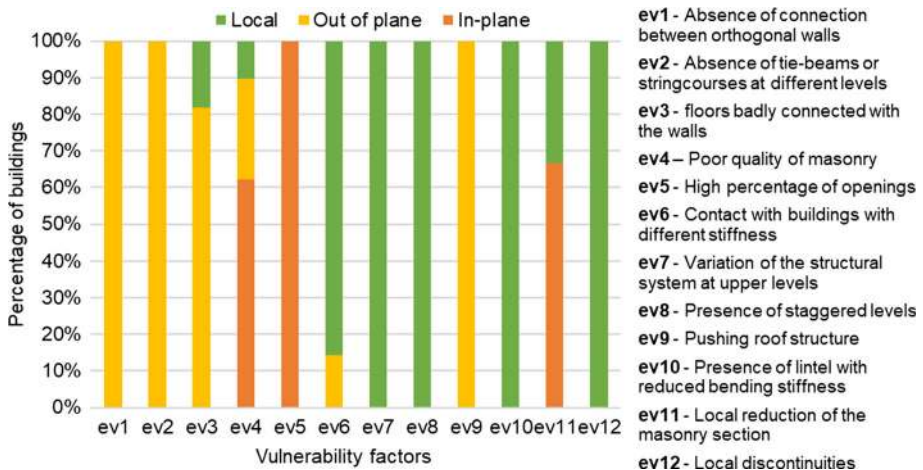
Figure 20 shows the type of damage mechanism (in-plane, out-of-plane, local) for each vulnerability factor.

It is worth noting that in plane mechanisms are only caused by ev5 (high percentage of openings), ev4 (poor masonry quality) and ev11 (local reduction of thickness). Out of plane

Fig. 20 Damage mechanism and vulnerability factors

mechanisms are due to ev1 (lack of connection between walls), ev2 (absence of string-courses), ev9 (heavy roof), and partially to ev3 (connection wall-floors), ev4 (poor quality of masonry) and ev6 (contact with other buildings with different stiffness). Local failure mechanisms are due to ev7 (variation of the structural system at upper levels), ev8 (presence of staggered levels), ev10 (presence of lintel with reduced bending stiffness), ev12 (local discontinities), and ev6.

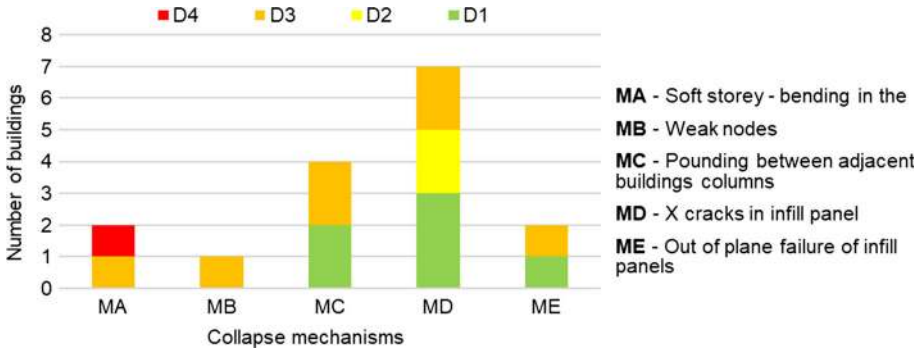
Fig. 21 RC buildings: correlation between damage mechanisms and damage levels for the 16 RC buildings with damage D1–D4

The most frequent type of damage for RC structures, as shown in Fig. 21, was the MD (cracks in infill panel) connected to the vulnerability factor evA (Table 4, frame with inadequate beams and infill walls). The Hotel Roma building, which was rated D4, presented a soft-storey mechanism and had been demolished at the date of our survey; therefore the damage level was assigned based on newspaper images.
