## Damage resistance and tolerance of carbon/epoxy composite coupons subjected to simulated lightning strike

Paolo Feraboli\*, Mark Miller

Department of Aeronautics and Astronautics, Box 352400, Guggenheim Hall, University of Washington, Seattle, WA 98195-2400, United States

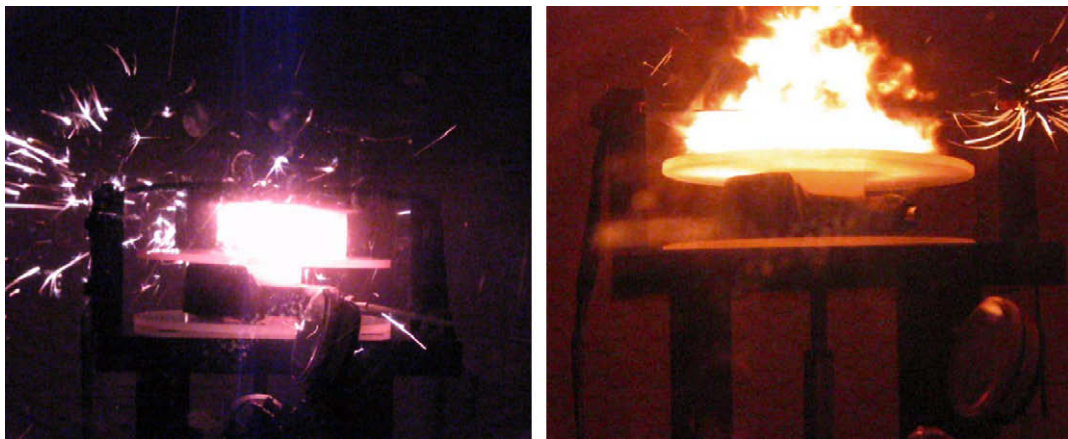
The strikes produce a loud sound, similar to that of a detonation, and generate a short, bright light, followed by a cloud of fire and sparks, likely due to the incandescent blast wave charged with carbon fiber and epoxy particles. Fig. 6 is extracted from a digital video recording at the time of peak current during the strike. However, if a digital camera with an exposure time longer than the

Fig. 6. Still image extracted at peak intensity from a video recording of a 50 kA strike.

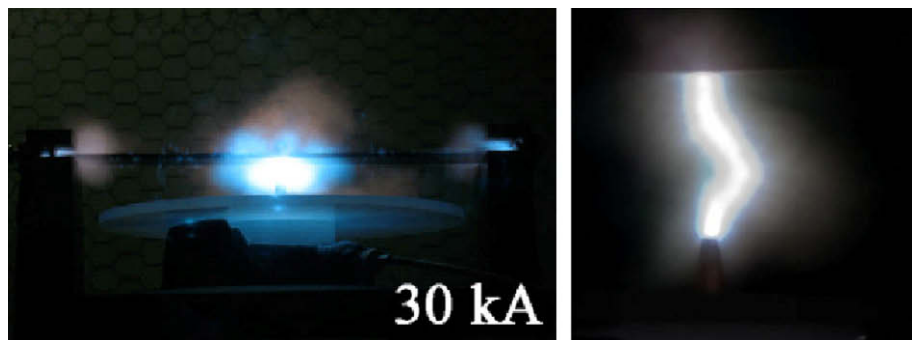
duration of the strike itself, and a series of polarized filters that reduce the intensity of the lighting are employed, it is possible to actually reduce the amount of “noise” in the image and focus on the central portion of the electrical channel, Figs. 6 and 7.

Fig. 7. Details of the strikes at 30 kA, obtained using a digital camera with a long exposure time and a system of polarized lenses to reduce the intensity of the light.

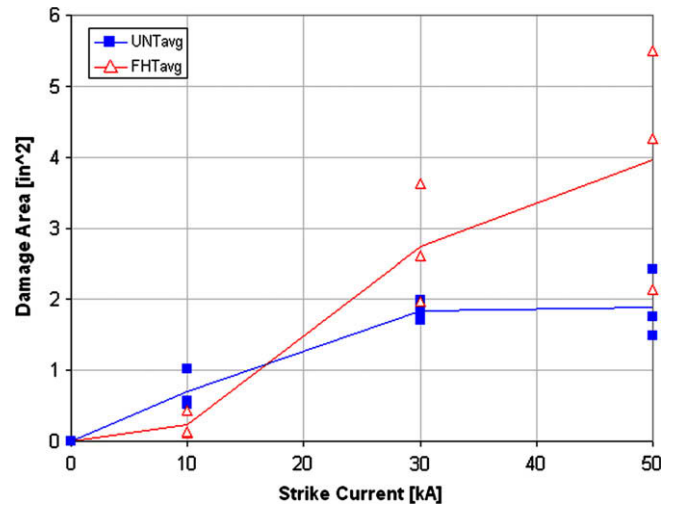
Fig. 11. Projected damage area for unnotched and filled-hole specimens.

Trends observed in projected damage area for filled-hole specimens are reported in Fig. 11, together with the unnotched ones. For filled-hole specimens, the damage area is very small for the 10 kA strikes, but there is a clear inversion in the trends observed for the 30 and 50 kA strikes, where it rapidly grows to larger values than the unnotched specimens. While initially the damage area appears to grow at a slow rate, between 10 and 30 kA there is a sharp increase, and even between 30 and 50 kA strikes the area appears to grow substantially, albeit at a lower rate. The steel fastener appears to act as an electrical damage sink for the low current levels, whereby it absorbs the majority of the damage, but at the higher current levels it appears to become an amplifier, thus distributing the load throughout the entire laminate rather than containing it on the outer plies.

It should be noted that the variation in damage area measurements for the filled-hole specimens is much greater than for the unnotched ones, and in particular it becomes nearly unacceptable at 50 kA. It is suggested that fastener fit may have a fundamental role in introducing the electrical load in the surrounding laminate, and hence the quality of the fit may be responsible for the great variation observed. Future work will have to focus on the fundamental role of the metallic fastener in the formation of damage.

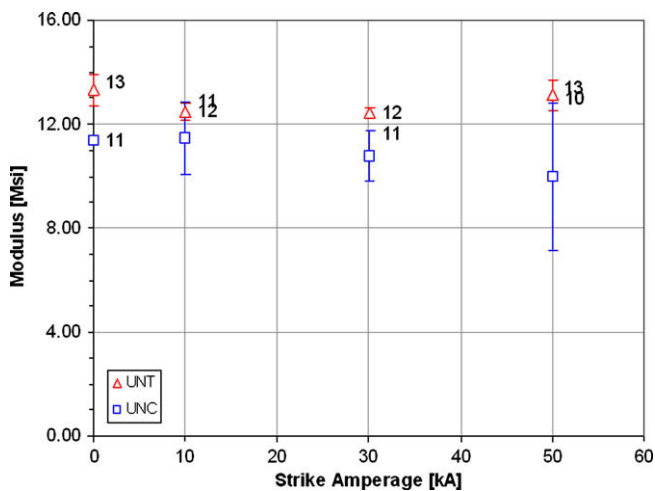
Fig. 17. Residual tension and compression modulus plot as a function of current intensity for unnotched specimens.

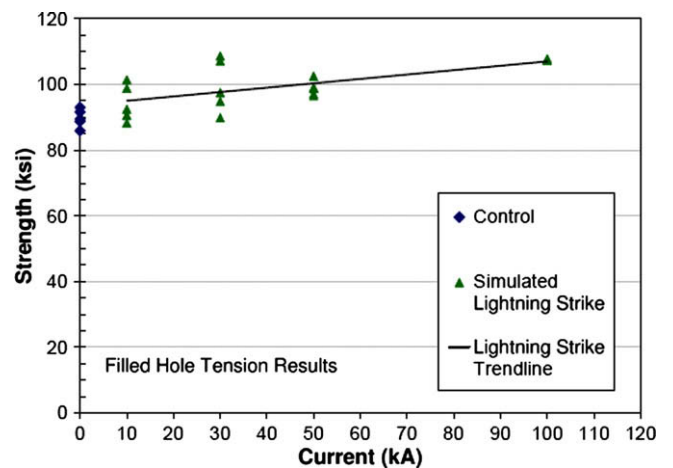
FHT and FHC results are reported in Fig. 18. Average strength values for FHT appear to increase with increasing damage state, up to 13% for 30 kA, then decrease back to the pristine value for the 50 kA specimens. Initially these results may seem surprising, but previous results published by Boeing [6] appear to confirm the observation of increasing FHT strength with lightning strike damage. In [6], FHT specimens having the same geometry as those of this study are shown a clear trend of increasing apparent strength after strike, Fig. 19. Noticeable scatter is present in their data, as well as in the current investigation. It should be noted that the specimens used in [6] are stitched AS4/3501-6 resin film infused deriving from the NASA advanced composites technology (ACT) program, and are substantially thicker than the ones used in this investigation. Nonetheless, for both specimen types it is thought that the lightning strike damage surrounding the fastener acts as to relieve the stress concentration around the hole in a fashion not too different from that of the damage zone evolution reported by several authors during testing of open- or filled-hole specimens [16,17].

Fig. 19. Increase in residual strength with increasing current for filled-hole tension specimens reported in [6].

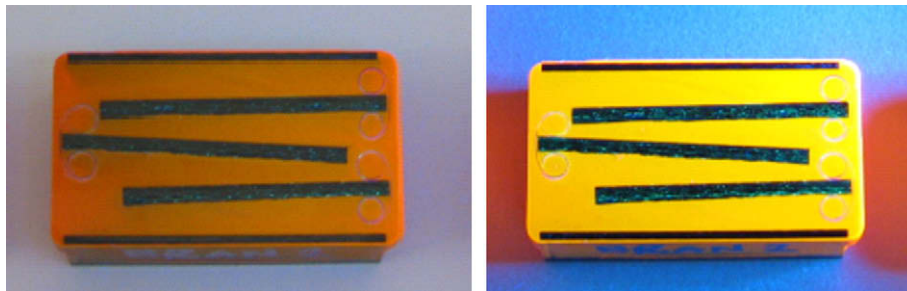
Fig. 21. Specimen mounted in epoxy resin with laser dye under regular light (left) and under UV light after application of dye penetrant (right).
