Damage Study and Future Direction for Structural Design Following the Tuscaloosa Tornado of 2011

David O. Prevatt, Ph.D., P.E., University of Florida, Gainesville, FL
John W. van de Lindt, Ph.D., University of Alabama, Tuscaloosa, AL
Andrew Graettinger, Ph.D., University of Alabama, Tuscaloosa, AL
William Coulbourne, P.E., Applied Technology Council, Rehoboth Beach, DE
Rakesh Gupta, Ph.D., Oregon State University, Corvallis, OR
Shiling Pei, Ph.D., P.E., South Dakota State University, Brookings, SD
Samuel Hensen, P.E., Simpson Strong Tie, Pleasanton, CA
David Grau, Ph.D., University of Alabama, Tuscaloosa, AL

July 27, 2011

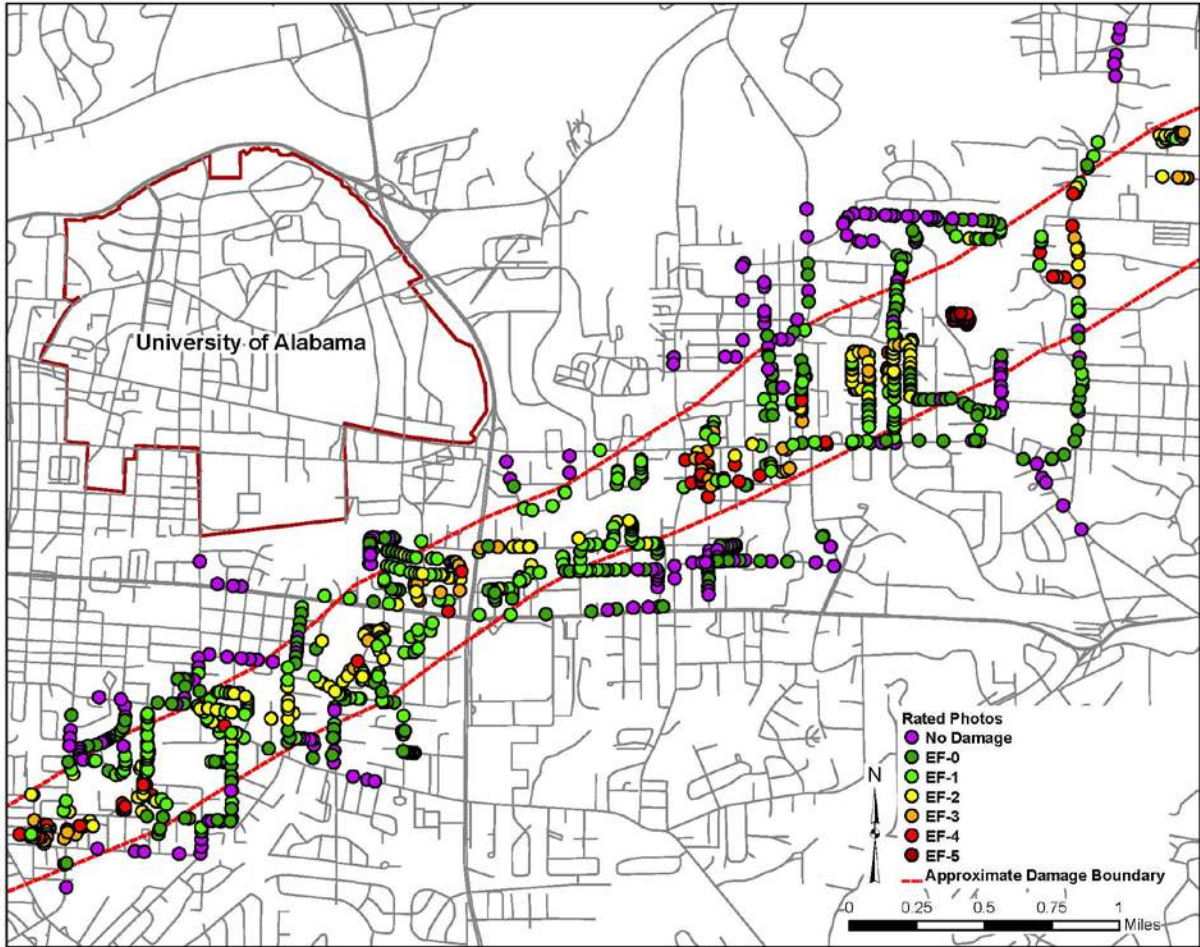
A map showing EF categories for buildings is shown in Figure 2.4. The degrees of damage observed and documented in Tuscaloosa ranged from no building damage to damage associated with EF-4 level wind speeds. It can be seen from Figure 2.4 that higher EF wind speeds (reds) tend to be located along the center line of the tornado, while lower EF wind speeds (greens) tend to be along the edges of the tornado path as would be expected. A contour map of the EF wind speeds developed from observed building damage is shown in Figure 2.5

Figure 2.4, Map showing EF rated photos along the tornado path in Tuscaloosa.

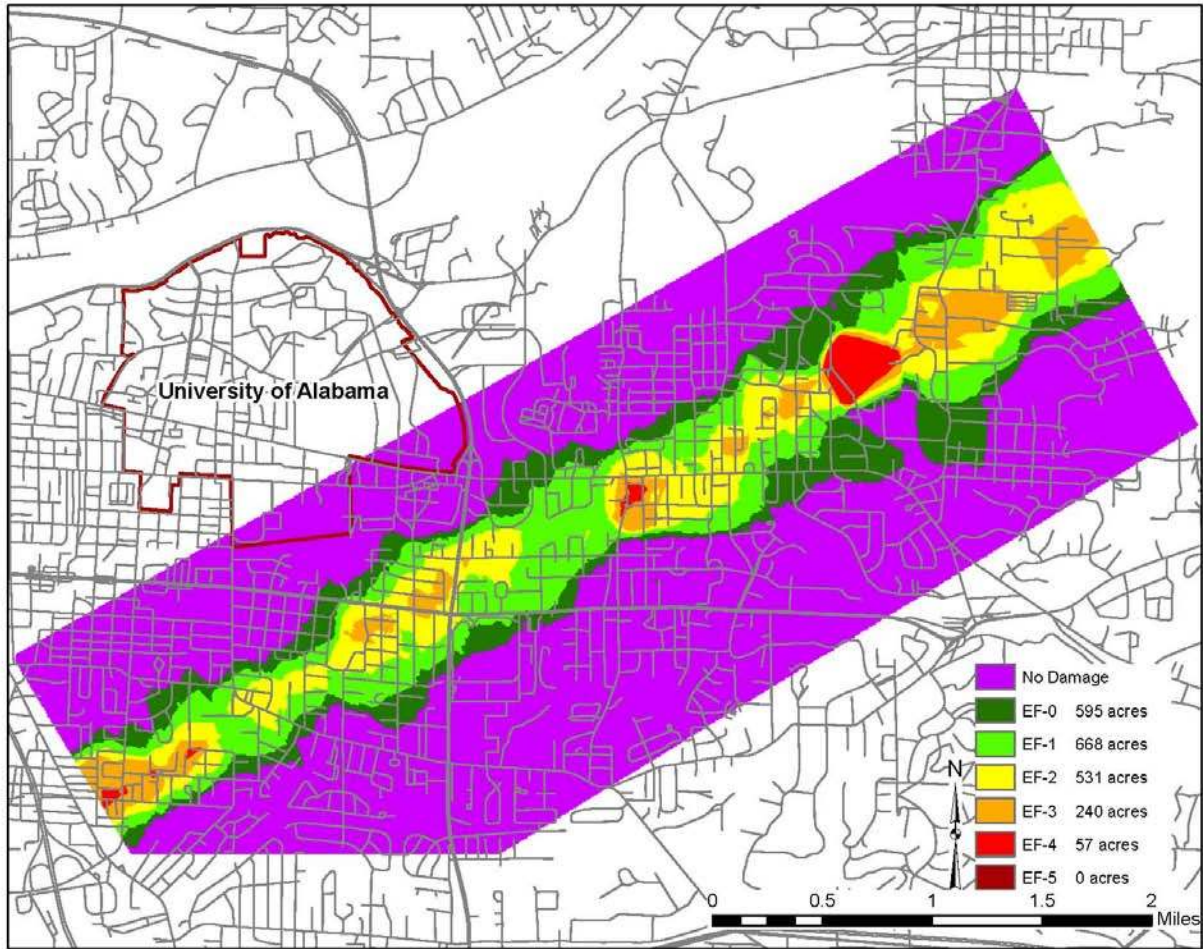
As expected, the contours in Figure 2.5 show that the majority of buildings in Tuscaloosa received no building damage. The area of each wind speed (in acres) calculated from the map in Figure 2.5 is shown in Table 2.1. The vast majority (92 %) of damage was at the EF-2 category or lower (wind speeds below 137 mph).

Figure 2.5 Contour map of EF wind speeds based on observed building damage

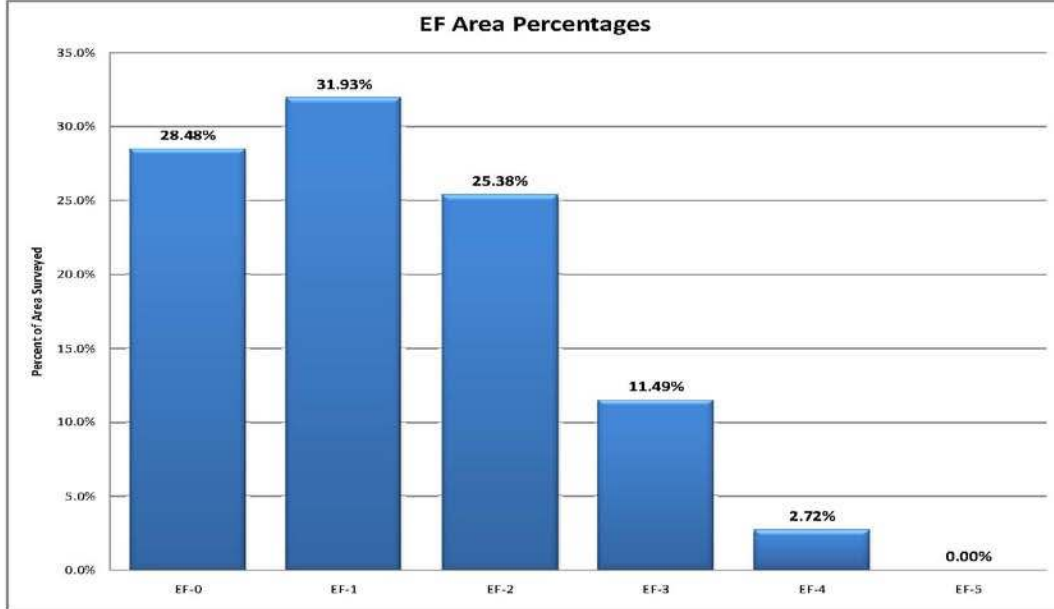
Figure 2.6: Portion of tornado affected area related to each EF designation.

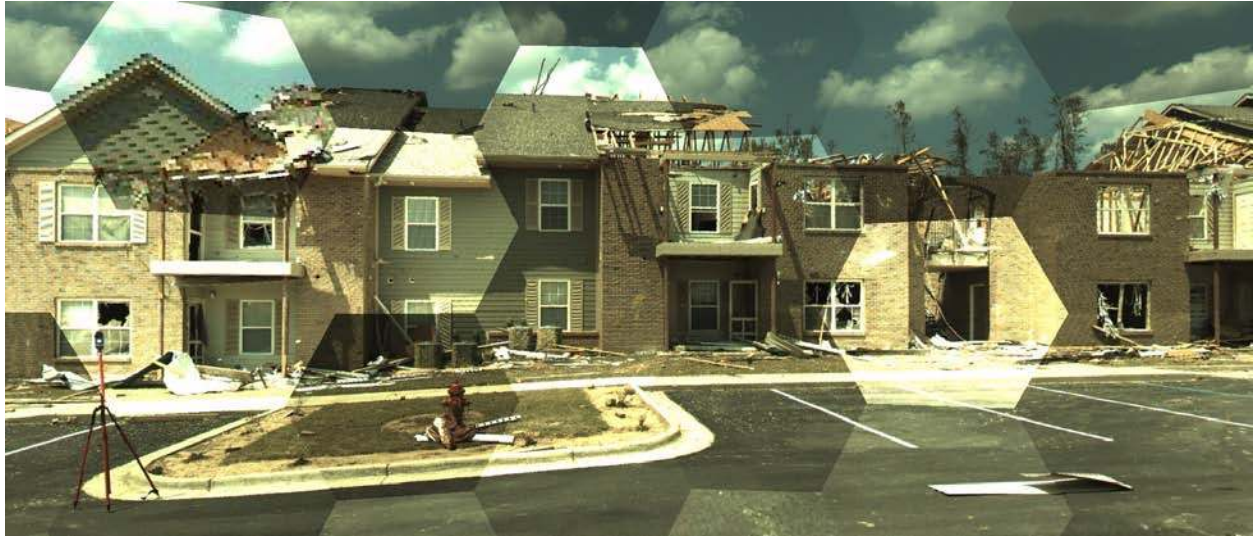
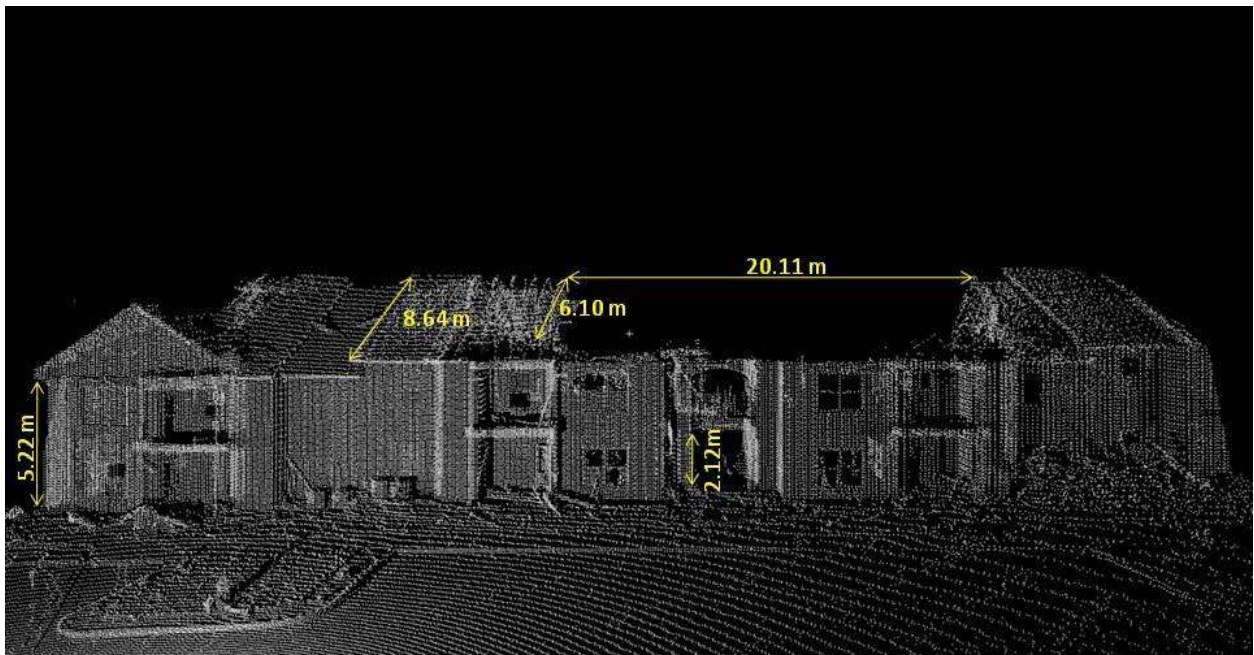
Figure 2.8. (a) Panoramic view of apartment complex and (b) equivalent measurement of damage extent with point clouds view

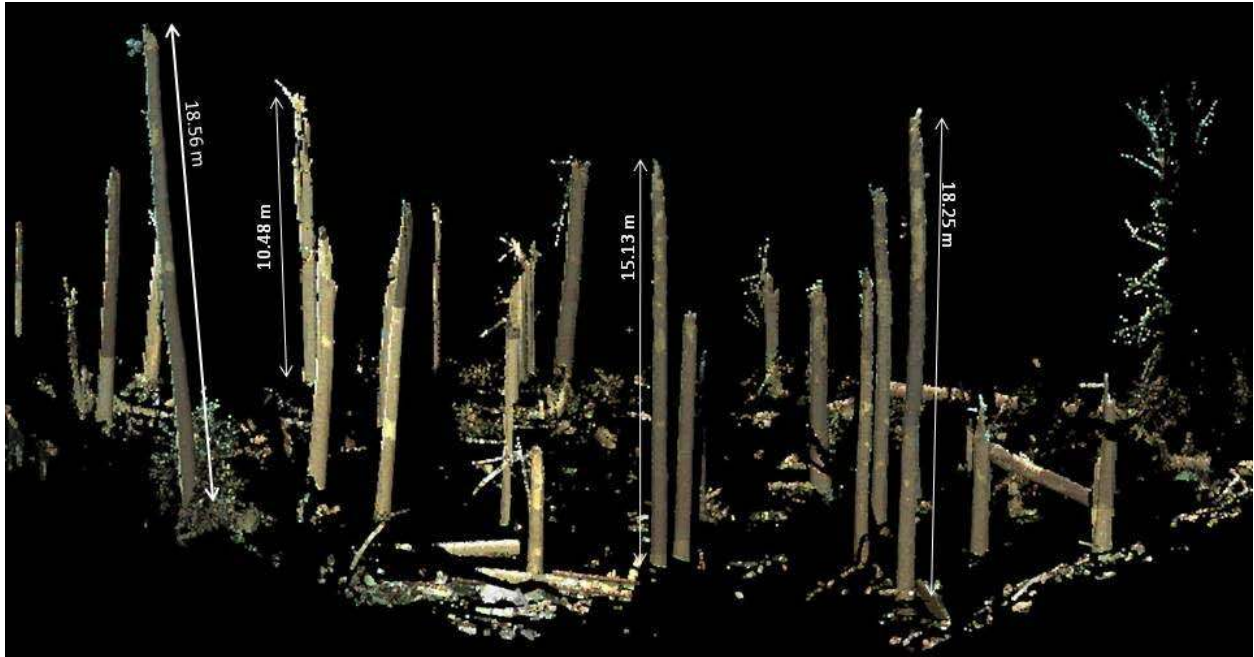
Figure 2.9. Measurement of debarked trees height

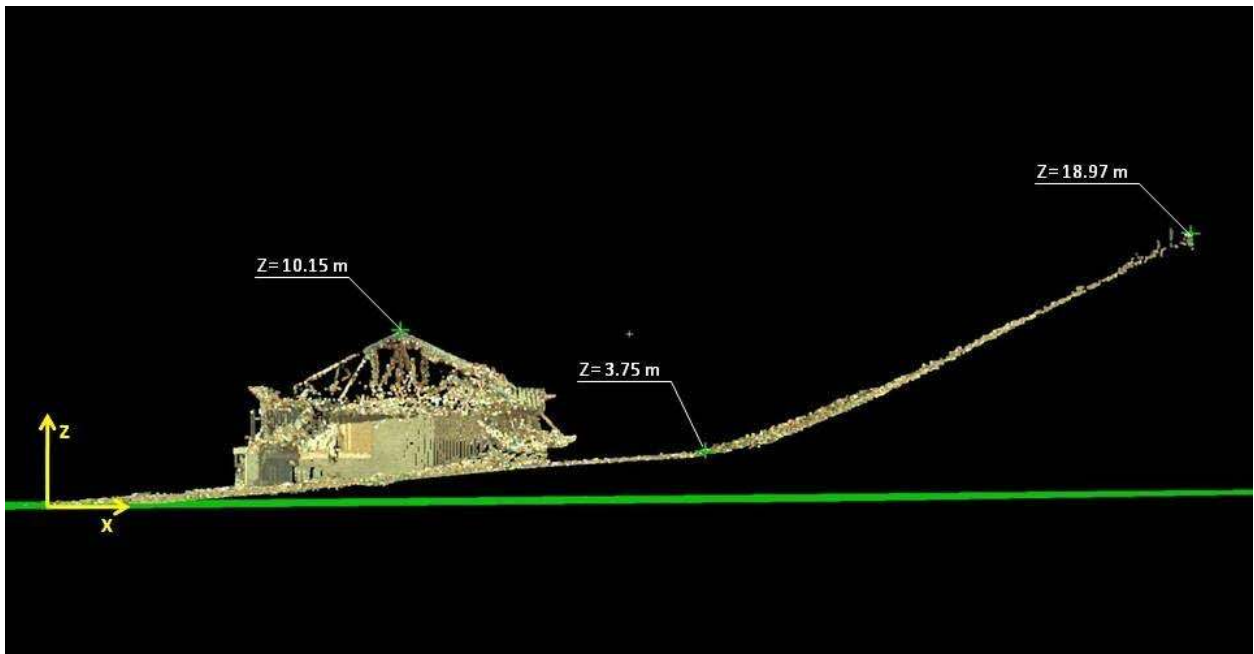
Figure 2.10. Elevation measurements across a damaged apartment and nearby terrain profile
